Whinnah, A5086 Lamplugh Distribution Centre and Agricultural Storage

Road Safety Assessment of Junction Access Options

Report No. NS23/836/RSAss

May 2023

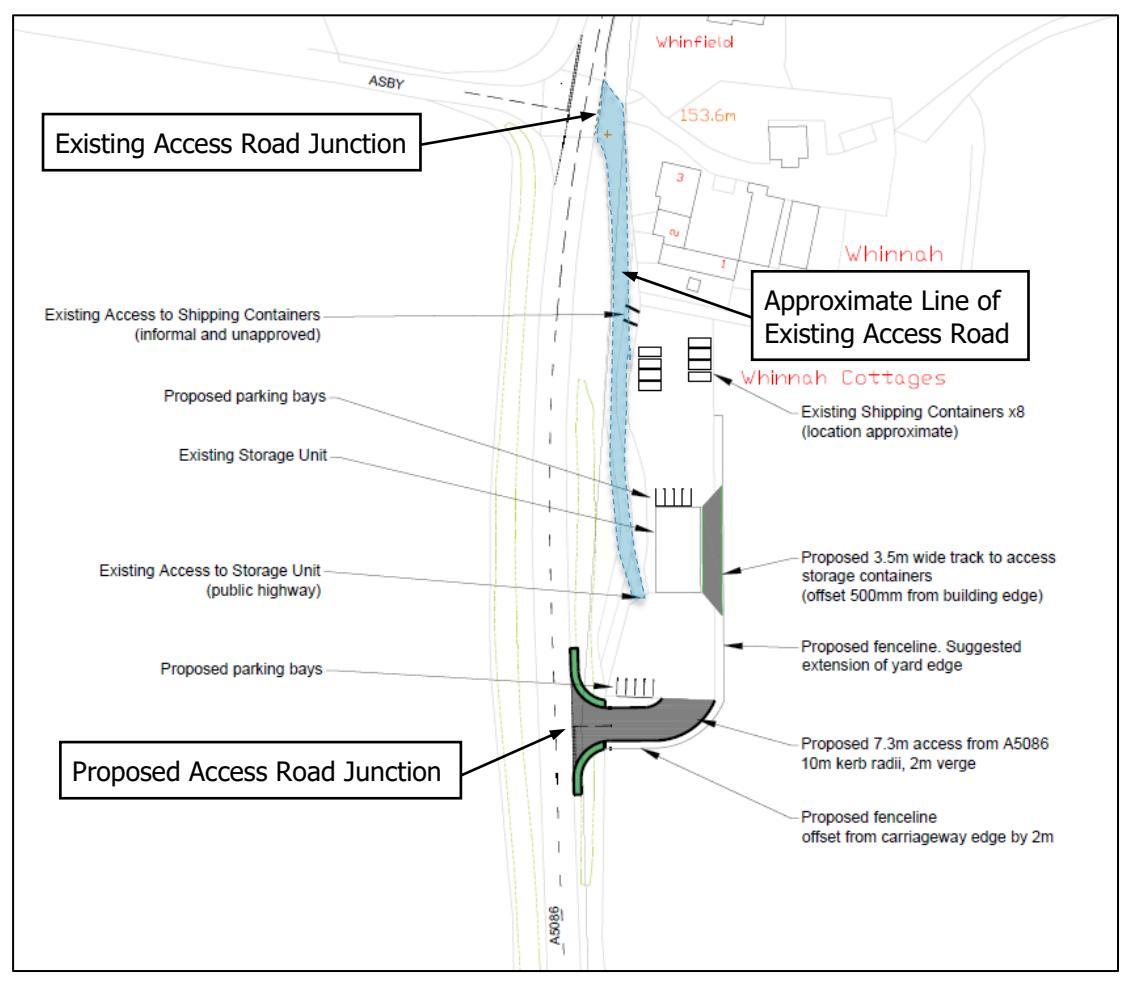
Figure 2: The Existing and Proposed Junctions and Access Roads

parallel to the A5086 and is part of its previous alignment. However, this alignment, when combined with its proximity to the A5086, means that drivers of long vehicles (in particular rigid HGV's) cannot complete the right-turn in and left-turn out of the access junction without encroaching within the Asby Road junction opposite. This is supported by videos submitted to the Assessment Team showing (a) an articulated HGV turning into and out of the access junction, and (b) a large rigid vehicle turning in. The videos showed both vehicles encroaching slightly into the Asby junction while turning.

- 4.5 Recommendation 1: Proceed with Option 2 and provide the new junction;
- 4.6 Recommendation 2: On the assumption that Recommendation 1 is accepted and progressed, change the existing centre line system to warning lines on the junction approaches;
- 4.7 Recommendation 3: On the assumption that Recommendation 1 is accepted and progressed, restrict the use of the existing junction for vehicles accessing the facility. As a minimum, this would remove the right-turn in and left-turn out for long vehicles (this can be achieved by agreement with the applicant).
