# SPECIFIC DEFECTS REPORT DAMPNESS TO AIRING CUPBOARD WHITEHAVEN CASTLE, WHITEHAVEN, CUMBRIA, CA28 7RA

March 2021

Reference: 3495-06-18- GG Prepared By: Storm Tempest Ltd 3 Apollo Court Koppers Way Monkton Business Park South Hebburn Tyne and Wear NE31 2ES Version 1: Prepared For: Home Group Anthorne House Irish Street Maryport Cumbria CA15 8AD

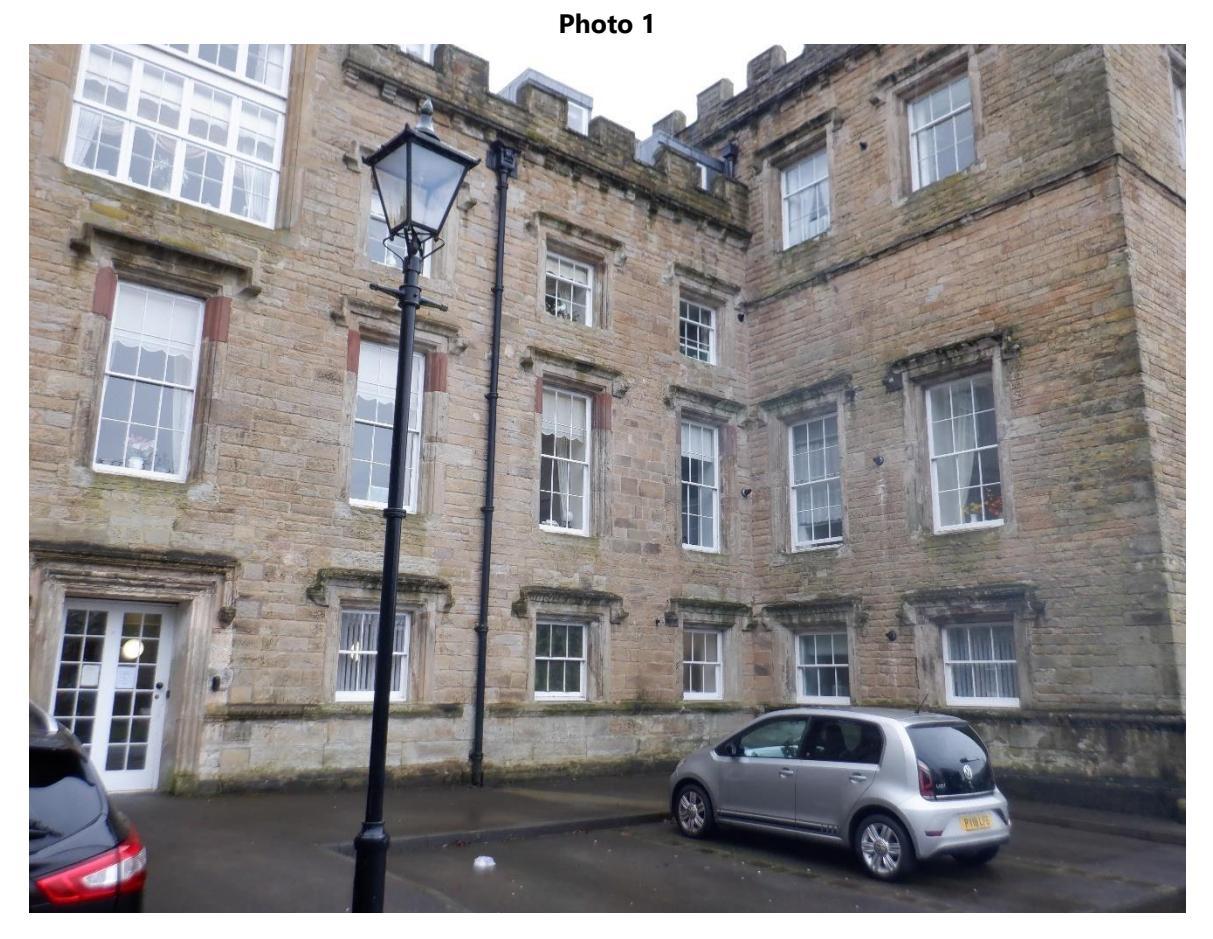
We inspected the external envelope of the property in the area directly corresponding to the damp meter box cupboard and noted the walls to be generally in a satisfactory condition. The rear wall of the meter box cupboard is the solid stone external wall directly between two ground floor windows. We identified some staining in this area which we attribute to rainwater dripping down the surface of the walls from the above parapet. From our limited ground-based inspection, we believe there is a hidden gutter behind the parapet that discharges through a concealed penetration into a cast iron hopper and downpipe.

We cannot comment on the condition of the hidden gutters, however the hopper and downpipe appeared in satisfactory condition. Based upon the location of the staining leading from the parapet corbeling and to the wall directly below, we suspect there may be a defect to the hidden gutter/parapet wall detail, allowing rainwater to escape.

- 3.1 The staining visible to the solid stone external walls in the area that corresponds internally with the airing cupboard is attributed to rainwater tracking down the surface of the external elevation walls. We identified an area directly below the parapet corbeling as the most likely origin of the dripping water and recommend it is inspected at roof level along with the hidden gutter behind the parapet wall for signs of defect. It is unlikely that the rainwater dripping onto the external walls is solely responsible for the damp issues noted internally to the cupboard, however it will prolong drying out of the walls after periods of wet weather and may be exacerbating the dampness internally.

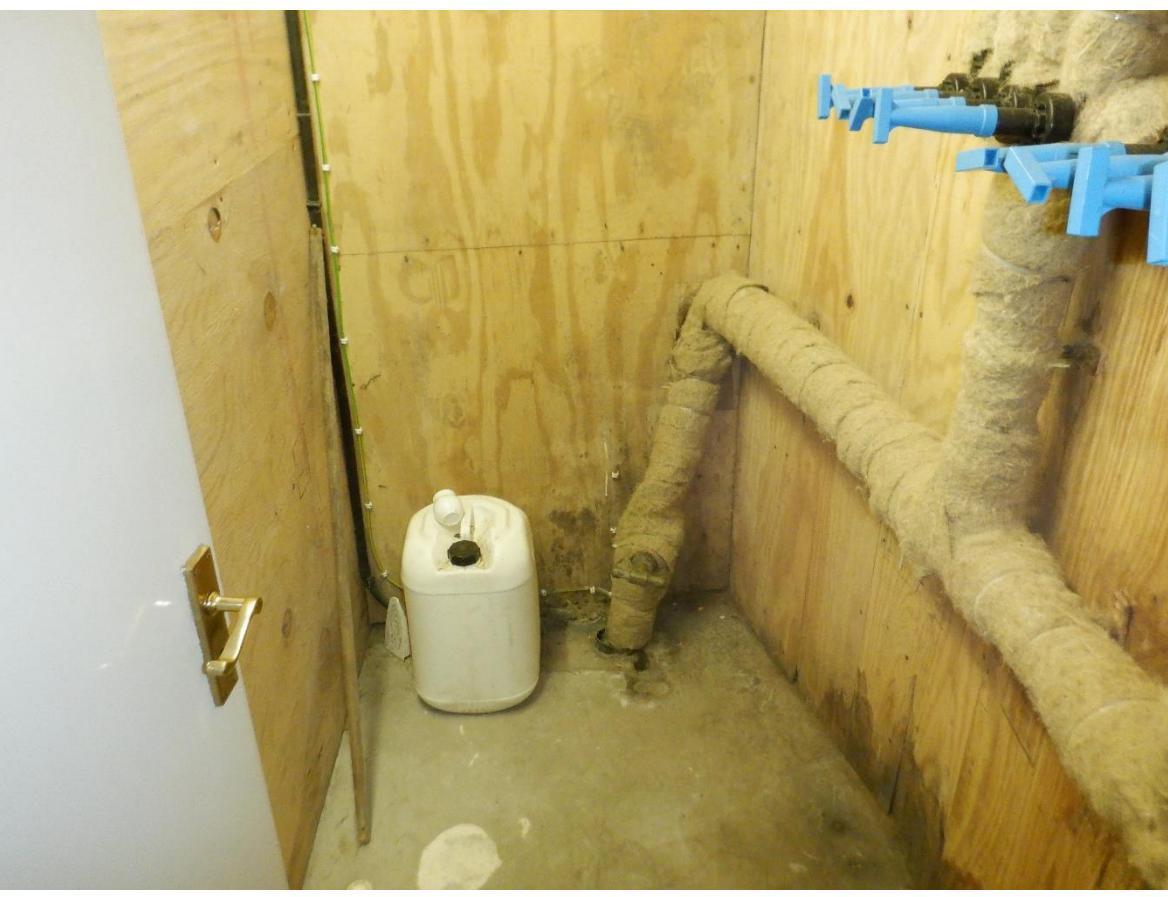
Photo 5

Internally the airing cupboard is situated between a stairwell and the electrical plant room. We immediately noted the damp odour that had been described by the residents and that the door to the airing cupboard has louvred vents from which the smell is likely escaping. Internally the cupboard was a small space and noticeably warmer than its surroundings due to the heat radiating from the pipework. The damp odour presented very strongly within the cupboard itself, however we did not identify any condensation mould growth at the time of our survey.

The heating pipes had been wrapped in a mineral wool type insulating lagging that may be absorbing moisture and smells and contributing to the issue. The walls of the cupboard were lined with plywood panels that were visibly damp stained directly above floor level and had started to decay. We tested the timber with the electronic moisture meter and recorded elevated moisture levels, we also recorded elevated moisture levels to the floors, which we attributed to rising dampness as there was no evidence of leaking pipework.

- 3.5 We recommend that the timber panelling is removed from the walls and disposed of in order to allow the stone walls to breath naturally and prevent the moist air becoming trapped within the wall void. The low-level rising dampness to the walls and floors can be remediated by installation of a liquid DPM and retrofit DPCs, however as the walls are un-plastered and in a non-habitable location it may be preferable to simply let the moisture evaporate naturally. The existing pipe lagging should be removed and replaced with a foam type product that will be more resilient to moisture and does not readily absorb odours. Finally, we recommend the installation of a consistently running mechanical extractor to the solid stone external wall in order improve ventilation and remove warm moist air and odours from the cupboard itself. It is our opinion that it would be a more sympathetic option to control the moisture levels through ventilation, rather than by attempting to seal away the dampness with retrofit barriers and membranes.

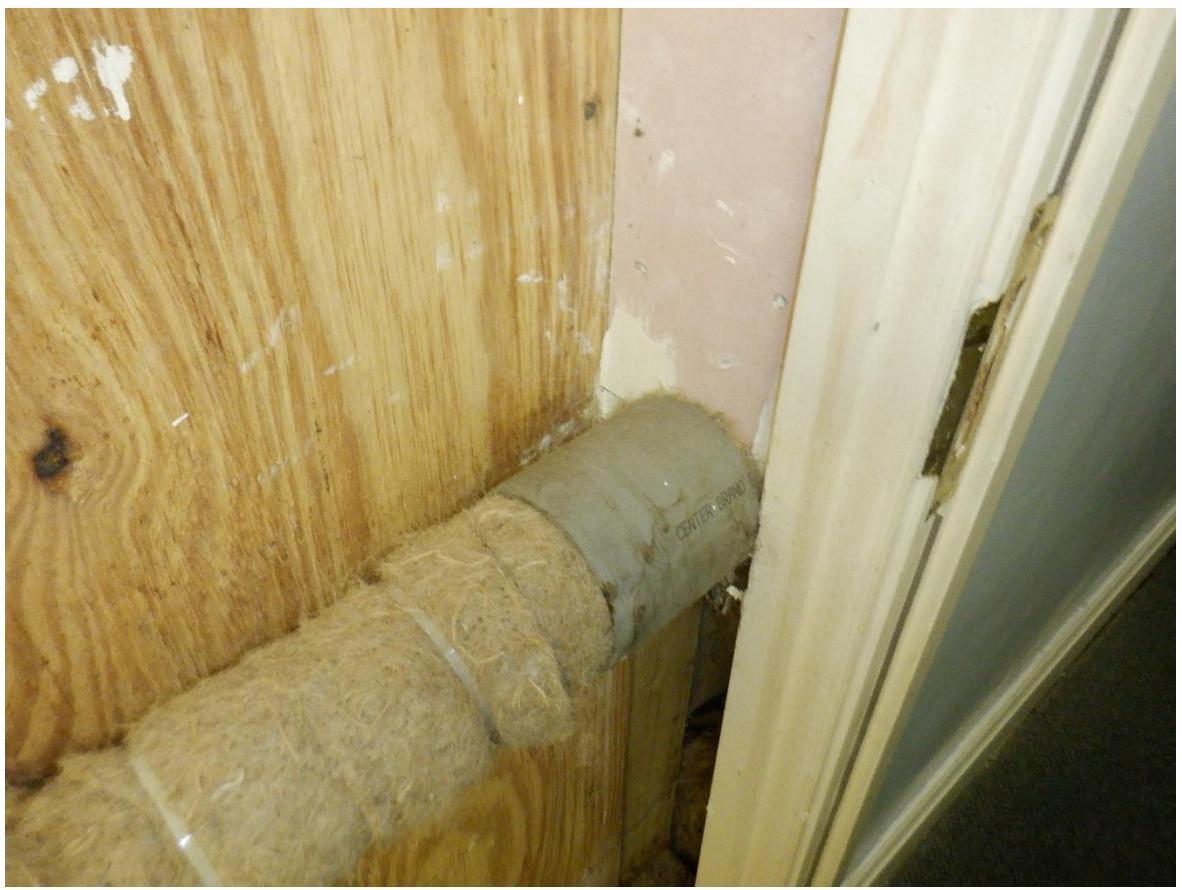
Photo 8

We inspected within the electrical cupboard to the left-hand side of the damp cupboard, which we found to be free from dampness and odours at the time of our survey. On the other side of the solid partition wall to the right-hand side of the airing cupboard is a stairwell, the damp smell was also present here and we noted heavily corroded sections of spare metal pipework. We tested the solid partition walls and the rear elevation solid external walls within the stairwell and recorded elevated damp readings to both.
