Millom Castle and Holy Trinity Church Conservation Area Appraisal

October 2023

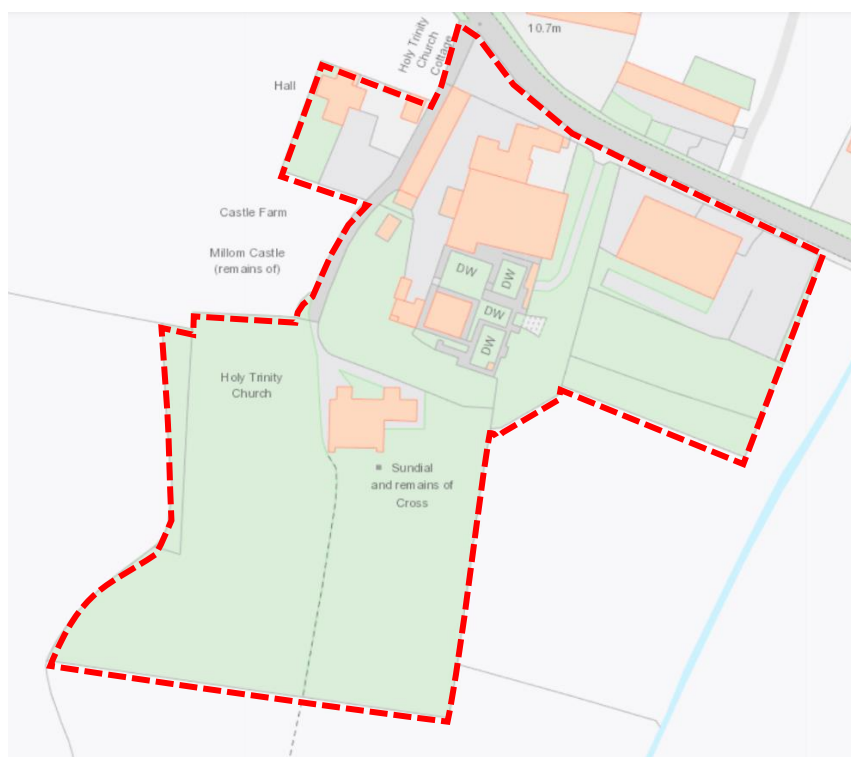
Figure 2 Conservation area boundary. Approx. area 2.3 ha.

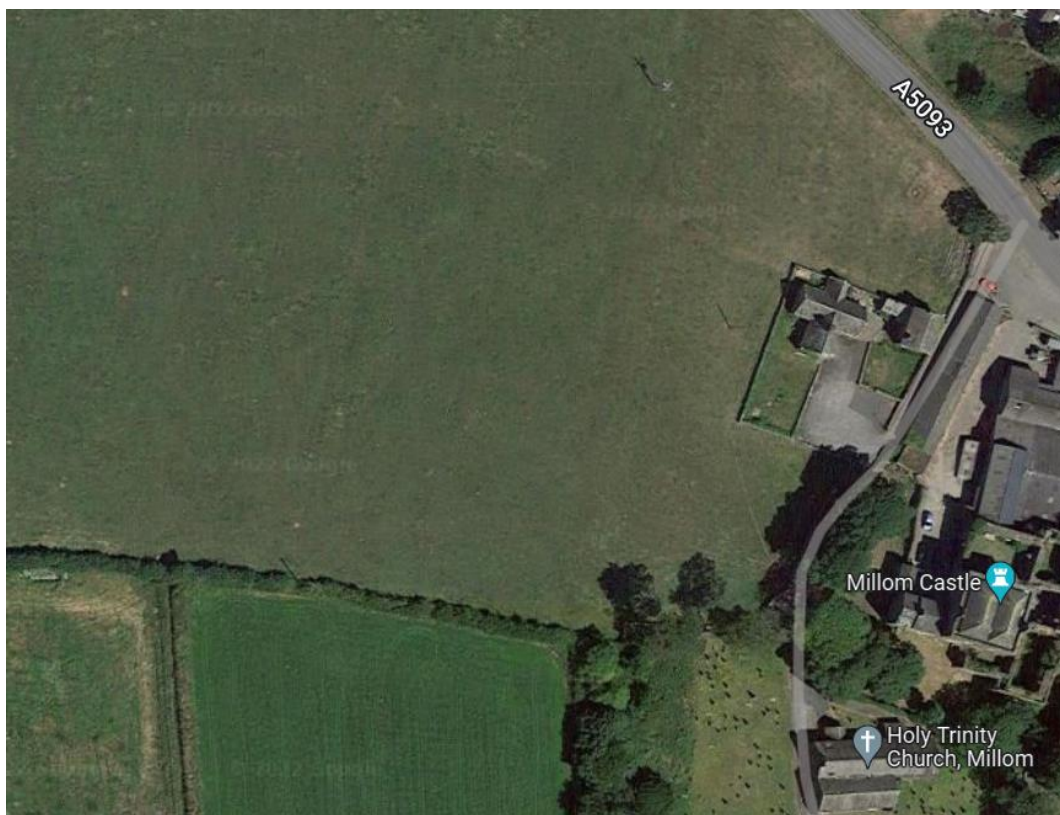
Figure 6 The boundary line of the old glebe enclosure is still faintly visible in aerial photography

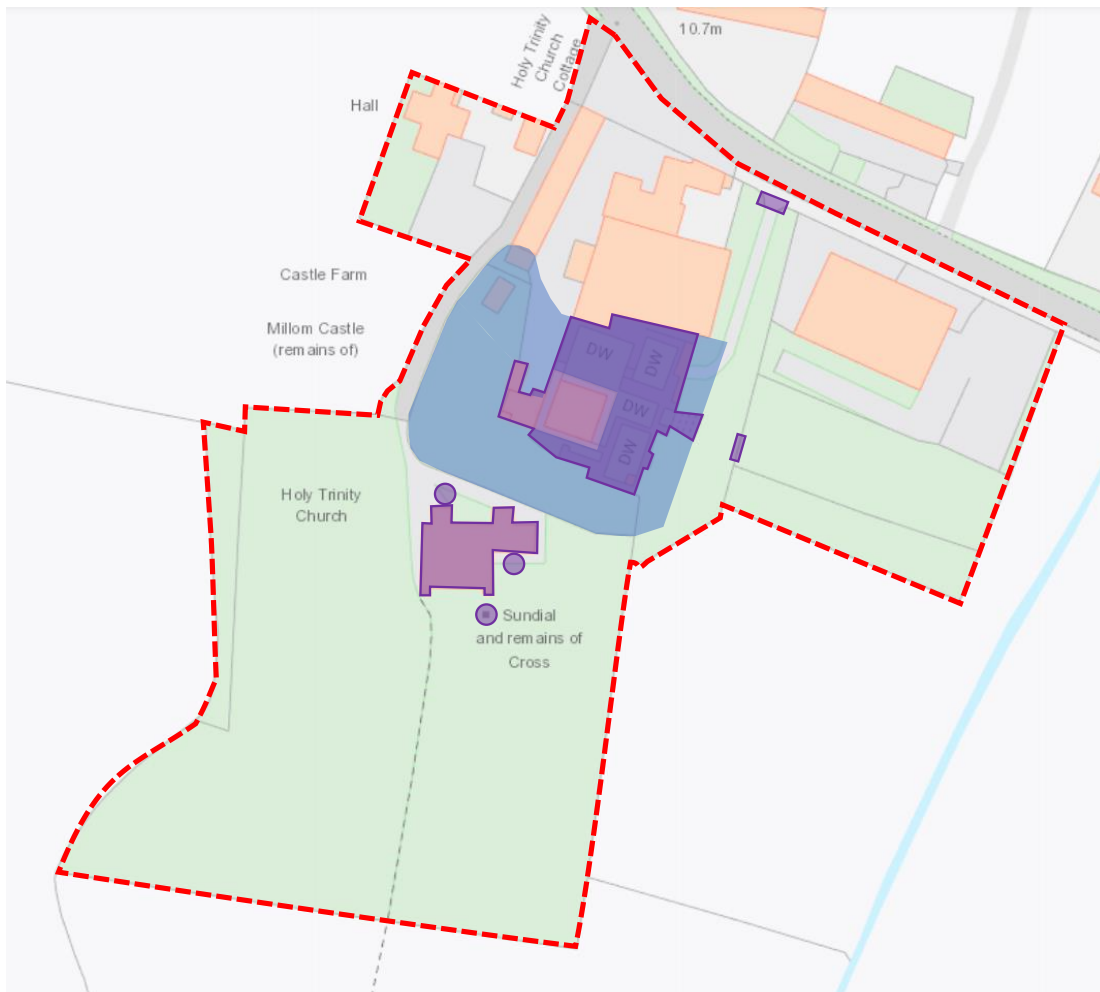
Figure 7 The area as it appears today, with listed buildings (purple)² and scheduled monument (blue) highlighted. A modern farm building has been inserted to the north-east of the castle, but very little has otherwise changed in the last century

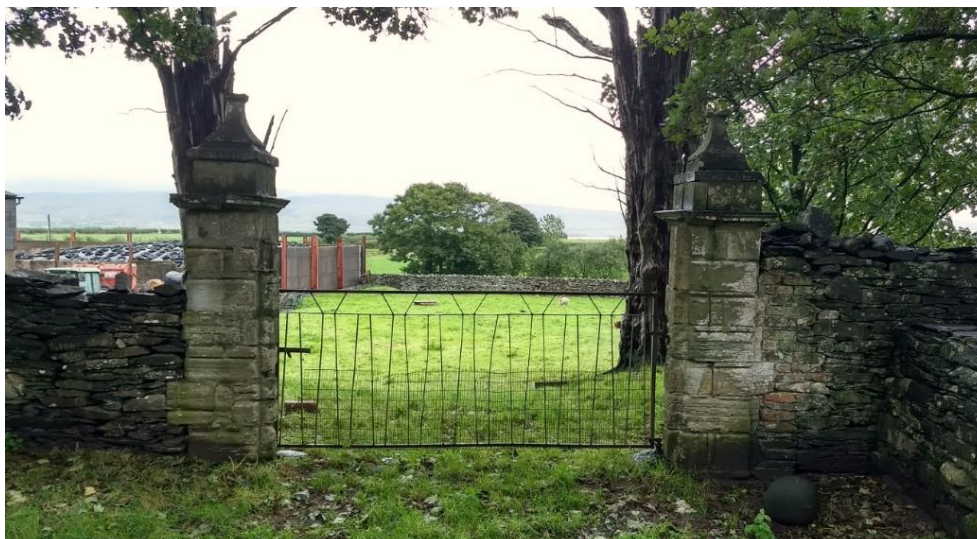
Figure 8 One of the pairs of grade II listed gate piers, to the east of the castle ruins. One of the ball finials appears to be lying nearby.

- Additionally, two sets of stone gate piers dating from the 17th or 18th centuries – conceivably contemporary with the last major round of repairs the castle received in 1670 – are to be found in the east and north boundaries of the area. Both are grade II listed. The Buck engraving of 1739 reveals that the wall in which these are set was originally of much more “polite” appearance, being of low-set masonry with piers at regular intervals containing either ironmongery or wooden fencing. It appears that the right-hand gate pier in the image below retains some fragments of its original wall masonry within the more recent wall. Both of these were originally surmounted by ball finials, one of which can be seen lying on the ground. This gateway lead into a garden. In the Buck engraving of 1739, a row of small ornamental trees is shown in about the same position as the line of mature trees now present. Cowper’s account of 1924 refers to the pair of gate piers adjoining the road as having ball finials, but now only one is in situ. The other one may be nearby.

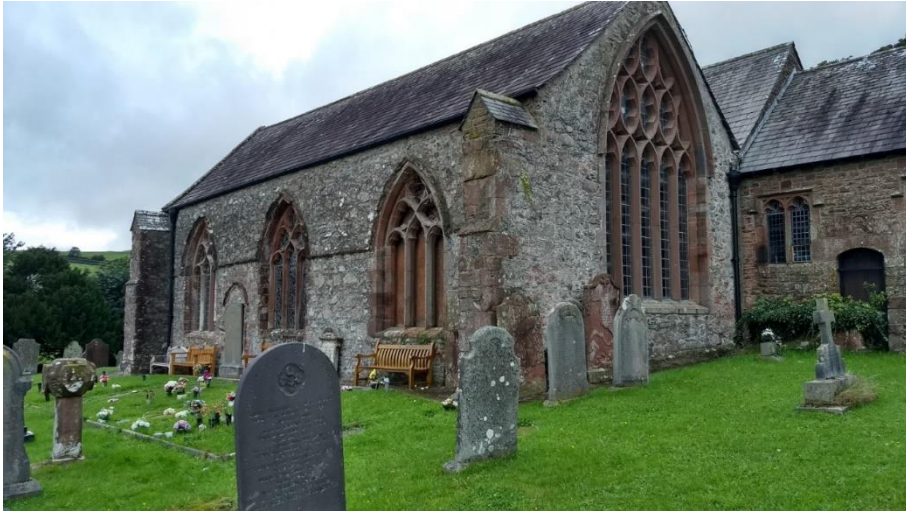
Figure 9 Holy Trinity Church from the south. The graveyard contains stones from a number of centuries, as well as a chest tomb and sundial that are listed in their own right.

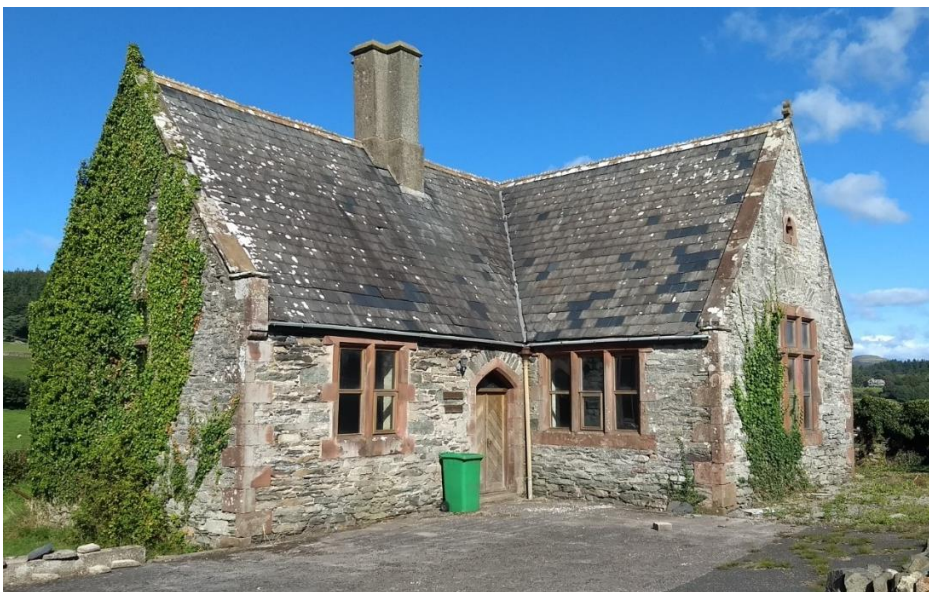
Figure 10 The schoolroom

The schoolroom of 1858 is a handsome little stone building on a cross plan, with gothic revival elements such as the mullioned and transomed windows, fake stone window arches and monumental chimney stack. Although not listed, it is a non-designated heritage asset and of sufficient quality to sit comfortably alongside the other buildings.

The schoolroom is an early type of school belonging to the church, evidence of innovative education practices. It has communal value through shared memories of its use by the local community, having had longstanding use for the Sunday school. At one point, it also contained a library.

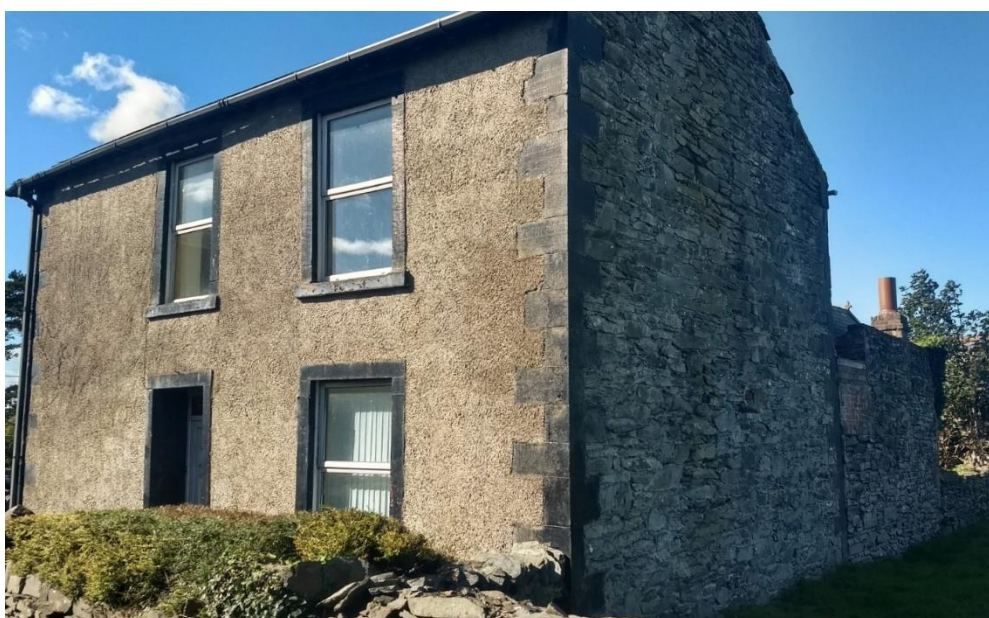
Figure 11 The headmaster's house

The headmaster's house was built slightly later than the schoolroom, sometime about 1865, when a tender advertisement for the job was placed in the *Whitehaven News*. It is a small, two-storey house with end and intermediate chimney stacks and quoined corners in the style typical of late-19th century West Cumbrian cottages. To its west side is a single storey wash house connected to the cottage via a porch that acts as a link. The windows have been replaced with unattractive plastic units.

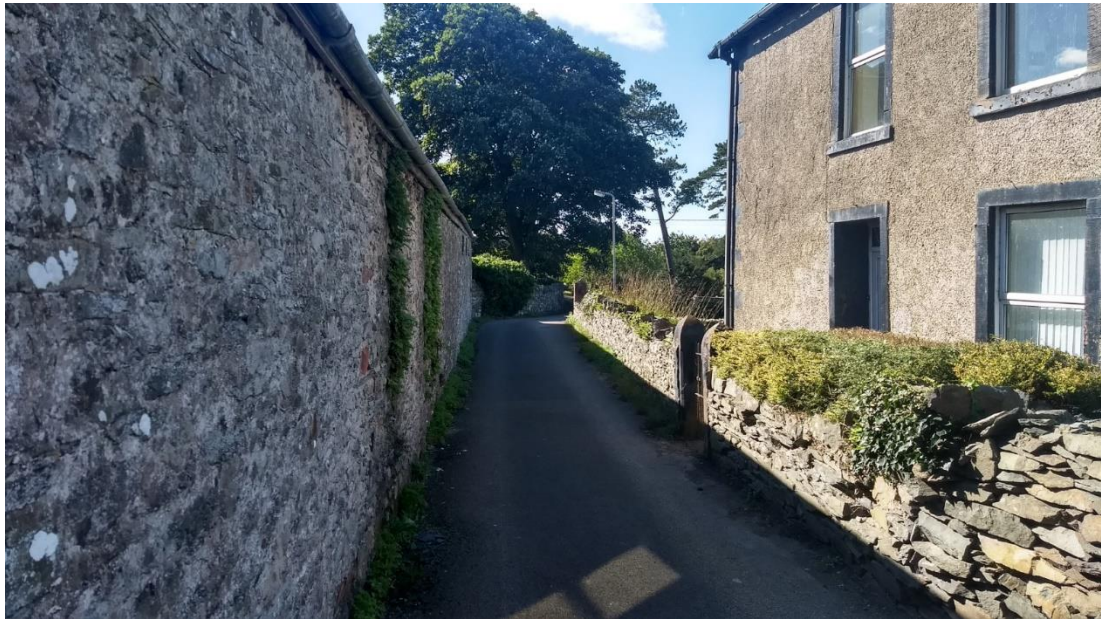
Figure 12 The lane that leads to the church between the headmaster's house (left) and the rear of the farmyard byre (right). The entrance to the Schoolroom car park is just past the headmaster's house on the right.

A lane leads from the roadside, between the byre and the Headmaster's House, down to the door of Holy Trinity Church. It is large enough to permit car access, but only just, and maintains the intimacy and intrigue of the area.

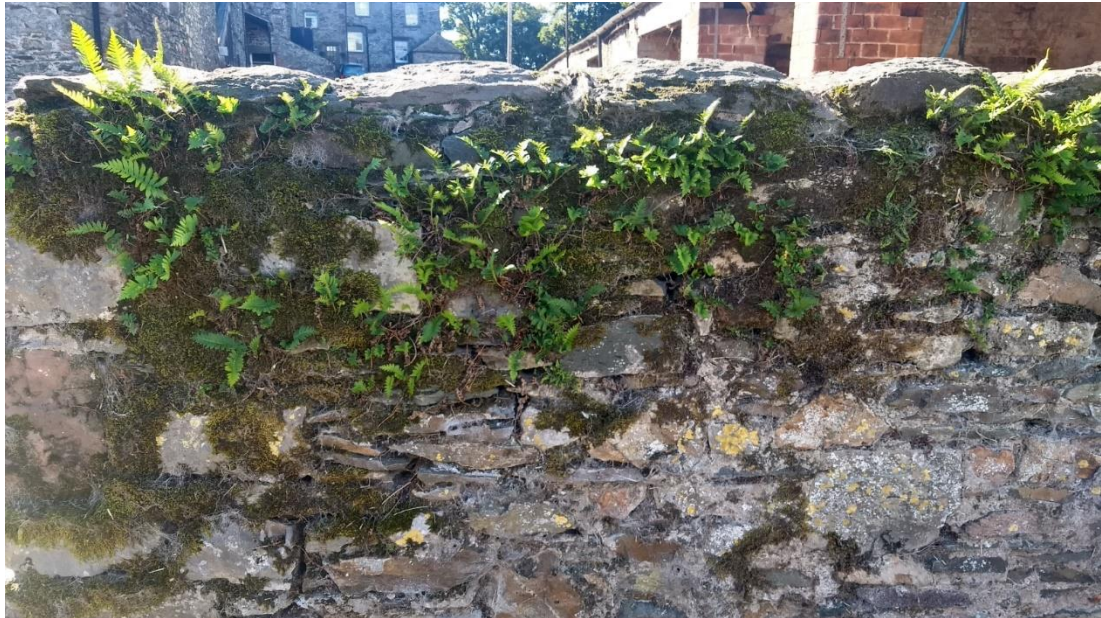
Figure 13 The old rubble wall at the roadside

The site is bounded by a number of old masonry walls that greatly enhance its character and appearance, including on the roadside. In two places, these walls also contain gate piers that date from the 17th or 18th centuries and are grade II listed.

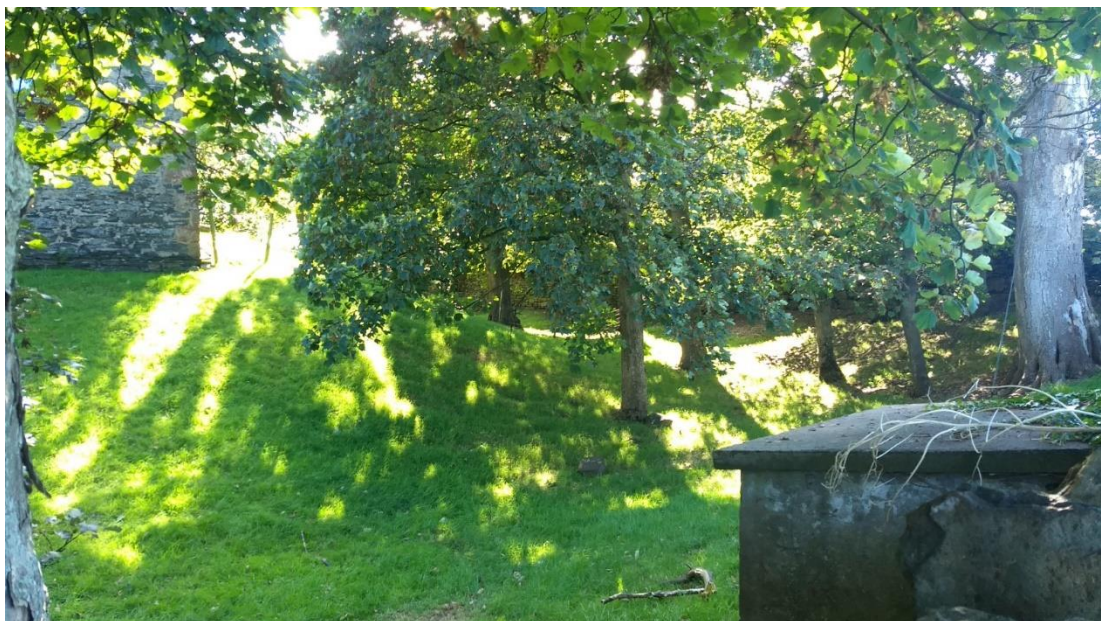
Figure 14 The moat is still visible at the castle's south-west corner

The remains of a dry moat survive on the castle's south and west sides. Its appearance emphasises the impression of height given by the castle tower from these angles, which sits above the embankment on the other side.

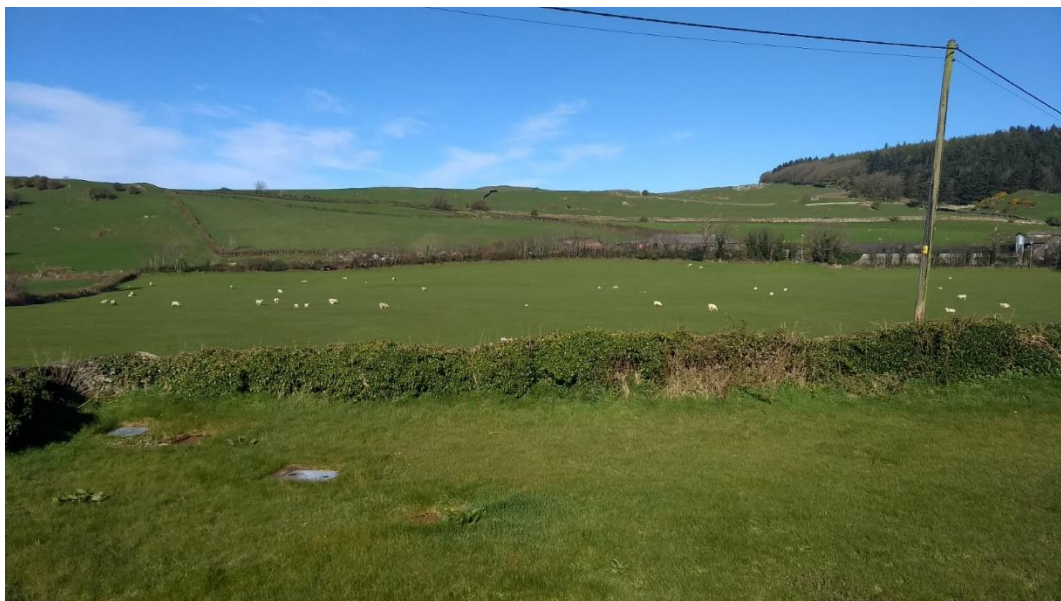
Figure 15 The grass curtilage of the schoolroom, looking westward over the former church glebe, now subsumed into Childrum Field beyond

The schoolroom has a small grass curtilage to its south, and a tarmacked car park that, while no aesthetic contributor, does greatly improve access by car to the conservation area.

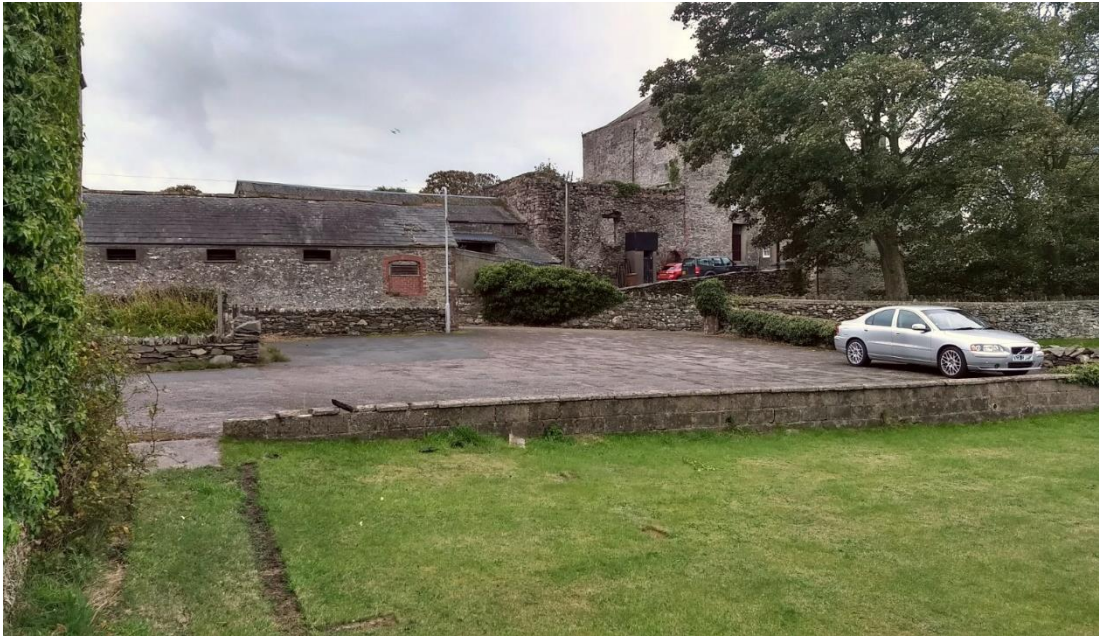
Figure 16 The car park at the schoolroom does not make a positive contribution to the character and appearance of the area, but it is well concealed and very useful given the site's relative inaccessibility

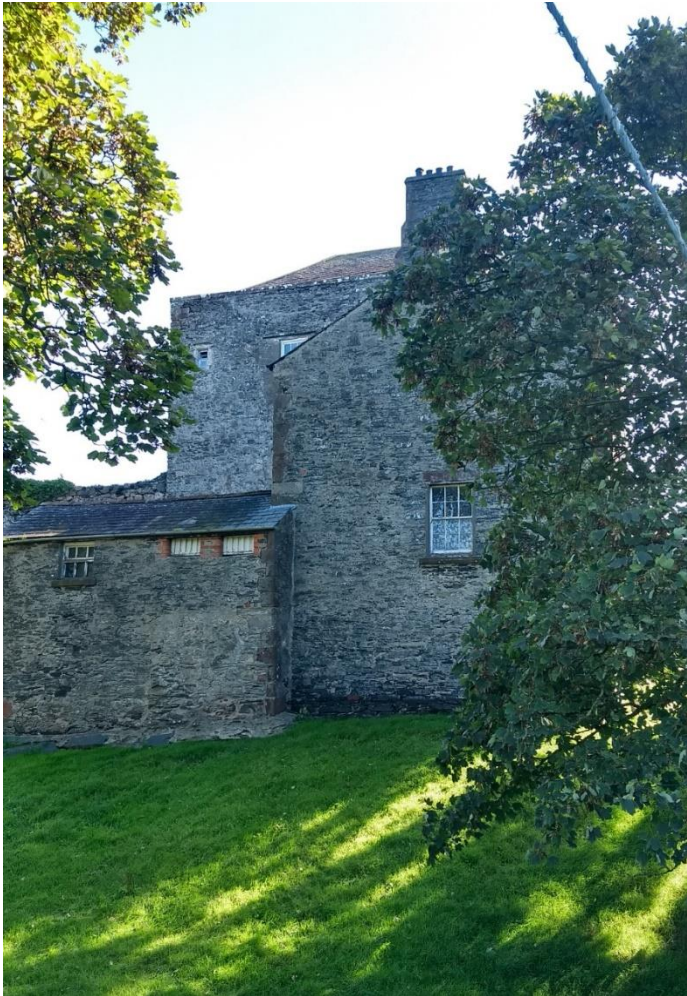
Figure 17 The castle and church sit alongside mature deciduous trees. There are also pines and yews in the church yard

Mature deciduous trees play an important role in softening the appearance of the site, and introducing dense shadow and greater impression height, particularly during summer.

Care should be taken, however, that self-seeded saplings don't cause further damage to the masonry. A substantial young tree is already visible high in the south-east corner of the castle ruins, and will be causing further damage with every growth season.

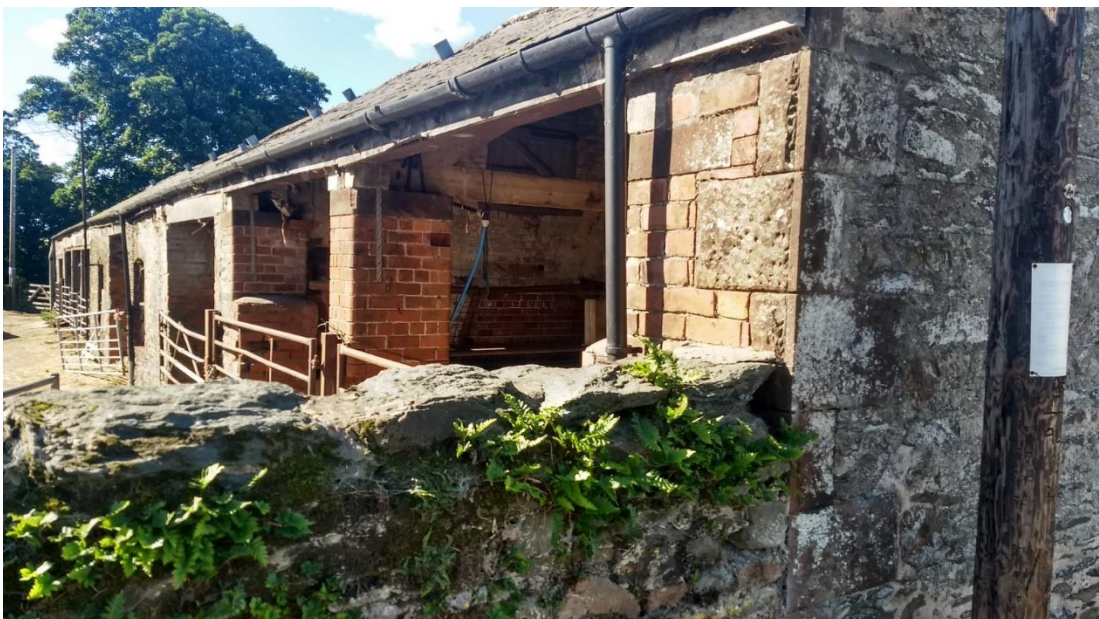
Figure 18 This old wall adjacent to the byre has small ferns growing in the top that enhance its character. Plants can, however, cause damage in masonry when left unchecked.

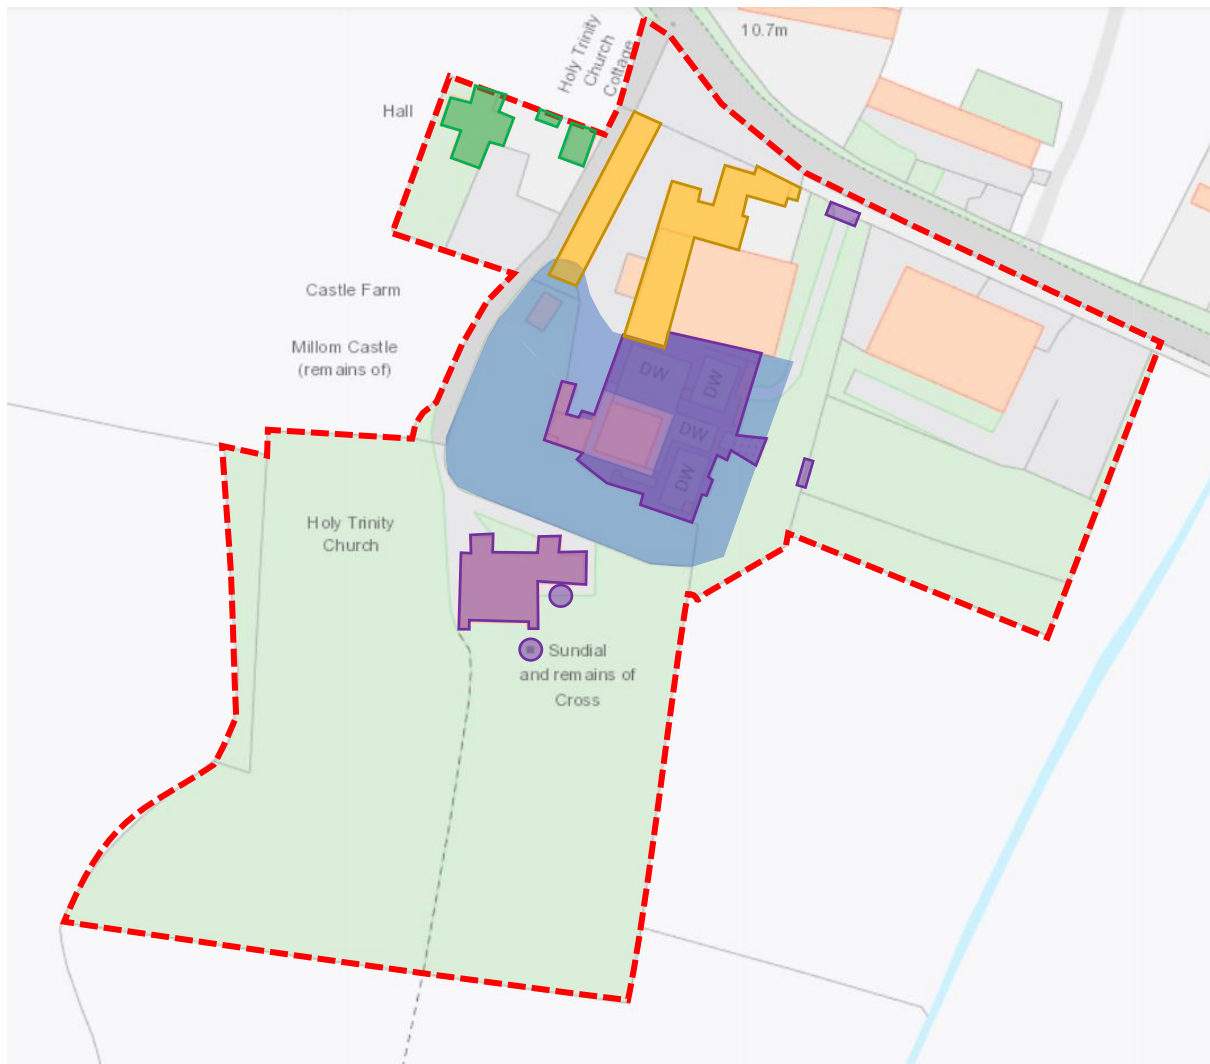
Figure 20 Map of conservation area with heritage assets

- Boundary (red dashed)
- Listed buildings (purple)
- Scheduled monuments (blue)
- Assets considered within the curtilage of the Castle listing (Yellow)
- Non-designated heritage assets (green). This shows the buildings only; walls and surfaces are not shown, but are still significant and should be identified using heritage assessment.
- Some trees are significant; others are problematic. These are not shown here.

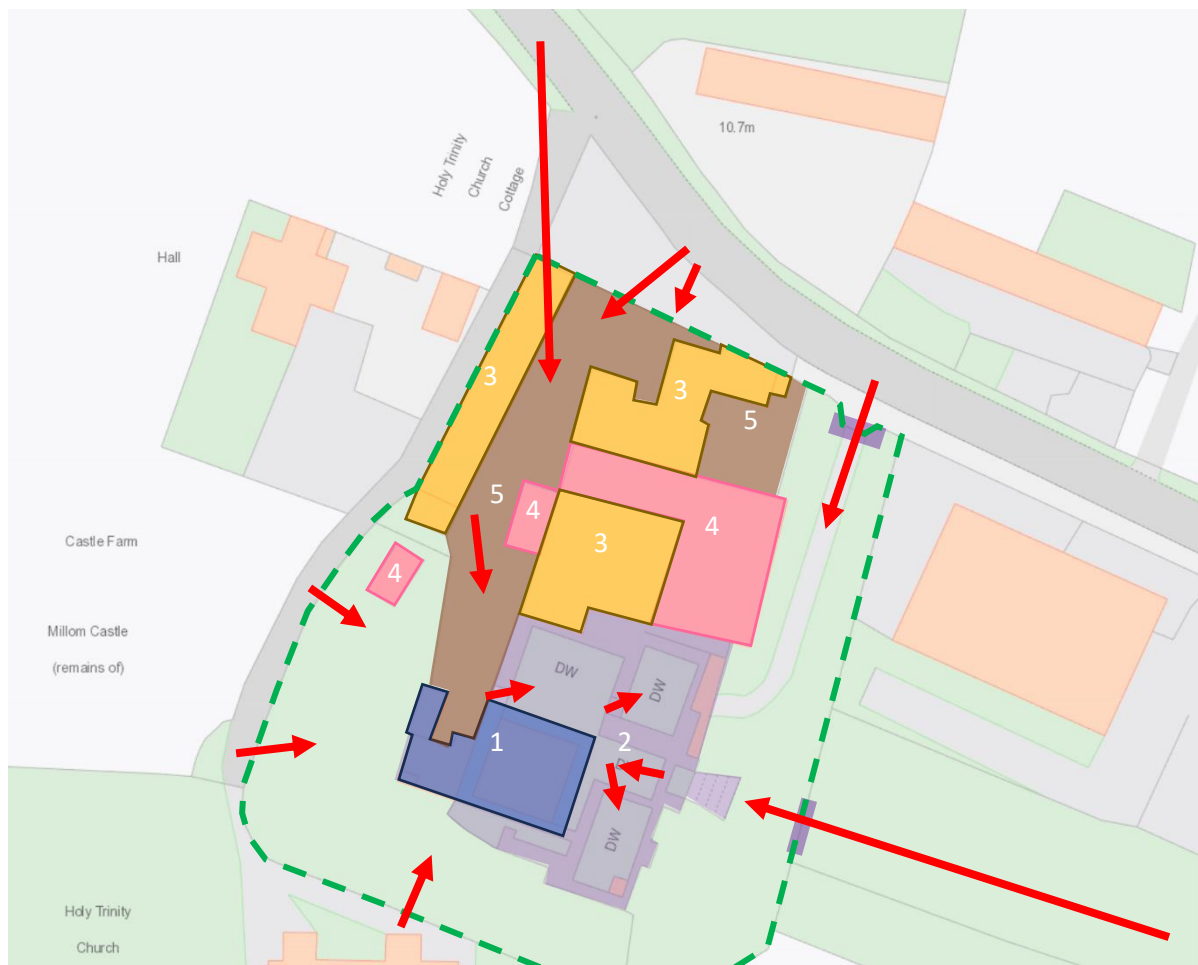
Figure 21 Farmstead Assessment Map for Castle Farm

1. Grade I listed farmhouse (Dark blue)
2. Grade I listed ruins of castle, and grade II listed gate piers (Purple)
3. Historic farmstead buildings in existence by 1922 (Yellow)
4. Farmstead buildings added since 1922 (Pink)
5. Farm yards (Brown)
6. Historic boundaries enclosing Castle curtilage, also containing Millom Castle (Ruined portions) scheduled monument, including moat (Dashed line)
7. Important views⁴ (Arrows)

Please also refer to Appendix 6.3.2 Castle Farm Site Assessment Map
