St Bees Conservation Area Appraisal

2021

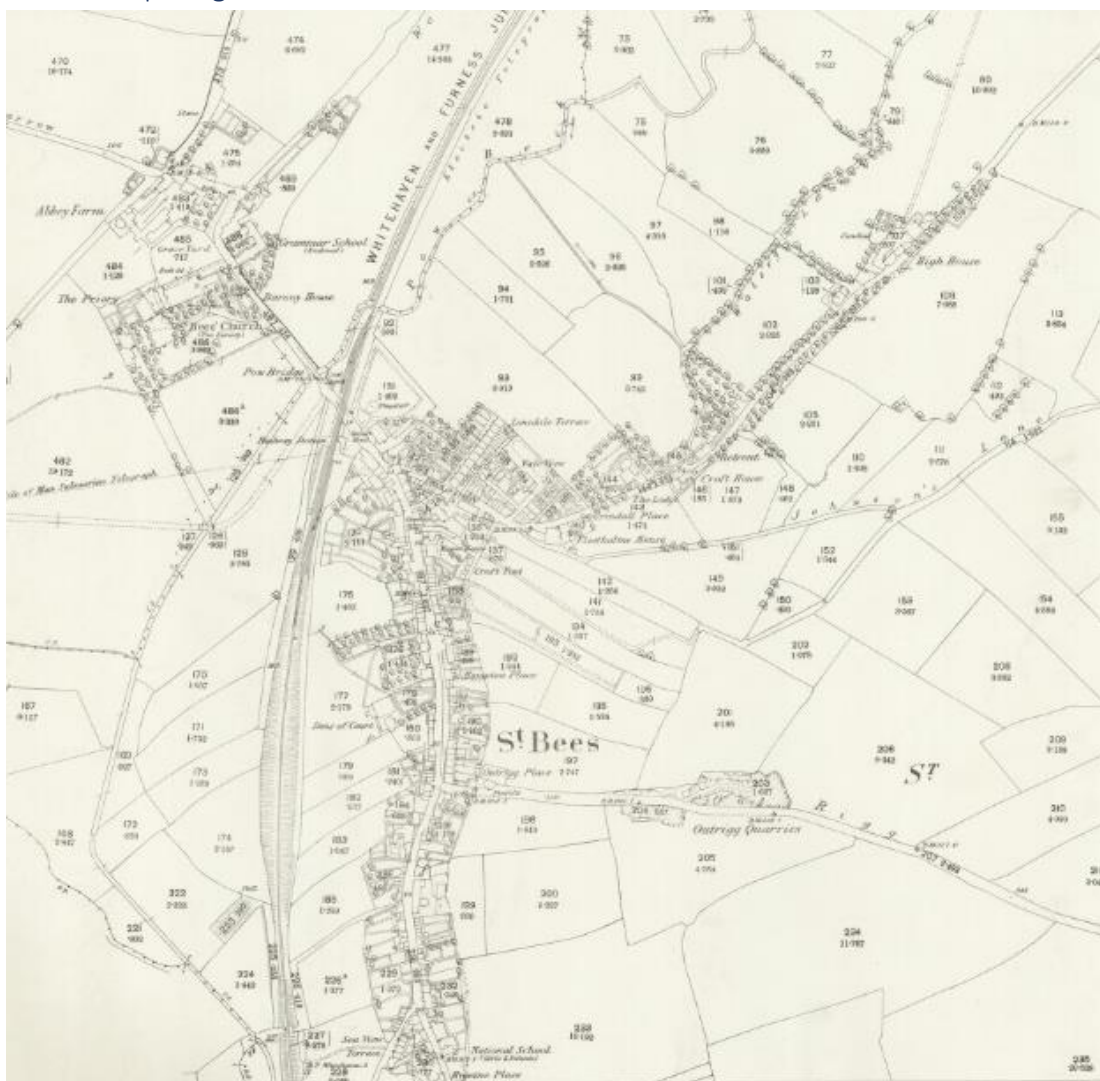
Figure 3 OS 25" 1863.

Figure 3 shows St Bees during a period of expansion for both the school and the village itself. Generally speaking, the village originated at the top-left corner, with the priory and the school, however, even by the 16th century there were various other properties dotted about, such as Cross Hill House/Manor Stead, the now divided birthplace of Edmund Grindal. Gradually, the separated farmsteads have been infilled with later houses, and Main Street has progressed southward.

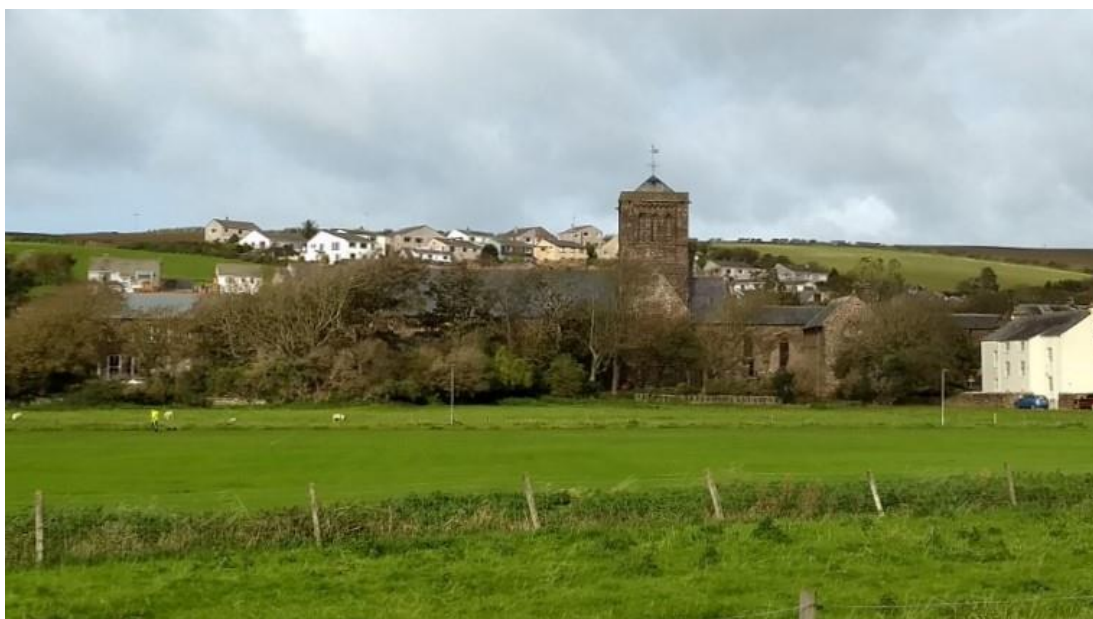
Figure 7 The setting of the priory church has been harmed by post-war housing that not only lacks architectural merit but is positioned on a hill so as to be visible from the entire surrounding area.

The Pow Beck valley character area serves as a good example of the ways in which setting can be harmed. Although its character is mostly intact, development has taken place outside its boundary that has reduced the ability for the priory's significance to be appreciated, and in some sense has harmed that significance too in cutting it off from the fields that were historically a part of its working landscape.

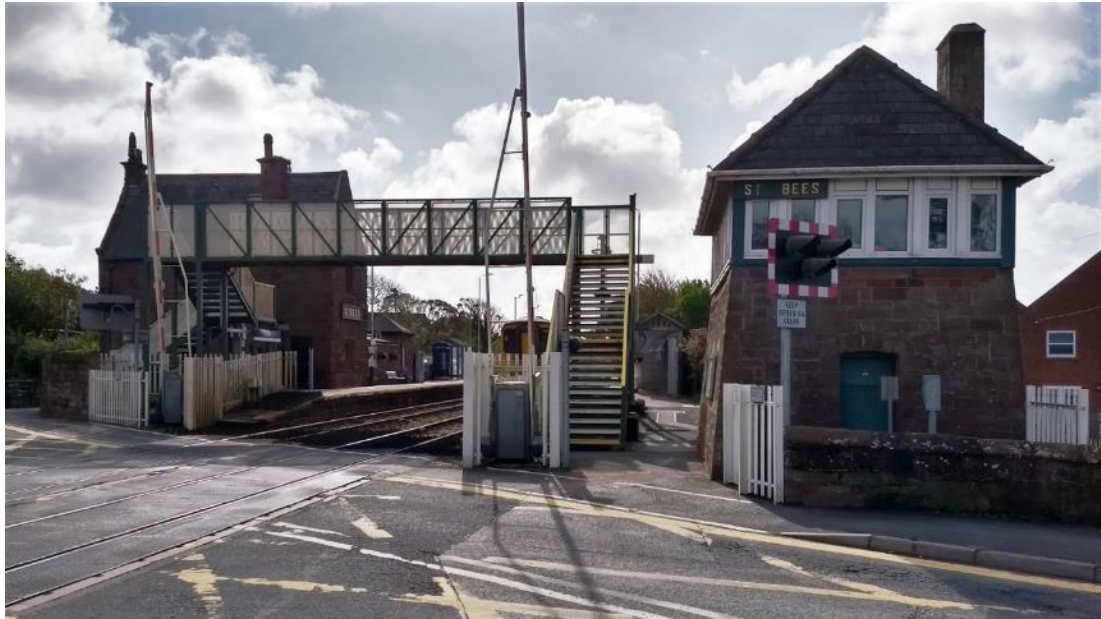
Figure 8 The 1860 station (L) and 1891 signal box (R), viewed from the level crossing on Main Street

The station itself is not listed, although its signal box is, and though the railway and first station arrived in St Bees in the summer of 1849 it wasn't until 1860 that the current building was constructed in red sandstone. The listed signal box, possibly by well-known Lancaster firm Paley and Austin, who handled many local projects in the mid- and late-19th centuries, dates from 1891, and was needed to cope with the increasing volumes of rail traffic.

Both these buildings are in red sandstone, characteristic of many civic and industrial examples of the period, with steep roofs clad in local slate. They are quite prominent, given their proximity to both the road and the railway line, although they are somewhat obscured by the footbridge, which is sadly of no architectural merit.

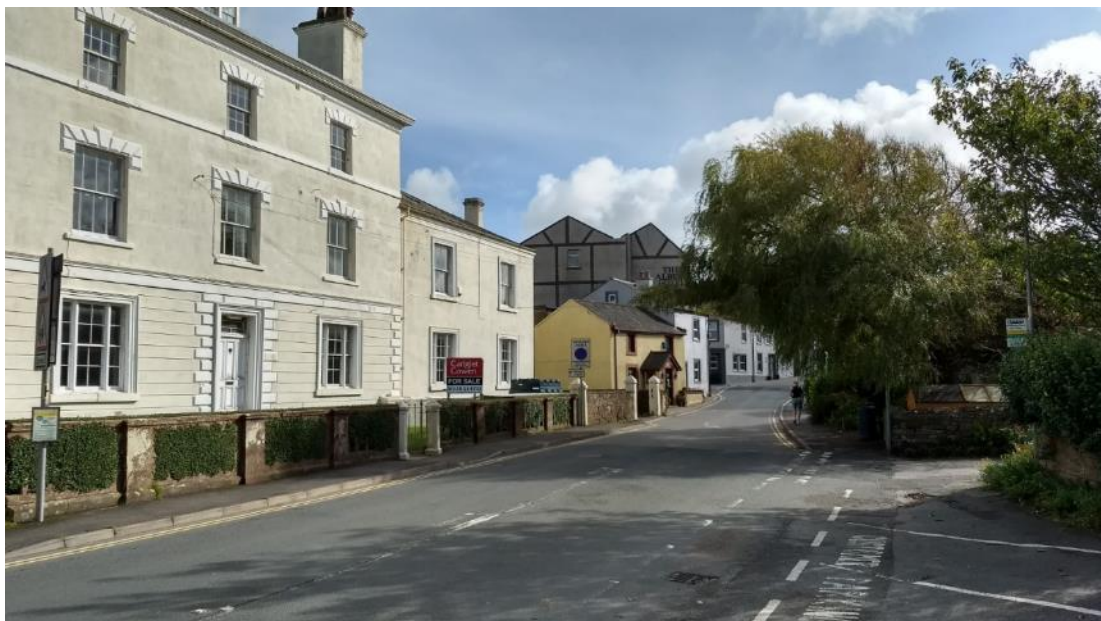
Figure 9 Grindal House, a grand and somewhat elaborate Victorian building that is listed grade II, as are the boundary walls in front of it. Together, these create a very positive impression. Though various poor quality extensions to the rear have had a detrimental effect, these are fortunately fairly hidden from Main Street.

Grindal House, located nearby, was originally constructed shortly after the arrival of the railway as the Station Hotel. It was bought by the school following the reversion of the Whitehaven mineral rights in 1842, which brought greatly increased spending power to the school and preceded the expansion of its facilities. Grindal House and the areas of planting on the opposite side of the road make a very pleasing gateway that divides the upper part of St Bees (Main Street, Finkle Street and High House Road) from the valley.

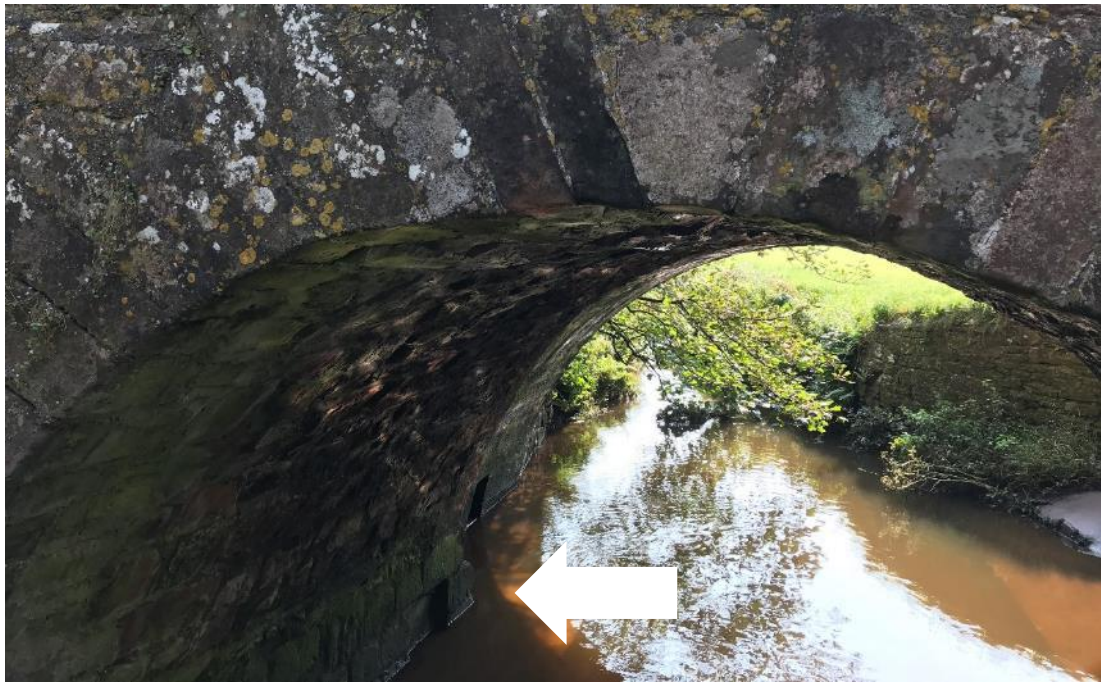
Figure 10 The grade II listed bridge over Pow Beck, with the join between the 16th century original arch (the nearer section) and the later part (further away) indicated. On top of the bridge, the difference can also be appreciated in the different levels of weathering of the east and west parapets.*

The Grindal coat of arms on the bridge is a 1912 replica, the original having been removed (causing some controversy) to the interior of the school to protect it from damage.

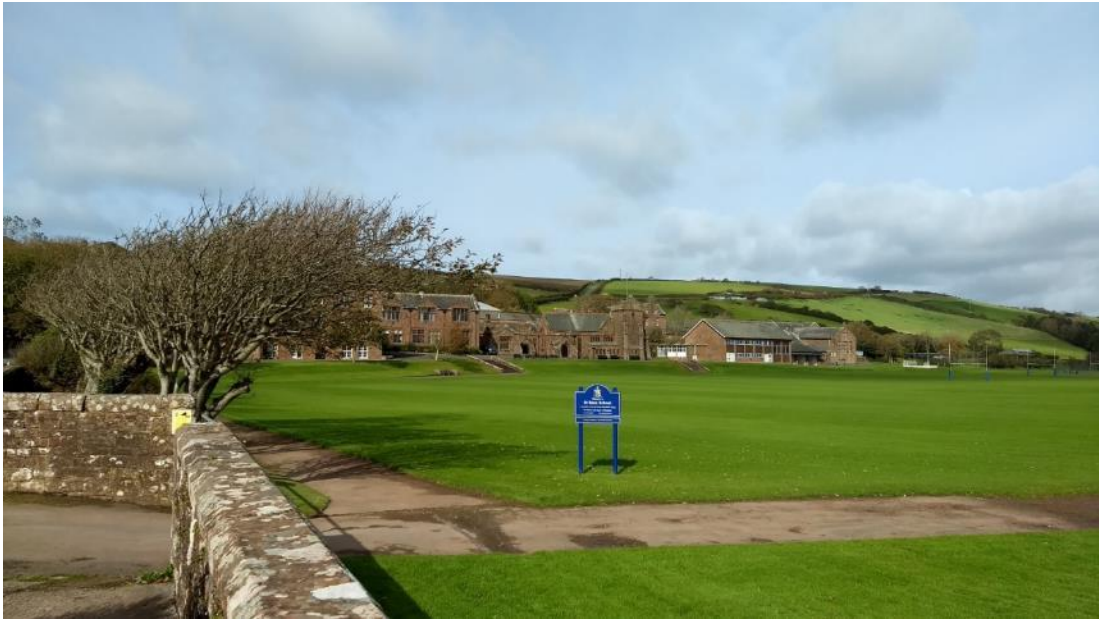
Figure 11 Looking north from Pow Beck bridge toward the school. The view of red stone buildings with manicured grass in front and hilled farmland behind is important and valuable.

At this range, the individual buildings are not easily distinguishable, but collectively convey an impression of red sandstone and slate gables that is evocative of the romanticised idea of ancient learning, and calls to mind the “dreaming spires” of Oxford, a Victorian romantic idea that was coined in the 1860s.

Despite the air of great antiquity – and despite the genuine ancientness of the school’s origins and early fabric – all the buildings in Figure 11 are mid-19th to mid-20th century. This is not to undermine their quality, but is a fact worth acknowledging, especially in the context of appreciating the value of heritage from this period.

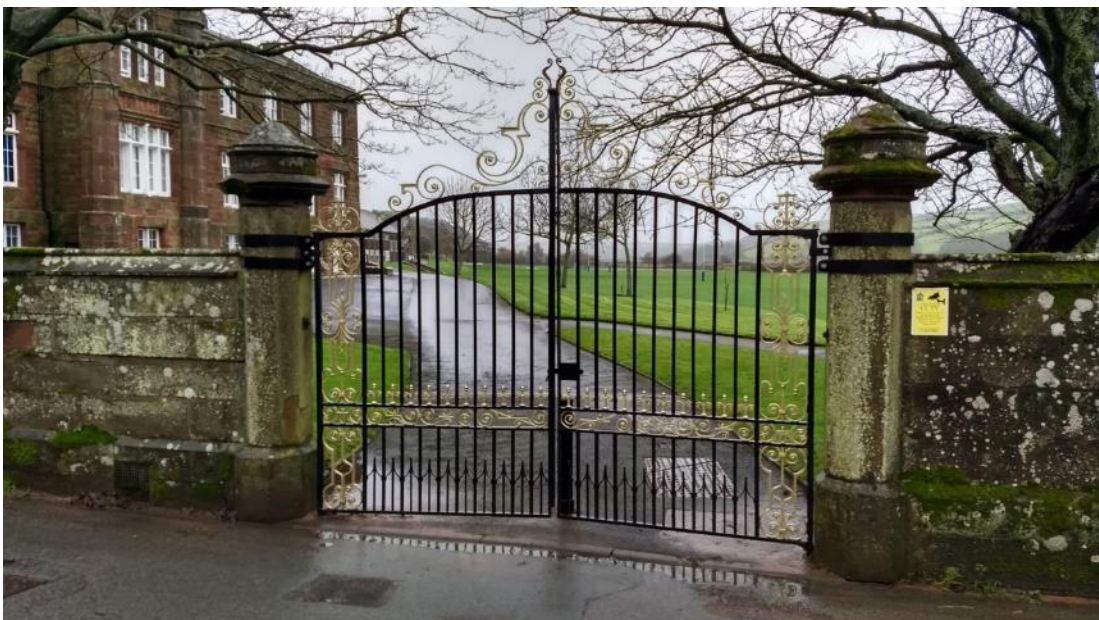
Figure 13 The gates and wall south of St Bees School

At one approaches, certain features make themselves known. The entrances to the school and the priory are close together. The grand iron gates south of the school offer a view along a drive around the sound side of the buildings, where it disappears towards the parts arranged further east.

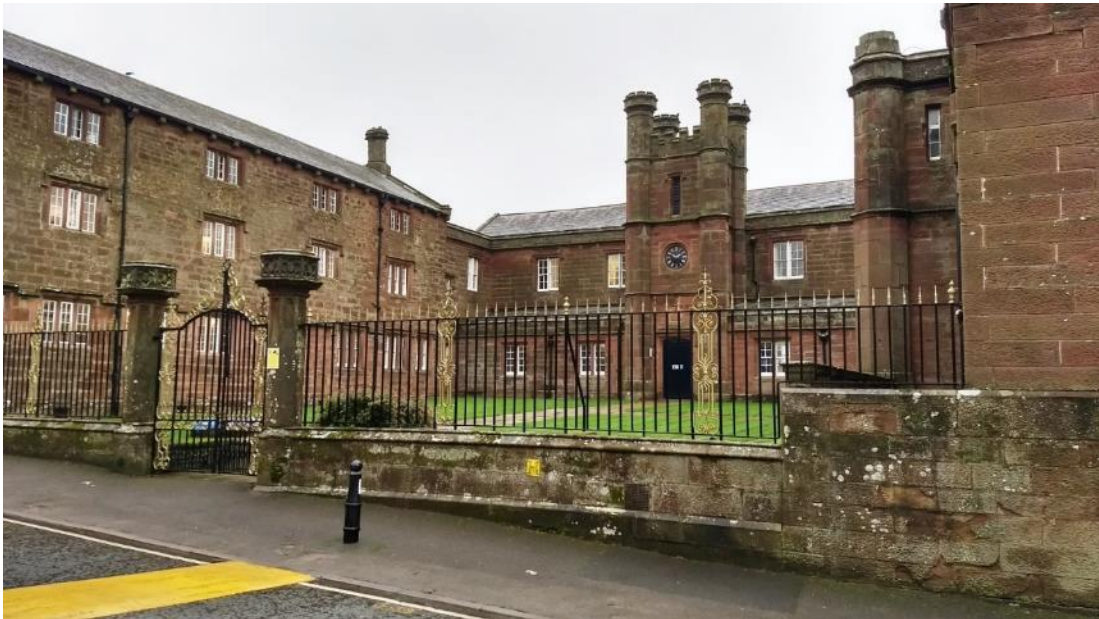
Figure 14 School quadrangle. The original building is to the left, although it was originally lower.

St Bees School underwent its greatest period of change during the mid- and late-19th century, beginning in 1846 with the creation of the quad by enclosing a square to the south side of the original 16th century building.

The original school building is located on the north side, the left as one looks at it. This is the late 16th century part founded by Edmund Grindal, which likely incorporated material recovered from the former abbot's house, left vacant following the dissolution some forty or fifty years earlier. This building was altered with the addition of an extra storey in the early 19th century (it was originally two storeys), but the major expansion was not to occur until the 1840s, at which point the remainder of the three ranges was constructed. The classical arrangement, castellated clock tower, symmetrical green lawns and ornate ironwork and gate piers to the front come together to create an arresting sight.

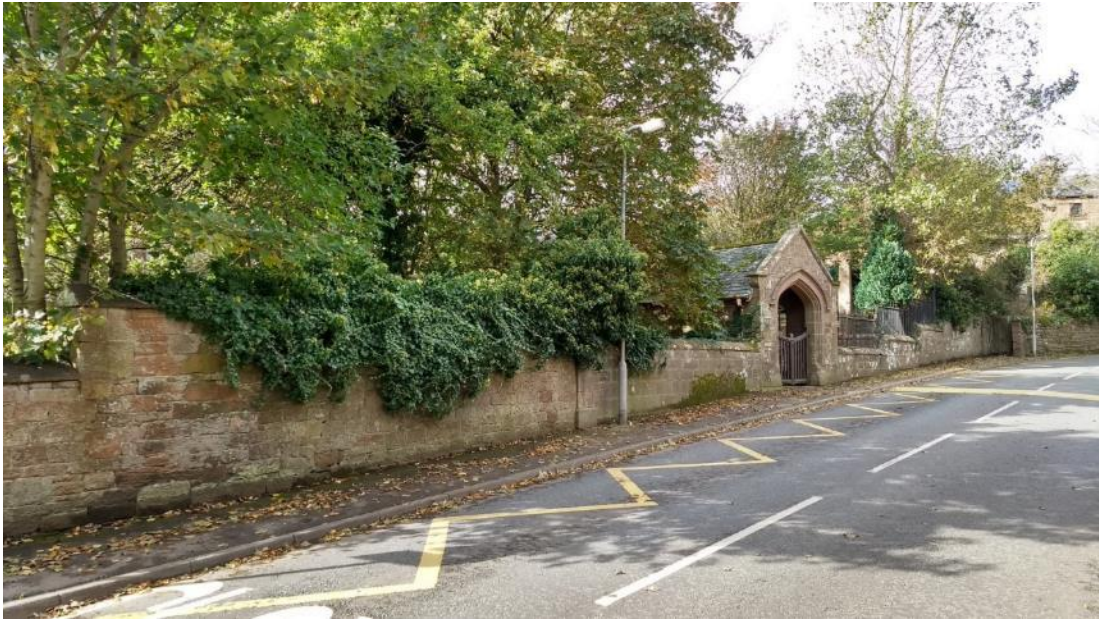
Figure 15 The grade II listed early 20th century lych gate and walling with railings at the front of the priory.

The lych gate is opposite the the front of the school quadrangle, and contributes to this group at one of the conservation area's key sections. Just to the north of the gate, behind the wall, is the original WWI memorial, also listed grade II.

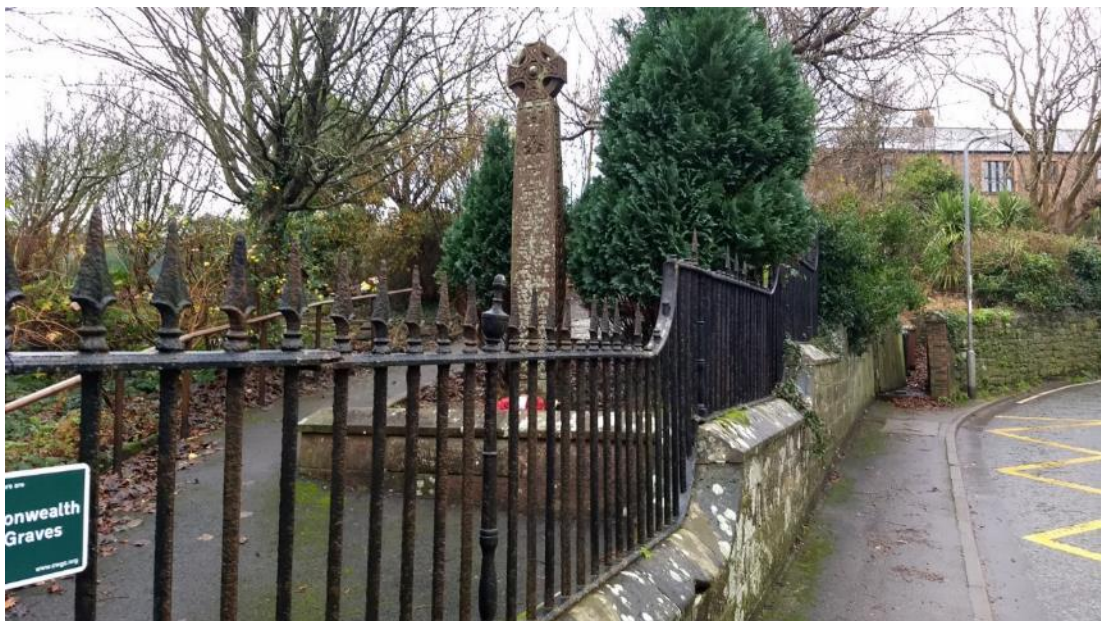
Figure 16 Historic iron railings have survived near the priory lych gate, although one or two finials have been broken off. This photo also shows the earlier of the two WWI memorials. WWII names were added below on an engraved stone.

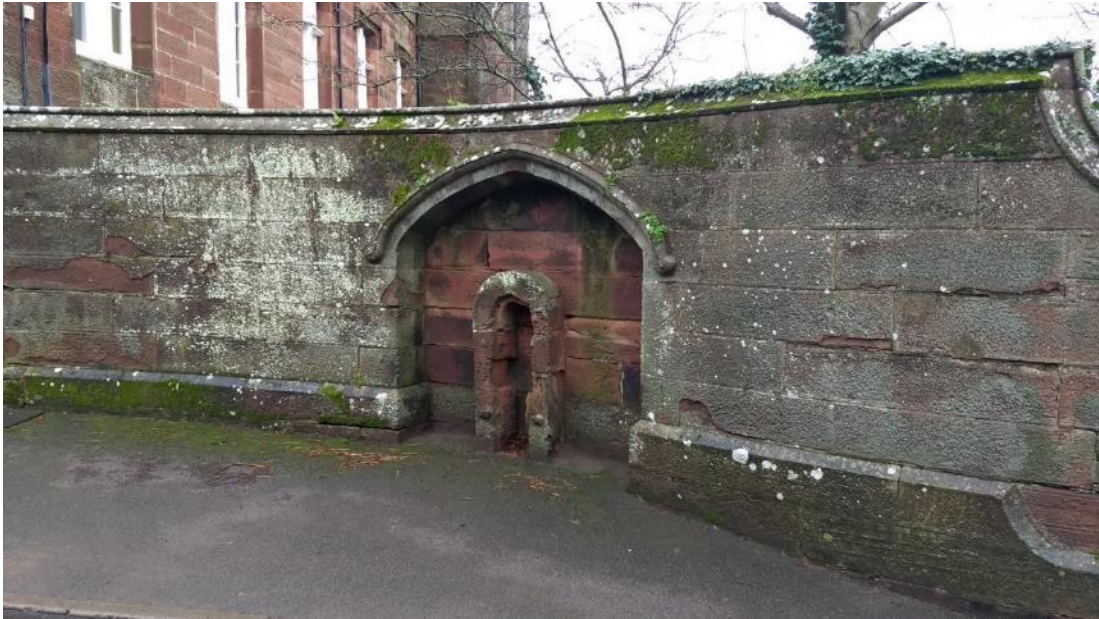
Figure 17 The old village pump

Set within an attractive gothic arch on the road side is the location of the former village pump. Although missing its mechanism and in a somewhat degraded state, this remains an interesting feature that lends weight to the idea of this location being a fully-fledged place of its own, in which quad and precinct are united, as opposed to separate places on either side of a road.

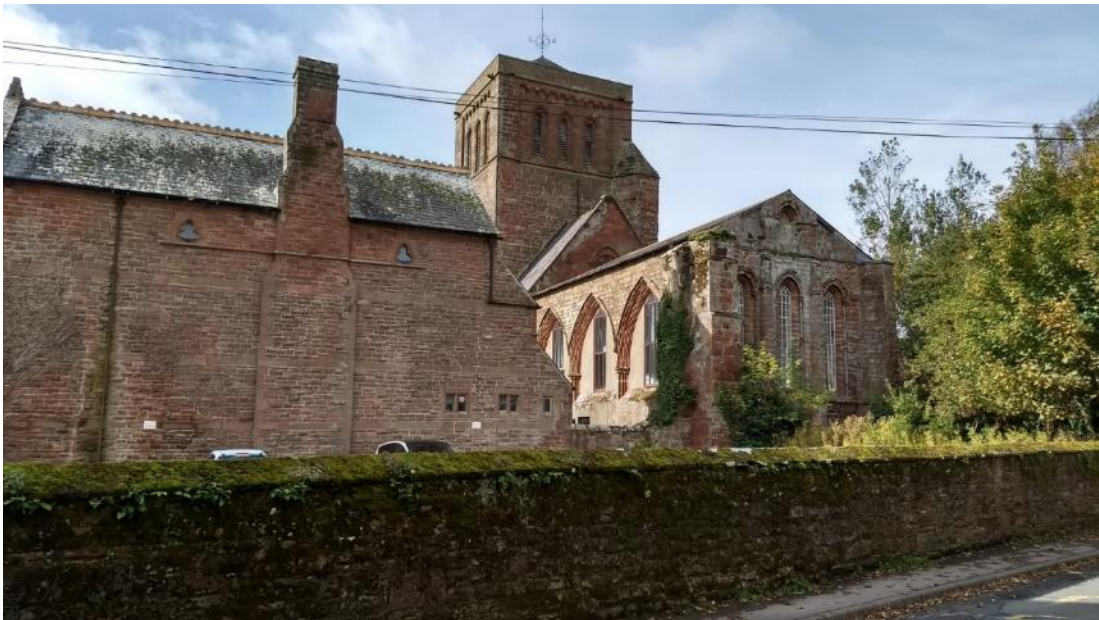
Figure 18 New College Hall and the priory. Note the altered chancel roof pitch.

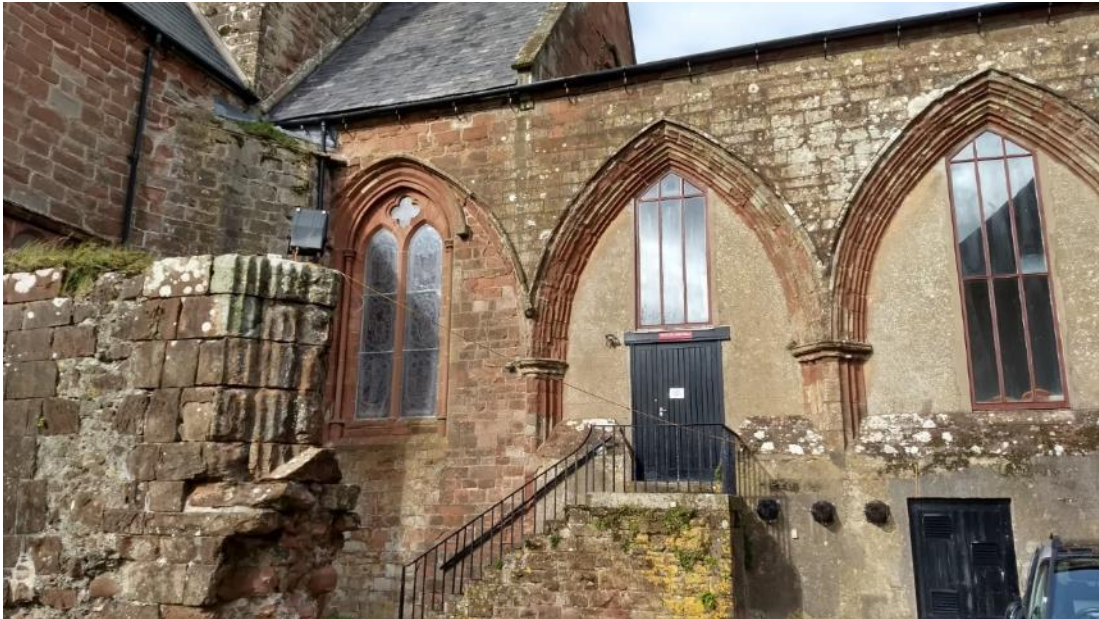
Figure 19 The Old College Hall, viewed from the south. The fluted masonry in the foreground is likely part of the current building's original 12th century phase.

Old College Hall was the original part of the Theological College, housed within the re-roofed priory chancel. Ruined remains of the medieval chancel south aisle are visible in front of it, and it was beneath this ruined aisle floor that the St Bees Man burial was discovered in 1981.

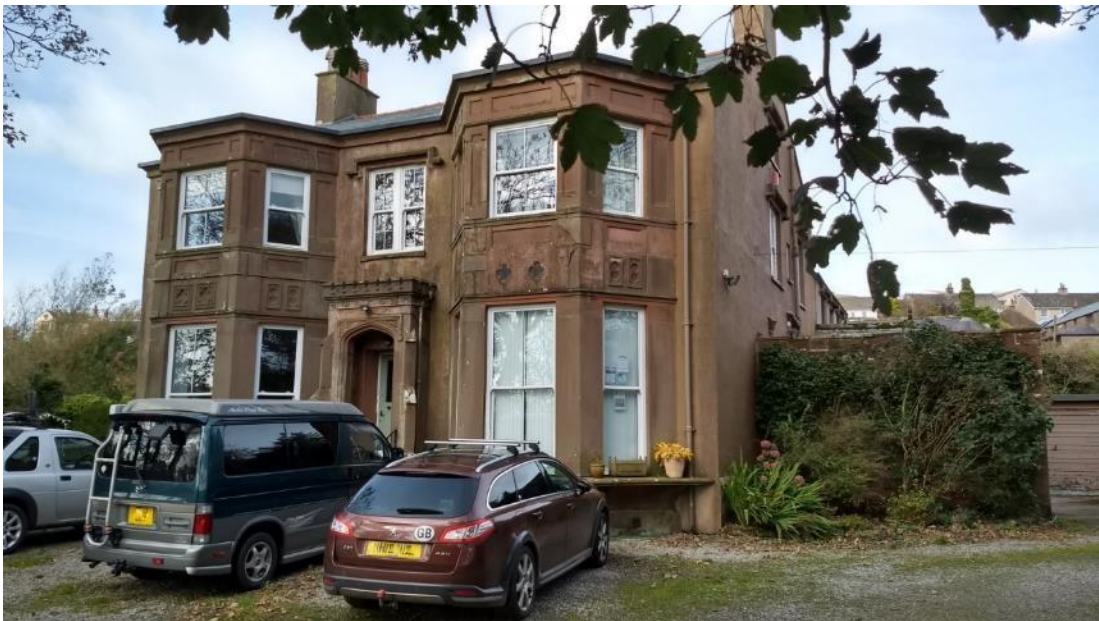
Figure 21 The vicarage at the west end of the priory. This handsome although well-hidden building dates from 1816, contemporary with the creation of the Theological Collage and also the time at which the remaining elements of the monastic cloister on the south side of the nave were demolished after standing ruined for almost three centuries.

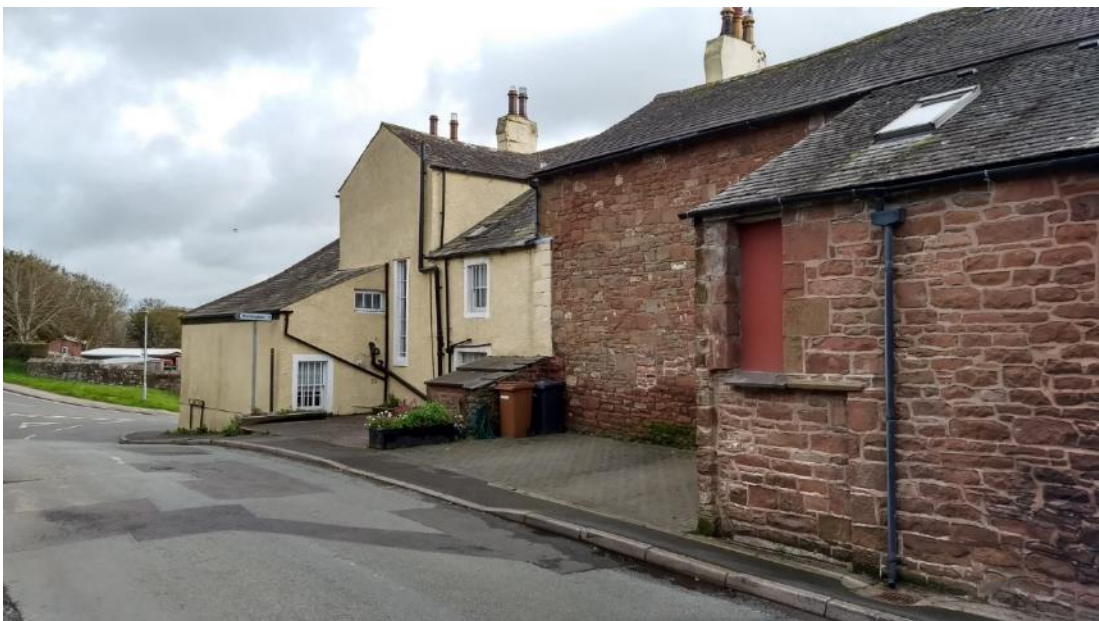
Figure 23 Abbey Farm house itself, the yellow building, dates back originally to 1679, although has received further additions. It is grade II listed, and makes a positive impression at the corner as one enters the north side of St Bees.

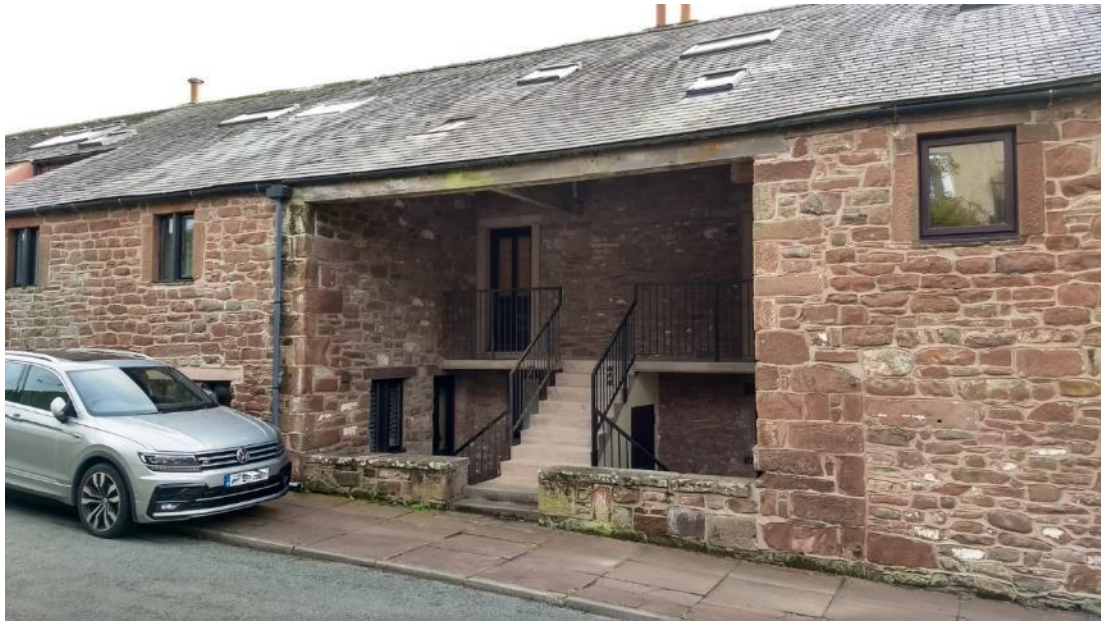
Figure 24 10, 11 and 12 Abbey Farm

These are three houses created in 2016 with the successful conversion of grade II listed 18th century barns attached to Abbey Farm. The Abbey Road elevation (shown here) features a sloping cart entrance with paving up to what is now a domestic door, and a covered opening into which two house entrances have been neatly integrated.

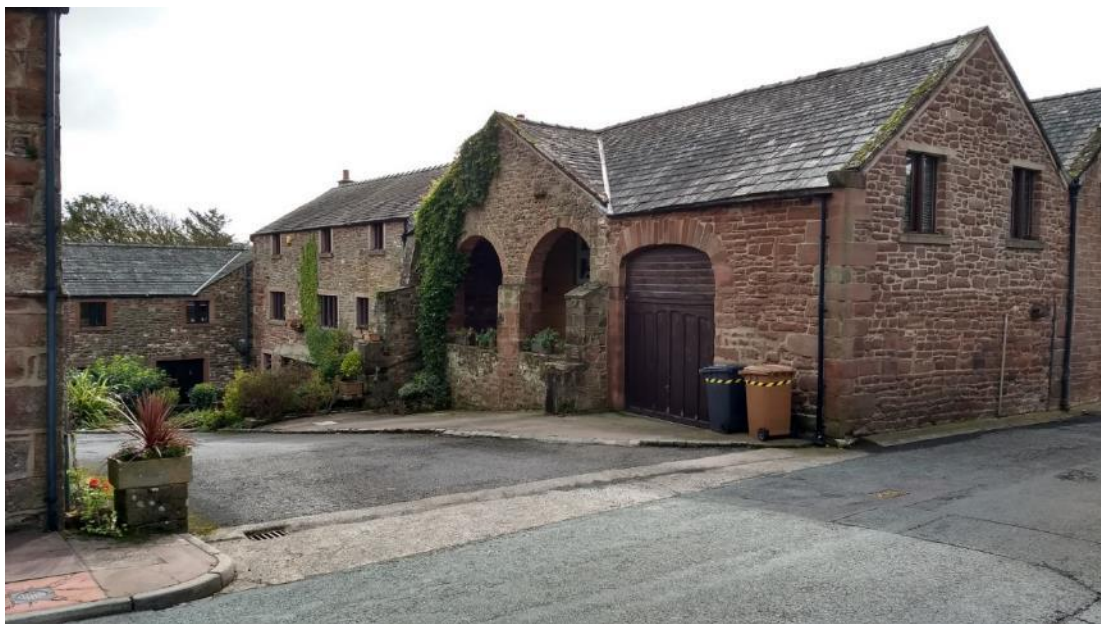
Figure 25 8 and 9 Abbey Farm

Though not listed, 8 and 9 Abbey Farm make a very attractive pair, set at an angle to the road in what used to be the entrance to the farmyard. As with 10, 11 and 12, articulation in the façade in the form of arches and set-backs, creates interest, shadow and richness that perfectly complements the red sandstone, slate and greenery.

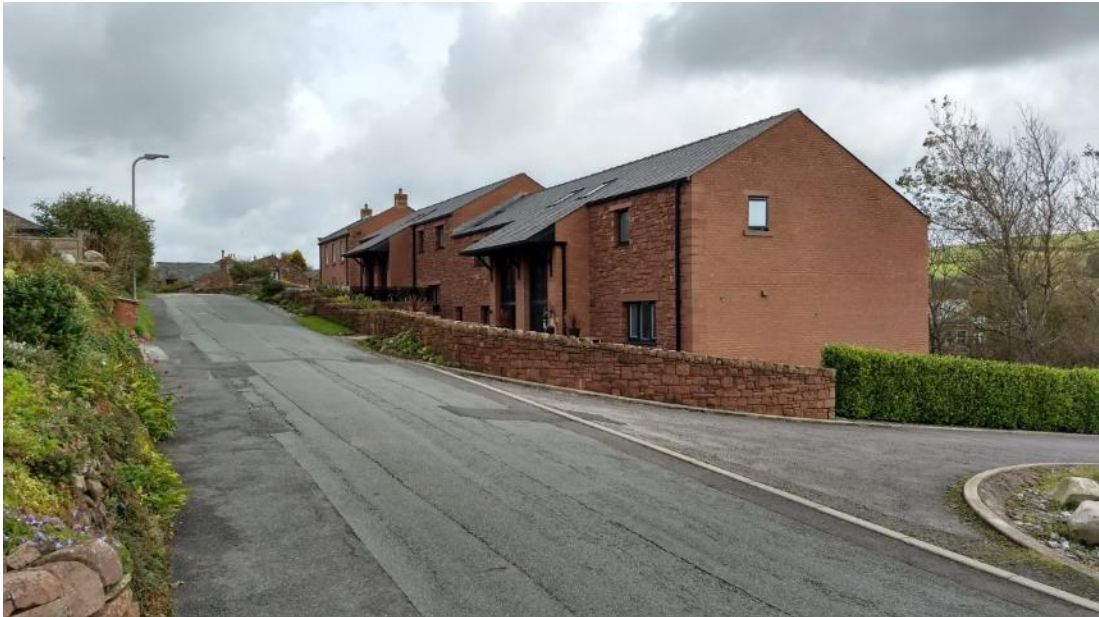
Figure 27 The recent Holly Mews development

The Holly Mews houses are quite successful, and make use of a façade articulation with projecting roof, and red sandstone cladding that looks at home alongside the converted buildings of Abbey Farm. However, sites in this area are visible across wide surroundings and great care should be taken in urbanising the remaining green spaces of the valley as this is key backdrop to several highly significant heritage assets, the conservation area, and the village itself, and is a finite resource.

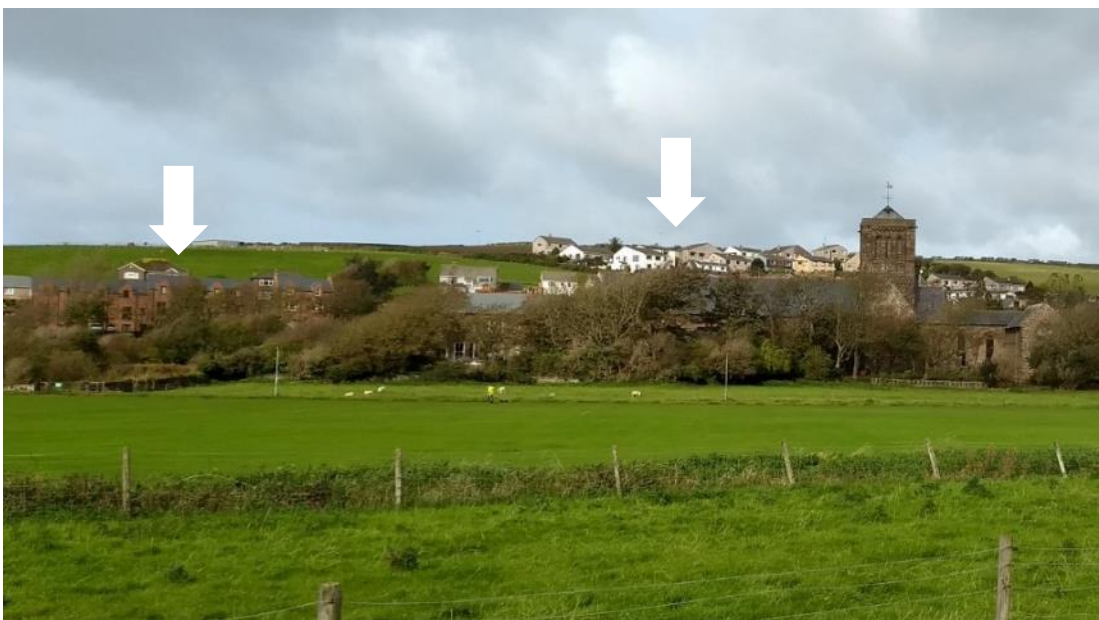
Figure 28 This image shows the relative impacts of two developments on the setting of the priory.

Pictured above, the houses of Abbey Vale on the higher ground outside the conservation area (R) are conspicuous, whereas the newer red stone and brick ones on Holly Mews (L),

with their darker walls, gables, lower position and sheltering among trees, are less visible, although their visibility is seasonal. What is visible of them is more elegant, but set against the backdrop of other houses, rather than the fields and sky.

Now that Abbey Vale exists, relatively little can be done to redesign it, however it is interesting to speculate on what effect might be achieved if all its residents coordinated to paint their houses green. This idea would probably appeal to Humphry Repton, the famed Georgian-period landscape designer who advocated the popular “invisible green” shade to make railings and other structures blend into their backgrounds.

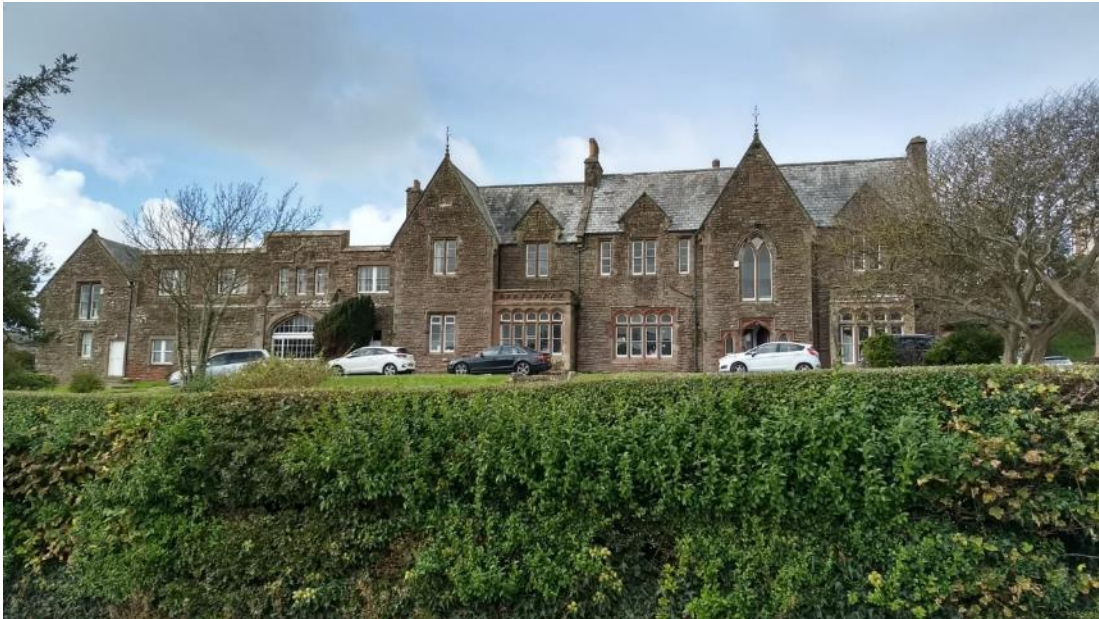
Figure 29 Abbots Court, outside the conservation area but within its setting

Also of note, situated approximately 100m west of the edge of the conservation area, is Abbots Court. This is a mid- to late-19th century property, built originally as two separate blocks, the lower western part likely having been stabling, and then later combined together. Although not within the conservation area, it is one of the grandest houses in the locale (though no longer residential), and both its neo-Gothic appearance and its curving drives and lawns make a positive impact on the setting of the conservation area.

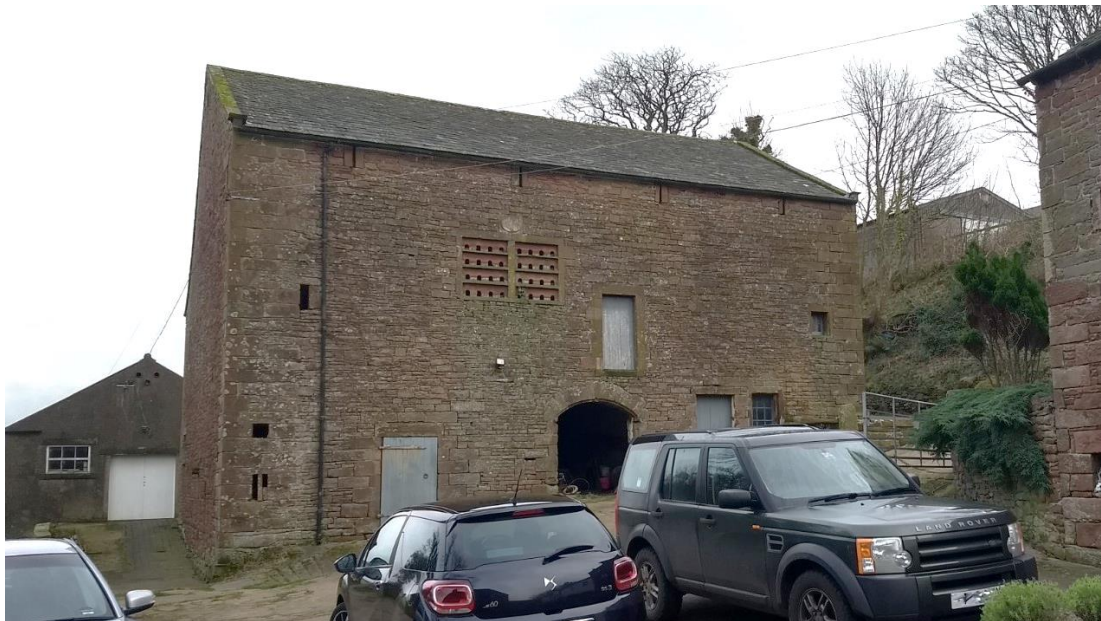
Figure 30 This attractive barn forms the northern reach of the conservation area on High House Road. It is grade II listed. Above the dove holes is a round stone reading "William & Hannah Fox 1810".

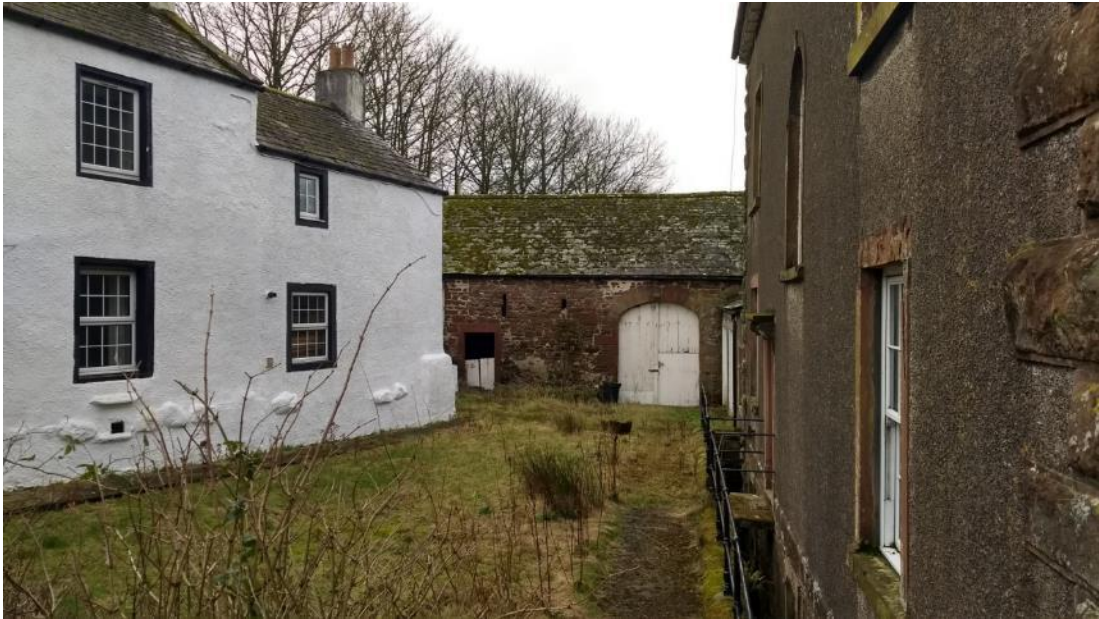
Figure 31 A cluster of historic buildings at the north-eastern corner of the conservation area on High House Road

Although largely secluded from view from the public highway, this cluster of buildings is both highly historic and highly varied. It consists of the following:

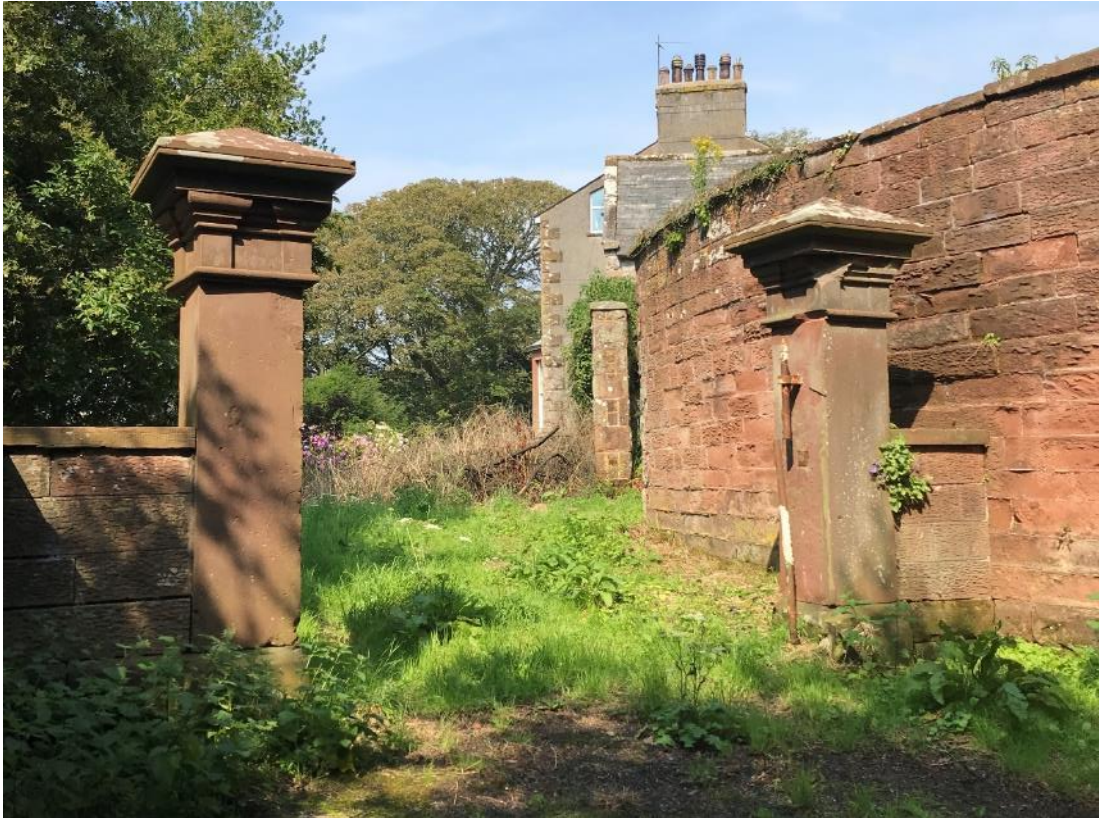
Figure 33 Grand red late 19th century sandstone gate piers and walls at the entrance to High House. Parts of iron gate hinges remain, but the gates themselves are gone.

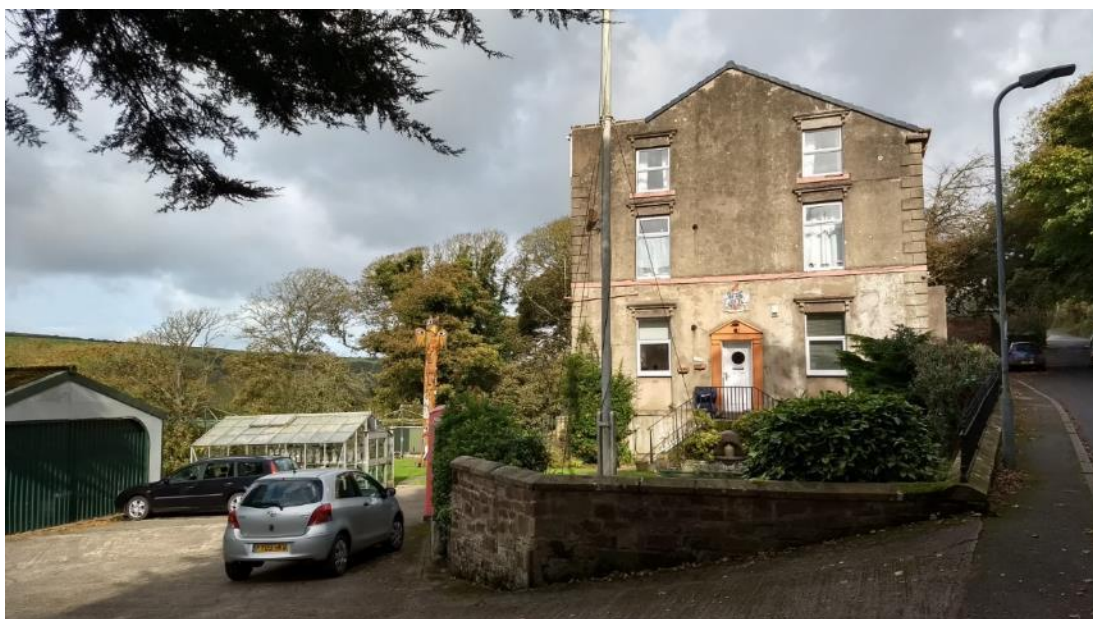
Figure 34 Meadow House, converted to flats, with unsympathetic dormer and plastic windows. There is also a K6 telephone box (one of at least three in St Bees), which appears to have been moved here as an ornament.

Meadow House appears to date originally from the eighteenth century. The central part of the building is the oldest, but it was extended at both ends quite substantially in the late 19th century. In the early 20th century it was in use as the school's sanatorium.

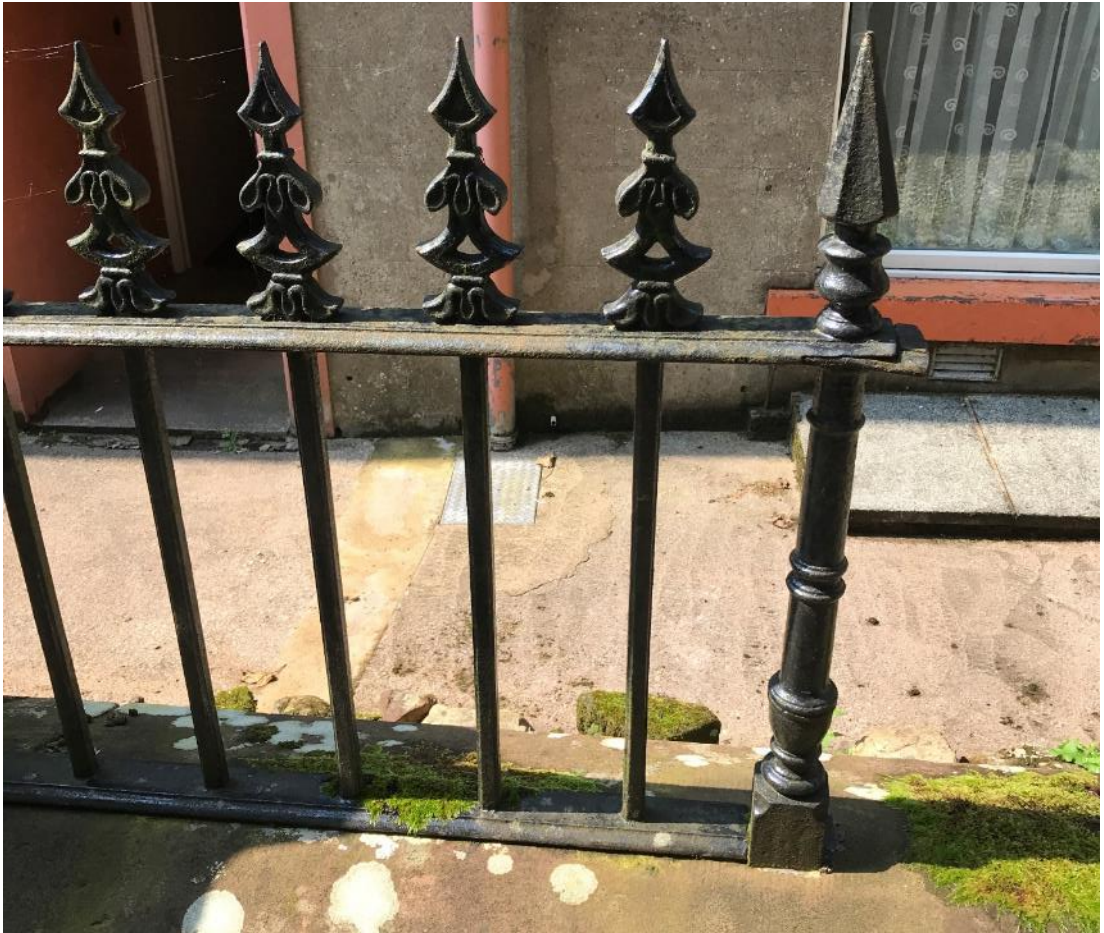
Figure 35 Historic iron railings and sandstone wall surviving outside Meadow House, in combination with unattractive concrete additions, either associated with the building's use as a school sanitorium or its later conversion into flats.

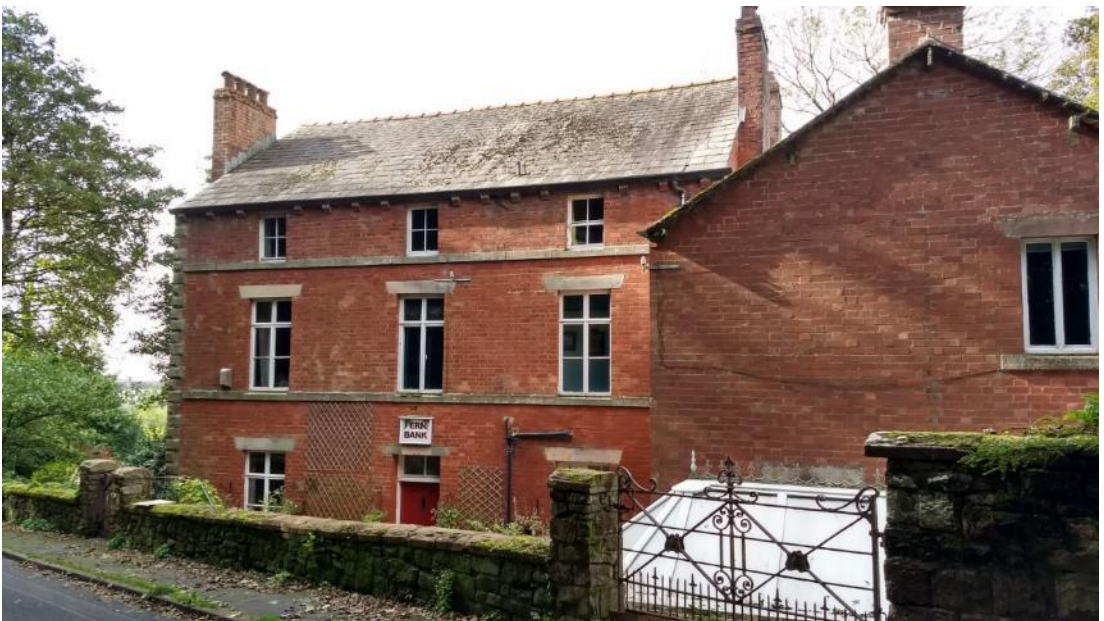
Figure 36 Fern Bank

Fern Bank is a dramatic, tall brick house, quite different from the more vernacular 17th century buildings nearby. It also features extensive mature gardens, and is both designed and situated as to make an impression on people travelling up and down High House Road.

It dates from the latter 19th century and was originally named Rickerby House. Various garden features, such as a fountain and glass houses, were added in the early 20th century, presumably as the owners were interested in developing the grounds.

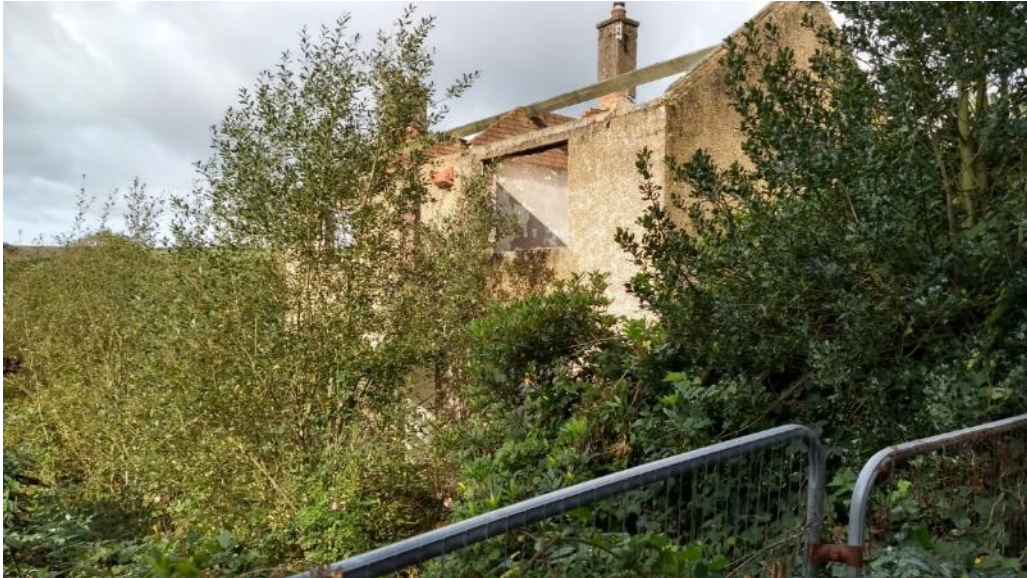
Figure 37 The Knoll on High House Road

The Knoll, a 1950s house of no particular architectural merit, has been gutted within the last ten years and its site allowed to grow untamed. This has been a mixed blessing, as the foliage does hide the building. In its current state it makes a negative impression on the conservation area, although it is fairly well hidden. Nonetheless, there exists an opportunity here for the plot to be appropriately redeveloped.
