St Bees Conservation Area Appraisal

2021

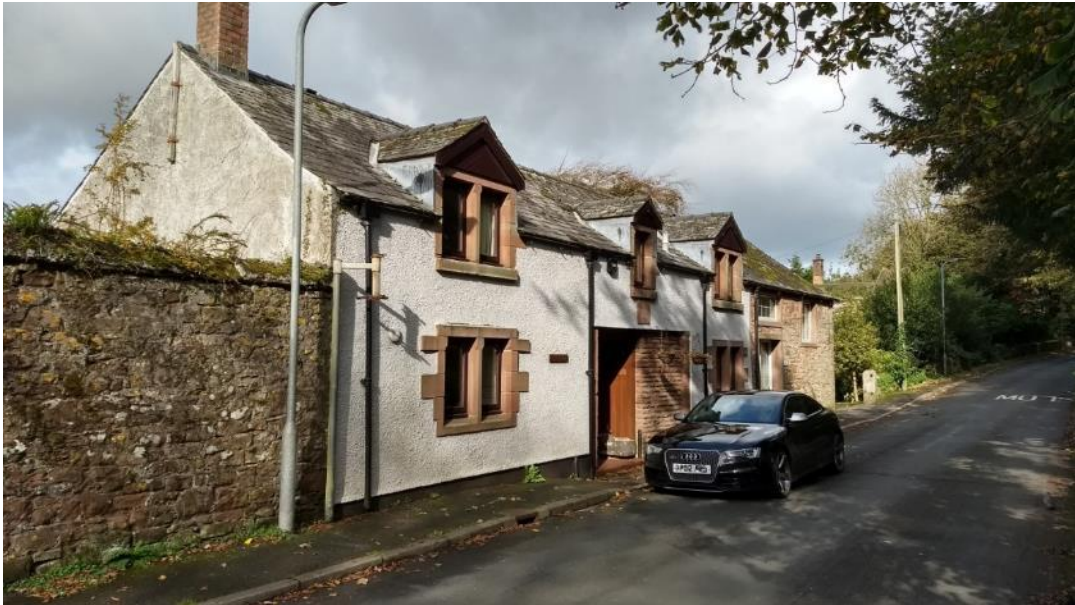
Figure 38 Retreat Farmhouse

Though it is clearly altered, Retreat Farmhouse bears a date stone of 1671, making it one of the oldest properties in this part of St Bees and probably about contemporary with High House Cottage a short distance up the road. Some of the fenestration and external doors prevent the building achieving its full potential though. Although not easily visible, its gardens are very attractive and well maintained.

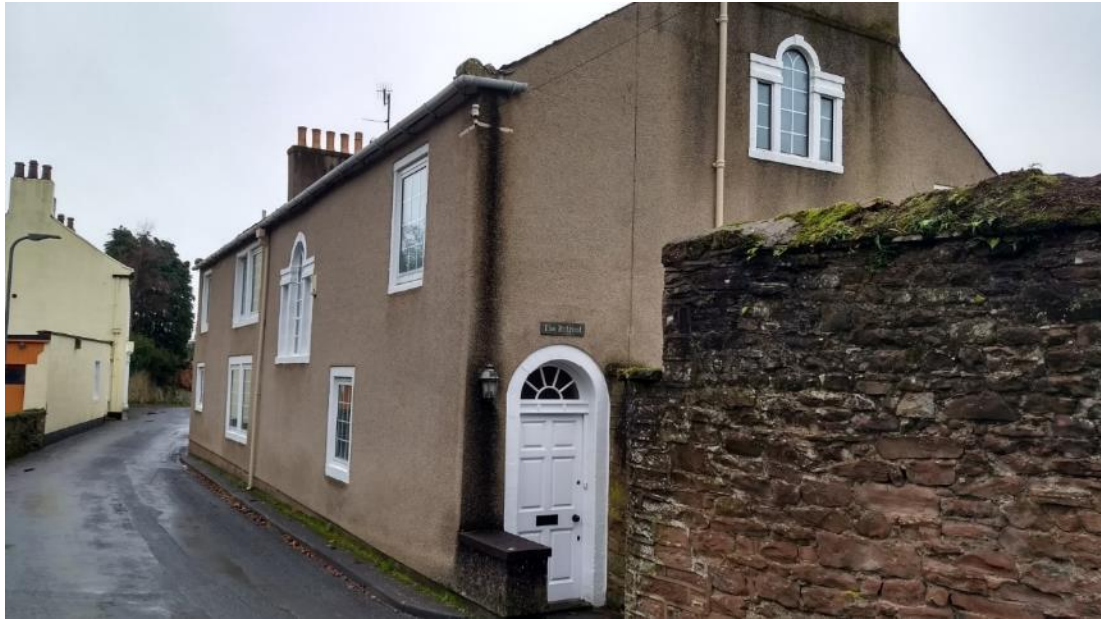
A separate property, The Retreat, a little further down the hill dates probably from the 18th century, and contributes positively to the character and appearance of the conservation area. It contains some elegant Venetian windows, composed of a central taller round-headed light flanked by two lower rectangular ones separated by mullions. A simple cornice accentuates the distinctive shape of the top. The larger one facing the street is very impressive with its gothic “Y” tracery in the round-headed portion. Smaller Venetian windows are found in the north and south gable ends. The remainder of the fenestration, however, is not suited to the house or location.

Figure 39 The Retreat

The Retreat also contributes to local character by being located right on the edge of the street, a distinctively historic arrangement that pre-dates motor traffic and reminds the visitor of St Bees' antiquity.

This effect is compounded by the single-storey extensions that both the Retreat and neighbouring grade II listed Croft House have been fitted with at some point during the 20th century. These extend toward one another on opposite sides of the road, although the one appended to Croft House is slightly less visible on account of it being more tucked beneath the embankment and trees. Both extensions end in a garage door, adapting these attractive buildings with mixed results to the needs of private car ownership.

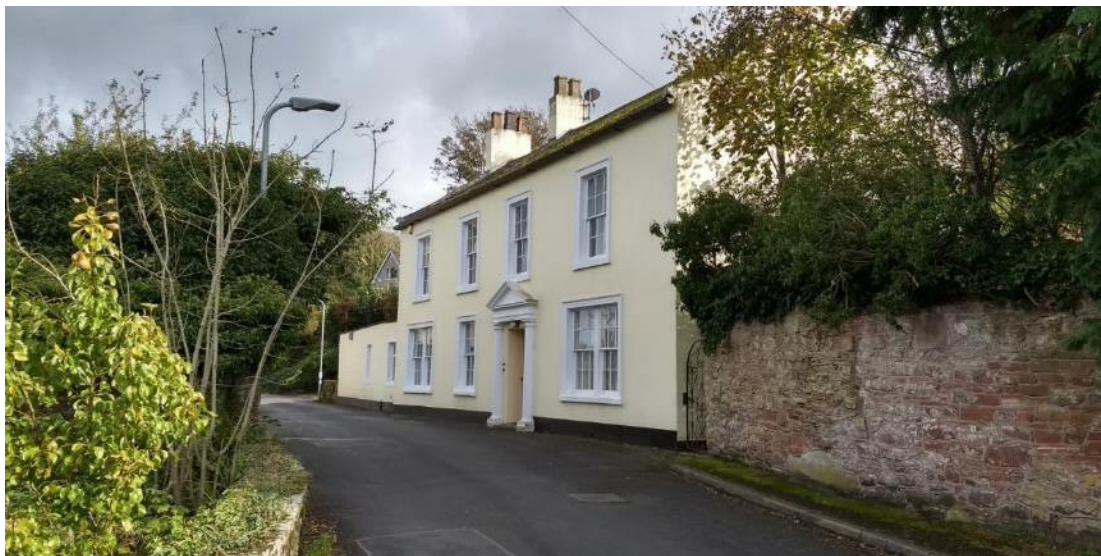
Figure 40 Croft House, a handsome grade II listed 18th century house makes a positive impression on this part of the conservation area

The bottleneck between Croft House and The Retreat makes a juncture between two sections of High House Road that have distinct characters. The lower section is more densely built up, although many of the properties make no particularly valuable contribution. To the north-east of the bottleneck, the historic properties are arrayed on the northern side of the road in a looser arrangement, and the opposite side of the road is characterised by a grassy embankment under mature trees, the top of which marks the boundary of the area.

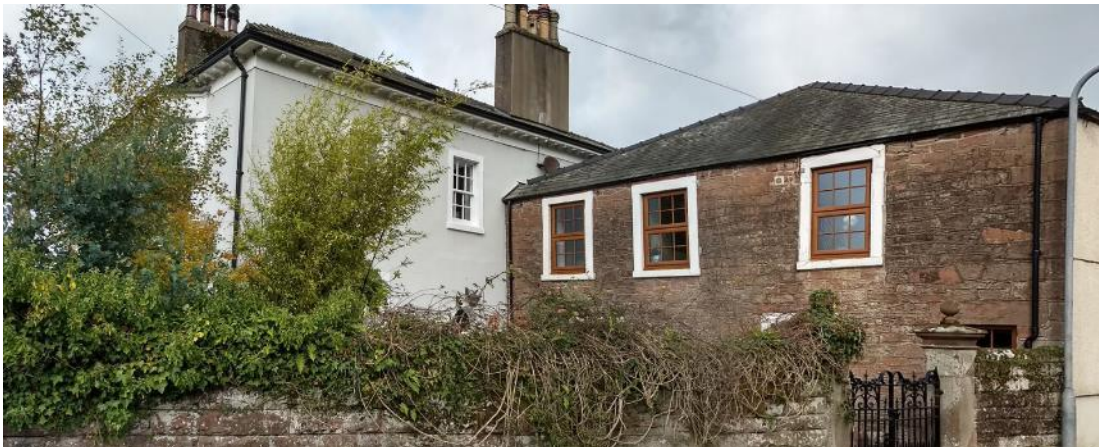
Figure 41 Khandellah (L) and Apple Cottage (R)

Khandellah is labelled erroneously on the 1898 and 1923 OS Maps as “Khendellah”, although appears to have been named “The Lodge” prior to that. Apple Cottage was formerly the property’s cart lodge, although has since been split off. Khandellah in particular is a fine, attractive house with deep, almost Italianate eaves and two-storey canted bay windows.

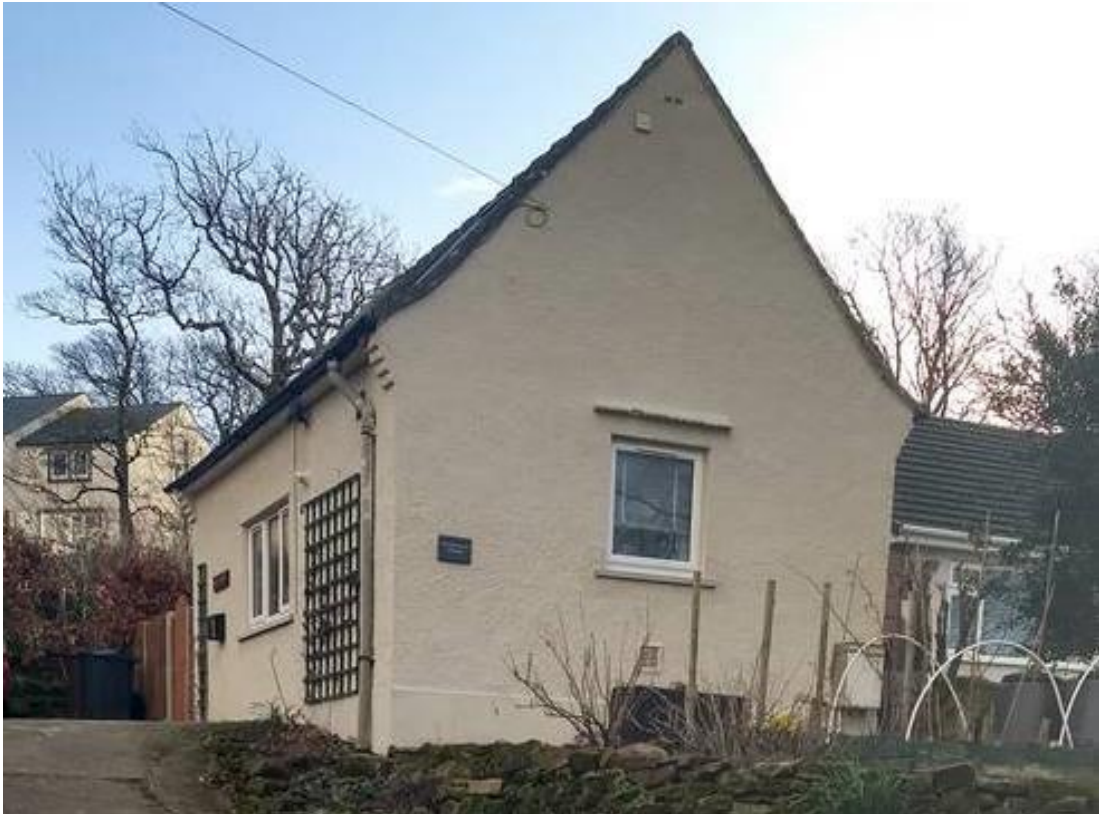
On the south side of the main road are a number of unremarkable bungalows, interspersed with more interesting buildings. The Old Telephone Exchange is a tiny building dating from the early 20th century that has been converted into a house.

Figure 42 The Old Telephone Exchange

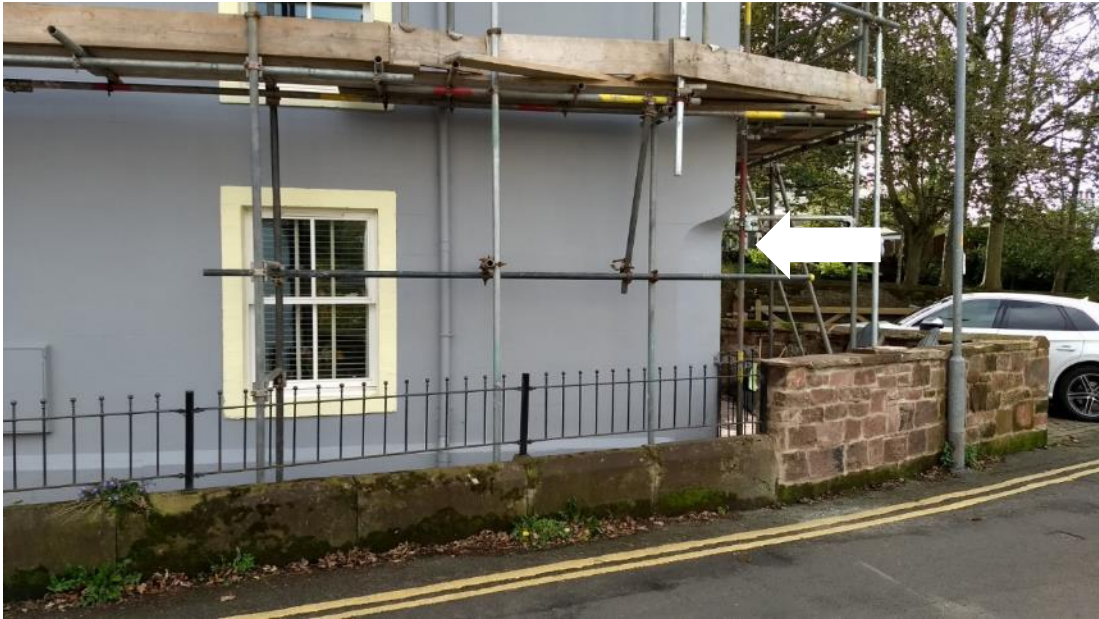
Figure 43 Stopped chamfer at the corner of Fleatham Farmhouse. This was probably either to allow space to pass behind the dwarf wall, or it predates the wall and was originally to protect the corner from passing carts etc.

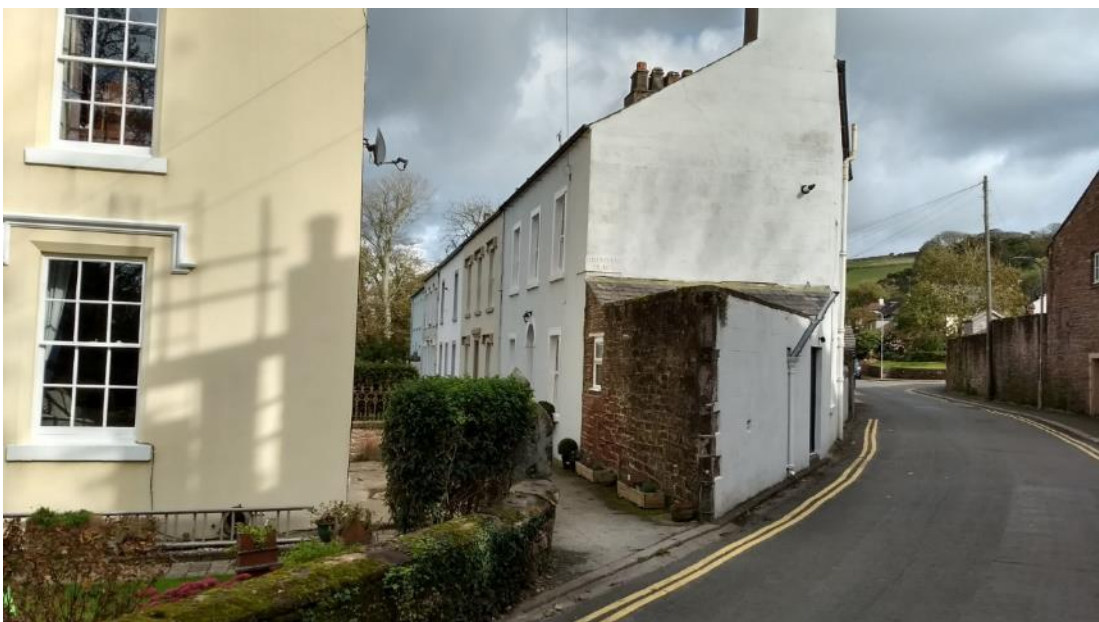
Opposite Fleatham Farm is a fascinating row of houses called Grindal Place, likely early 19th century, which are partly interesting because they have no vehicle access and partly because the row is entered via a small path onto High House Road that almost completely hides them. Like much of St Bees' fabric, its charm is in that it clearly predates both mass motor transport and mass-produced building materials, which have induced often dislocating, depersonalising effects on the formation of place.

Figure 44 Entrance to Grindal Place on High House Road, a whole row accessible only to pedestrians

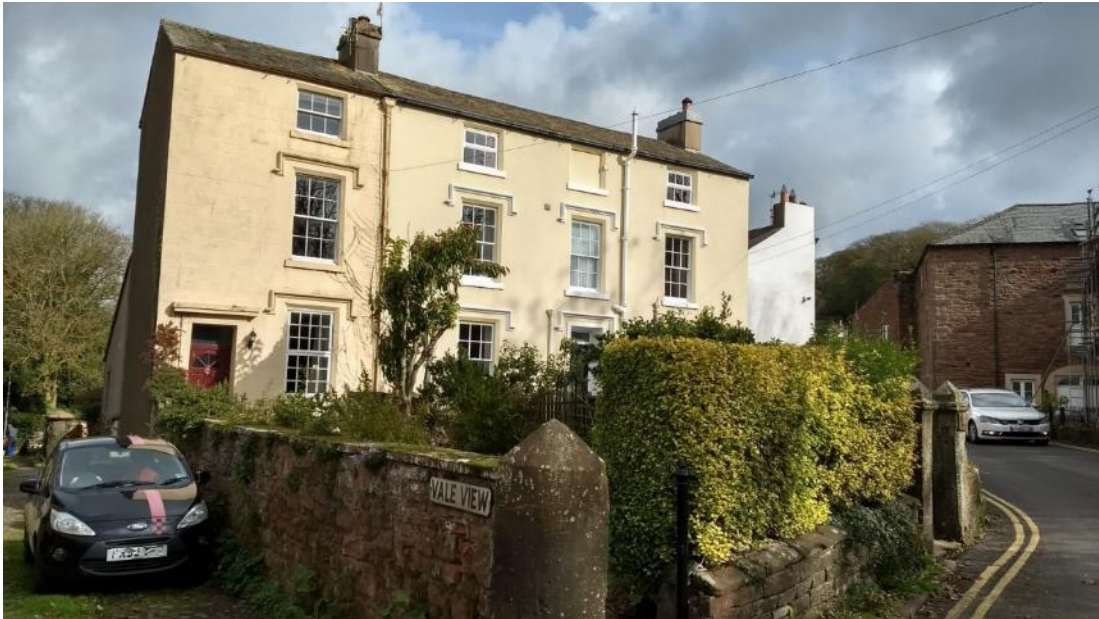
Figure 45 Mayfield, a very elegant grade II listed house dating from the 19th century. The irregular arrangement of plots, interspersed with mature planting and beautiful boundary treatments, are what gives this character area its nature.

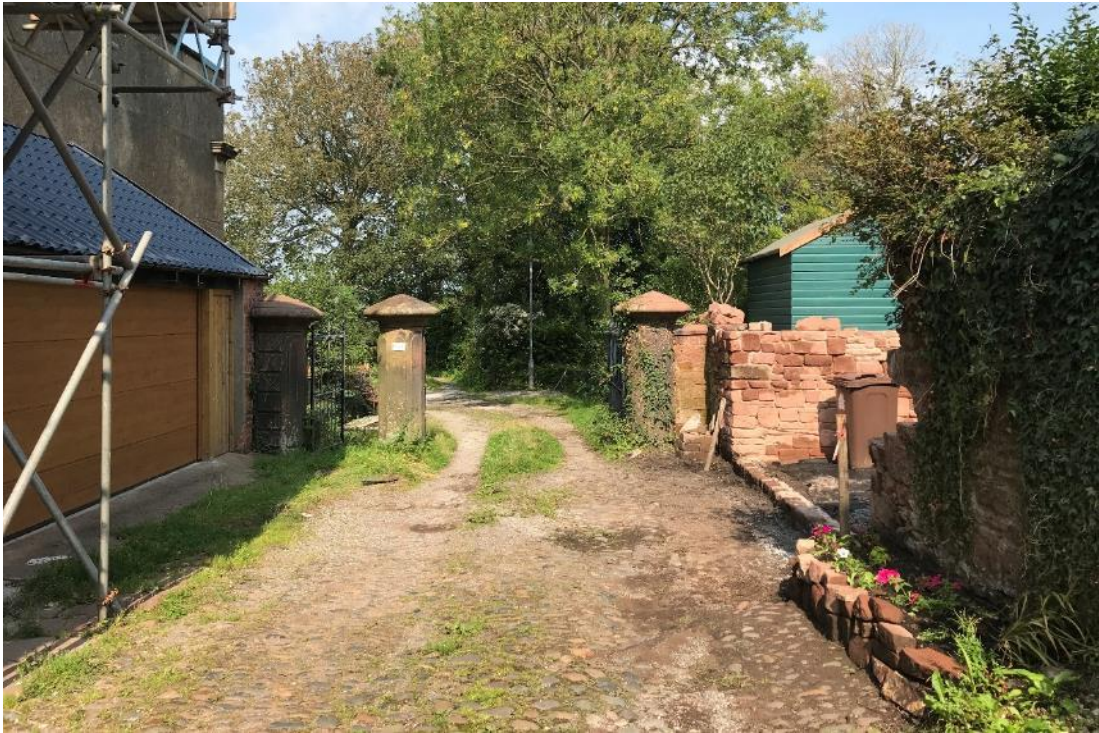
Figure 46 The distinctive piers dividing the two sections of Vale View. Note also the cobbled surface, which appears to have been damaged by the passage of heavy vehicles.

The character of this area has been harmed by the insertion of both a parking space in what was a garden, necessitating the removal of a section of the wall and increasing the vehicle traffic that is likely contributing to damage of the cobbled lane, and by an unattractive although fortunately neat lean-to structure on the opposite side. These have not had a flattering effect on the conservation area or the setting of the piers and listed houses.

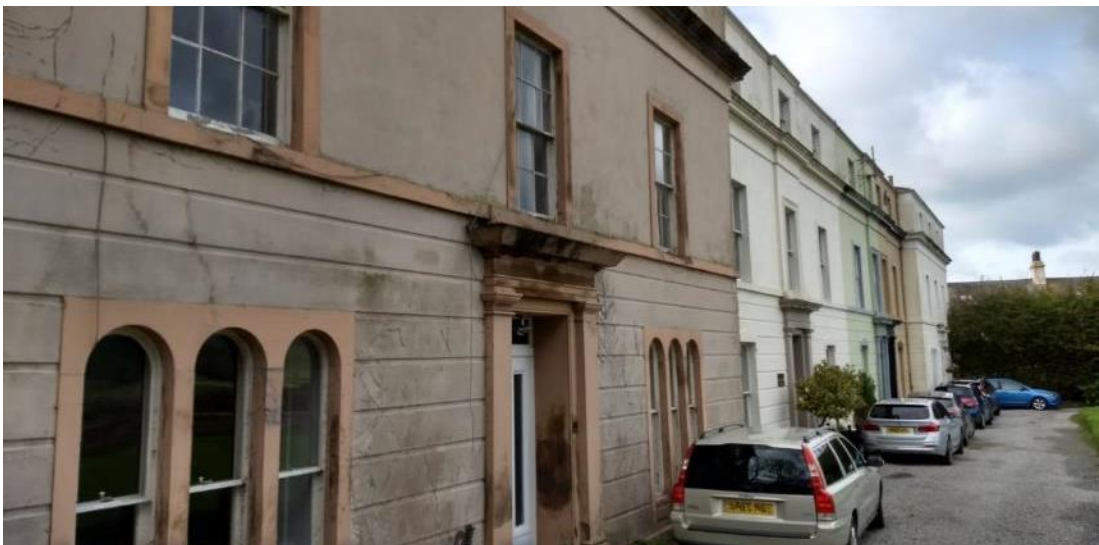
Figure 47 The impressive listed houses on Vale View, which occupy one of the quietest, most attractive corners of the conservation area, with a view over the grassy valley floor.

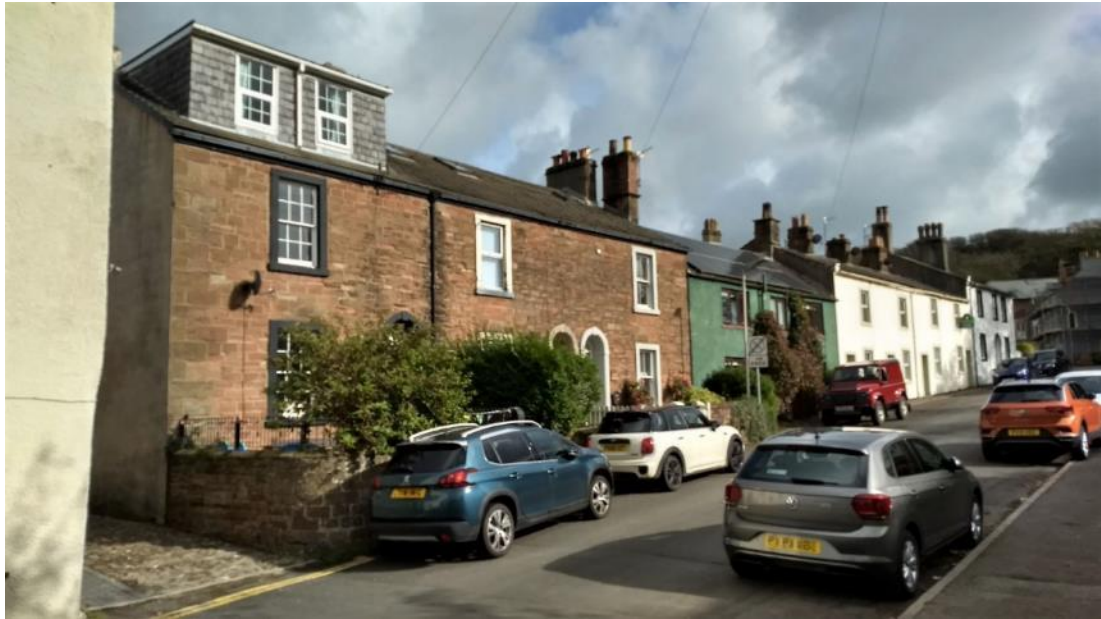
Figure 48 Numbers 8-16 Finkle Street, a mix of two-storey cottages that have mostly retained their chimneys. Number 16, at the far end, is a grade II listed house dating from the early 19th century. This image demonstrates some of the traffic problem that St Bees faces.

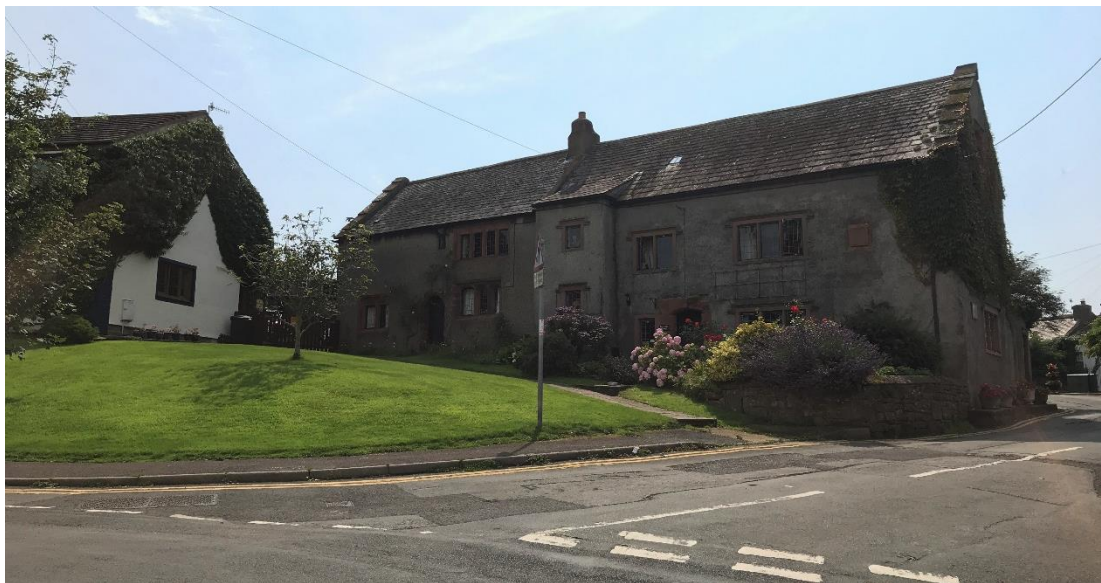
*Figure 49 Manor Stead and Cross Hill House, five hundred years old and listed grade II**

Manor Stead and Cross Hill House were originally a single late medieval hall house. Jointly they constitute St Bees' most historic residence. Externally, the building has been altered fairly little, although inside its full-height hall has been partitioned to create an upper floor. Its setting has been harmed very little too, and it makes a powerful impression over this little green. Behind, walled gardens divide the building from those on Main Street. A plaque on the south gable attests that this was the birthplace of Edmund Grindal, Archbishop of

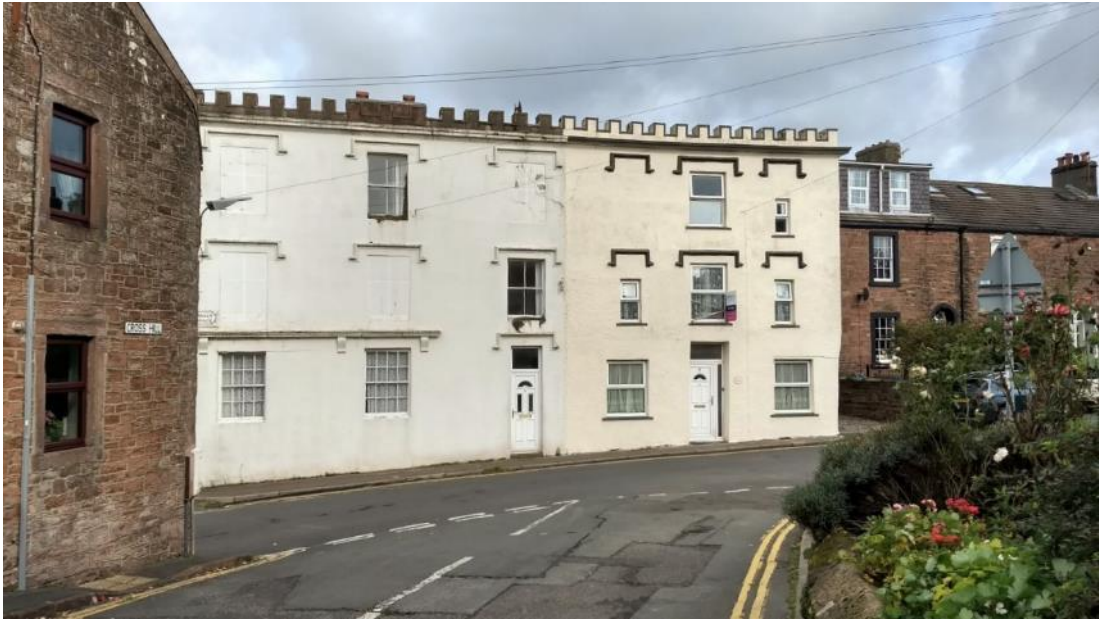
Figure 50 The side elevation of 1 Lonsdale Terrace and frontage 7 Finkle Street opposite the end of Cross Hill are unusual in being battlemented. They would be very striking had they not suffered a raft of unfortunate alterations. There is great potential here for improvement.

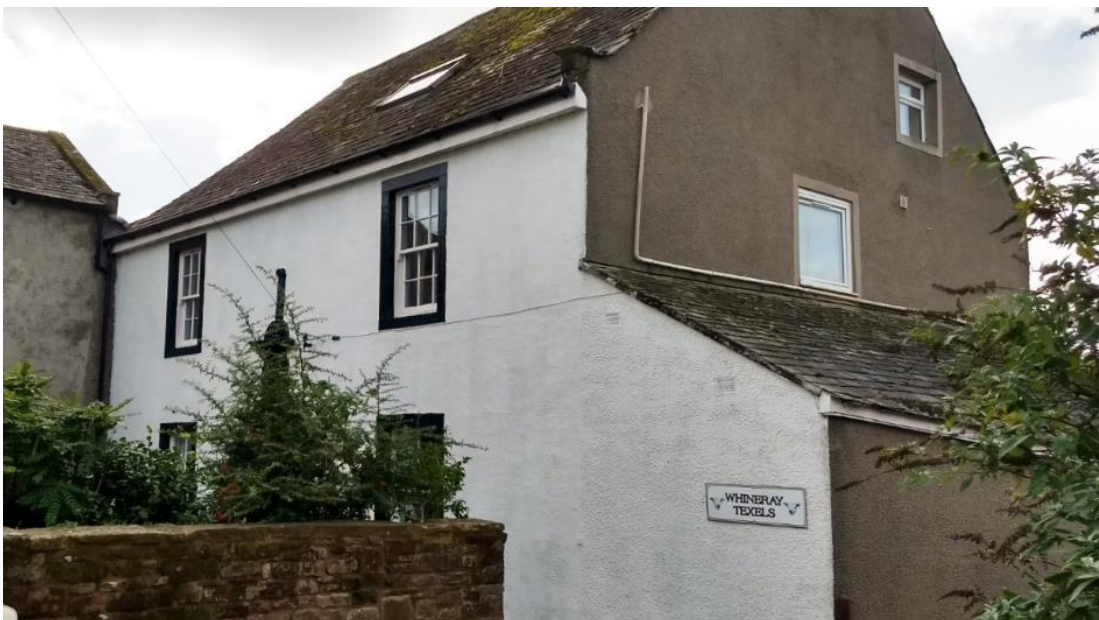
Figure 53 Stone House Farm is a grade II listed building, prominently visible although set back from the pavement with a front garden that is also bounded by a barn.

Stone House Farm is possibly early 18th century, with later additions and alterations. It features an ornate date stone over the entrance reading "Stainton" and "1712". The house

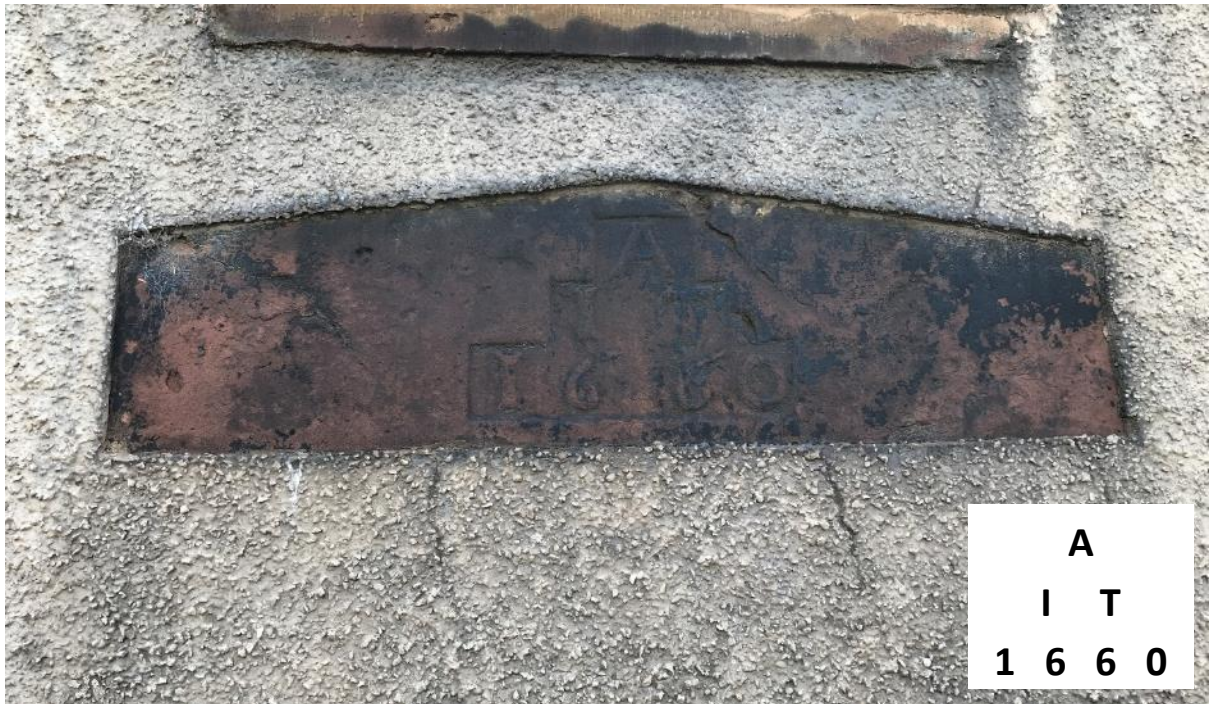
Figure 54 The gable end of the barn bears this date stone.

Although worn, the barn stone is still readable. Generally it is held that the top letter in such arrangements is for a surname and the two below for a husband and wife, so this datestone effectively reads "I and T A, 1660". The datestone was not necessarily originally made for this building; it may have been moved, but even if it was originally made for here, the date may equally not refer to the date of construction, but may be a date of importance to the people initialled, such as the year of their marriage.

This particular stone is clearly saturated, almost certainly caused by the coating of cement render the gable has received at some point. This will have the effect that any moisture entering the wall, e.g. from the footings or top, will have few options for escaping, other than through the porous stone itself. This is likely to lead to significant damage within the next few years unless it can be removed and replaced with a suitable lime render.

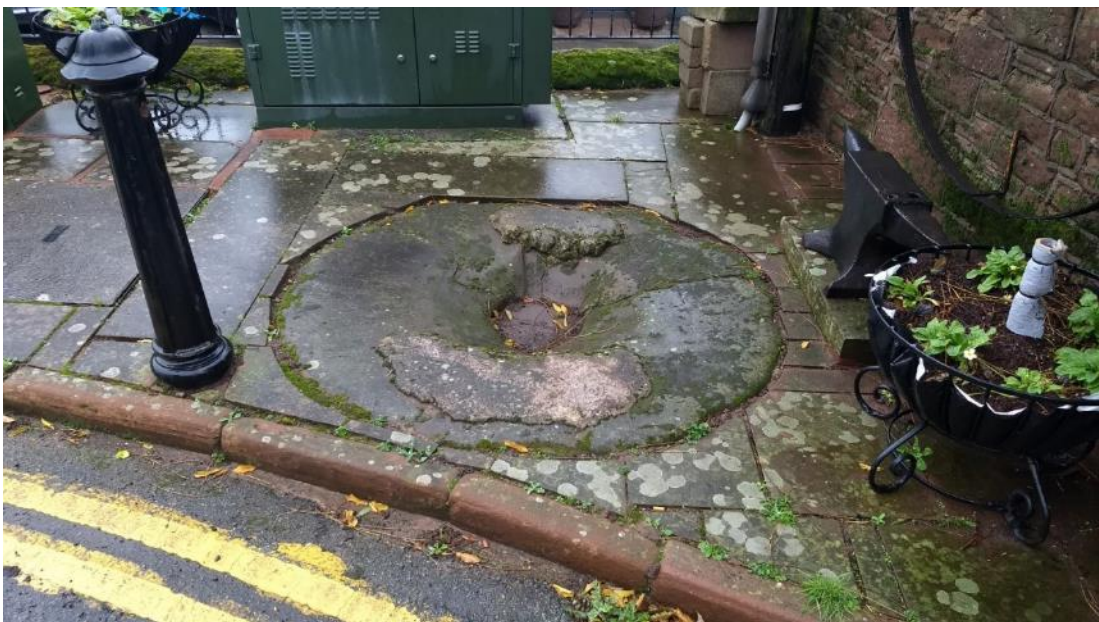
Figure 56 Opposite the Queens Hotel, on the raised end of Cross Hill, is this stone, which was used by the smithy that existed next door to the Queens Hotel until the 1950s, for mounting iron hoops to wooden cart wheels.

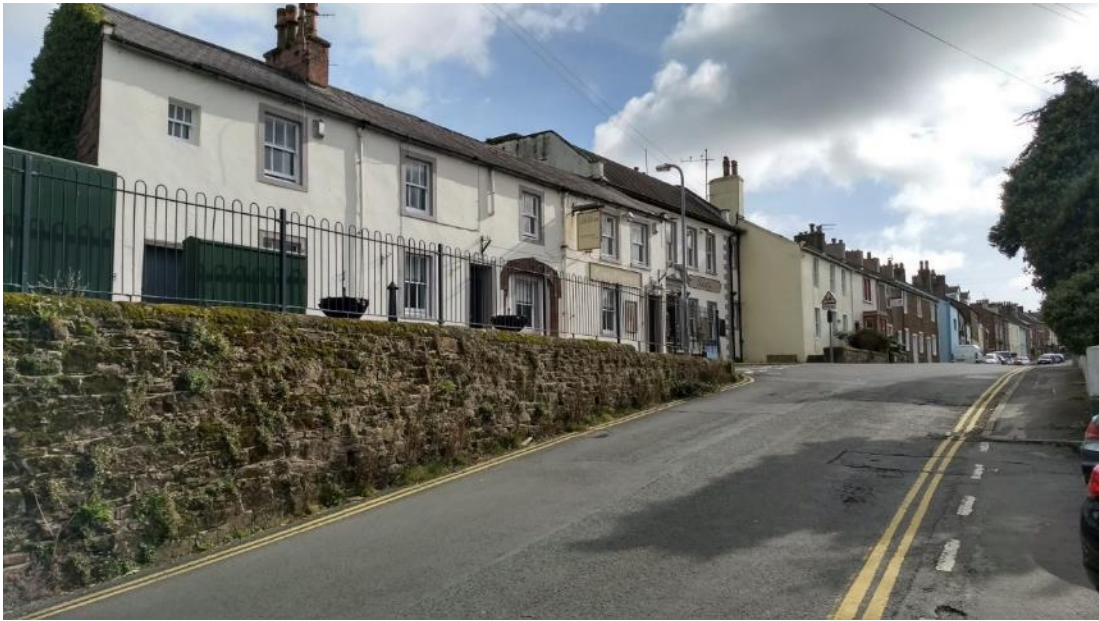
Figure 57 The Manor House Inn

The Manor House is located where Cross Hill meets Main Street. Note the infilled carriage arch in the centre, which would have given access to stabling and a yard at the rear. This building is an amalgamation of several, dating from the late 18th or early 19th century, with further alterations and additions. It is grade II listed.

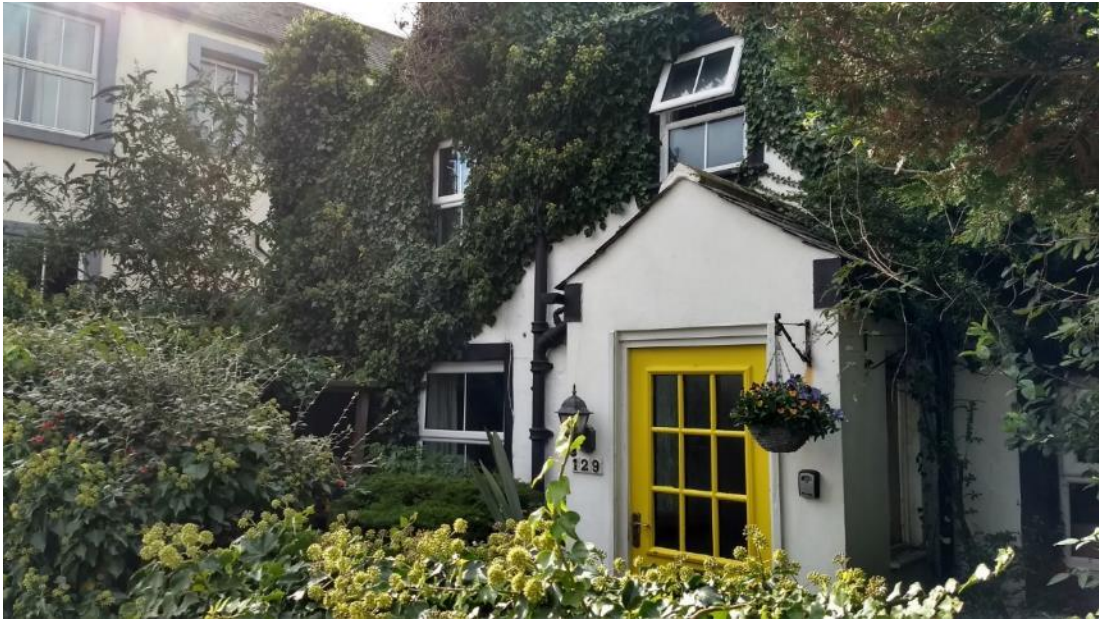
Figure 58 129 Main Street features an extremely lush front garden that gives a very pleasant, cottage-like appearance and softens the largely hard surfacing of this area. There is very little vegetation in general visible from the public areas of Main Street. Although beautiful, creepers can damage render and soft masonry.

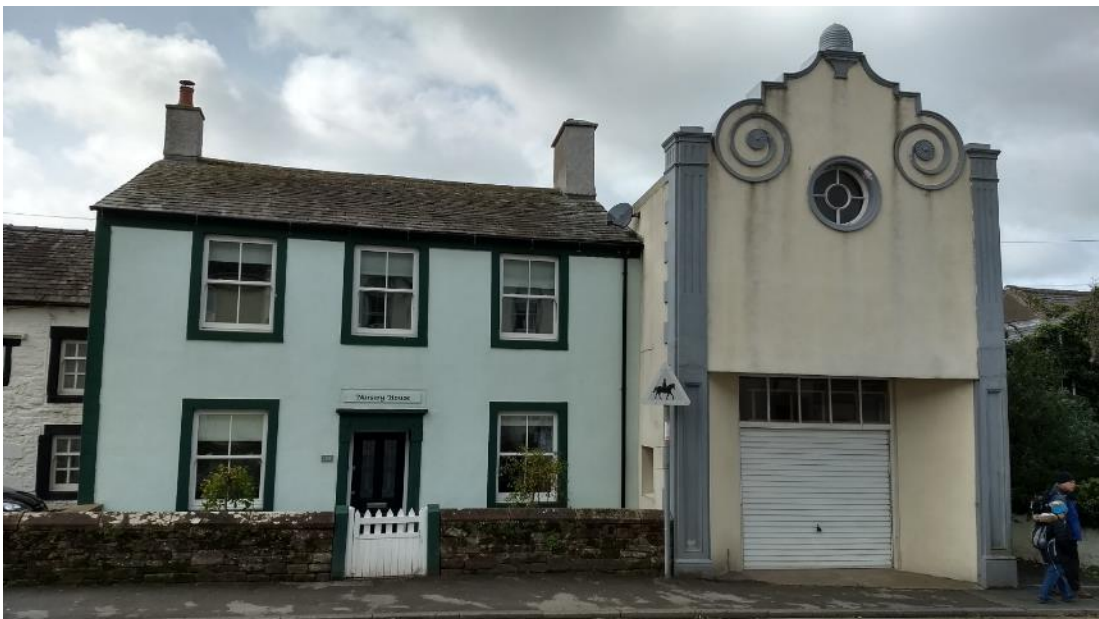
Figure 59 125 and 126 Main Street. From historic map evidence, 126 (former Co-Operative Society premises) appears to have been originally constructed as a barn in the 19th century; 125 is somewhat older.

125 and 126 Main Street are attractive buildings although could hardly be more different. 125 is a well proportioned and detailed example of a house dating probably from the early 19th century. 126 is positioned end-on to the road, and features an extraordinarily moulded and decorated gable, crowned with a beehive. It appears originally to have been a barn, and

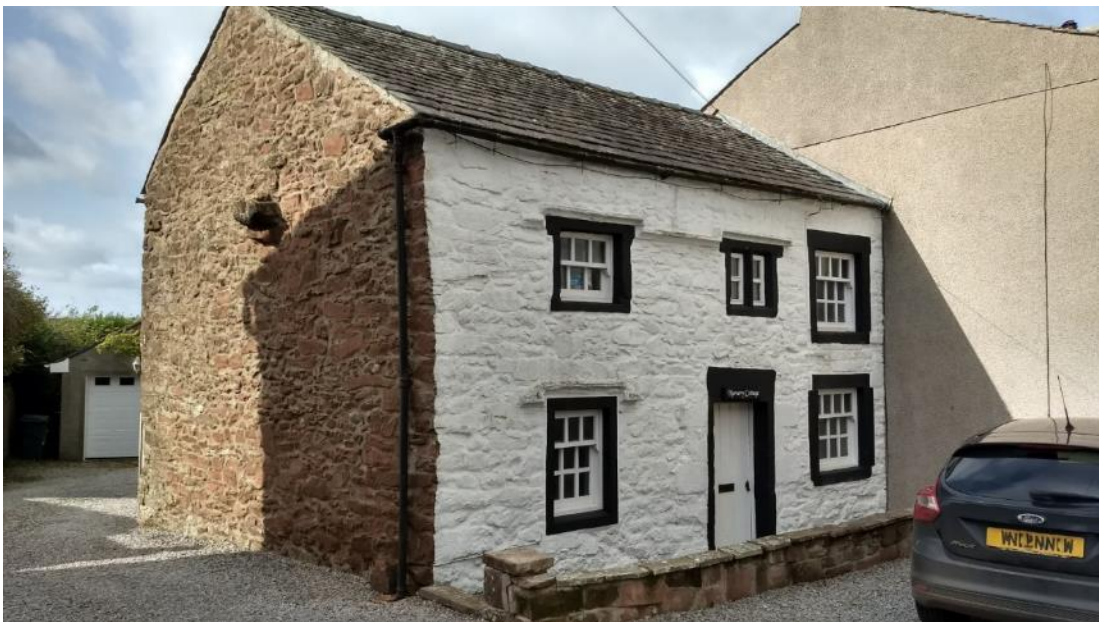
Figure 60 Nursery Cottage, a picturesque 17th century house.

As with a number of properties in recent years, what was the front garden at Nursery Cottage has been replaced with gravel and a parked car. The change has been neatly executed, and is clearly fulfilling a need, but there is no denying that parked cars are harmful to the conservation area’s character and appearance.

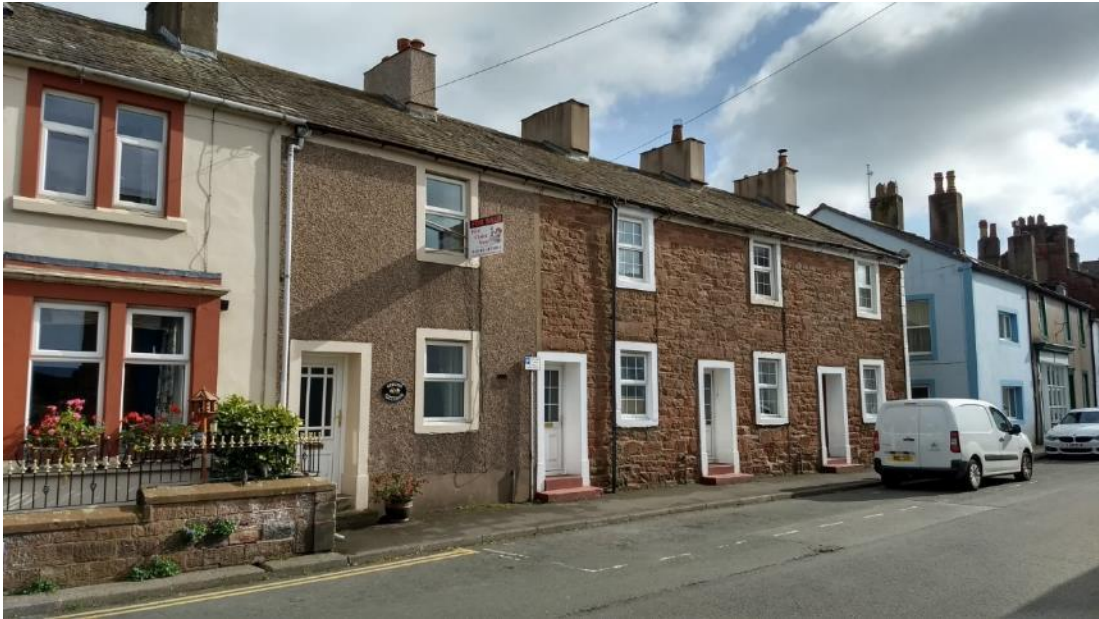
Figure 61 Sandstone cottages typical of Main Street: simple in appearance, two storey, and fronting the pavement. Though there are plenty of cottages like this on Main Street, the area's variation is one of its strengths. Note the completeness of the chimney stacks, an important detail, even if many are missing their pots.

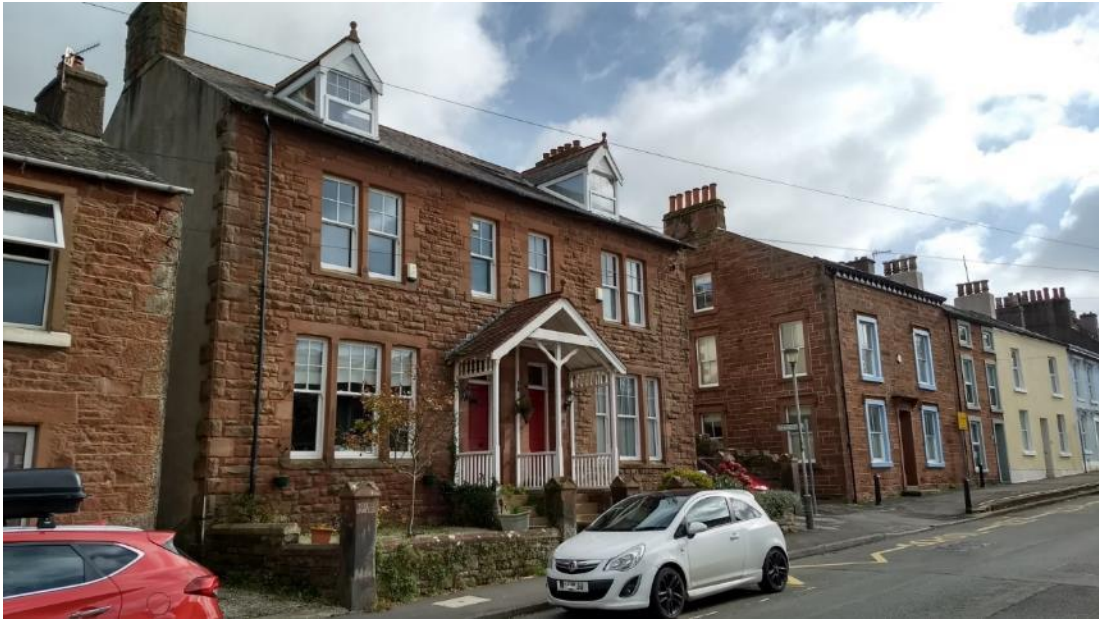
Figure 63 East Croft, 27 and 28 Main Street, a lovely symmetrical pair of houses constructed in the latter part of the 19th century. For the most part, the detailing has survived well, with the porch being a particular highlight. It is to the advantage of these properties that both halves still match.

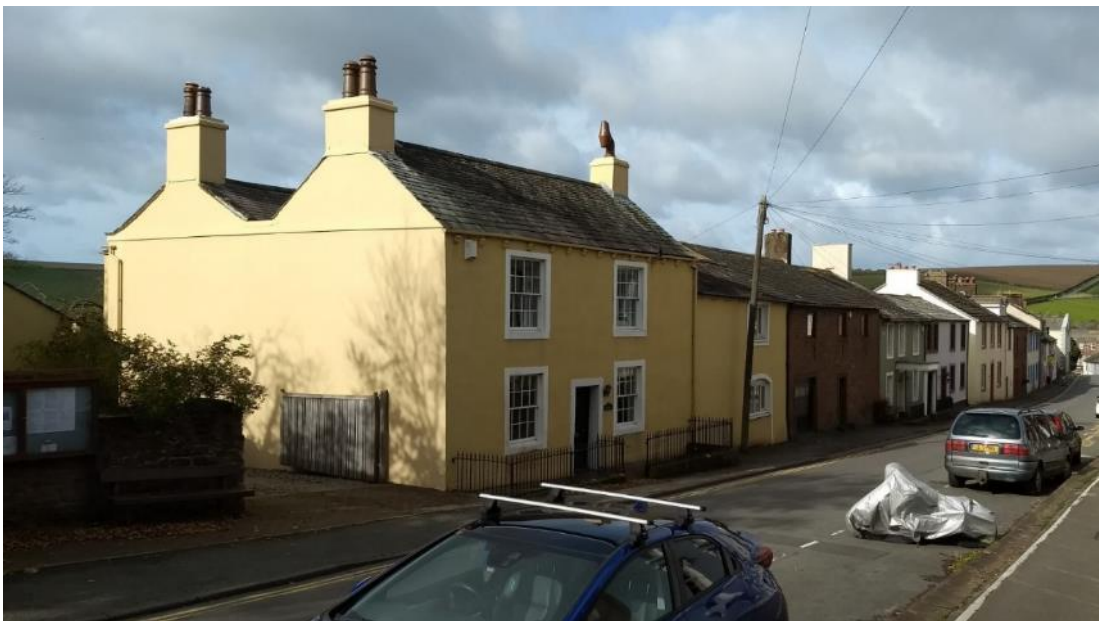
Figure 64 Orchard House (115 Main Street) is a grade II listed late 18th or early 19th century house with a distinctive late Georgian "double plan", consisting of two pitched volumes with a valley between them.

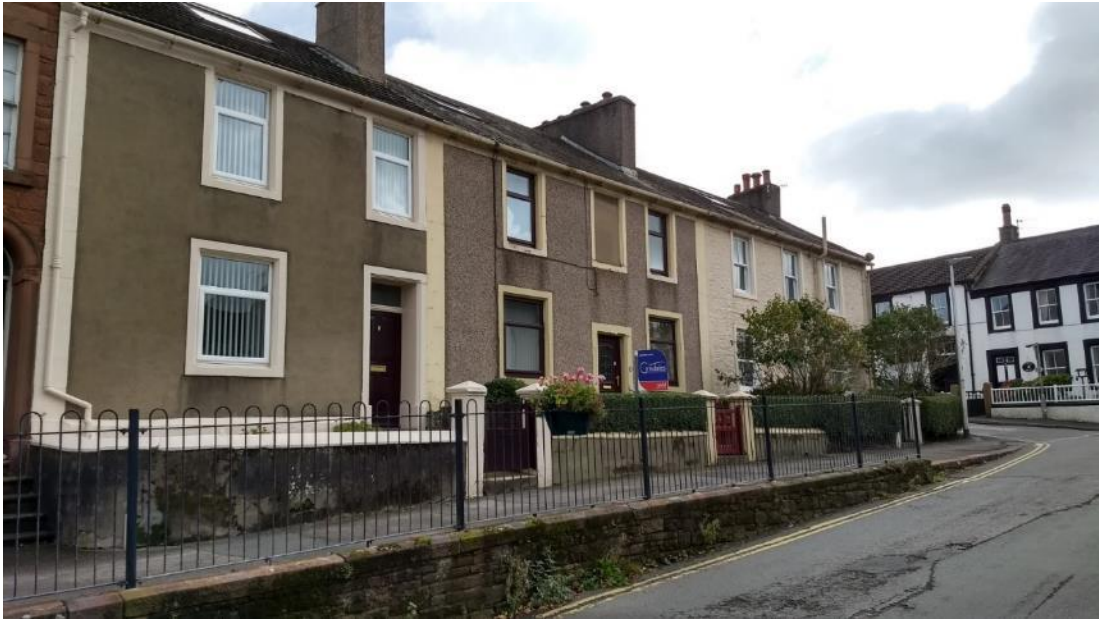
Figure 68 Numbers 48, 49 and 50 Main Street.

At 48-50, fenestration has suffered and the fore-walls have lost their iron railings (as did many, to contribute iron to the war effort). Number 50 appears to have had its render removed and the stone painted, and a soil vent pipe runs up the middle of the façade. Number 49 has been pebbledashed; it additionally used to feature a moulded triangular pediment above the front door, which gave this trio a centre point and emphasised their symmetry. With this gone, and the windows and colours no longer matching, the effect has been lost. However, the fore-walls themselves have been retained, and the rooflights that have been inserted into the front aspects of the roofs are mounted flush, so they don't protrude.

The increased height caused by the step in road height elevates these properties above those on the opposite side. This arrangement appears to have been caused by a mid-19th century road-straightening project, the purpose of which was to provide better access between the sandstone quarries on Outrigg and the station at the bottom of Main Street, from which it was transported. Much of it likely made its way to Barrow-in-Furness along this route. This left the "old" Main Street as the narrower, higher level part, with the new part lower and wider.

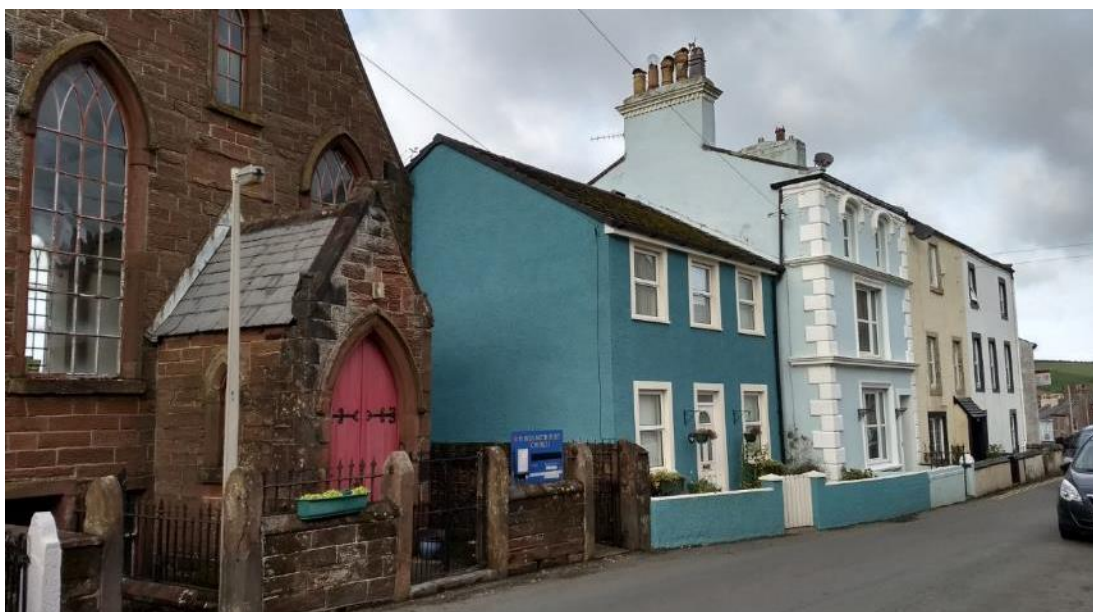
Figure 70 Former Methodist Church (L), 107A-109 Main Street. A simple repainting at 107A has made an enormous improvement to the appearance of this building within the last few years.

The Methodist Church dates from 1865. It is unlisted although contributes strongly to this part of the street. Being set back slightly, it is not widely visible, so one almost stumbles upon it when walking along. It ceased use as a place of worship in 2019, and is more vulnerable as a result. The tall gothic windows with their Y-tracery will not be cheap to replace should they become irreparable, which adds to its vulnerability. There is an engraved plaque above the porch, although it is too worn to be legible. The above photo highlights again the harm caused by insensitive lamp post insertion.

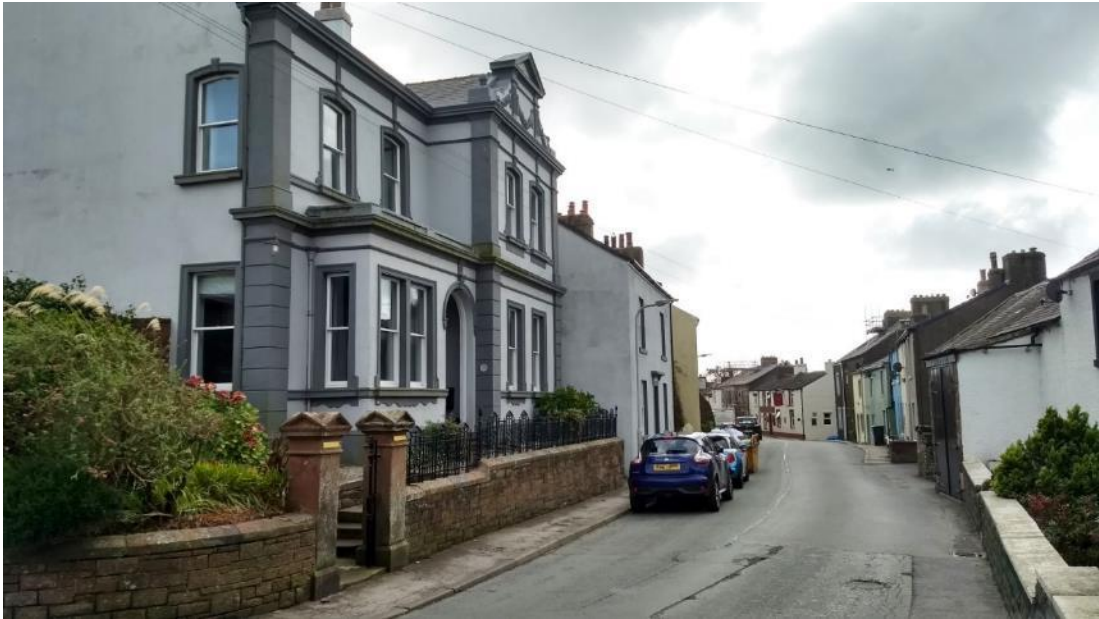
Figure 71 Redbourn House, an impressive and lofty grade II listed Victorian dwelling with baroque elements and separately listed boundary wall with railings

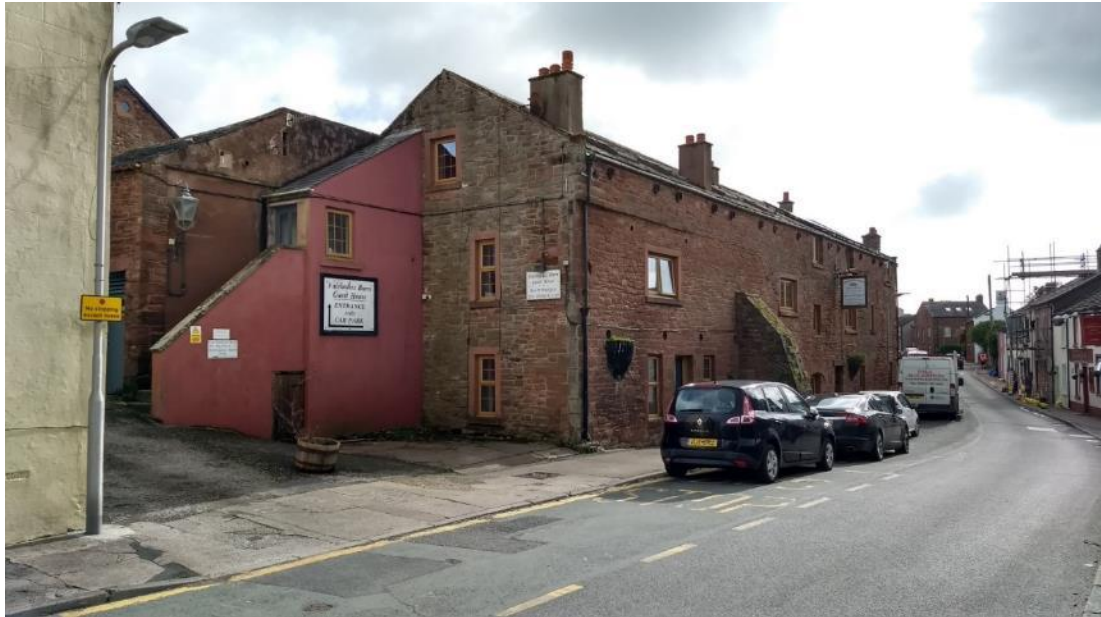
Figure 73 Fairladies Barn,

Fairladies Barn is a converted former agricultural building associated with Fairladies Farm, now in use as a bed and breakfast. The substantial buttress halfway along is presumably a more recent addition added to prevent movement.

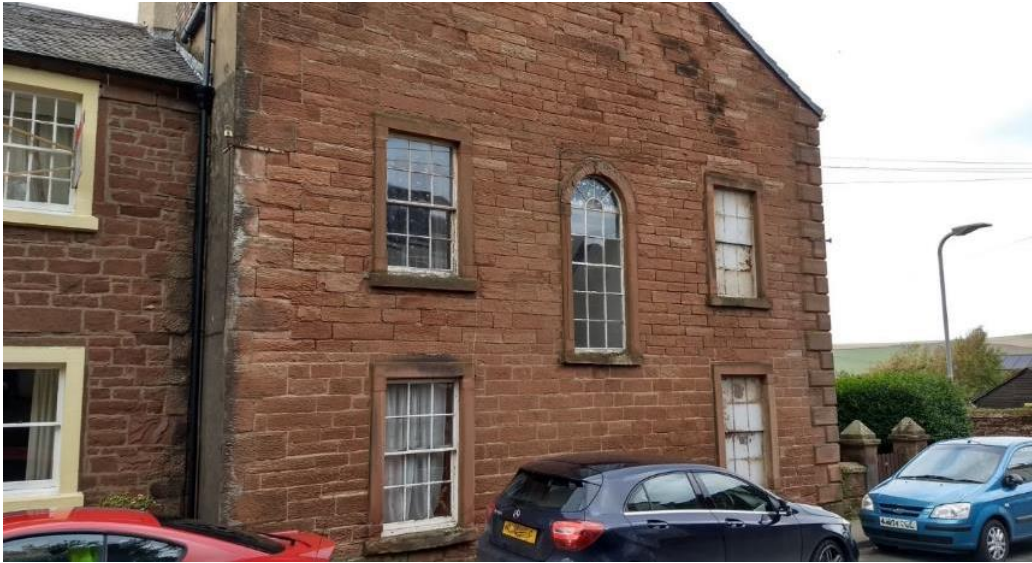
Figure 75 Grainger House

Grainger House is a grade II listed house from the late Regency or early Victorian period. Note the diagonal staining demarcating the route of an internal chimney that passes across a pair of blind windows. 81 Main Street, adjoining it, is about contemporary with it and bears a date stone reading “John and Jane Noble 1838”.
