St Bees Conservation Area Appraisal

2021

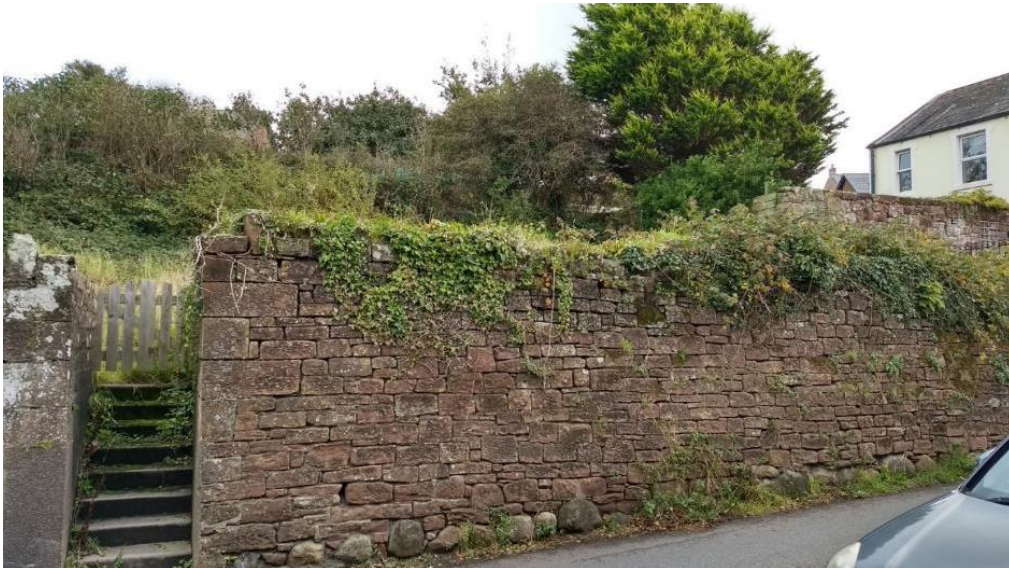
Opposite these properties is an undeveloped area, which appears from historic OS maps never to have been developed, but instead to have been a small field or garden. It is separated from the road by a tall and attractive “cock-and-hen” wall of snecked red sandstone, whereby the copings are alternately laid down and upright.

Figure 76 The attractive wall (its cock-and-hen coping stones are obscured by ivy) separating the road from an area of vegetation that, like the barn at Town Head Farm, allows the area to retain aspects of its agricultural history. Sites like this are vulnerable to infill buildings, or even pressure from car parking. The gradient of this plot has likely been its saving grace by making such development difficult.

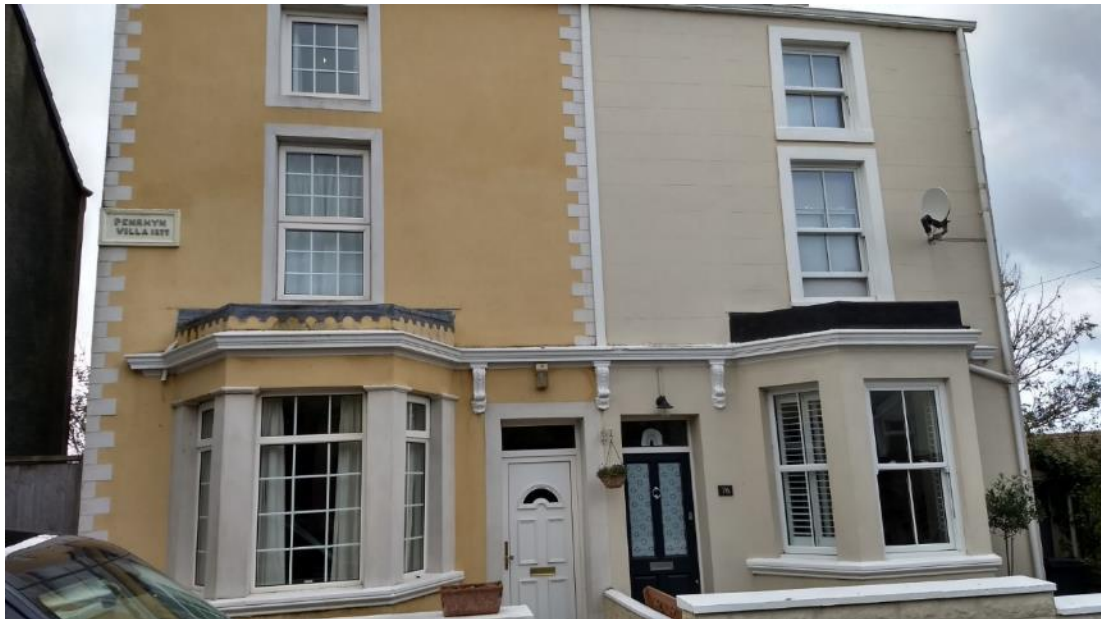
Figure 77 Penrhyn Villa, a semi-detached pair dating, from the plaque, from 1877.

Both halves of Penrhyn Villa (“penrhyn” is a Welsh word meaning “headland”, an appropriate name given their location overlooking the sea) have been repainted in recent years, and benefit from colour schemes that are harmonious with one another. It is also apparent that number 75 has lost a moulding with drip detail to match those above the front doors from its first floor window, and further drip details below the eaves. At the same time, it has gained two rows of quoins, and both properties have gained bands around the upper floor windows.

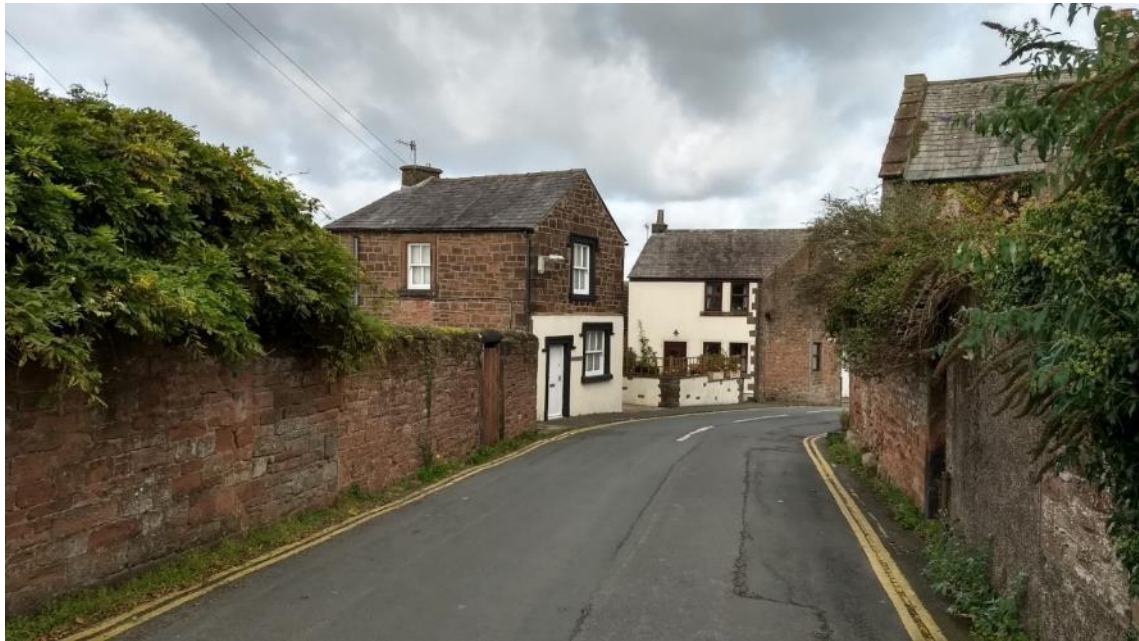
Figure 78 Red sandstone on Cross Street (Thimble Cottage in the centre), creating a wonderful richness and softness in combination with vegetation, slate roofs, and timber windows.

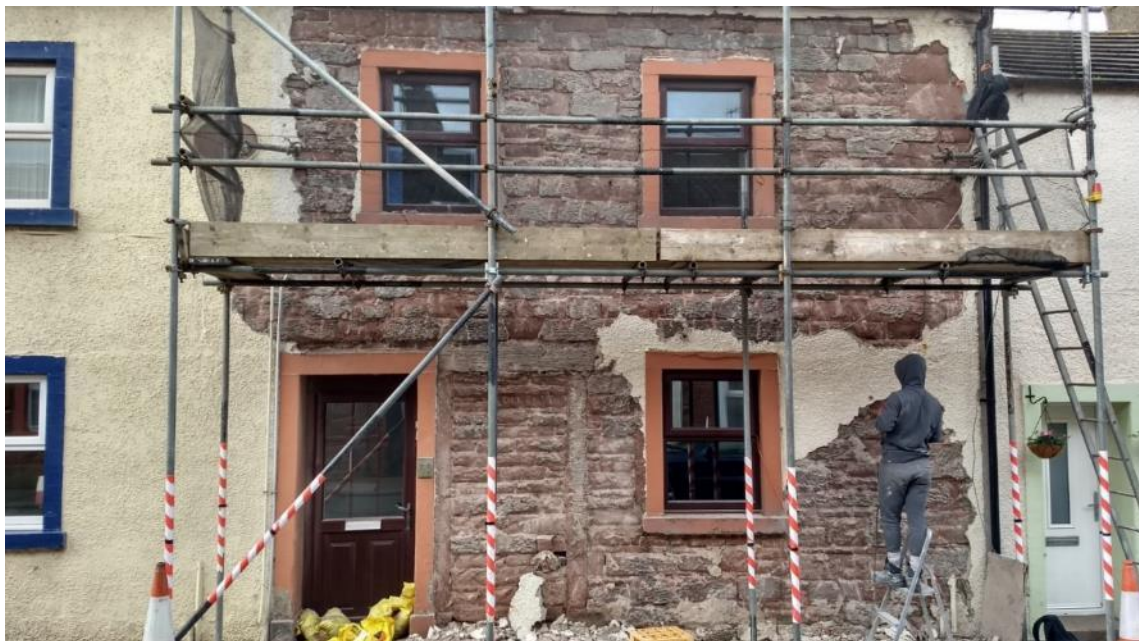
Figure 79 Removal of render gives an opportunity to see what's underneath.

Number 89 Main Street in Figure 79 has red sandstone rubble walls. Care should be taken with solid wall construction not to cause damp issues internally with cementitious wall coatings. Lime render and plaster should be used as a first option (advice on lime is freely available from the Council; it's a complex topic).

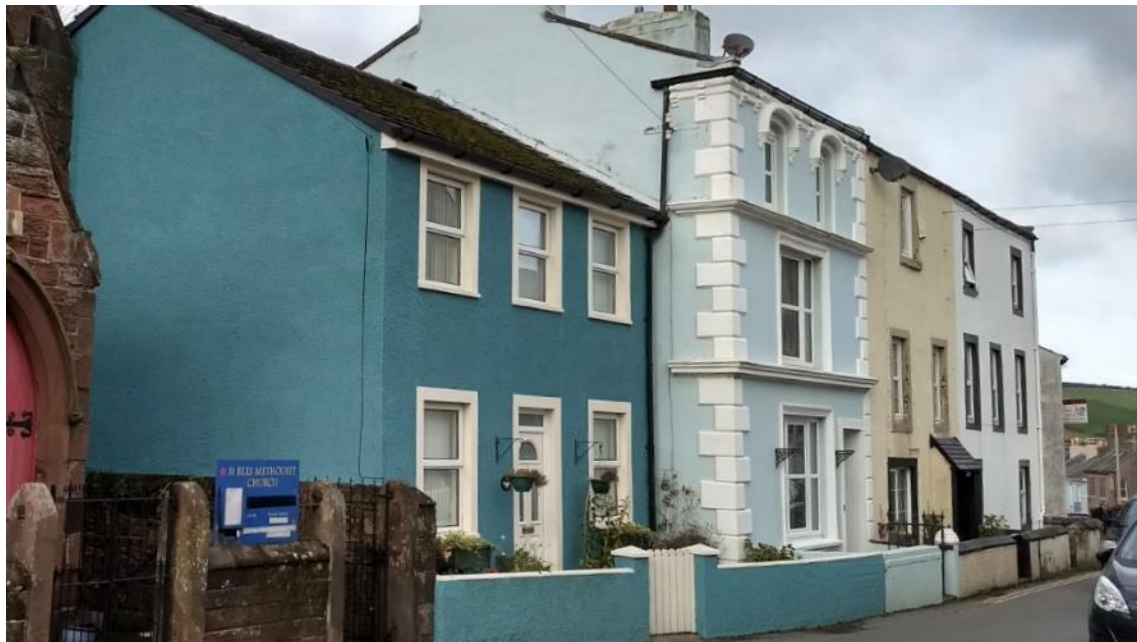
Figure 80 Coloured render also has a strong tradition in St Bees, with buildings providing uplifting splashes of pastel or earthy hues that contrast well with the deeper qualities of red sandstone. Painted render also has the ability to show off more ornate detailing, as is the case here with the paler blue house.

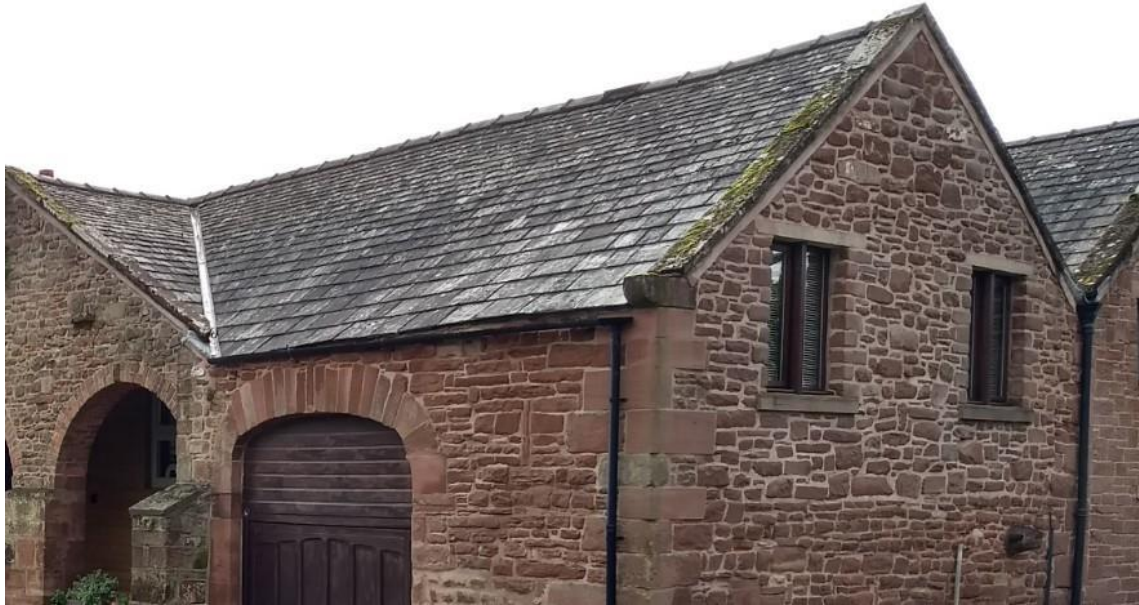
Figure 81 Lakeland slate roofs are characteristic of the conservation area, and sit well with red sandstone or coloured stucco. Their replacement with tiles is rarely beneficial to the area's appearance, and normally resisted.

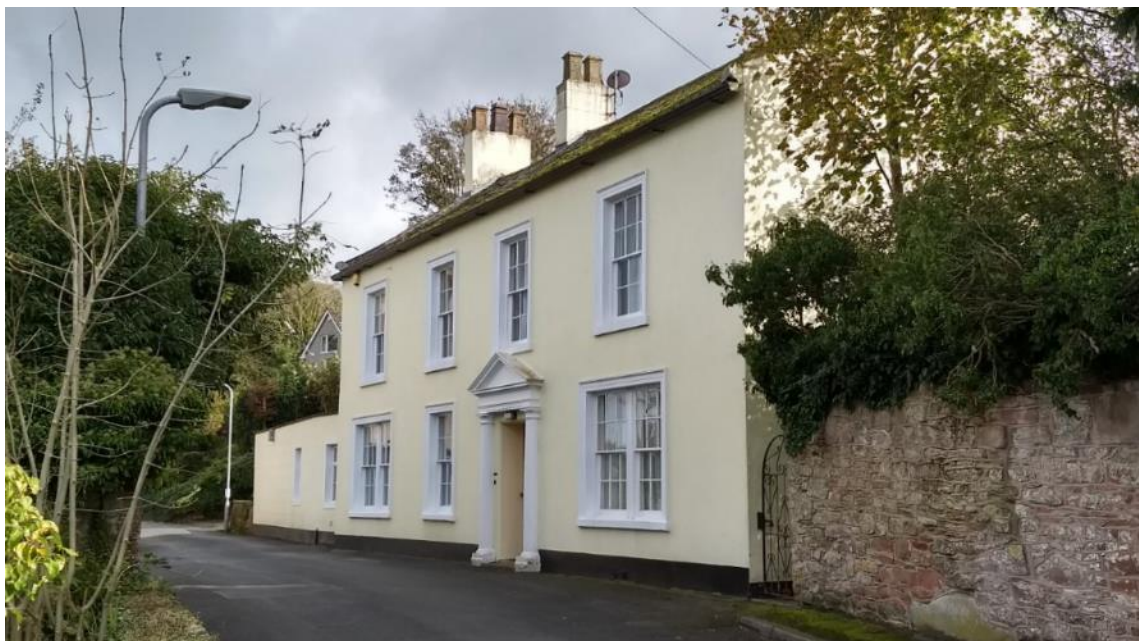
Figure 82 Timber sash windows have generally been one of the heaviest casualties in St Bees, however, where they are retained (even in a somewhat anachronistic brilliant white colour) they complement the area. Much can be done to improve the performance of timber single-glazed windows, and where renewal is necessary a suitably specified double-glazed example is often acceptable, and provides a balance between insulation and appearance.

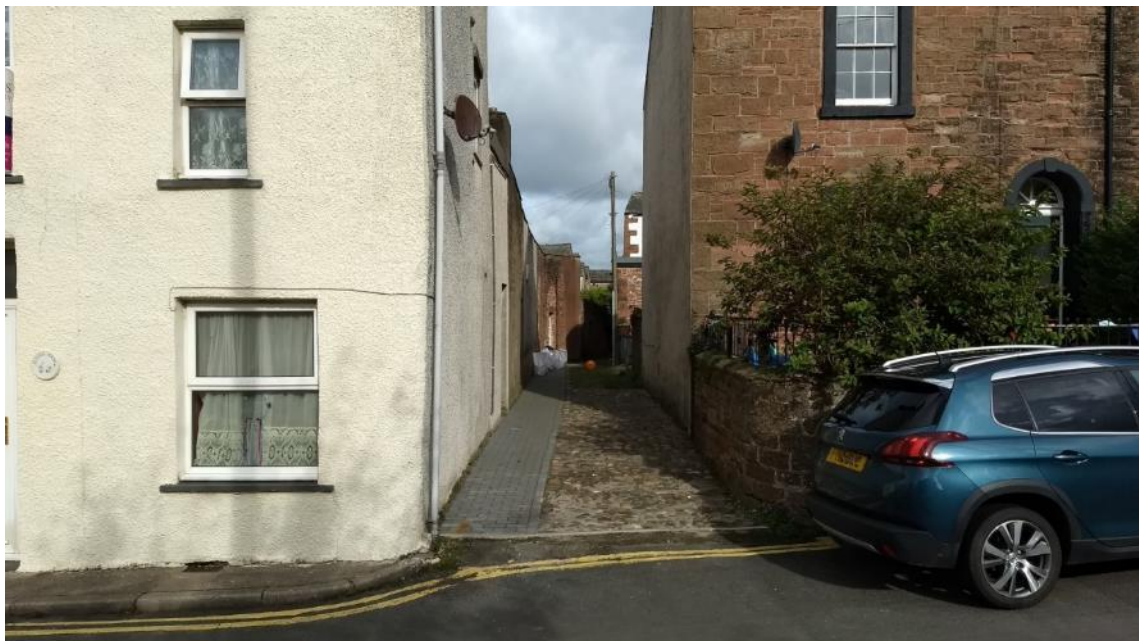
Figure 89 Views from High House Road and Finkle Street are often more directional due to the higher density of buildings. Intrigue plays a part here, glimpses of places that are tucked away and invite the passer-by to investigate. In this example, the quality of this snicket is heightened by its cobbled surface.

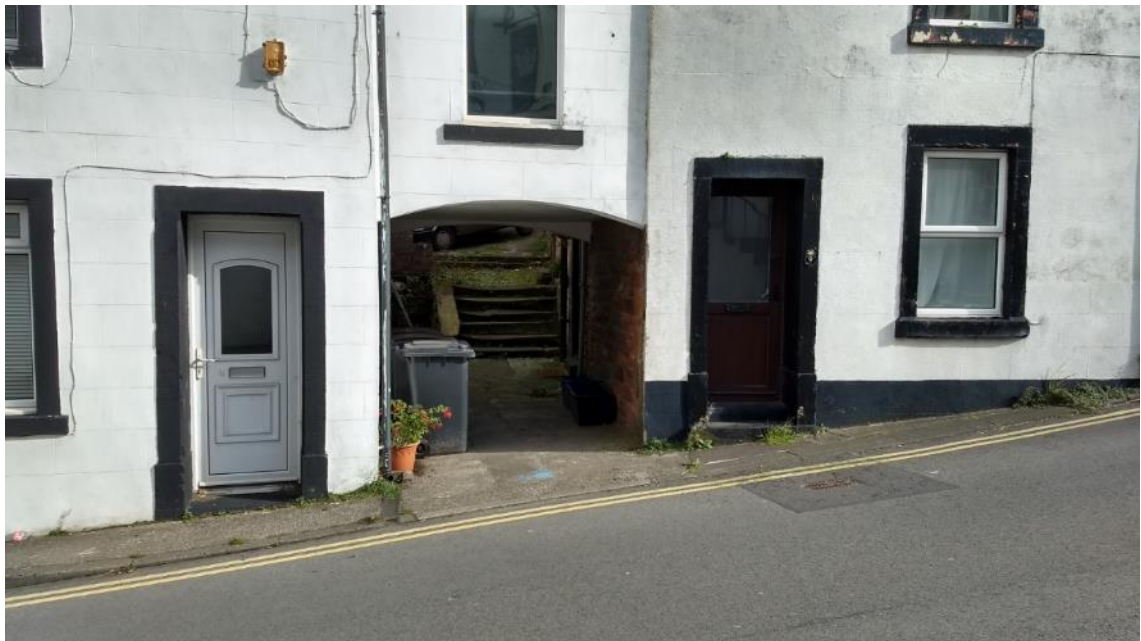
Figure 91 Surviving carriage arches such as this one on Main Street provide a glimpse into the semi-hidden spaces behind.

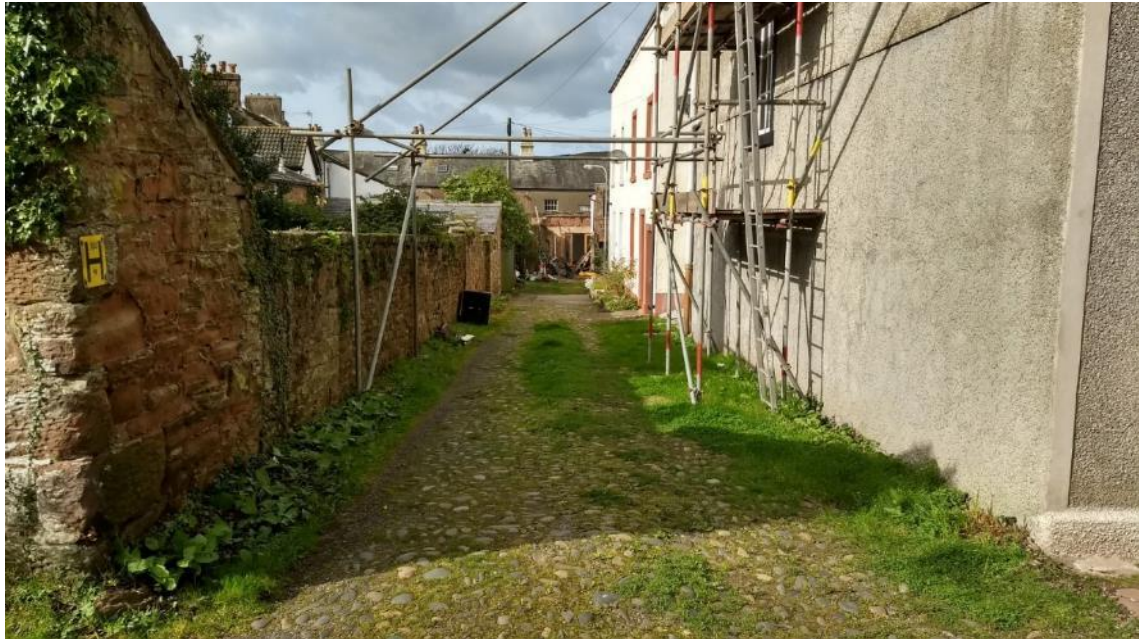
Figure 94 A few cobbled snickets survive in the Finkle Street/High House Road area, and these are precious, their enclosedness and texture a key part of their charm.

Cobbles do however survive in a number of the snickets that lead down the backs of rows, particularly around High House Road.

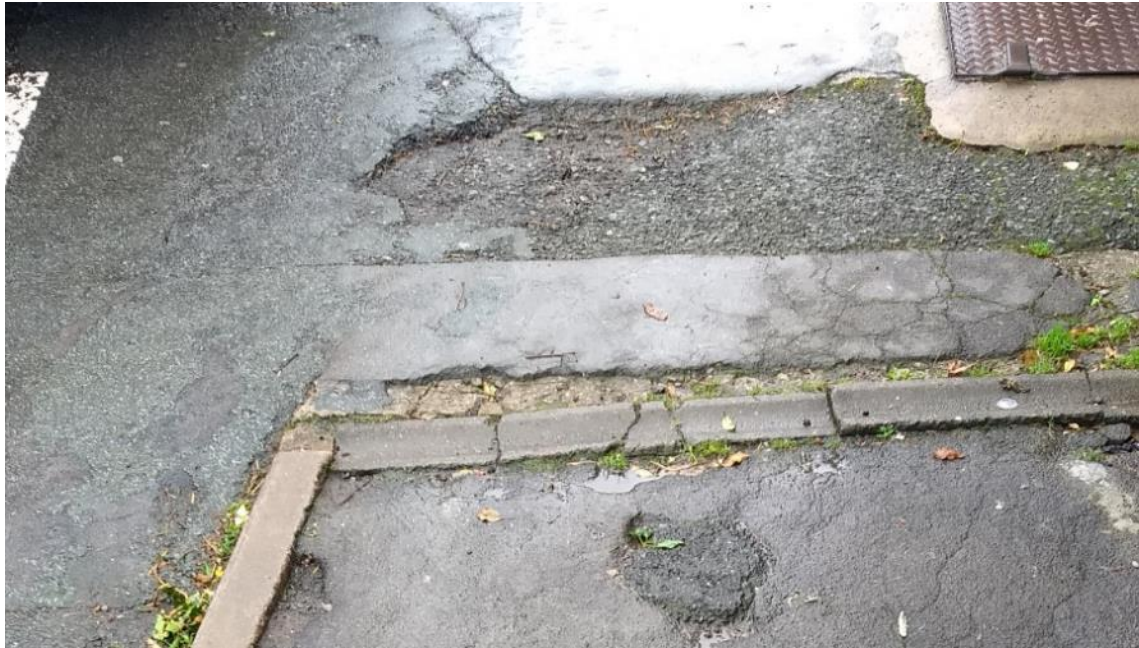
Figure 95 Tarmac causes more problems the older it gets. Any movement beneath it results in cracking, and repair leads to mismatched patches that move and wear relative to the original. Eventually, an unsightly mass of scarred material results, and furthermore contributes to surface water runoff.

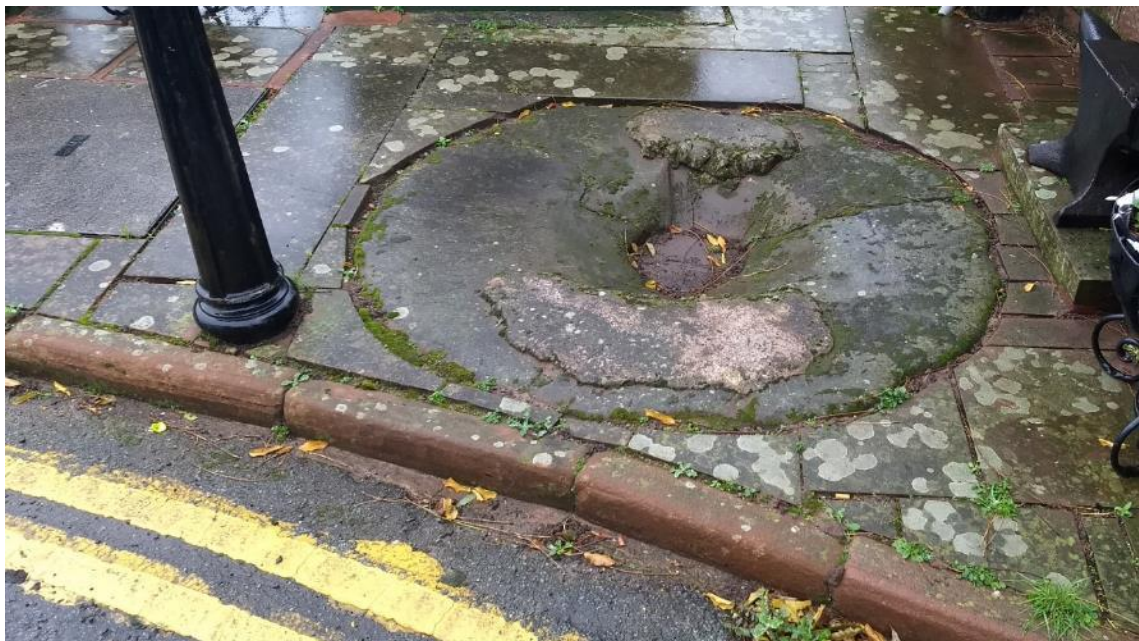
Figure 96 This area of pavement at the end of Cross Hill has an attractive flagged surface and, interestingly, red sandstone curbs that add a strip of colour along the edge. Being quite soft, red sandstone is not commonly seen as a curbing material.

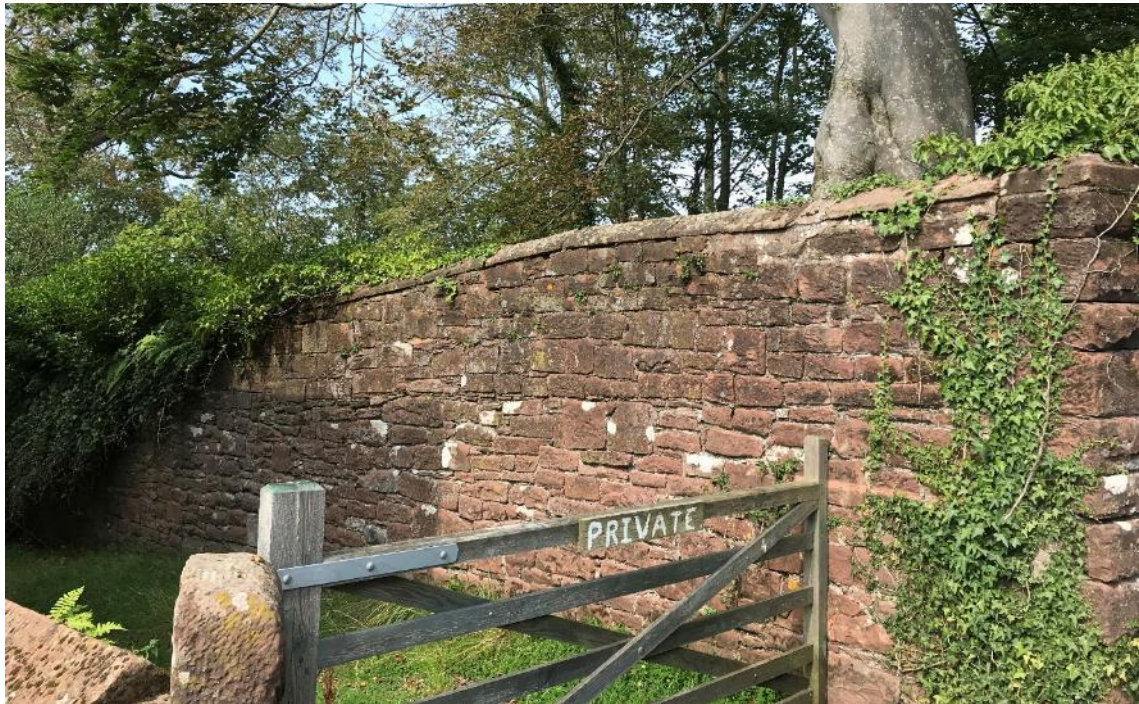
Figure 97 One of the many red sandstone walls that characterise St Bees' conservation area on High House Road. Dressed rubble with half-round copings. Many of these bound the gardens of large properties or define snickets, as here, leading up the side of Grindal Place.

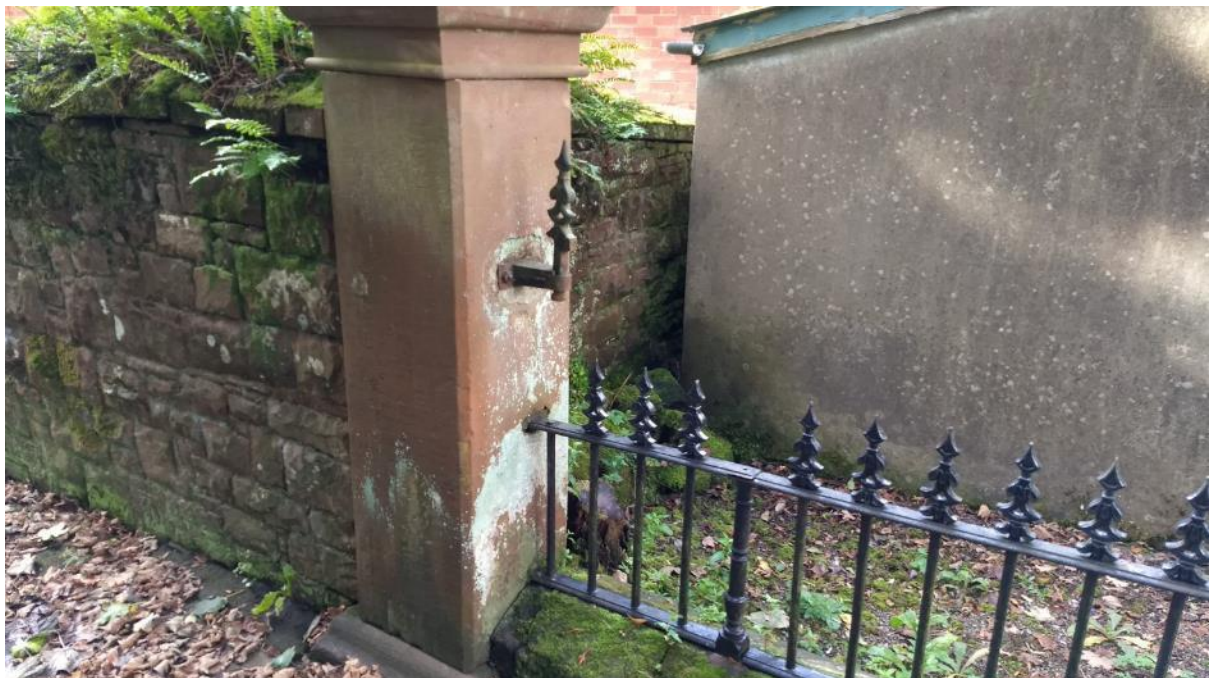
Figure 98 Iron railings survive in places, often as part of attractive red sandstone perimeter treatments. The mixture of high quality ornamental ironwork, red sandstone and vegetation creates a richness, colour and even smell, particularly after rain, that can be very pleasing.

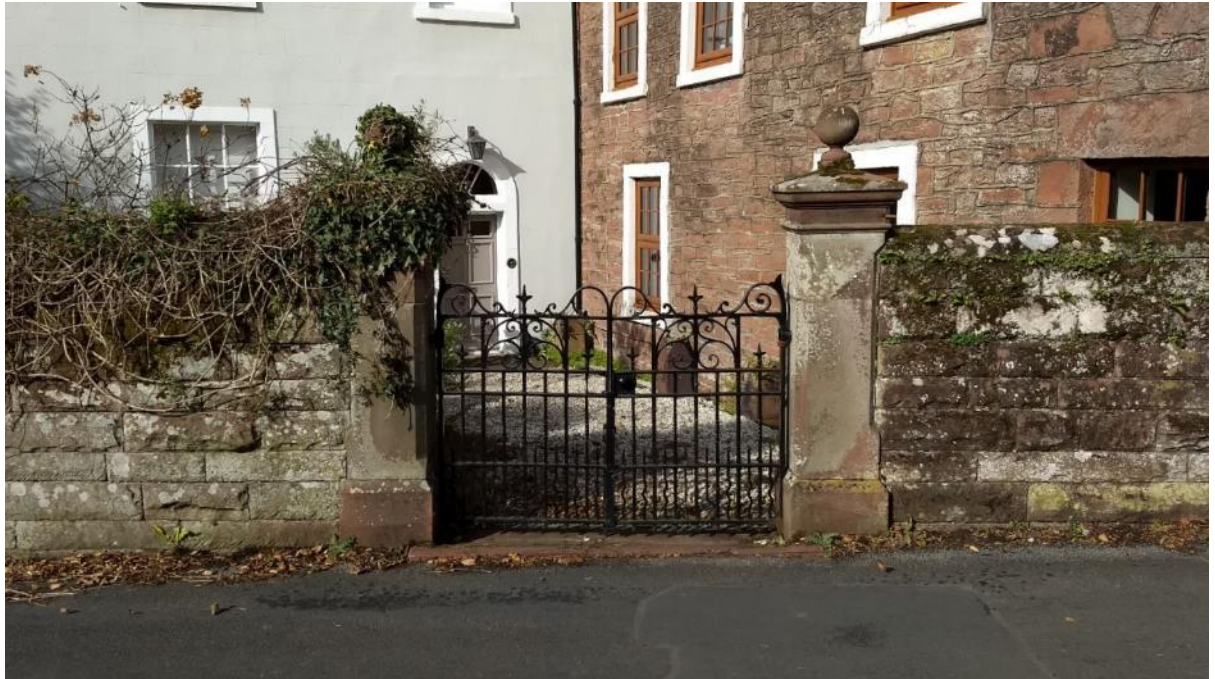
Figure 99 This property on High House Road features impressive squared rubble walling, with grand gate piers and a very attractive gate forming a feature.

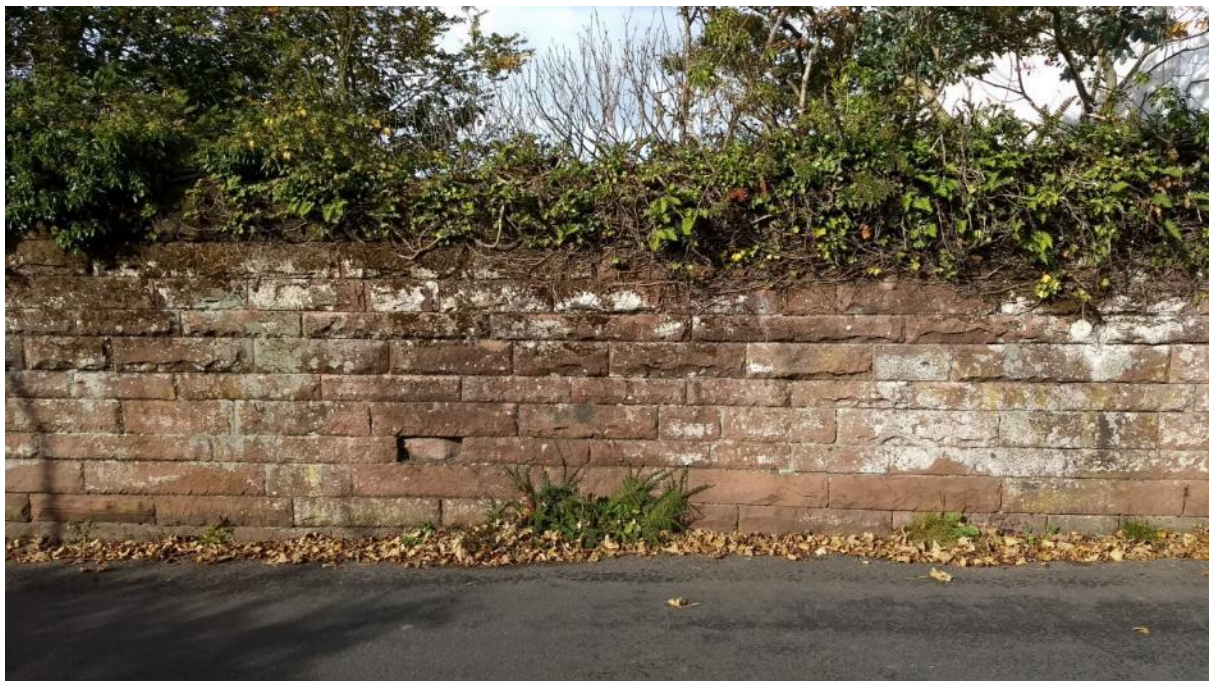
Figure 100 Squared red sandstone rubble wall with half-round copings and vegetation on High House Road. Though the vegetation is a key part of the sensory qualities of this area, it can also damage masonry if left unchecked.

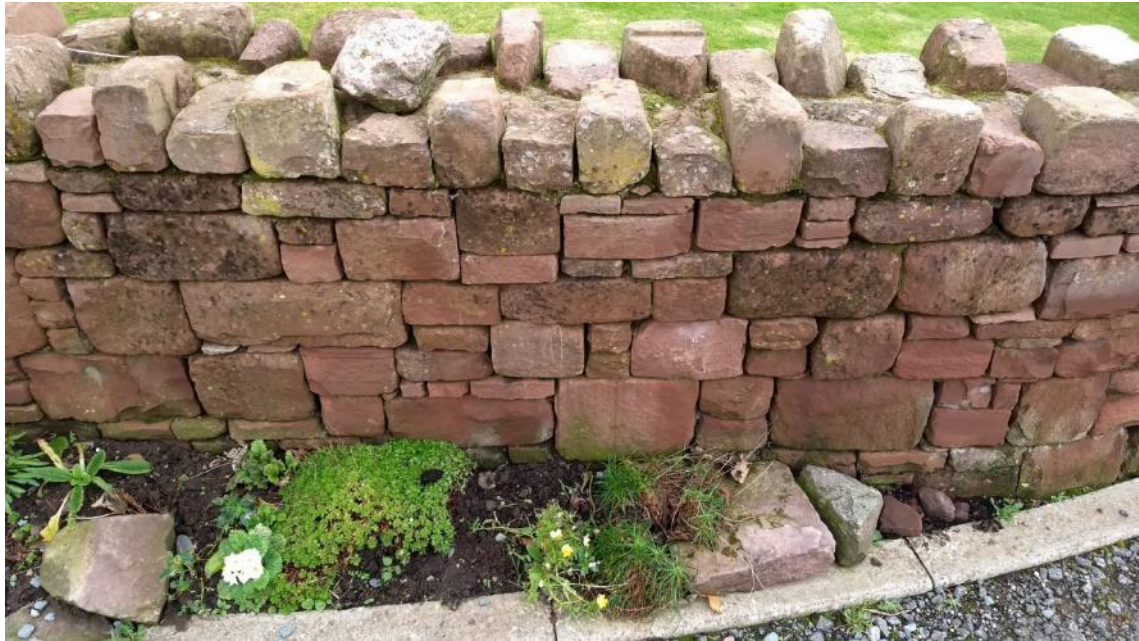
Figure 101 This "cock-and-hen" walling is only a few years old, but it is a well-executed example of a locally distinctive typology. Its use on Abbey Road successfully frames the street and entrance to a house.

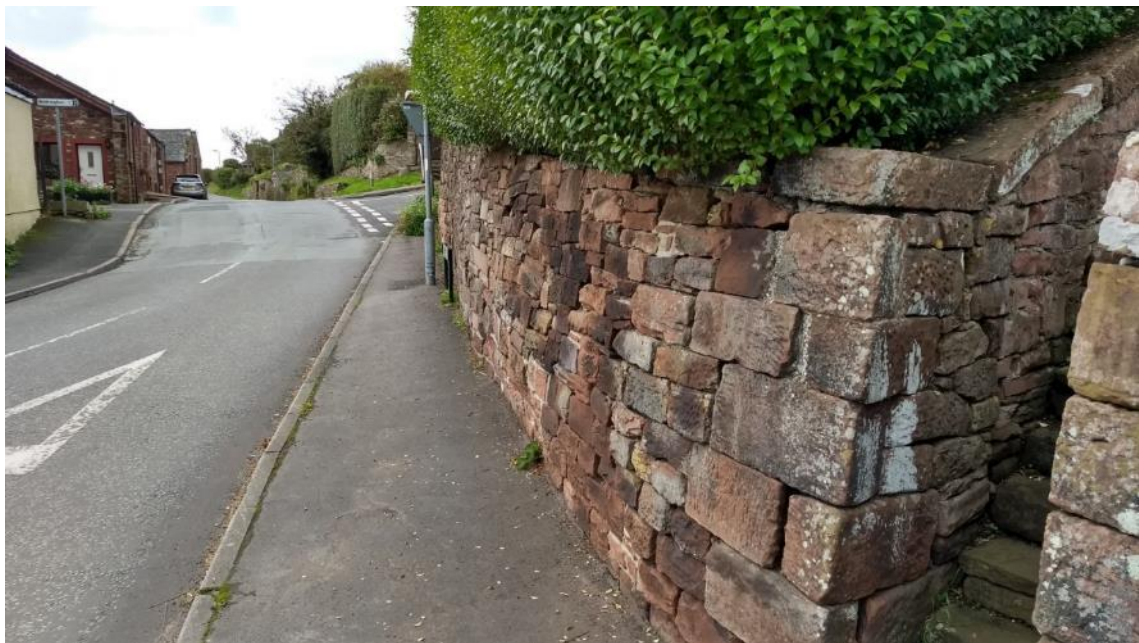
Figure 102 This wall on the corner of the B5345, just outside the boundary of the conservation area, is quite noticeably bulging. Many of the walls in this area are retaining walls, and the mix of little slopes and steps cut into the incline is characterful. However, these retaining walls need monitoring to make sure they do not lose integrity.

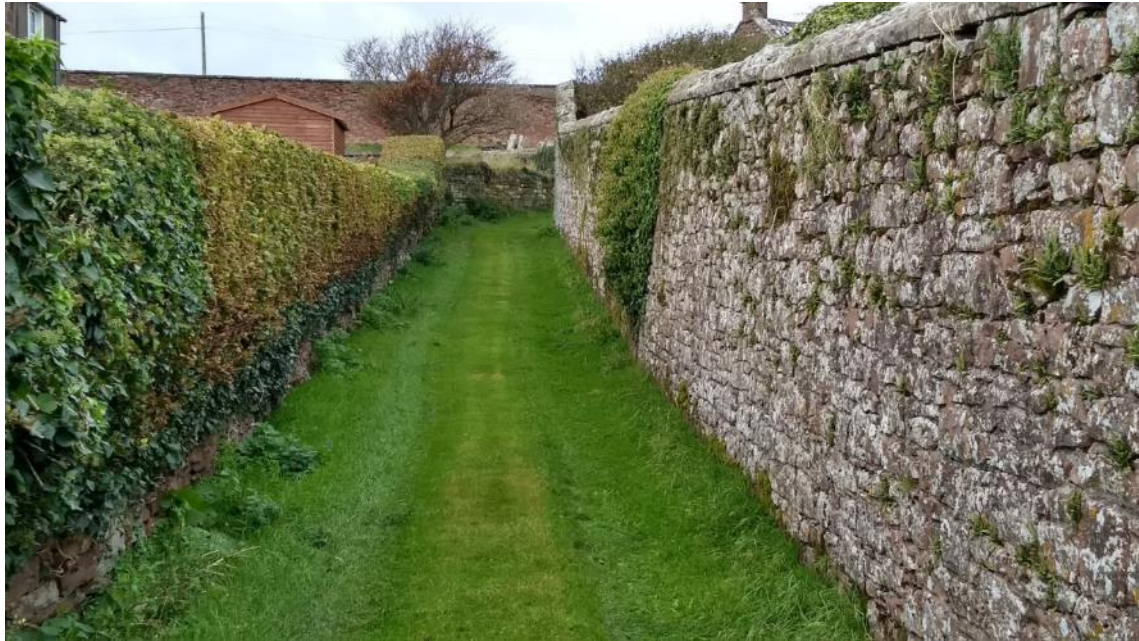
Figure 103 Hedges feature more prominently in the northern part of St Bees. This snicket is outside the conservation area, but contributes to its setting. Featuring a neatly mown hedge, lawned surface, and high stone wall, this particular one is a fine example.

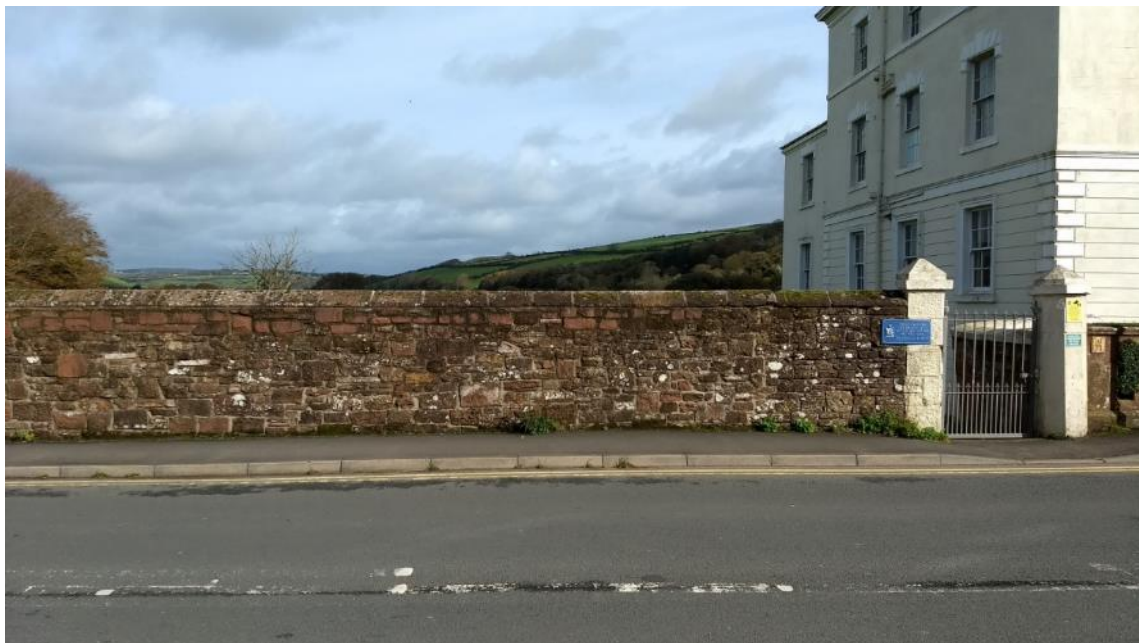
Figure 104 Characteristic red sandstone walling with triangular copings near the station and Grindal House

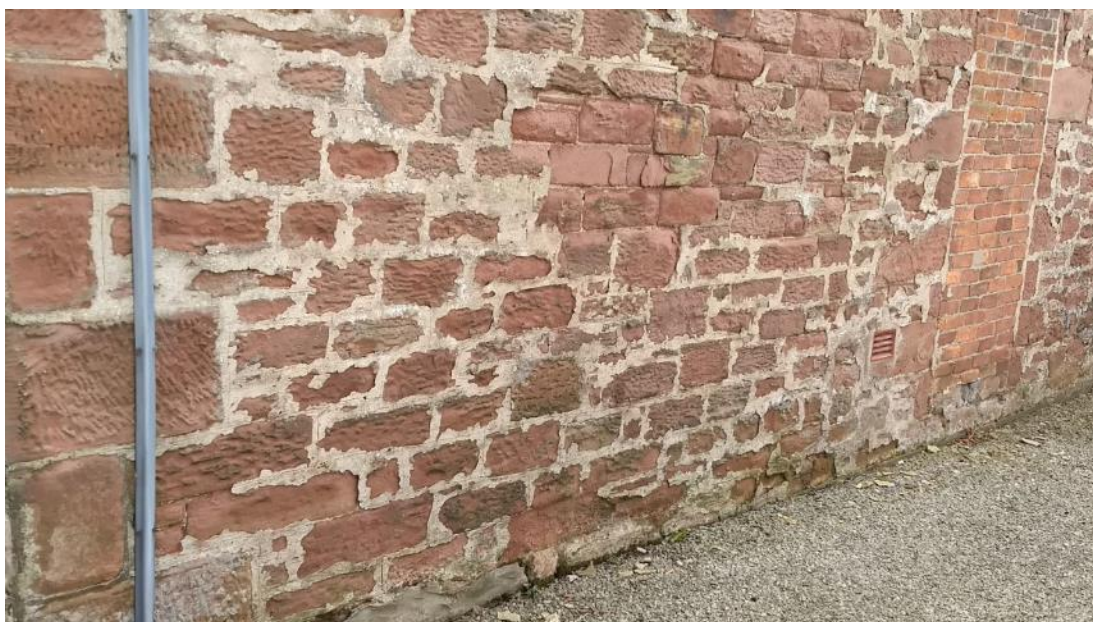
Figure 105 Poor quality pointing risks harming the characteristic appearance of St Bees' red sandstone. In certain cases, it will be contributing to damage to the fabric of the stone itself. This is particularly apparent where stone surfaces have delaminated or powdered away, leaving an edge of pointing standing proud.
