PROPOSED ELEVATIONS

DAVE AND LAURA NELSON

DRAWING NO.: 21.13.07c As Noted@A1 CW MAY 2021

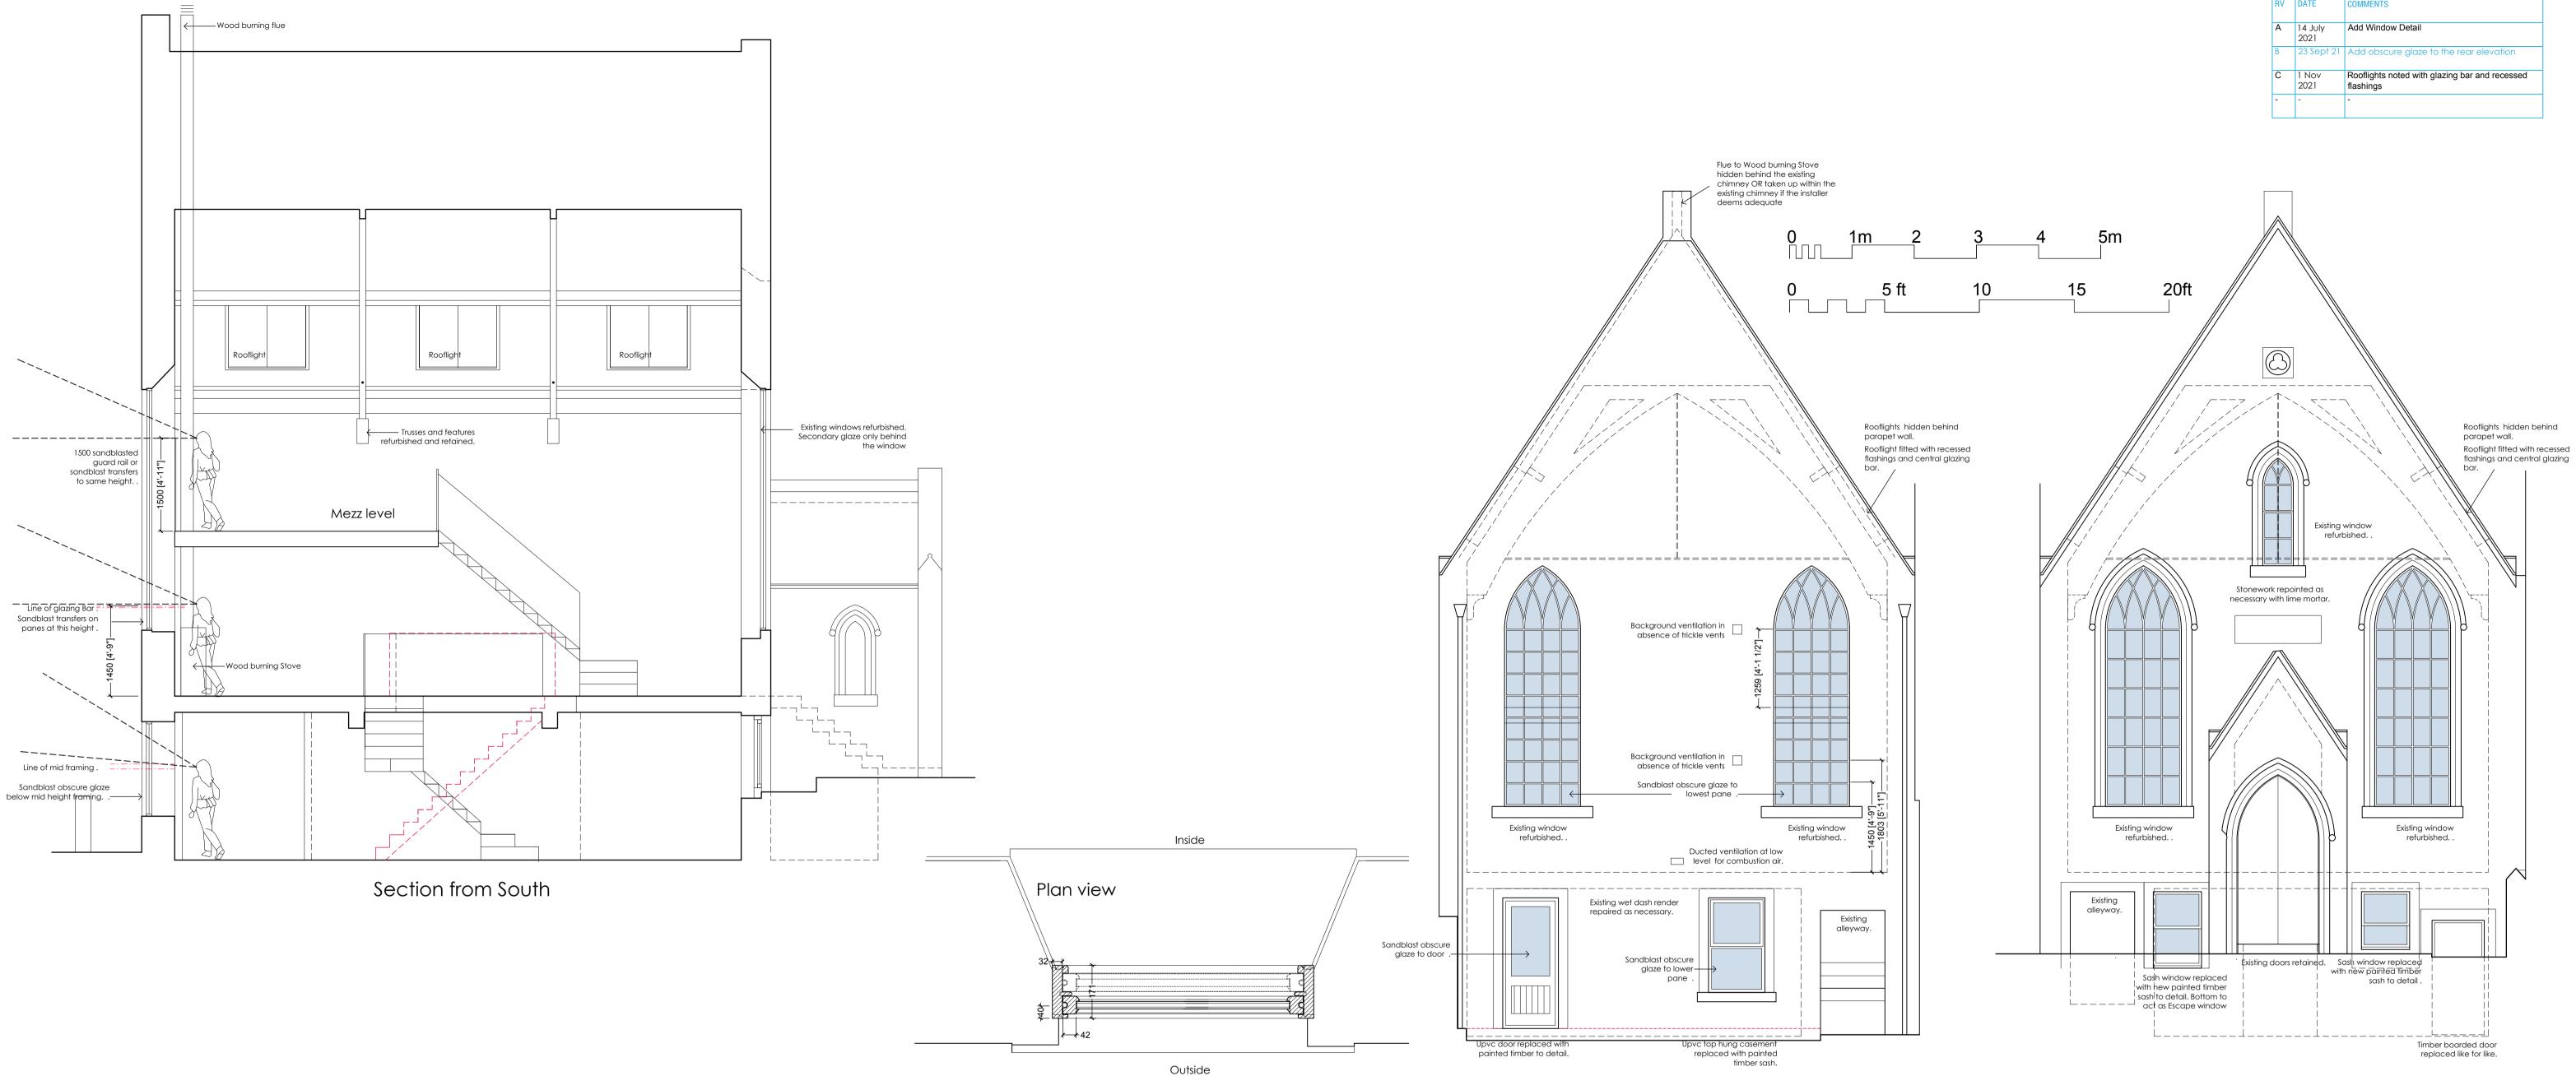
Rear (W) Elevation

Front (E) Elevation

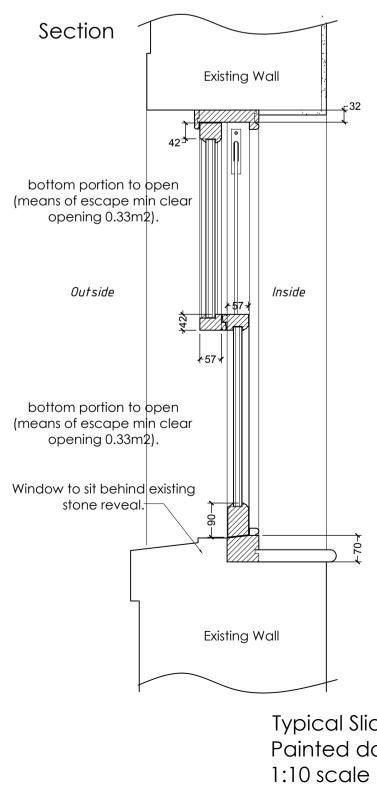
Typical Sliding Sash Window Detail as indicated Painted double glazed unit

Elevation

Existing Sandstone surrounds repaired as necessary. —___800—___ Horns

Existing stone cill with stooled ends
