Protected Species Survey: **Bats and Barn Owls**

Bat Survey Class Licence CL18 Registration no. 12316-CLS

Buildings at Town Head Farm
Nethertown
Egremont
CA22 2UH

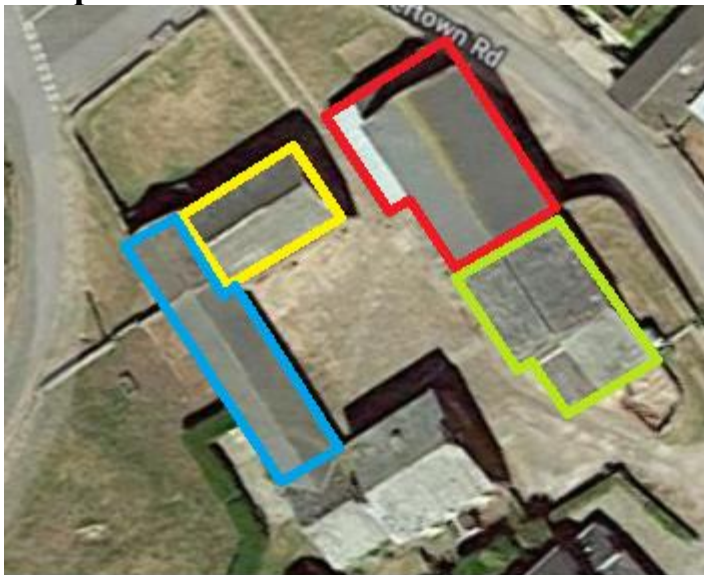
Site plan

SITE 1

SITE 2

SITE 3

SITE 4

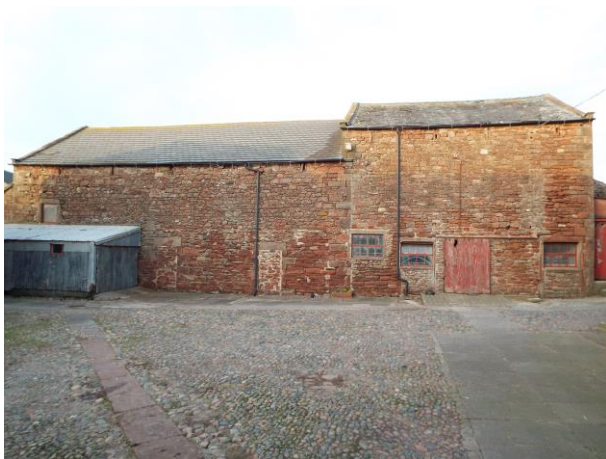
Front of sites 1 and 2

- **Site 1:** This is a large sandstone-built barn measuring approximately 16 metres by 9 metres and 8 metres to the guttering. It has a tiled roof with a breathable membrane which was renewed in 2003. There is no loft area. It is well-pointed both inside and out. There is an area on the north-eastern aspect which has been repaired in 2014 using breeze-blocks and re-pointed externally. There is a tin-built lean-to built on the south-western aspect and a small, single-storey, stone-built lean-to on the north-western gable. This has a slate roof and daubing.

- **Site 2:** This is a large, sandstone-built bank barn, measuring 9 metres by 9 metres and from 4-6 metres to the guttering. It has a slate roof with daubing and has some small areas of disrepair. The building is well-pointed both inside and out. It has a single-storey calf shed adjoining the south-eastern gable.

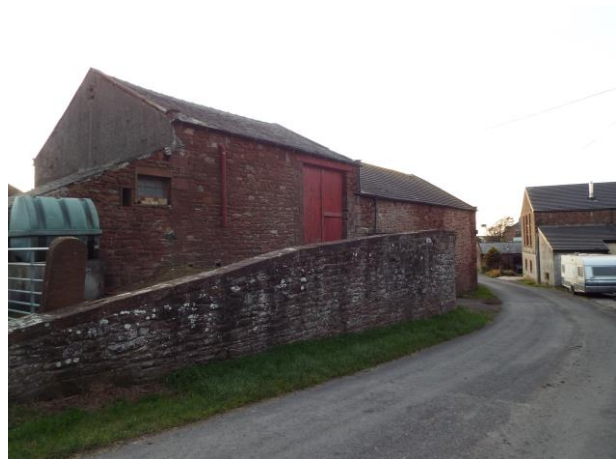
Rear of sites 1 and 2

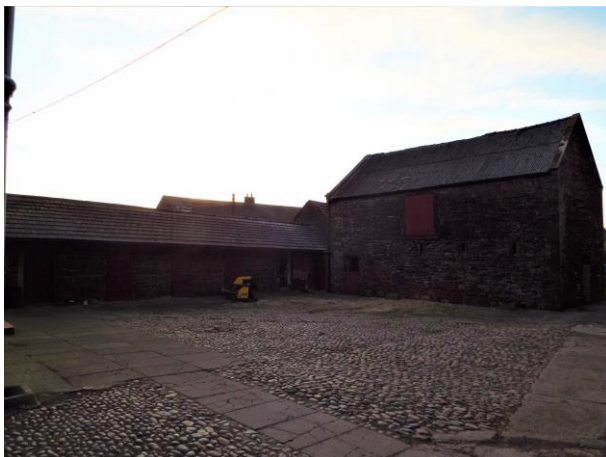
Front of sites 3 and 4

- **Site 3:** This is a sandstone-built barn with a concrete-sheet roof. It measures 12 metres by 7.5 metres and 6 metres to the guttering. It is well-pointed inside and out. It has a loft area throughout which is used for storing hay.

- **Site 4:** This is a row of single-storey byres with a tile roof and felt which was renewed in 2003. These are well-pointed throughout. This adjoins a two-storey, small, derelict cottage on the north-western gable which itself adjoins site 3. It also has a tiled roof which was renewed in 2000.

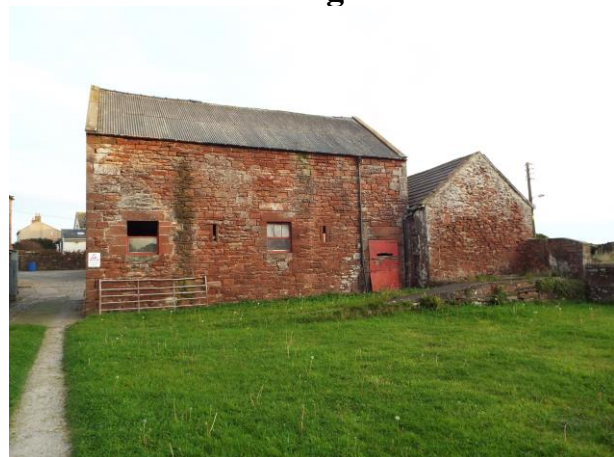
Rear of site 3 and gable end of site 4
