# **Protected Species Survey:** **Bats and Barn Owls**

John Temple  
Cragg House Farm  
Buttermere  
Cockermouth  
CA13 9XA  
Tel: 017687 70204  
Mob: 07798 767806  
Bat Survey Class Licence CL18 Registration no. 12316-CLS

Stuart Woodall  
Green Swallow North Limited  
Swallow Barn  
Blindcrake  
Cumbria  
CA13 0QP

Buildings at Town Head Farm  
Nethertown  
Egremont  
CA22 2UH

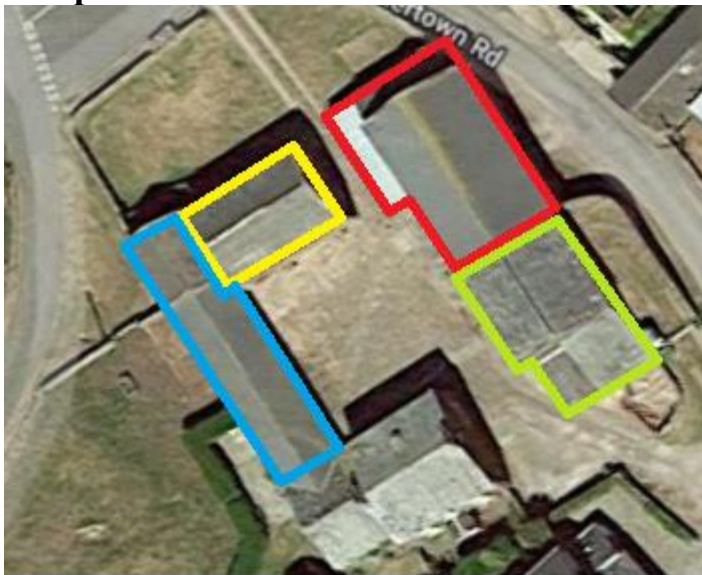
#### **Site plan**

SITE 1

SITE 2

SITE 3

SITE 4

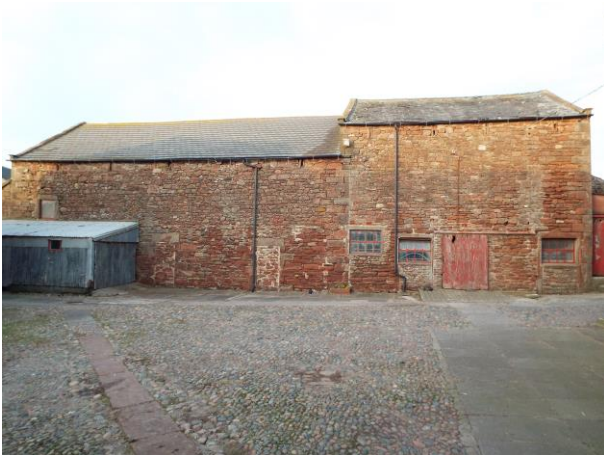
**Front of sites 1 and 2**

- **Site 1:** This is a large sandstone-built barn measuring approximately 16 metres by 9 metres and 8 metres to the guttering. It has a tiled roof with a breathable membrane which was renewed in 2003. There is no loft area. It is well-pointed both inside and out. There is an area on the north-eastern aspect which has been repaired in 2014 using breeze-blocks and re-pointed externally. There is a tin-built lean-to built on the south-western aspect and a small, single-storey, stone-built lean-to on the north-western gable. This has a slate roof and daubing.

- **Site 2:** This is a large, sandstone-built bank barn, measuring 9 metres by 9 metres and from 4-6 metres to the guttering. It has a slate roof with daubing and has some small areas of disrepair. The building is well-pointed both inside and out. It has a single-storey calf shed adjoining the south-eastern gable.

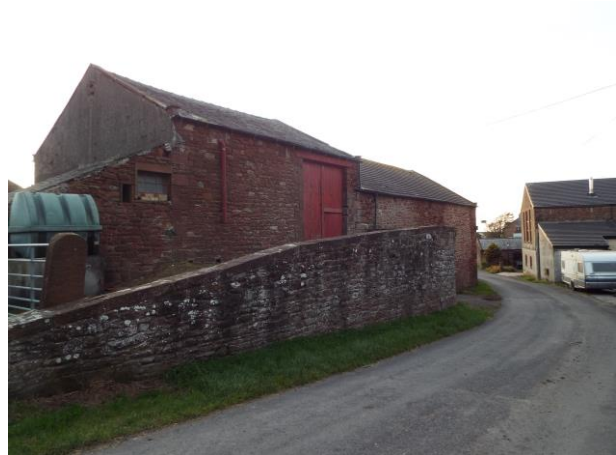
**Rear of sites 1 and 2**

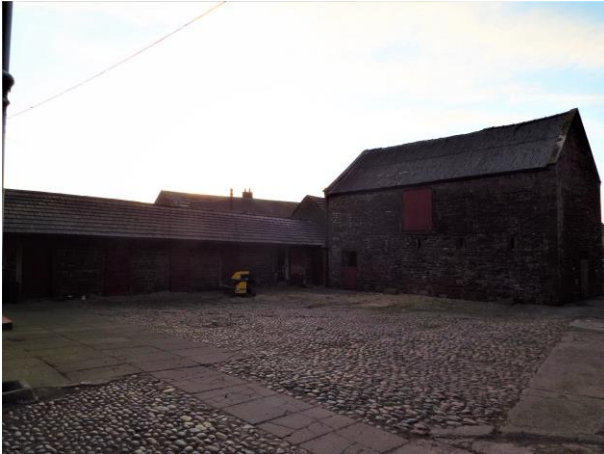
**Front of sites 3 and 4**

- **Site 3:** This is a sandstone-built barn with a concrete-sheet roof. It measures 12 metres by 7.5 metres and 6 metres to the guttering. It is well-pointed inside and out. It has a loft area throughout which is used for storing hay.

- **Site 4:** This is a row of single-storey byres with a tile roof and felt which was renewed in 2003. These are well-pointed throughout. This adjoins a two-storey, small, derelict cottage on the north-western gable which itself adjoins site 3. It also has a tiled roof which was renewed in 2000.

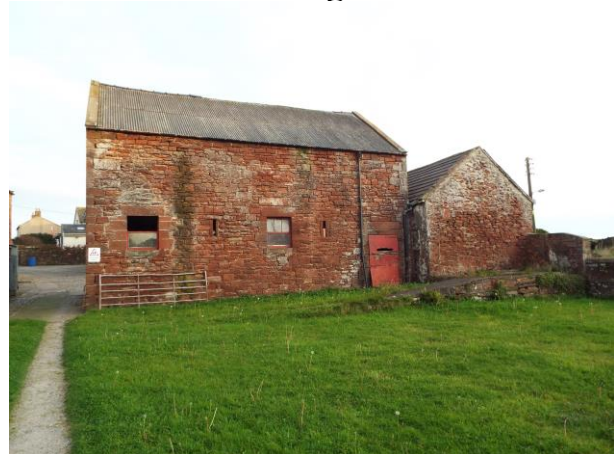
**Rear of site 3 and gable end of site 4**

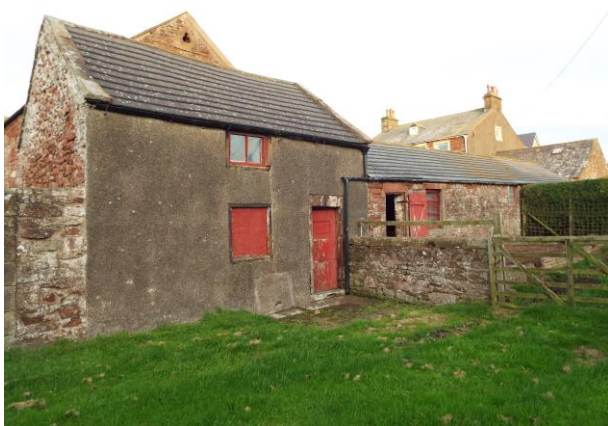
## Rear of site 4 showing disused cottage

Although the sites appeared suitable bat habitat, access points were limited due to the tight construction and pointing of the buildings. The single storey byres comprising part of Site 4 had minimal potential for use by bats due to the low height meaning that they would be accessible to predators.
