PLANNING

Alterations to The Central, Egremont

Drawing Title - As Proposed Site Entrance

Job No - 1428	Dwg No - 15	Rev:B
•	DATE: 3 August 2025	SCALE: 1:100	Paper A2

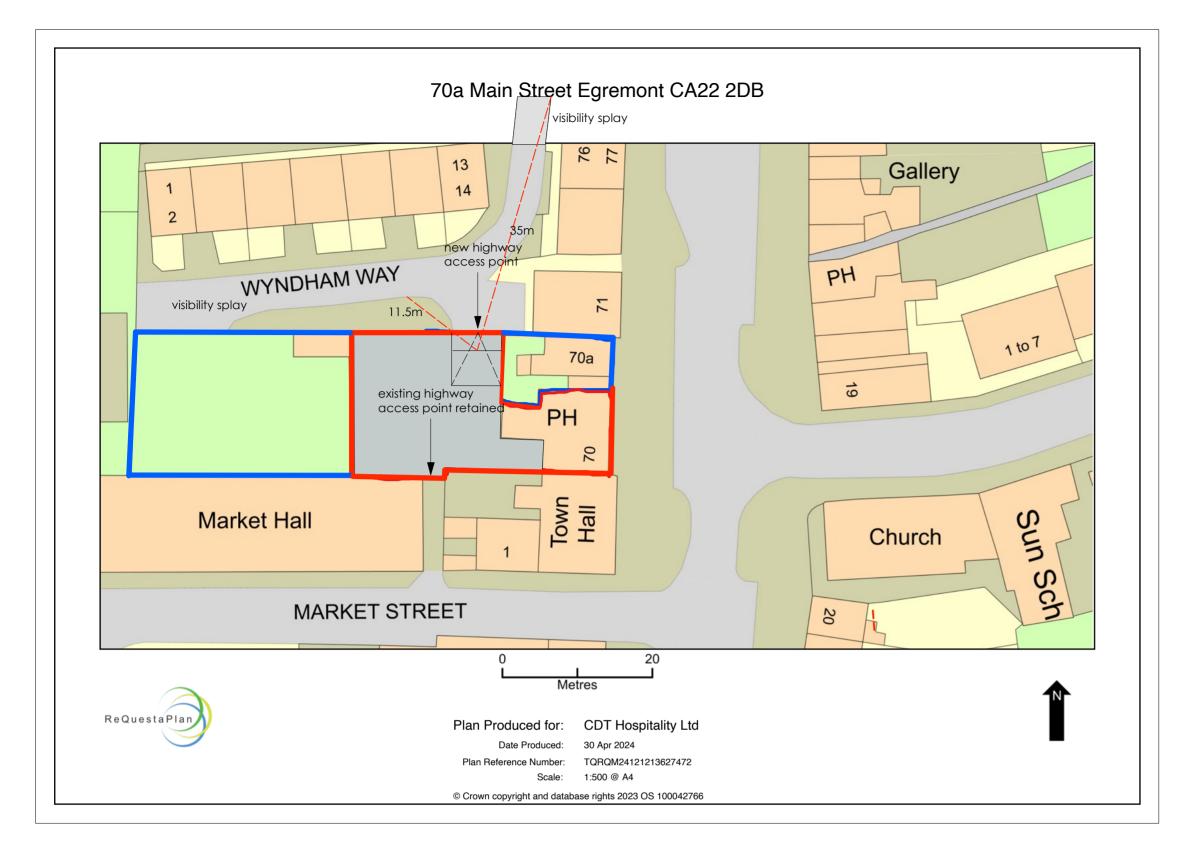
existing sandstone

returned

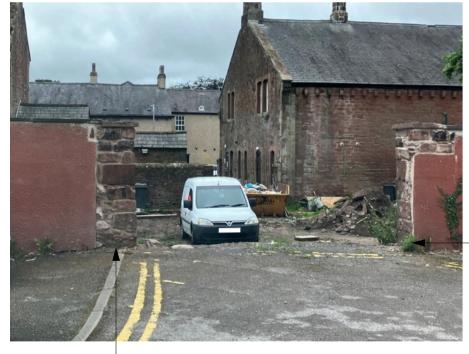
existing sandstone wall made good and returned

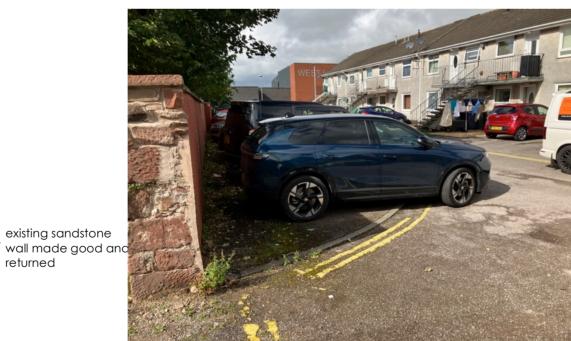
view looking West exiting site - cars parked on double yellow lines illegally blocking visibility at time of site visit

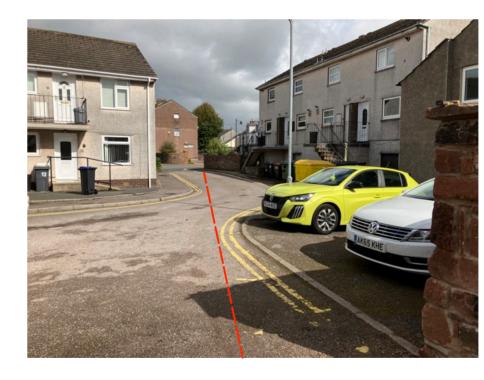
view looking North exiting site - forward visibility to main highway
