Our Ref: 4046-G-LR016 Rev A

Environment Agency Correspondence Reference NO/2020/113153/01-L01 in Respect of Reserved Matters - Outline Planning Application 4/13/2235/0/O1 – Wilson Pit Road/High Road, Whitehaven

POST REMEDIATION VALIDATION REPORT
FOR THE SITE AT THE FORMER TDG TANKER
DEPOT, HIGH ROAD,
WHITEHAVEN, CUMBRIA
FOR
STORY LAND

Ref: 2074
Rev: SS

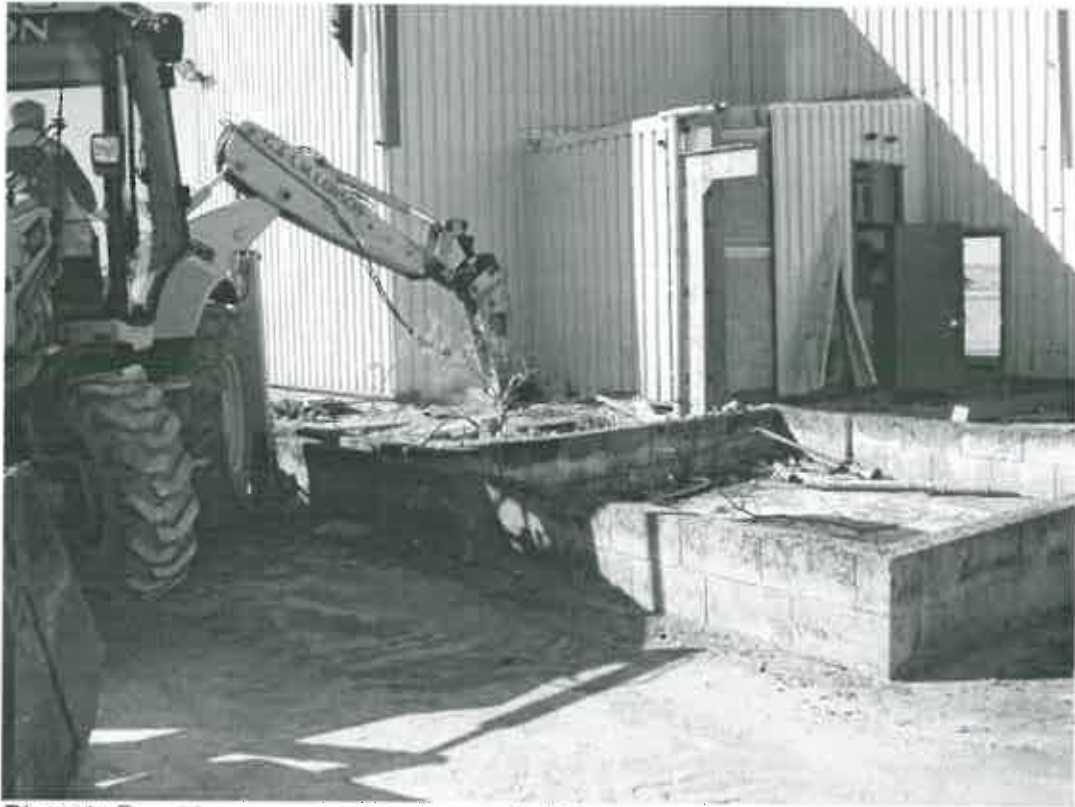
Plate 1: Breaking out concrete beneath location of former electrical transformer

The excavation of the soil from beneath the transformer and surrounding area was undertaken using a JCB 3CX on 11th May 2010. All soils demonstrating visual and / or olfactory evidence of hydrocarbons relating to the transformer spillage were removed from the excavation. It was noted during the excavation that the electrical transformer was positioned on a 0.5m thick rectangular concrete slab approximately 0.5m wide by 1.0m long and the concrete slab was not significantly stained with hydrocarbons. The area surrounding the transformer (approximately 2.0m by 3.0m) was covered by loose coarse gravel and stones. A leaking oil tap was located on the east side of the transformer and the area of gravel directly beneath the leaking oil tap was significantly stained with oil.

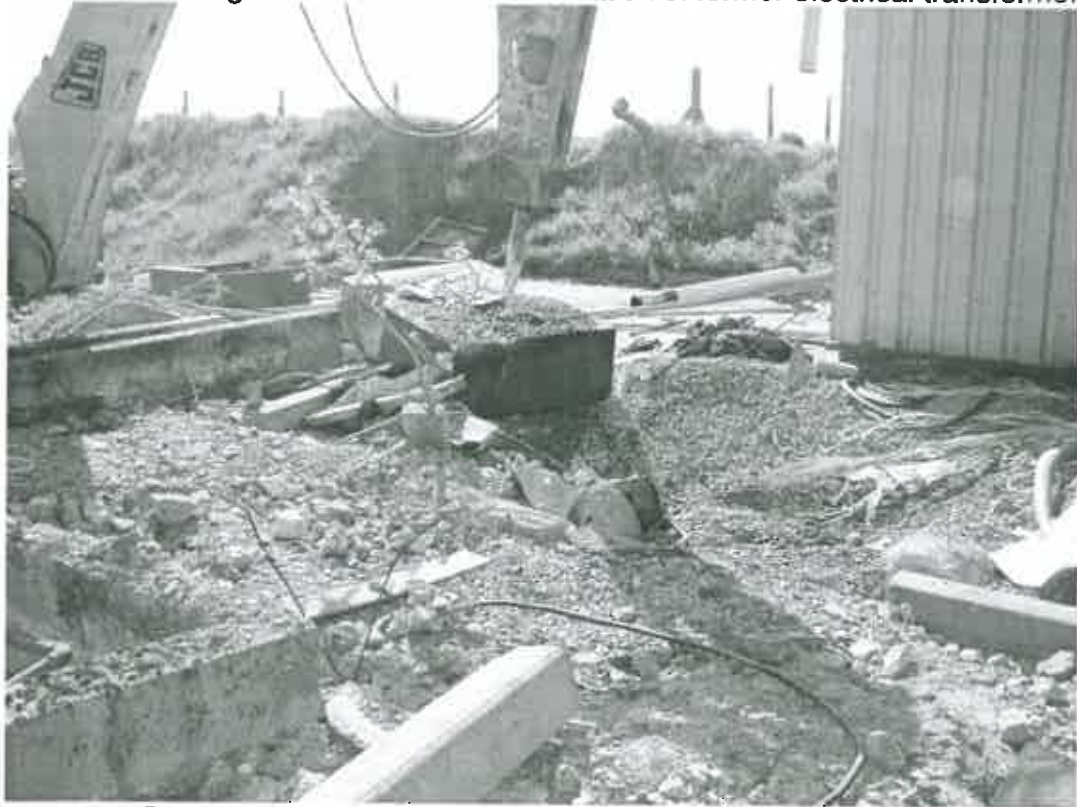
Plate 2: Removing concrete slab from beneath transformer

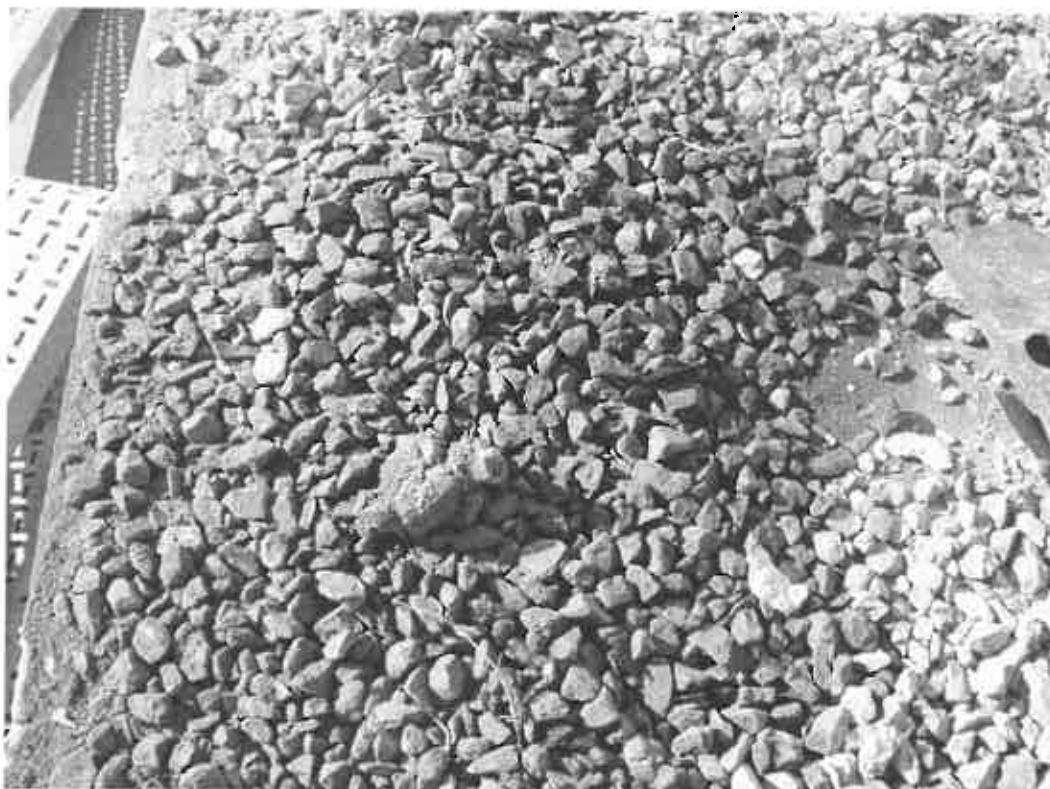
Plate 3: Stained gravel on concrete slab

URS report that the oil spillage was evident on the gravel surrounding the transformer (a 3m by 2m area) and staining of the concrete hardstanding was also noted although the extent of the staining was not indicated.

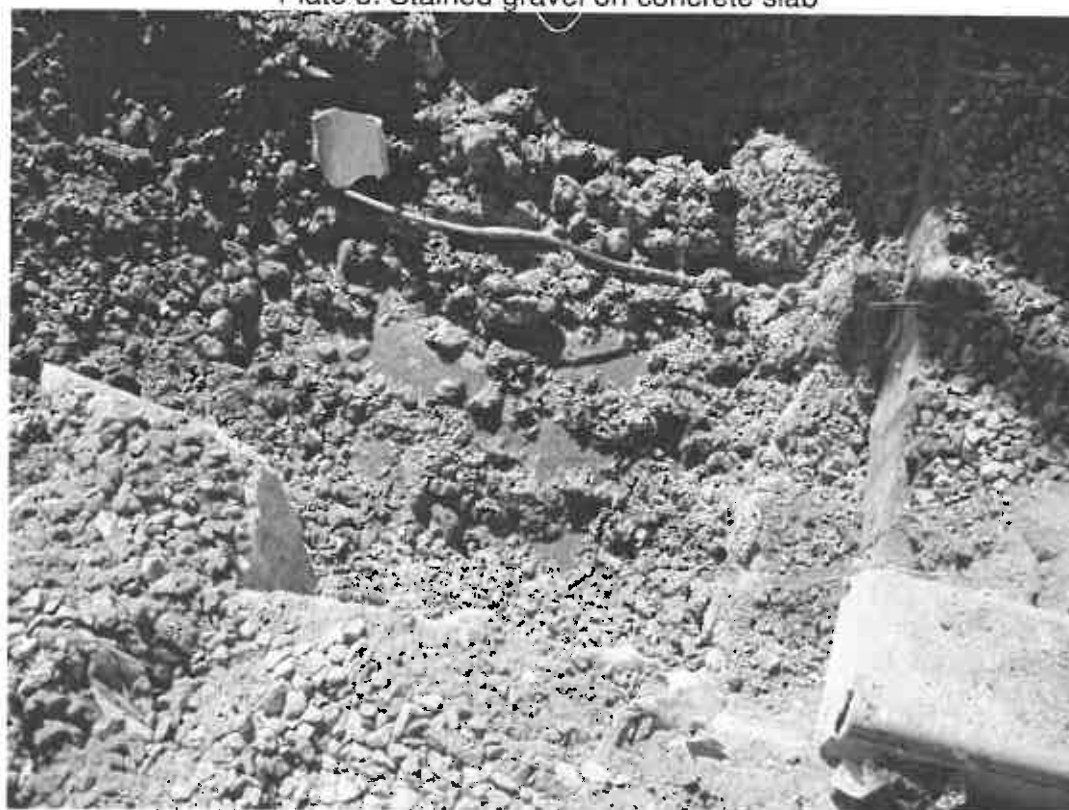
Plate 4: Evidence of oil contamination beneath transformer

During the excavation, a 0.2m thick layer consisting of gravel / stones coated in a black viscous substance with a strong hydrocarbon odour was encountered at a depth of approximately 1.1m below ground level, directly over the natural boulder clay. It is not known whether the electrical transformer is the only source of this hydrocarbon contaminated layer as it was noted in the earlier Integra Consulting Phase 2 Environmental Ground Investigation dated June 2009 that the hydrocarbon impacted soils extended beneath the majority of the raised bunded area. It is also likely that oil storage tanks were present on this area and may be a potential source of hydrocarbon contamination.

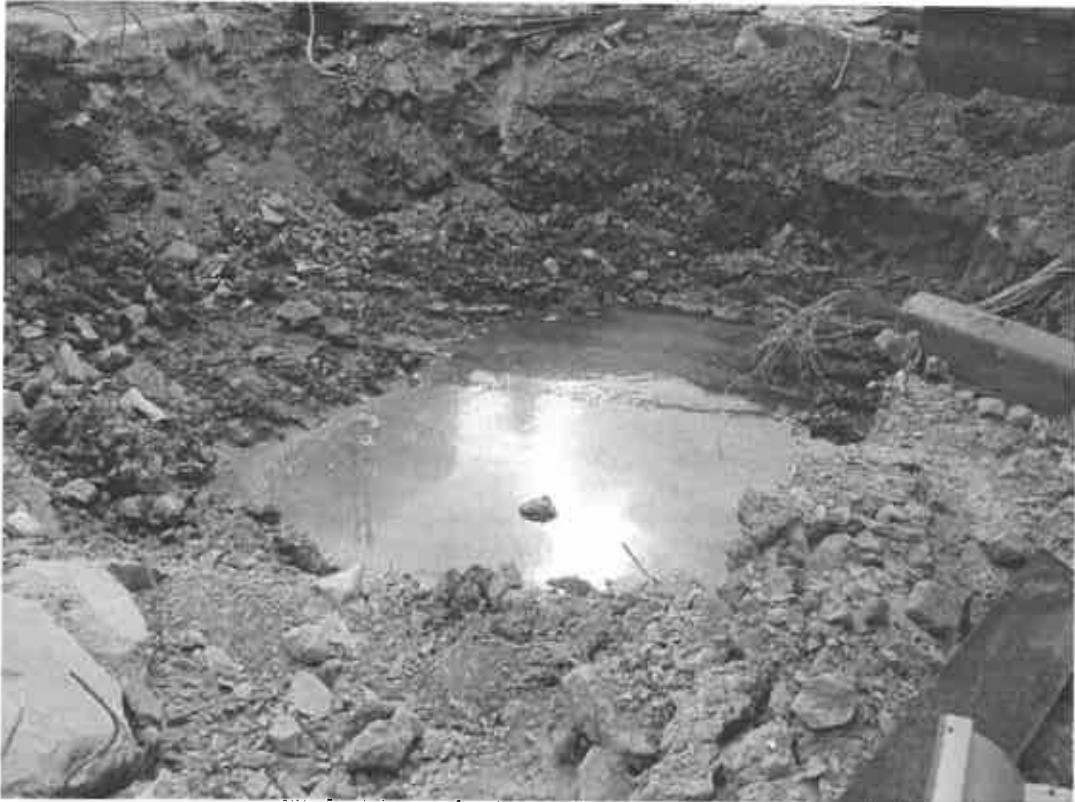
Plate 5: Excavation (water standing in base from existing drainage)

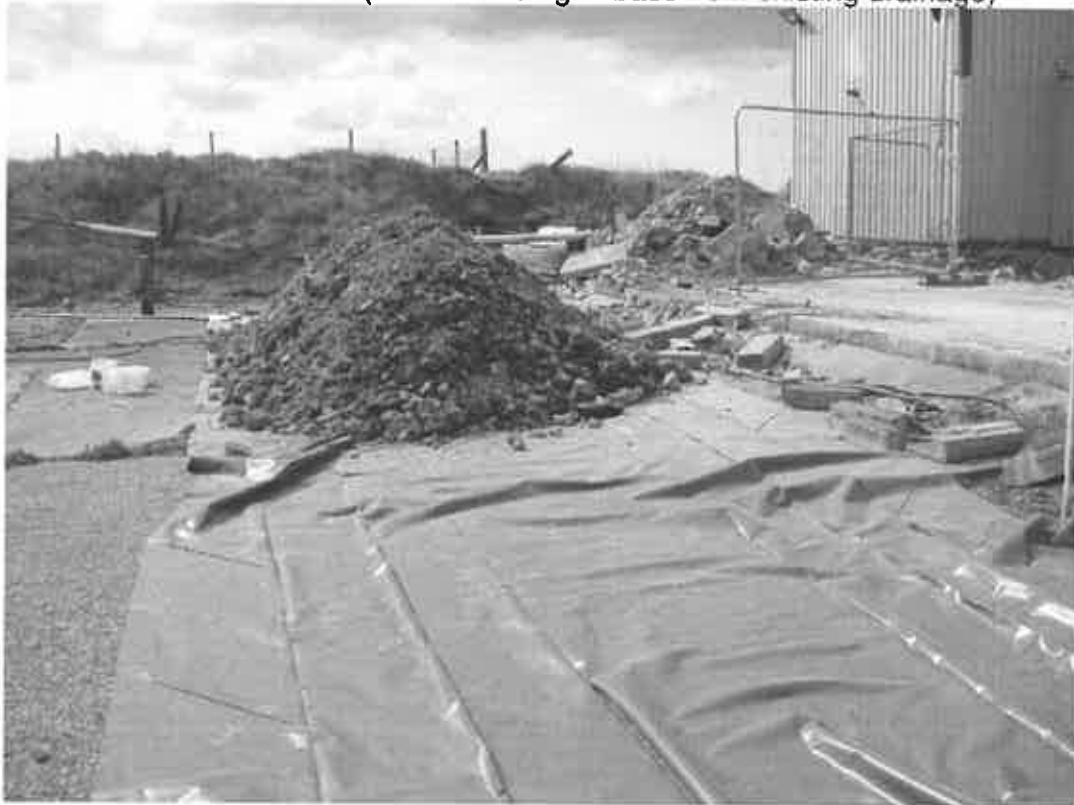
Plate 6: Stockpile

- 1.8 The hydrocarbon impacted soils (approximately 50m³) removed from the excavation and stockpiled on the impermeable Visqueen sheets were sampled and chemically analysed for relevant organic contaminants at an MCERTS laboratory. As a result, 1 No. sample (S5) recorded a slightly elevated concentration of Aliphatics > C12 – C16 and Aromatics > EC12 – EC16 and 2 No. samples (S1 and S5) recorded elevated concentrations of Aromatics > EC16 – EC 21. This material should either be disposed of at an appropriately licensed landfill site or remediated insitu.

All samples taken from the stockpile were tested for speciated PAH and were found to be below the relevant LQM/CIEH GAC.
