RE: Hensingham Housing Development, Egremont Road, CA28 8QB
Infiltration Testing Letter Report

This letter summarises the findings of the infiltration testing which was carried out on 12/07/2023 to inform the drainage design as part of the proposed residential development at Hensingham House.

Client: TOM MILBURN PROPERTY LTD
 Project: HENSINGHAM HOUSING DEVELOPMENT HENSINGHAM
 Title: SOAKAWAY INFILTRATION TEST LOCATION PLAN

Drawing No. WL_2328_SK01 Revision P1

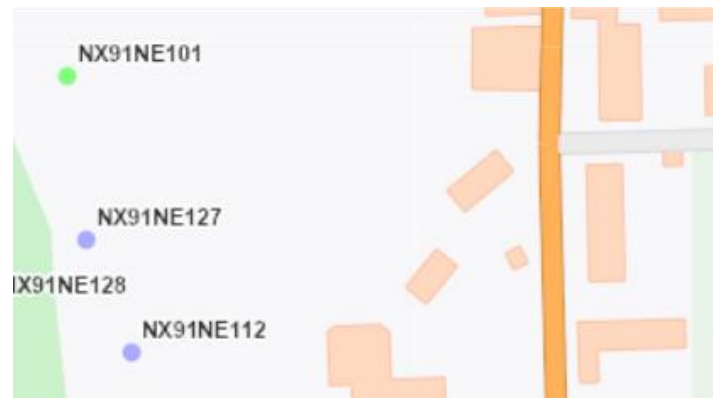
The location of each historic log is shown on the plan below and the historic logs are enclosed.

The historic logs are summarised below. For further detail refer to the logs themselves.

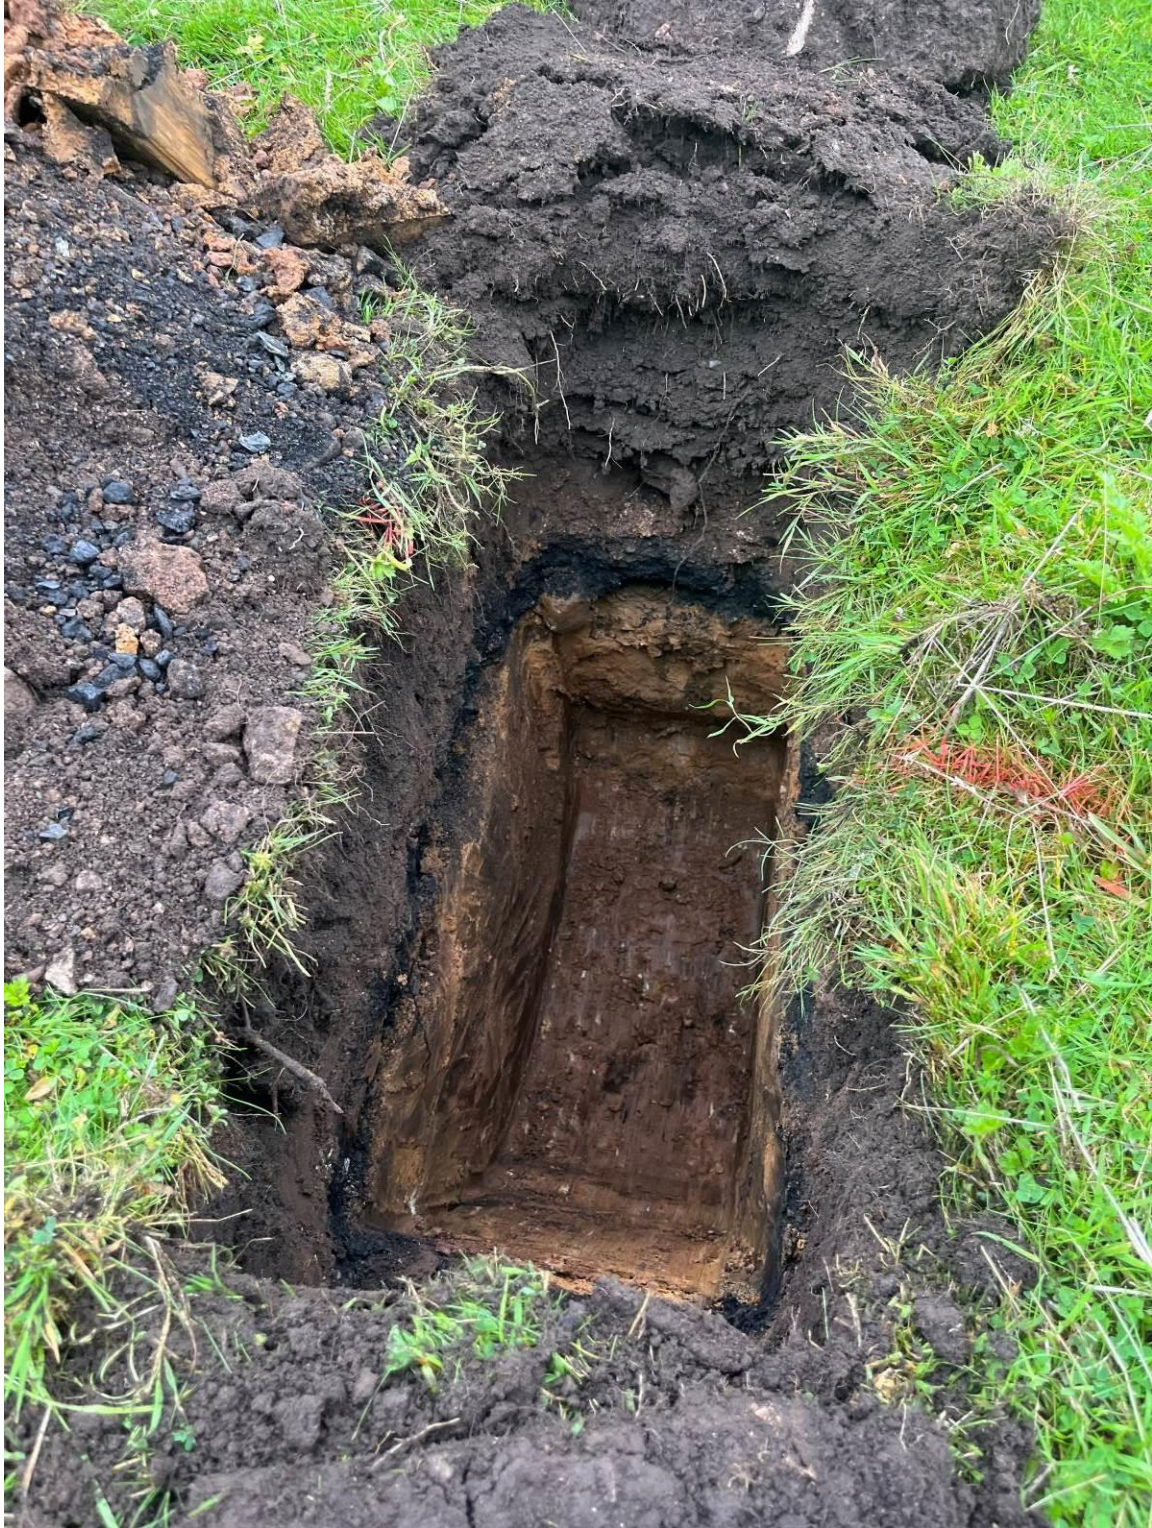
Photo 1: SA01 on completion

- **Clay.** The natural ground was encountered in both trial pit locations, beneath the Made Ground, at depths of 0.40m (SA02) and 0.50m (SA01) bgl. The natural ground comprised soft to firm slightly gravelly clay with variable sand content, which was found to extend to a maximum depth of 1.30m bgl (SA02). Local bands of fine to medium sand were recorded within the clay from 0.85m to 1.20m bgl (SA01).

Remarks: Position of soakaway test pit confirmed by client on site. Position checked for underground services using CAT4 scanner. Test pit excavated through Made Ground into natural superficial sand and clay to 1.20m bgl. 1 soakaway test conducted within the pit. Test failed after 3 hours. Test pit backfilled with arisings.

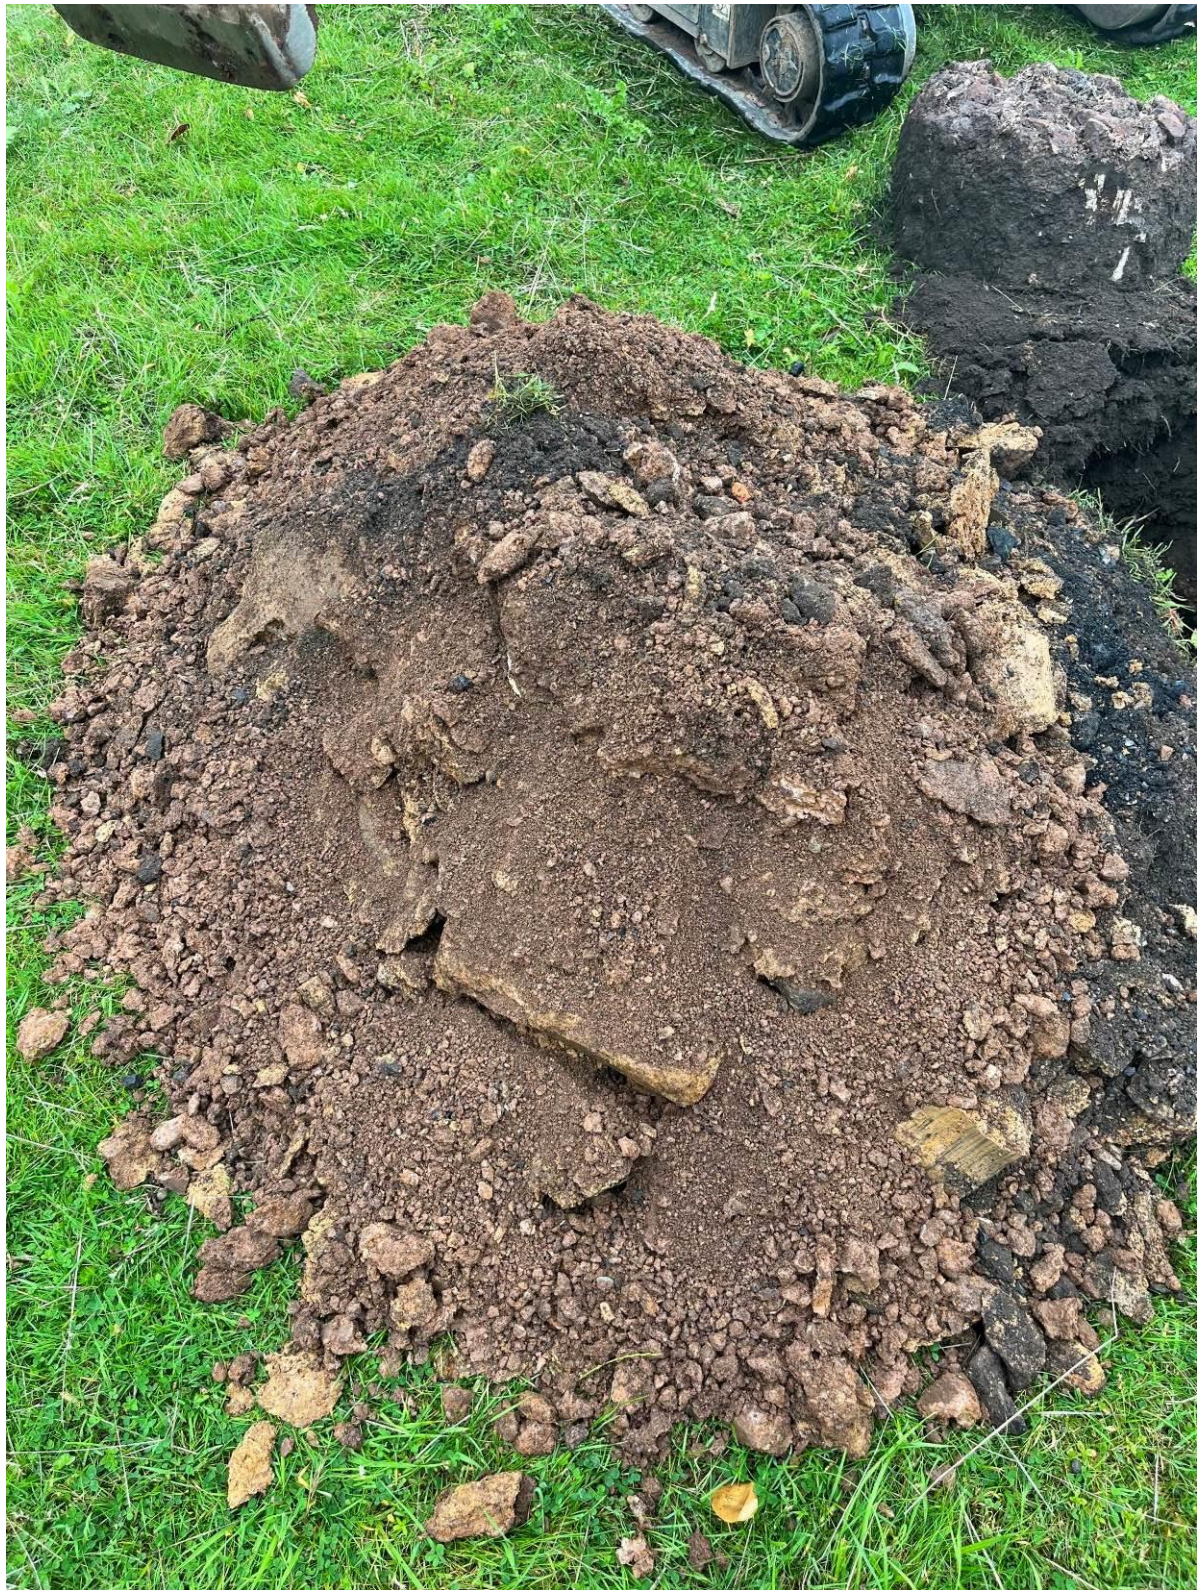
Photo 3: SA01 arisings

- **Made Ground.** Both test locations encountered Made Ground at surface level, which was found to extend to between 0.40m and 0.50m below ground level (bgl). This was typically dark brown clayey gravelly sand topsoil locally overlying black medium to coarse gravel to 0.50m bgl (SA01). The gravels included brick, concrete, ash, charcoal and natural stones. The black gravel consisted solely of ash, charcoal and mudstone.

No visual or olfactory evidence of contamination was observed during the excavation except from local black ash and charcoal gravel encountered in SA01 from 0.40m to 0.50m bgl.

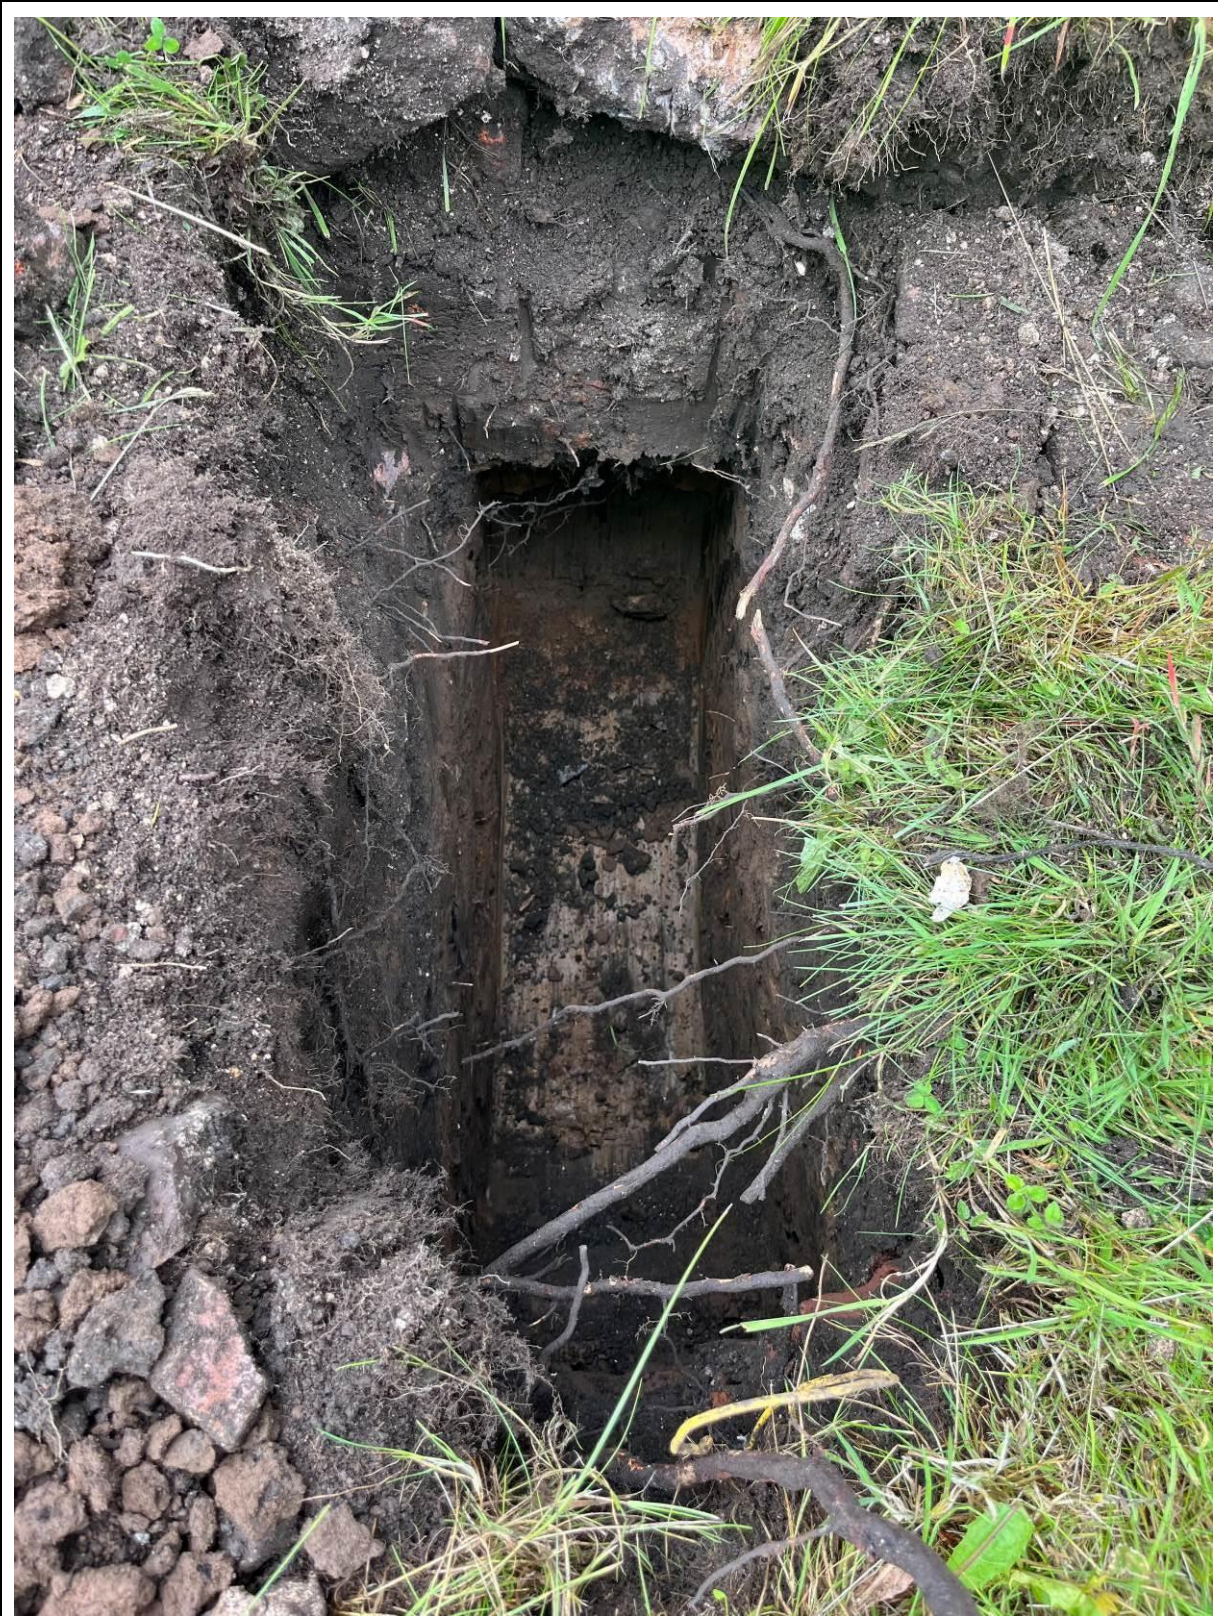
Photo 5: SA02 on completion

- **Sand.** Granular natural soils were recorded in both locations. In SA01, granular soil was recorded underlying natural clay from 0.85m to 1.0m bgl. In SA02, the granular soil was underlying Made Ground at 0.40m bgl to a depth of 1.10m bgl. In both locations, soils comprised clayey slightly gravelly sand. Clay content increased below 0.95m bgl. Sand was underlain by firm sandy slightly gravelly clay as described above.

Remarks: Position of soakaway test pit confirmed by client on site. Position checked for underground services using CAT4 scanner. Test pit excavated through Made Ground into natural superficial clay to 1.30m bgl. 1 soakaway test conducted within the pit. Test failed after 3 hours. Test pit backfilled with arisings.

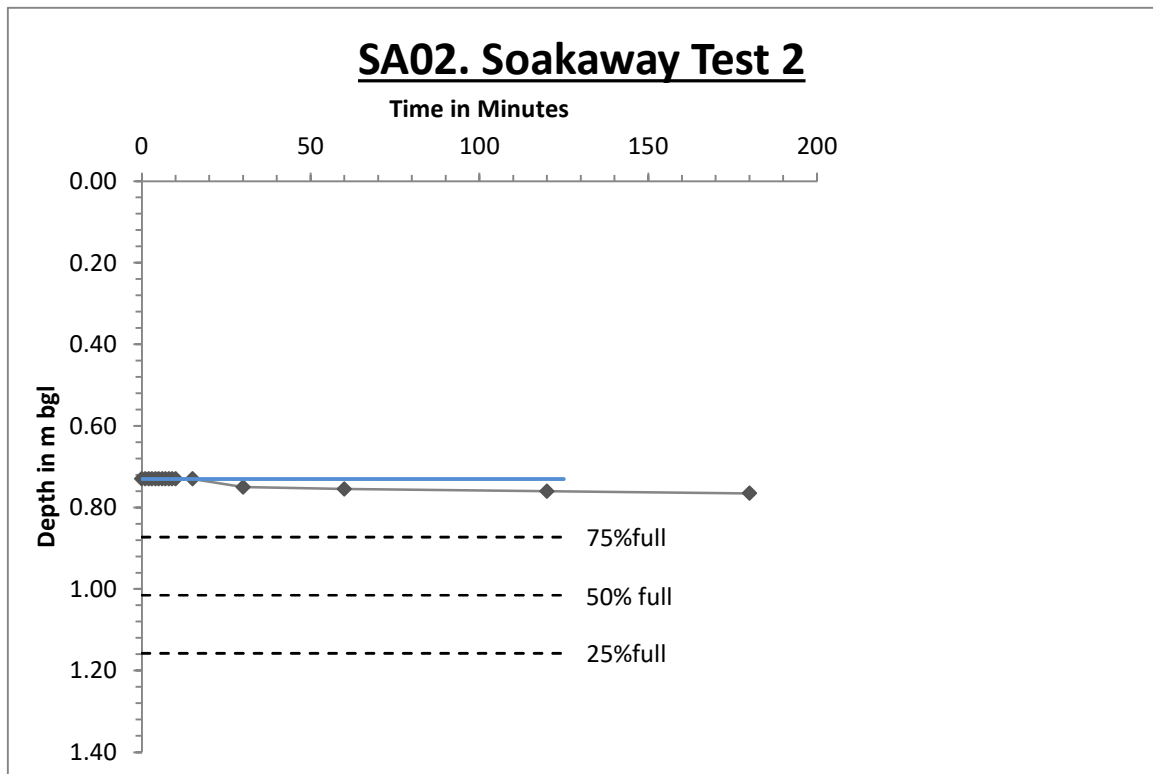
TEST 1 SA02

The tests were carried out in accordance with BRE365, in order to determine the infiltration rate of the natural granular and cohesive Glacial Till deposits. The SA01 test failed due to the water level remaining at 0.64m bgl for the duration of the 3 hour test. SA02 recorded a water level drop of 35mm over the duration of the 3 hour test which also resulted in a failed test.

Depth to top of water 0.73 m
Depth to bottom of pit 1.3 m
Depth of water 0.570 m

Time minutes	Depth to water m	Head of water
0	0.73	0.570 m
1	0.73	0.570 m
2	0.73	0.570 m
3	0.73	0.570 m
4	0.73	0.570 m
5	0.73	0.570 m
6	0.73	0.570 m
7	0.73	0.570 m
8	0.73	0.570 m
9	0.73	0.570 m
10	0.73	0.570 m
15	0.73	0.570 m
30	0.75	0.550 m
60	0.76	0.545 m
120	0.76	0.540 m
180	0.77	0.535 m

N/A m/s
TEST FAILED

The results therefore suggest that soakaway drainage would not be suitable at this site.

It is considered that soakaway drainage is not suitable at the site as part of the Phase 1 developed. Alternative means will therefore be required to disposal of surface waters generated by the development. Consideration could be given to discharge to a nearby watercourse or discharge to the public drainage system, both of which require attenuation to an agreed discharge rate with the associated authorities. This should be considered further as part of the future site drainage design.
