## Heritage Statement

Moresby Hall, Moresby, Whitehaven. CA28 6PJ

Reference No. 2511

April 2026

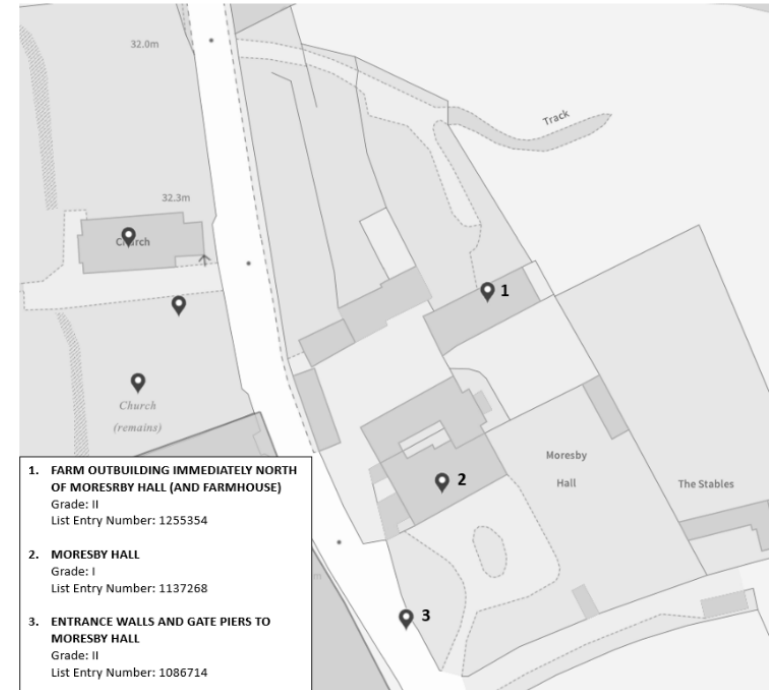
List Entry: Moresby Hall (Grade I)

*Large house. Overall courtyard plan. Date and development. 3 main building phases.*

C18 and C19 modifications. Materials. Almost all concealed by rendering, but mainly either random rubble or sneaked ashlar sandstone; graduated slate gable-end roofs. Exterior: S elevation (phase 3). Symmetrical 7 bay front, 2½ storeys, rusticated throughout. Cornice carries blocking course with pilasters.

Central studded door in round headed rusticated surround with Fletcher coat of arms in open segmental pediment supported by pilasters which are 'crossed by bands, tied, as it were, to them by lozenge shaped nails', an unusual motif found also at Catterlen hall, newton Reigny, Cumbria.

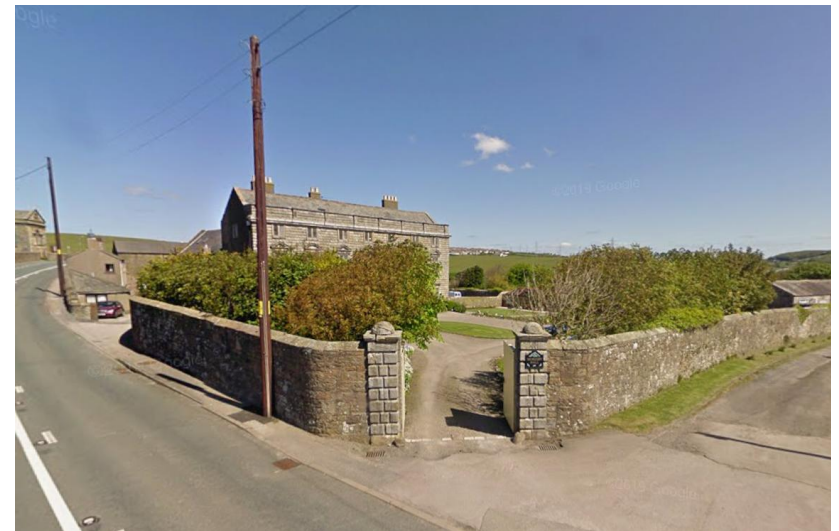
*Wall and gate piers, probably late C17. Sneaked rubble wall, with triangular coping, c6 ft high. Rusticated gate piers, square in plan c8 ft high, with domical tops to corniced caps.*

*Entrance Walls & Gate Piers to Moresby Hall*

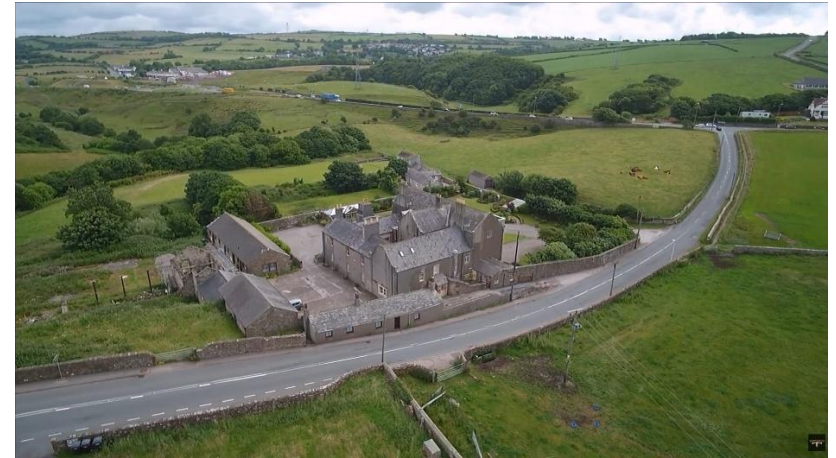
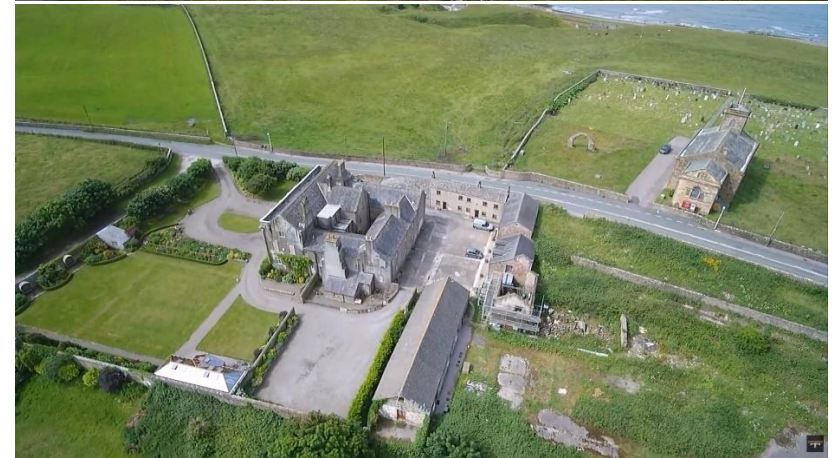
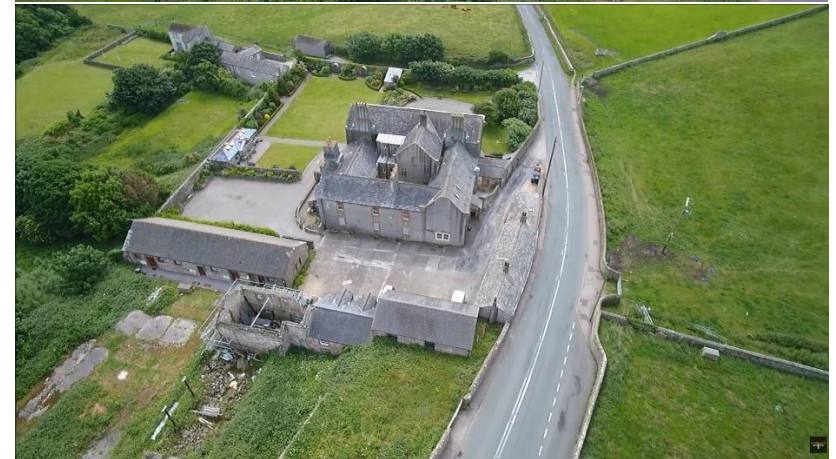
Drone photographs (2016 - skydronauts.uk)

*Farm outbuilding. Late C18, with late C20 re-roofing. Sneaked sandstone, with ashlar dressings and a slate roof laid to diminishing courses. Plain gables. 2 storeys to south, (farmyard/Moresby Hall side); 2 entrances under plain sandstone lintels, with window between. No windows above; 3 slit ventilators under eaves. Rear( via a ramp from field level); 2 doors similarly detailed, one ventilator slit. Internal wall of stone; roof with tie beam, through purlins and ridge piece. A good example of the uncomplicated vernacular building traditions of the area which makes an important contribution to the setting of the adjacent Moresby Hall. Listed for group value.*

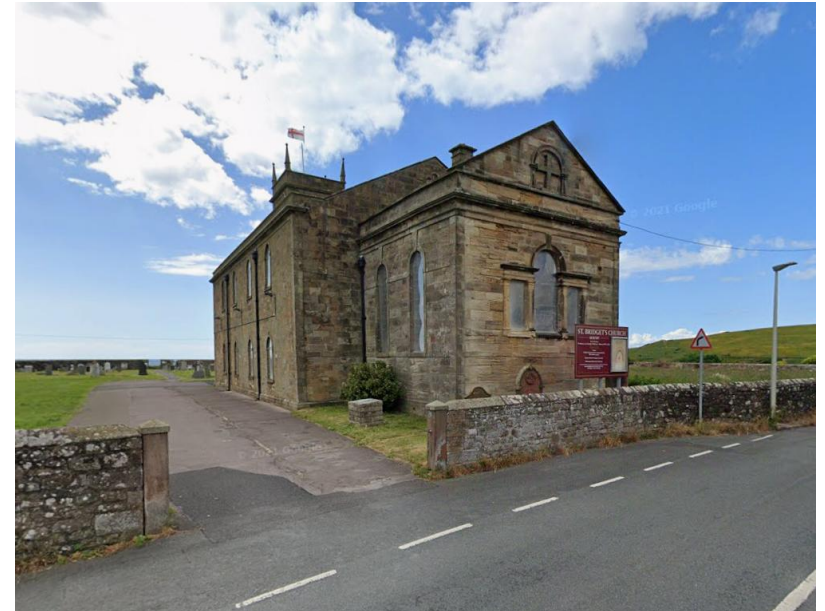
Church of St Bridget

*Symmetrical west front with central plank door and semicircular fanlight on ground floor of tower; vestry to left, baptistry to right. 2 rows of windows to nave, all round-headed. Chancel has 2 tall windows to either side and Venetian window to east end. Dragons to rainwater heads; decorative down-pipes.*

*Interior: Porch with stairs up to 1885 western gallery which is supported on cast-iron columns with Gothic traceried spandrels. Semicircular chancel arch carried on Ionic responds; text board to either side. Late C19/early C20 stained glass to lower windows by Heaton, Butler, & Bayne (London). 1902 panelled reredos. 1885 square wooden pulpit by Simpson & Rich; decoratively carved with painted panels. Late C19 octagonal marble font in baptistry; font from medieval church (stone, with octagonal bowl) outside vestry. Pedimented marble memorial slab in baptistry, 1843 for Mary Ann Steward, shows profile.*

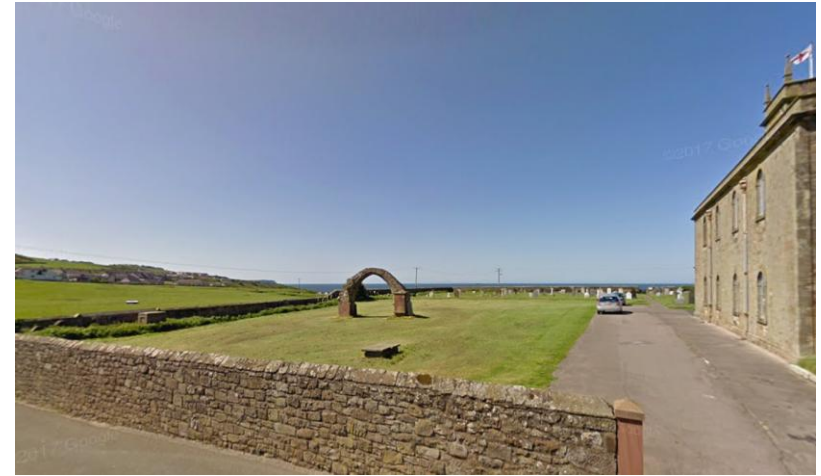
Britton's Tomb

*Table tomb. Inscribed and dated in Roman lettering: SEPTEMBER 17 1663 (or 8) for William and Thomas Brittons (father and son) who were lost at sea on the same ship. Sandstone blocks supporting flat top.*
