ECOLOGICAL APPRAISAL

HAVERIGG II WIND FARM LIFE EXTENSION NORTH LANE, HAVERIGG, CUMBRIA

THRIVE RENEWABLES (HAVERIGG II) LTD

SEPTEMBER 2019

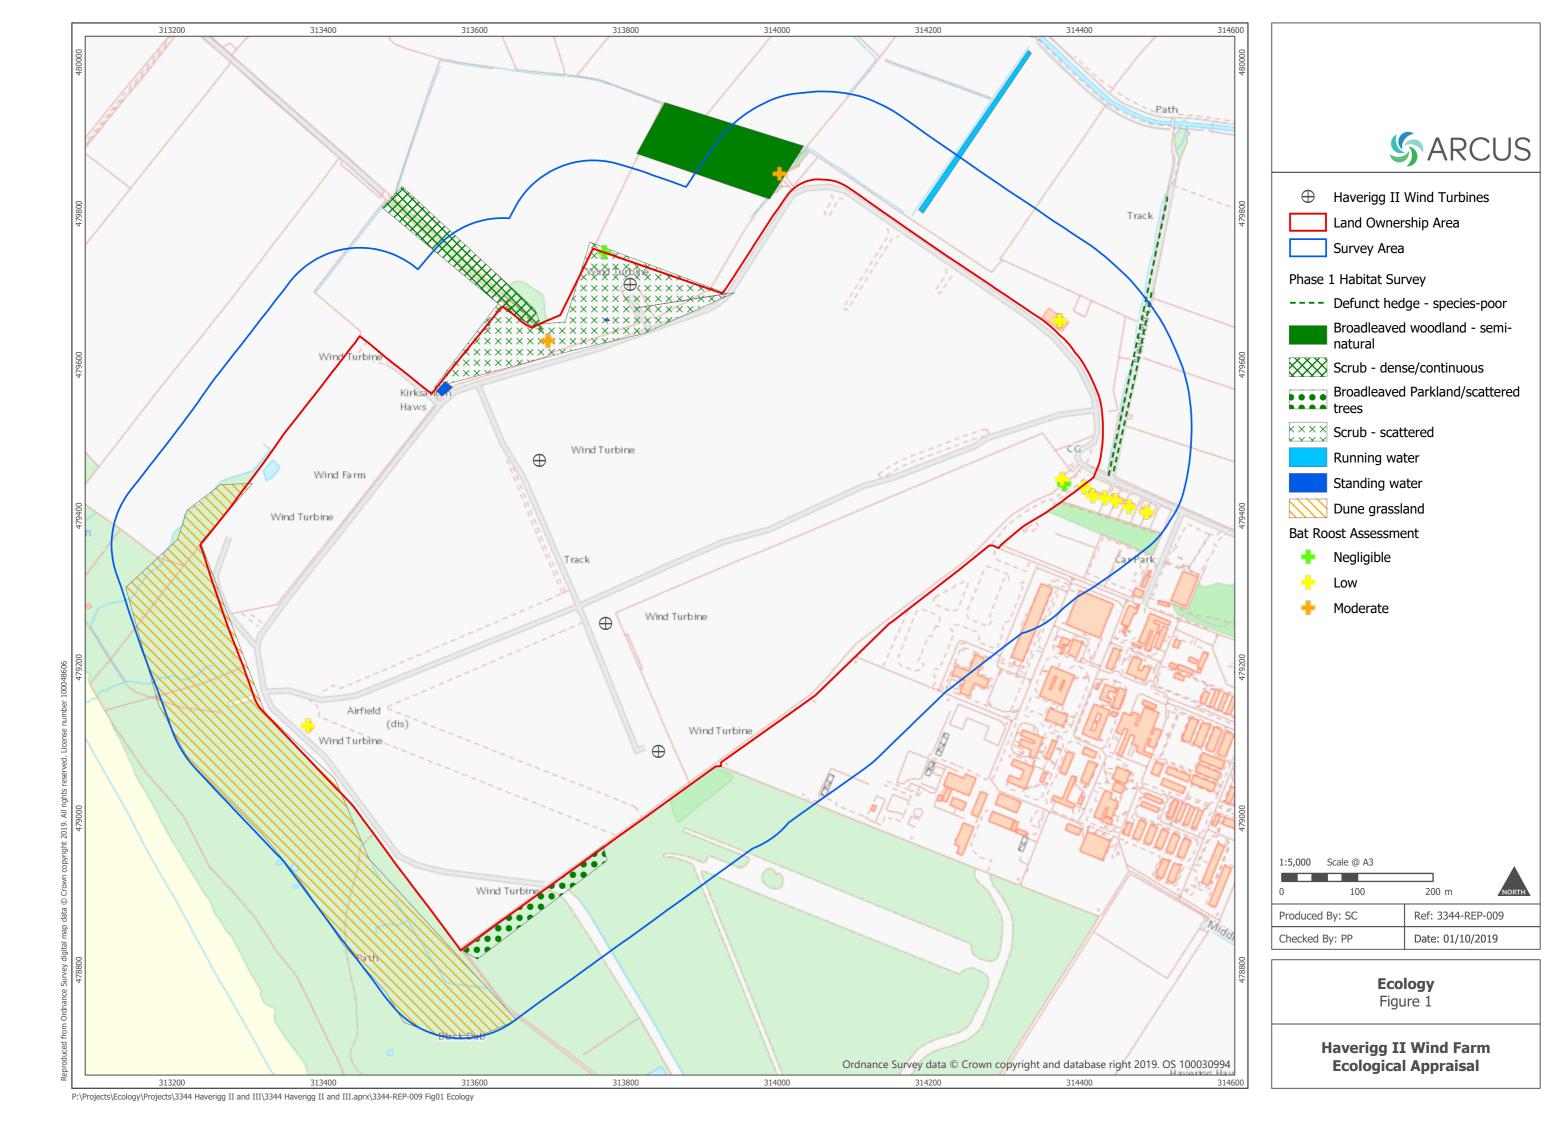
APPENDIX A: FIGURE

For the purposes of this report, 'Site' refers only to Haverigg II Wind Farm, whereas Survey Area refers to both wind farms plus a buffer of 200 m from the boundary of each wind farm, as shown in Figure 1 of Appendix A.

A survey of the Site was undertaken on 17th April 2019 by Senior Ecologist Caroline Airson MCIEEM¹ (Natural England Bat Licence: 2015-16953-CLS-CLS). The aim of this survey was to assess habitats for their potential to support commuting, foraging, and roosting bats. The survey covered the Site and the Survey Area, as shown on Figure 1 in Appendix A.
