GEOENVIRONMENTAL APPRAISAL

**PHASE 4, EDGEHILL PARK,
WHITEHAVEN**

STORY HOMES

Report No. 4046-G-R024

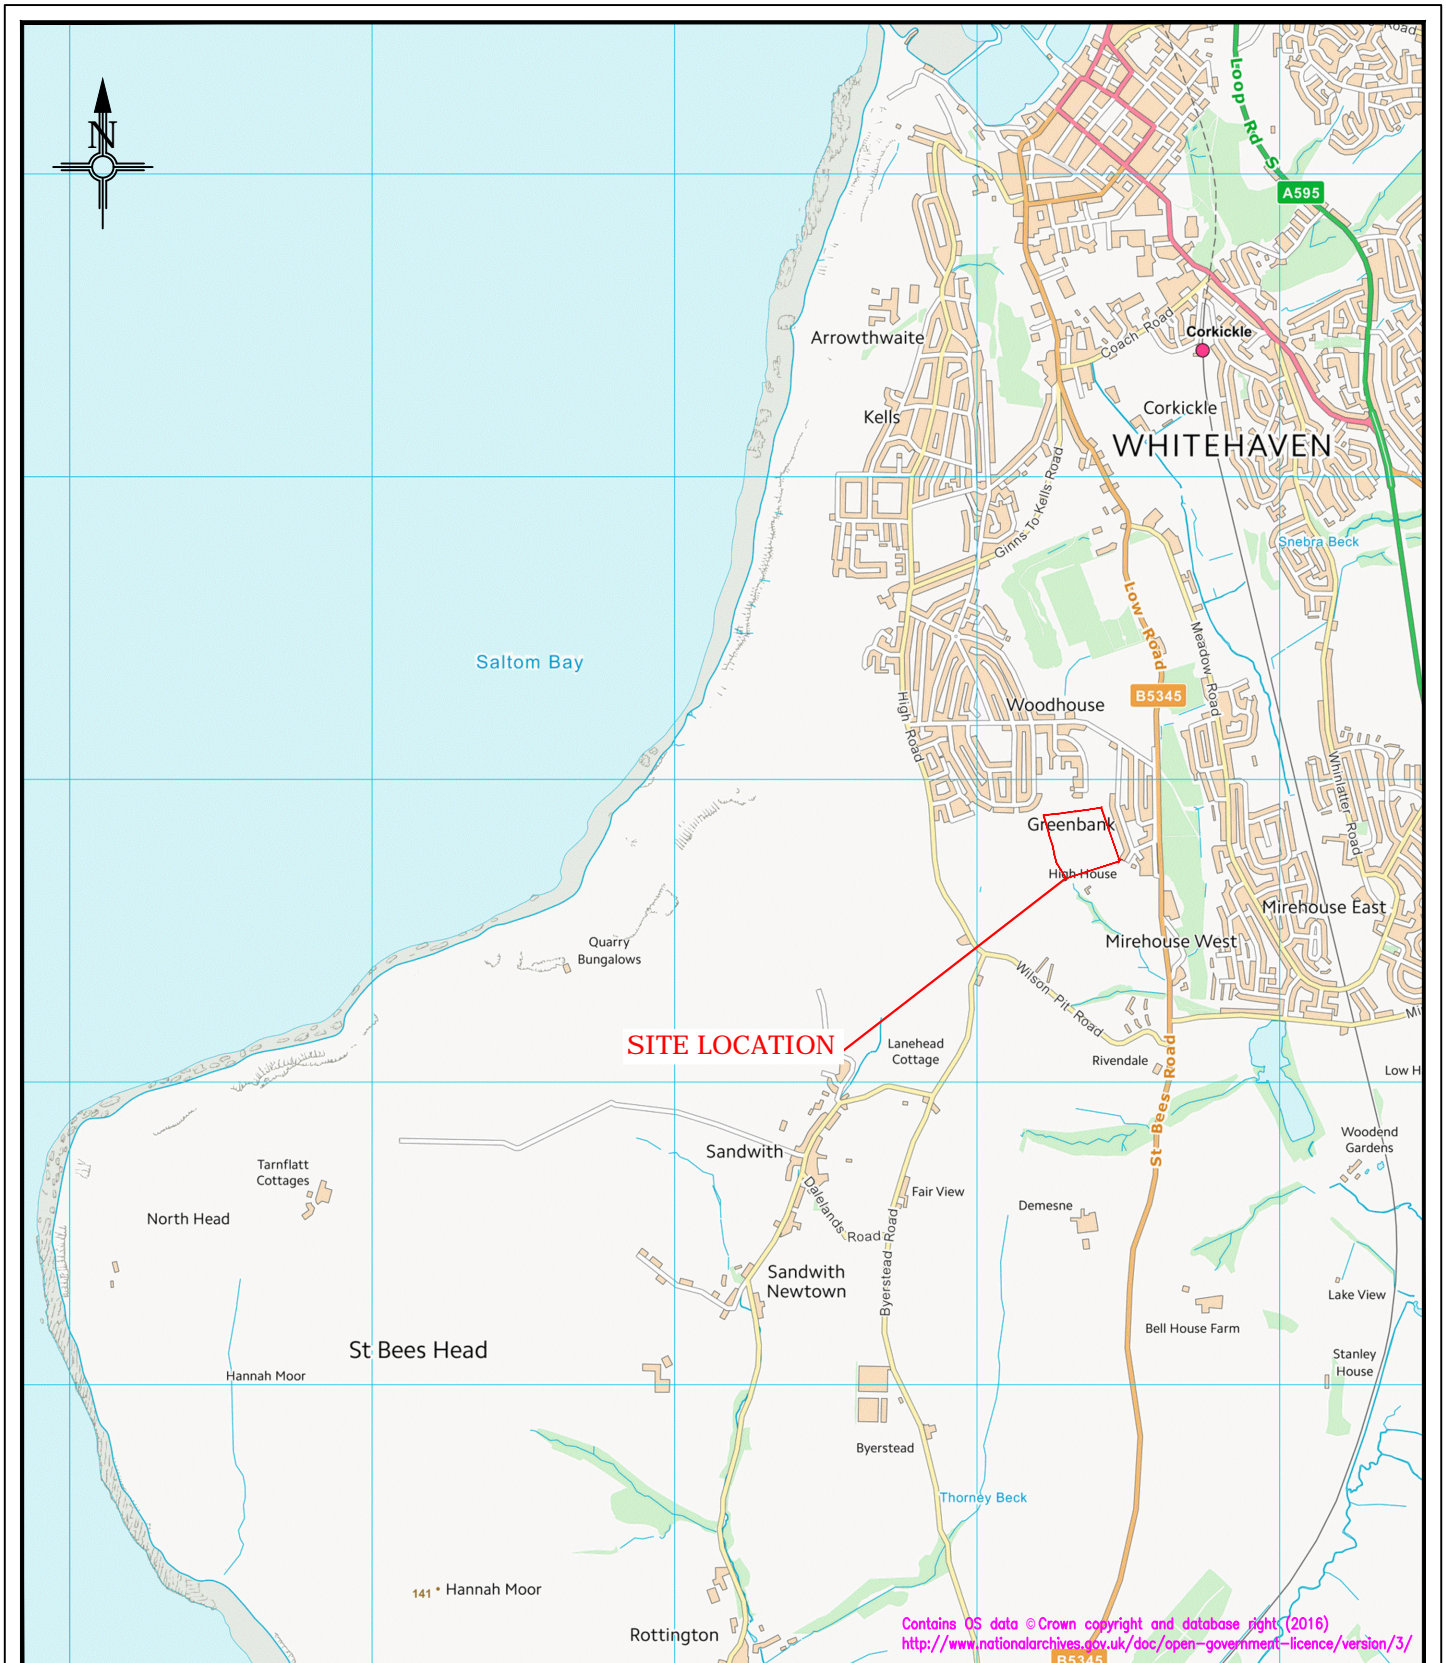
DRAWN BY NW	SIGNATURE	DATE 5-10-20	STATUS FINAL
APPROVED BRB	SIGNATURE	DATE 5-10-20	SCALE 1:25,000@A4
			DRG No. 4046-G-D038

CLIENT	Story Homes
JOB TITLE	Phase 4, Edgehill Park, Whitehaven
DRAWING TITLE	Site Location Plan

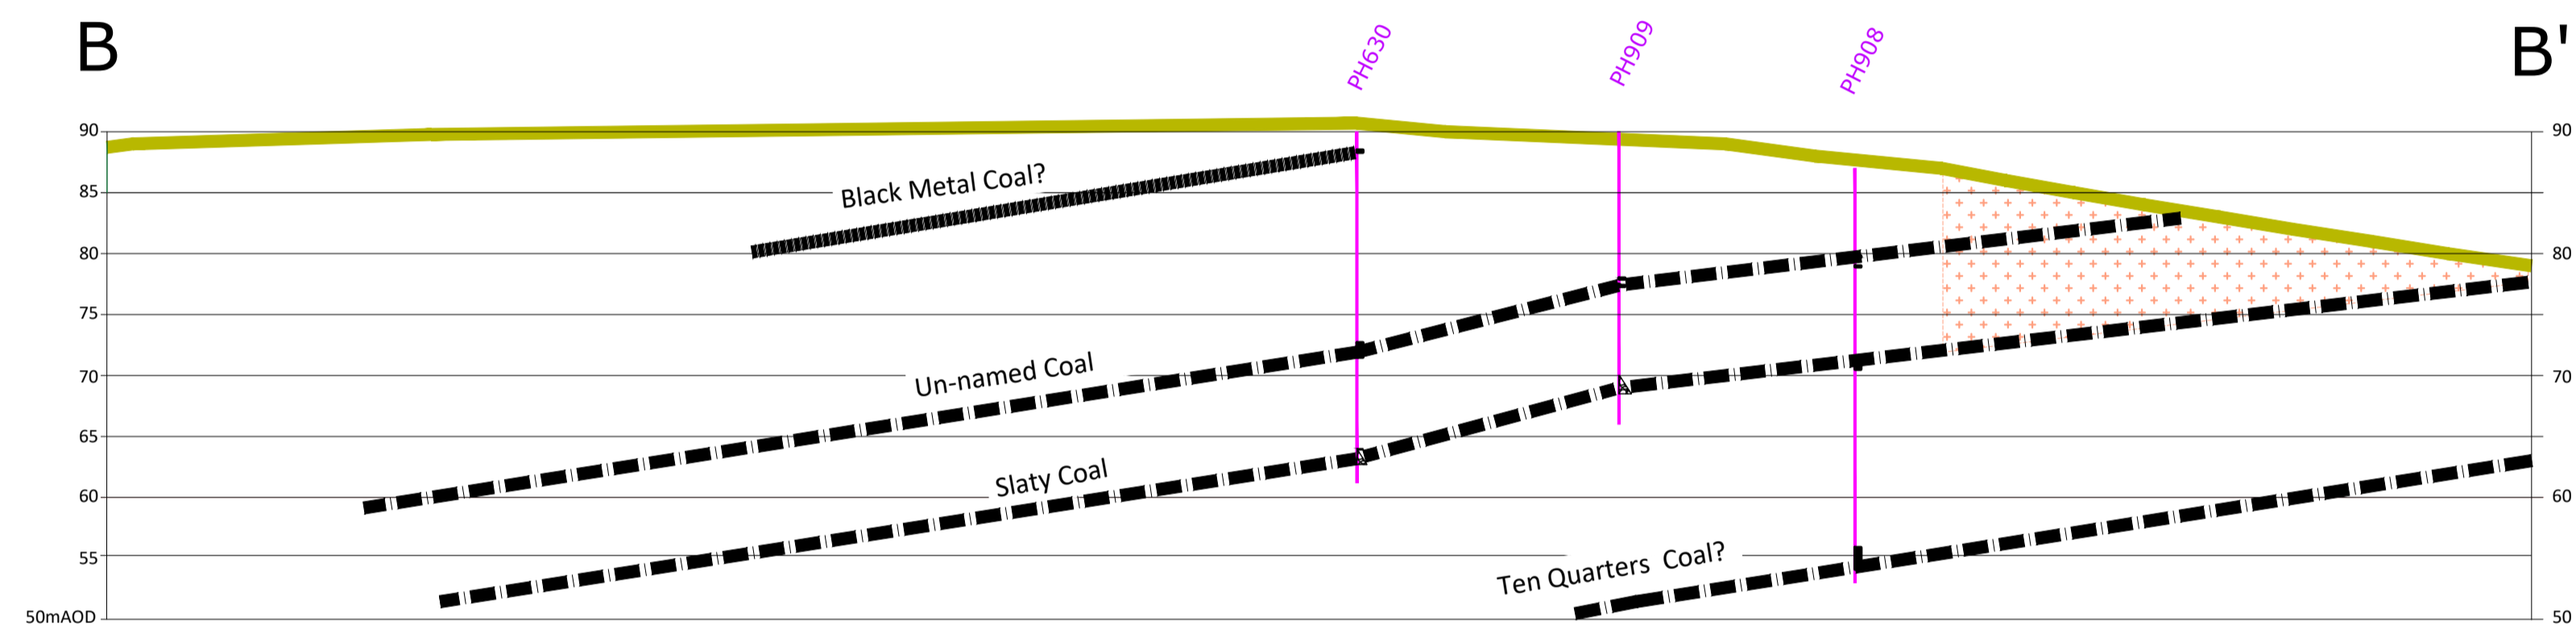
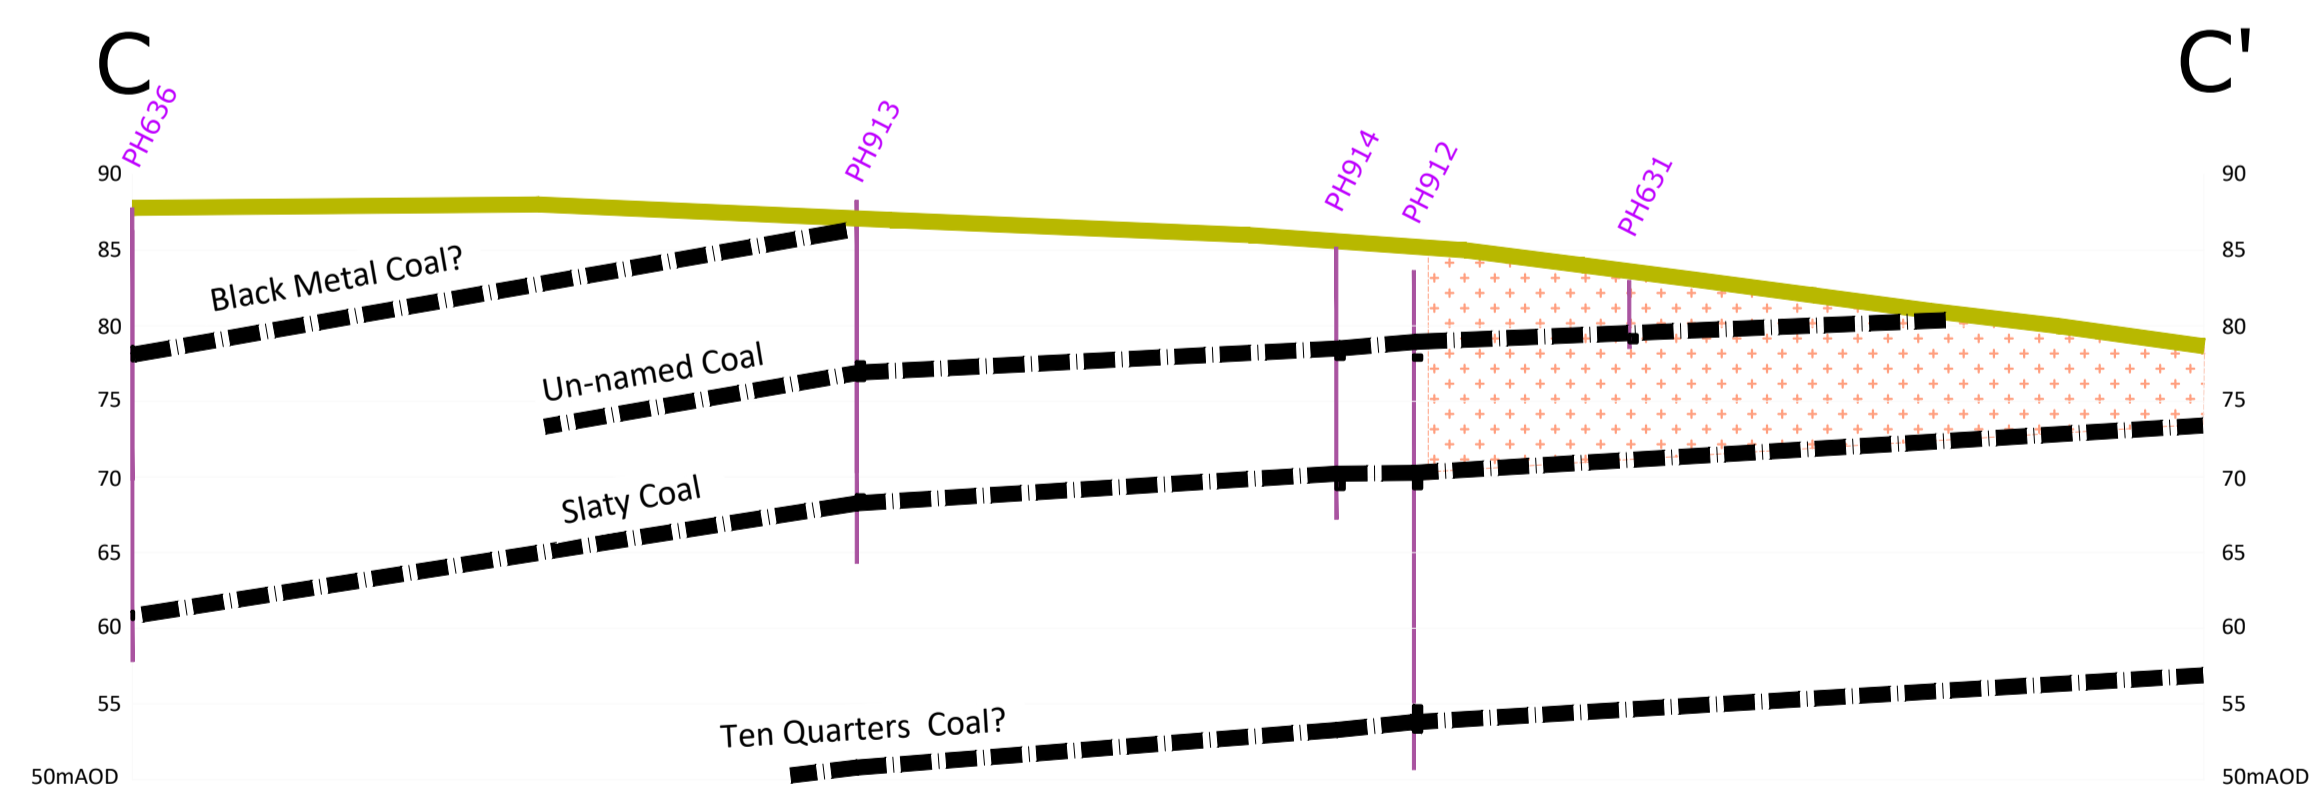
STATUS		
DRAWN BY NW	SIGNATURE	DATE 23-11-21
APPROVED BRB	SIGNATURE	DATE 14-12-21
SCALE 1:500@A1	DRG No. 4046-G-D054

- 6.1.9 Broken ground accompanied by loss of flush indicative of probable shallow mineworkings was proven in the north-eastern quarter of the site in six locations between depths of 18.4m (PH902) and 27.8m bgl (PH630). The Geological Cross Sections A=A' & B-B' indicate these workings are likely to be within the Slaty Coal seam.

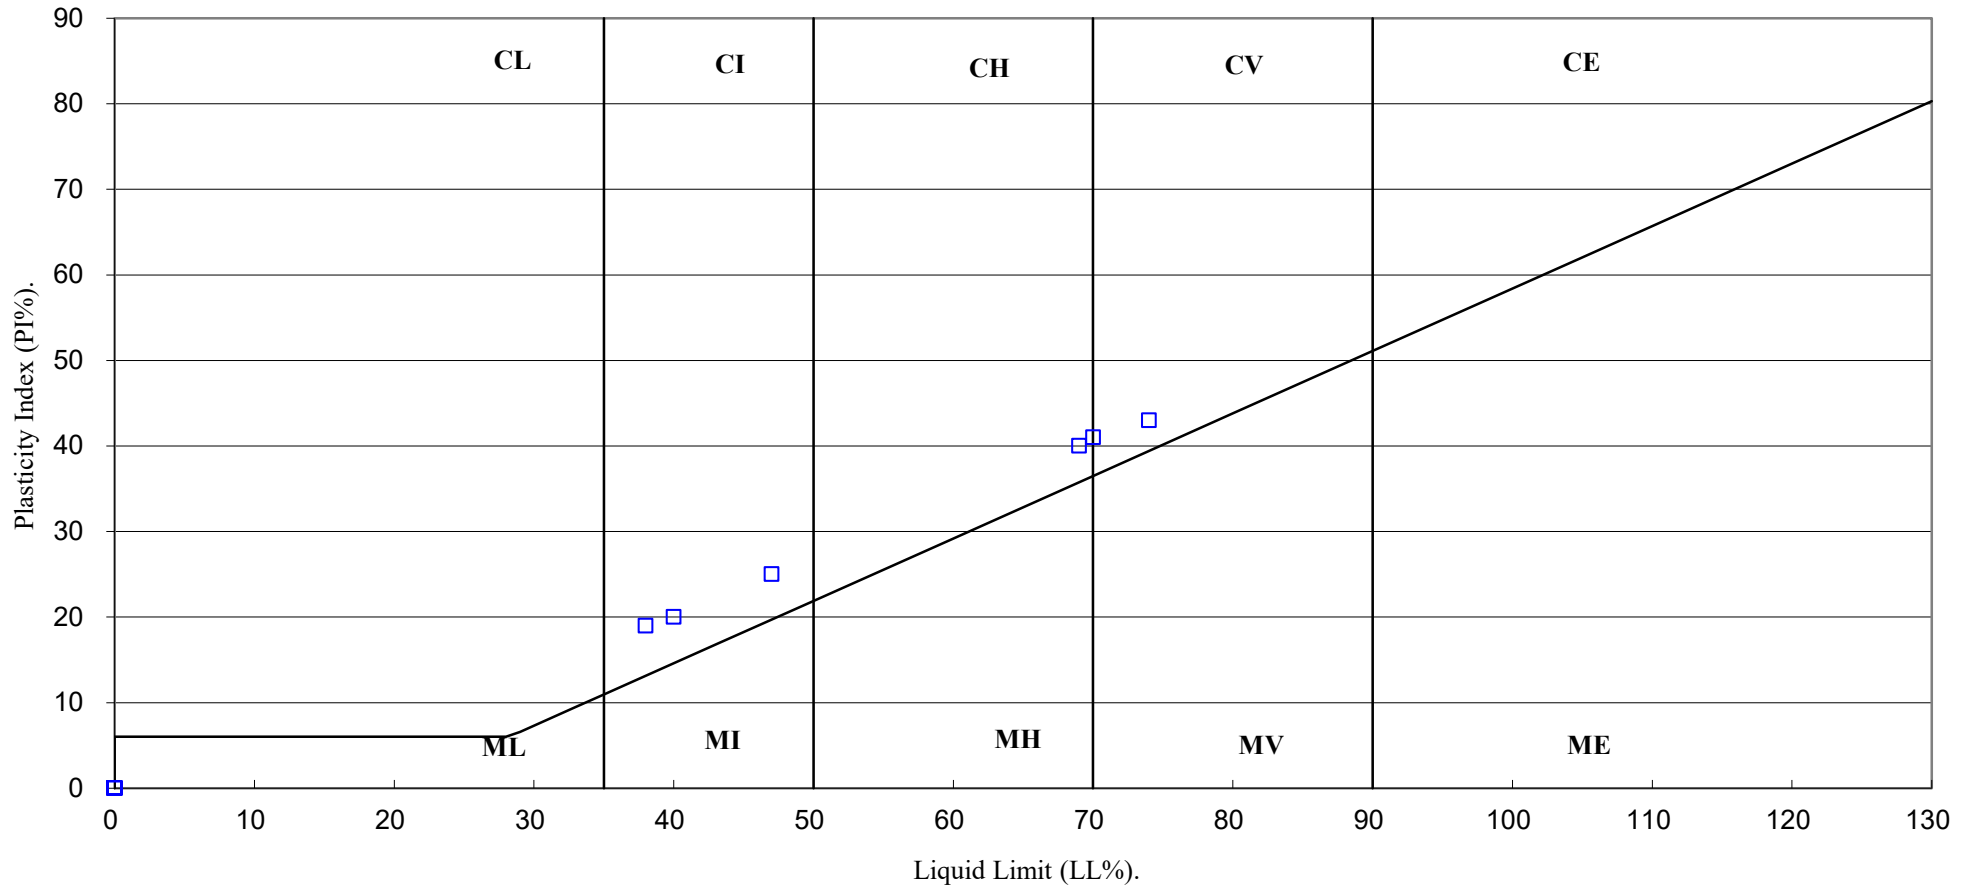
PLASTICITY CHART FOR CASAGRANDE CLASSIFICATION.

11.2.3 The exploratory records indicate that samples of the weathered Coal Measures which recorded high plasticity (TP772, TP773) were associated with distinctly weathered mudstone bedrock, recovered as clayey sandy gravel sized peds of mudstone. This material is considered to be bedrock and to not exhibit plastic behaviour. Residual mudstone recovered as silty sandy clay was also encountered at founding depth, which testing indicates to be of medium to high plasticity. Given this material is only locally present as a thin bedrock carapace, typically within the upper 1.0m of the site, there is unlikely to be a significant change in volume. It is considered that medium volume change potential is most appropriate classification for design purposes.

11.2.4 For the purposes of foundation design, it is recommended that all cohesive soils be regarded as being of medium volume change potential.

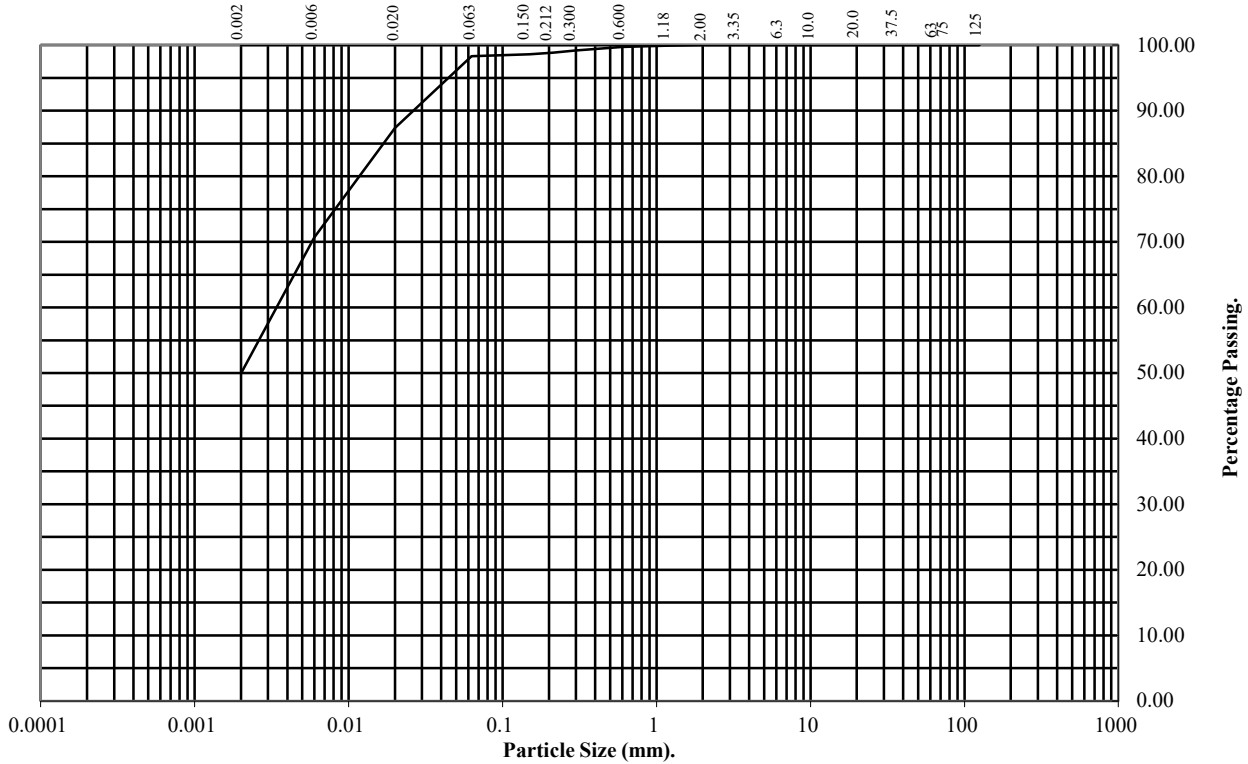
BS Test Sieve (mm)	Percentage Passing
125	100
75	100
63	100
37.5	100
20	100
10	100
6.3	100
3.35	100
2	100
1.18	100
0.6	100
0.3	99
0.212	99
0.15	99
0.063	98

Particle Diameter	Percentage Passing
0.02	87
0.006	71
0.002	50

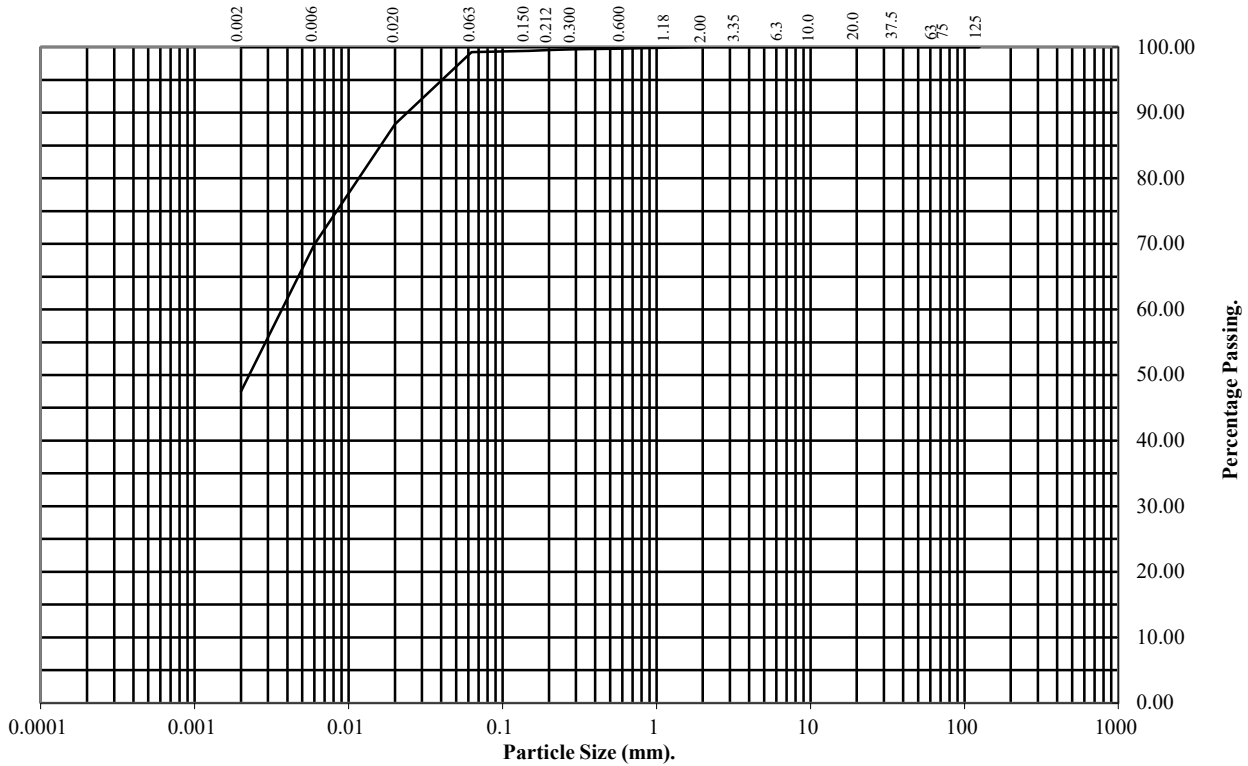
BS Test Sieve (mm)	Percentage Passing
125	100
75	100
63	100
37.5	100
20	100
10	100
6.3	100
3.35	100
2	100
1.18	100
0.6	100
0.3	100
0.212	100
0.15	99
0.063	99

Particle Diameter	Percentage Passing
0.02	88
0.006	70
0.002	48

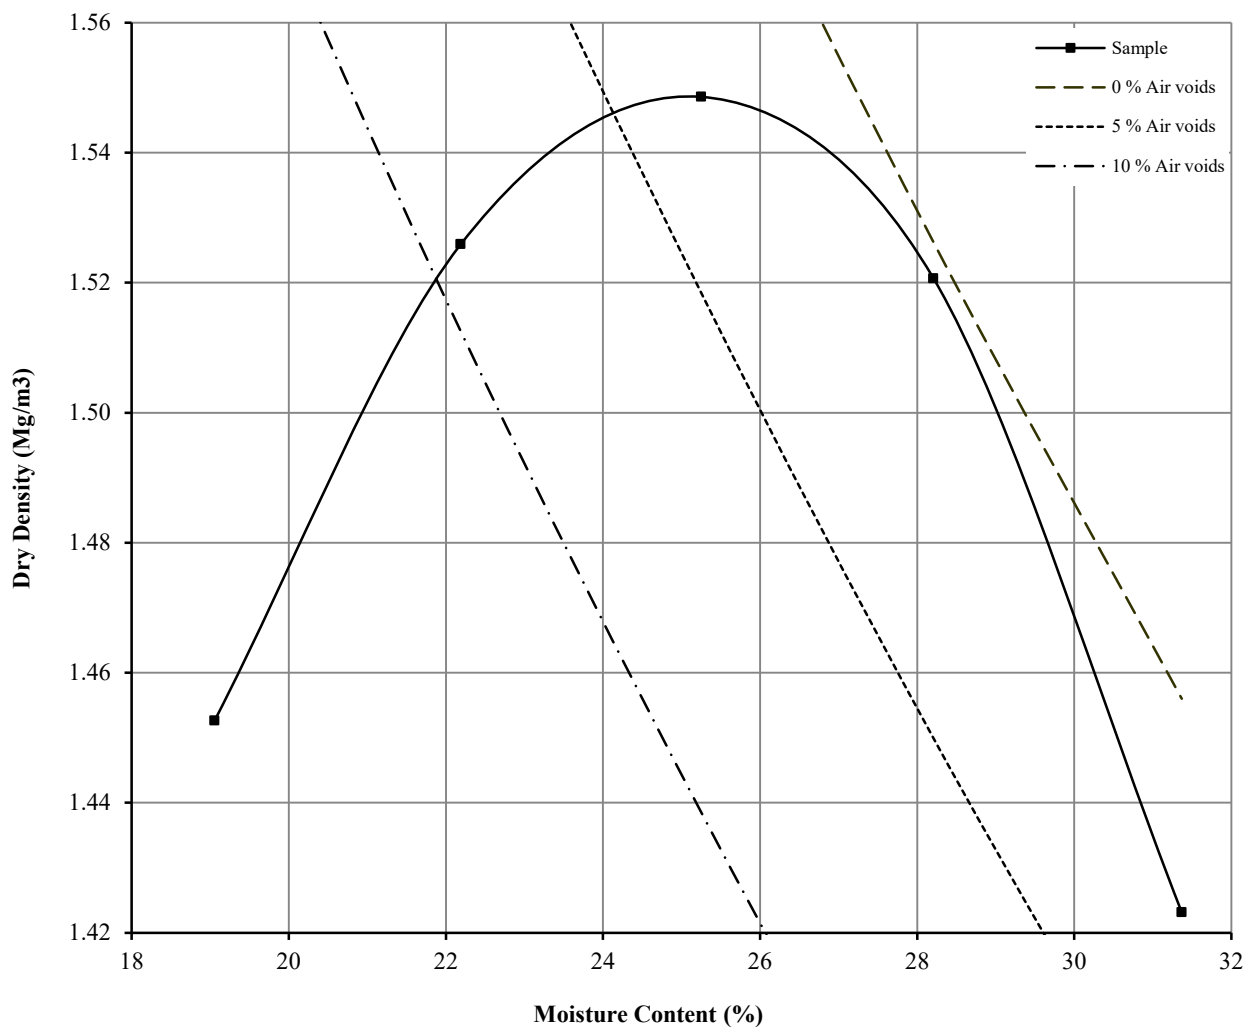
Initial Moisture Content:	28	Method of Compaction:	2.5kg	Separate Samples
Particle Density (Mg/m ³):	2.68	Measured	Material Retained on 37.5 mm Test Sieve (%):	0
Maximum Dry Density (Mg/m ³):	1.55	Material Retained on 20.0 mm Test Sieve (%):	0	
Optimum Moisture Content (%):	25			
Remarks See summary of soil descriptions

Sample location & depth	G _s (Mg/m ³)	MDD (Mg/m ³)	OMC (%)	Allowable mc range for 95% MDD & <5% air voids	In-situ moisture content (%)
TP772 (0.2-0.7m)	2.68	1.55	25	24.0 – 27.0	23
TP773 (0.2-0.7m)	2.67	1.55	25	23.5 – 27.0	27

- 11.5.6 Based on the above results it is apparent that the in-situ moisture content of the weathered mudstone bedrock is generally not within the allowable moisture content range to achieve 95% of the maximum dry density.

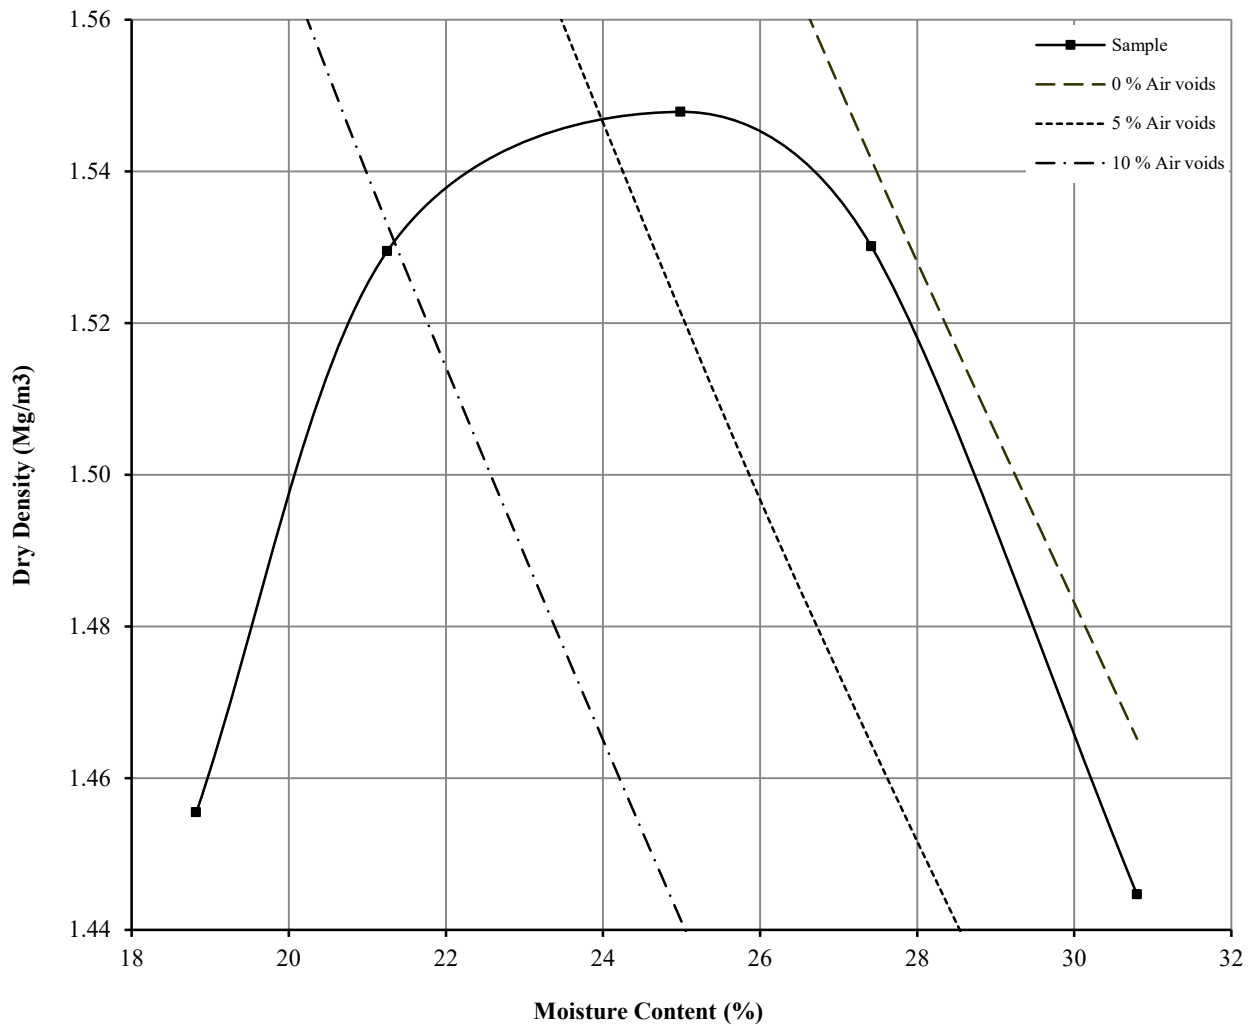
Initial Moisture Content:	27	Method of Compaction:	2.5kg	Separate Samples
Particle Density (Mg/m ³):	2.67	Measured	Material Retained on 37.5 mm Test Sieve (%):	0
Maximum Dry Density (Mg/m ³):	1.55	Material Retained on 20.0 mm Test Sieve (%):	0	
Optimum Moisture Content (%):	25			
Remarks See summary of soil descriptions
