# Mill Way, Millom

## Bat Survey Report

**For As If By Magic Ltd.**

**August 2019**

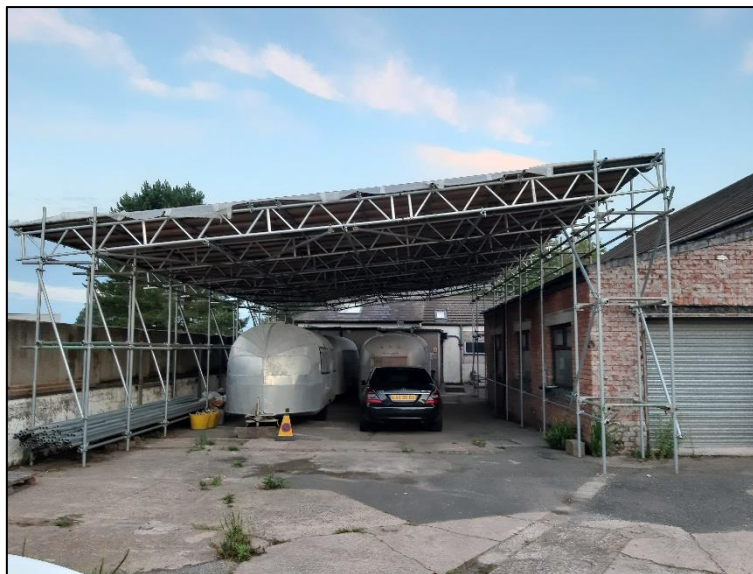
During the additional day roost inspection it was noted that an external outdoor scaffold with plywood roof was present within the building yard between B1 and B2 (see Photograph 1). No other changes to site conditions were noted with comparison to the Ecological Appraisal results (WYG, 2018).

**Photograph 1 – Showing external scaffold with a plywood roof.**

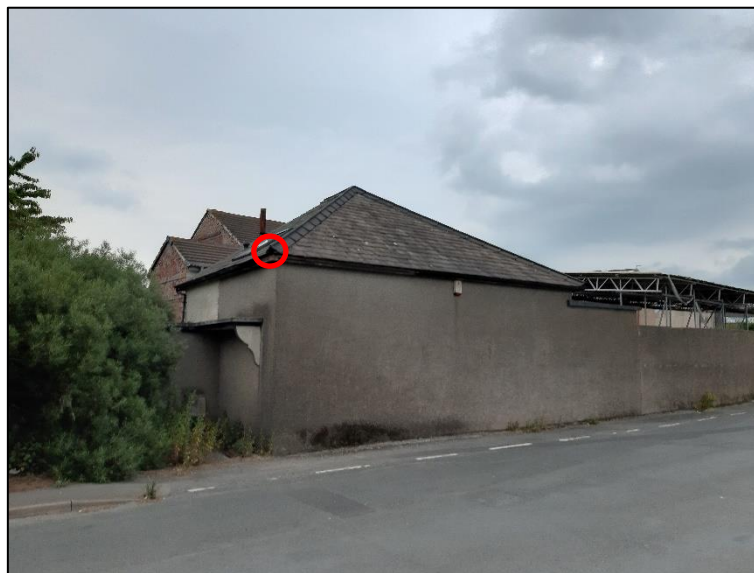
| Date of survey | Start and end times | Species | Roost Type | Roost Location | Access Points | Dimensions of roosting location or explanation where the roost is (as appropriate) |
|---|---|---|---|---|--|--|
| 04.07.19 | Start: 21:32<br>End: 23:17<br>Sunset: 21:47 | <b>Common pipistrelle x1</b> | Day | Edge of the roof – southwest corner of B2 | Single access through the crevice under heap tile. | The roost is located under the heap tile at the southwest roof corner of B2 |

**A common pipistrelle was observed emerging** from the southwest roof corner of B2 at 22:18 (31 minutes after sunset). See Photograph 2 below for the roost location.

**Photograph 2 – Location of the day roost used by a single common pipistrelle bat on the 4<sup>th</sup> July 2019.**

- Roost R1 is located at the southwest corner / edge of the roof to B2, with the single egress point through the gap under a hip tile. A single common pipistrelle was observed using this roost on one occasion (during the dusk emergence survey) (see Photograph 2 and Figure 2).
- Roost R2 is located at the southwest hip ridge of the roof to B2, with the single egress point through the gap under a hip tile. A single common pipistrelle was observed using this roost on one occasion (during the dawn re-entry survey) (see Photograph 3 and Figure 3).

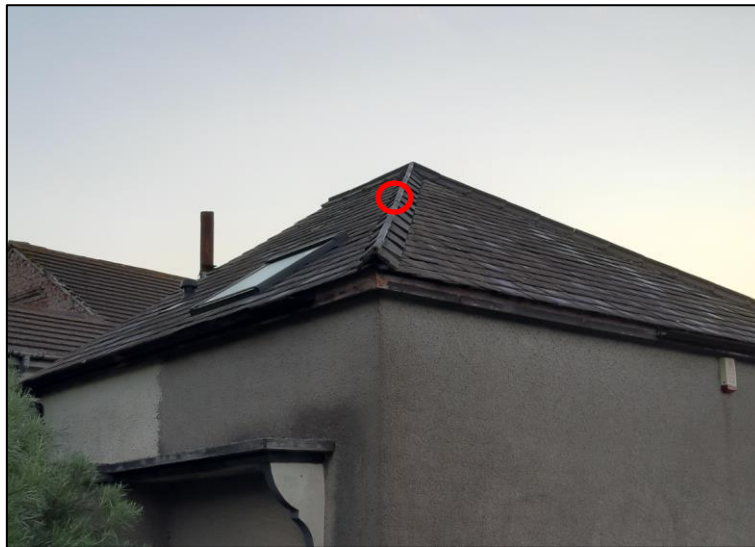
| Date of survey | Start and end times | Species | Roost Type | Roost Location | Access Points | Dimensions of roosting location or explanation where the roost is (as appropriate) |
|---|---|---|---|--|--|--|
| 26.07.19 | Start: 3:35<br>End: 5:31<br>Sunrise: 5:16 | <b>Common pipistrelle x1</b> | Day | Hip ridge of the roof - southwest corner of B2 | Single access through the crevice under heap tile. | The roost is located under the heap tile at the southwest hip ridge of the B2 |

**A common pipistrelle was observed entering** the southwest hip ridge of the building B2 at 04:34 (42 minutes before sunrise). See Photograph 3 below for the roost location.

**Photograph 3 – Location of the day roost used by a single common pipistrelle bat on the 26<sup>th</sup> July 2019.**

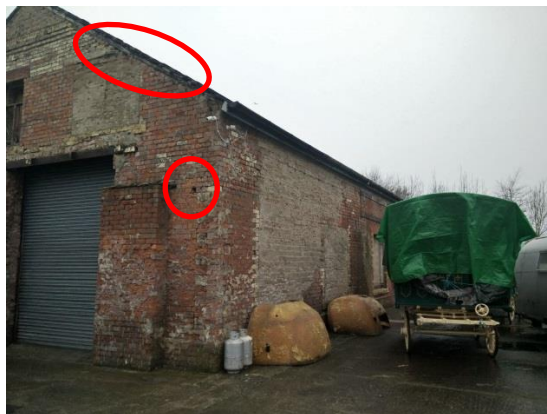
**Photograph 1: N & E elevations**

| Building Ref | Description | | Bat Roost Suitability |
|---|--|---|---|
| <b>B1</b> | <p>Building B1 comprises the detached workshop located towards the western edge of the site. The building comprises the main workshop, a single-storey lean-to extension to the southern elevation (Photograph 1), a single-storey lean-to extension to the western elevation and a 1.5 storey pitched roof extension to the western elevation (Photograph 2).</p> <p>The building is occupied during the daytime and is used for restoring caravans. The exterior walls are exposed brick, having been stripped of their render approximately 18 months prior to the survey. The workshop has a pitched concrete tile roof, with concrete ridge tiles.</p> <p>There are potential access points for bats at the eaves of the roof on the eastern and western gables, due a lack of pointing exposing gaps between the tiles and roof lining (Photographs 1, 3 &amp; 5). There are also numerous gaps in the pointing and brickwork on all elevations (Photographs 1 &amp; 4) including a notable void on the southern elevation between the lean-to part of the building and the main workshop, opposite B2 (Photograph 6). Crevices, which provide access to potential wall cavities are also associated with a sealed window on the eastern elevation (Photograph 7) of the building and a sealed doorway on the northern elevation. Gaps are present in the soffits, to the northern, southern and western elevations (Photograph 8) that could allow bats to access the interior roof void.</p> | <p>Internally, several loft voids are present. It was not possible to fully access the roof void of the lean-to part of the building on the western elevation and this area could only be viewed through a hole in the plasterboard ceiling. No access was possible to the roof void of the lean-to structure located to the southern elevation of the building. All other voids were fully accessible</p> <p>The main void has a modern trussed rafter construction and the roof is lined with a breathable membrane (Photographs 8 &amp; 9). The void is split into two by a concrete breeze block partition wall, with the eastern void space the largest. The ridge beam is a thin plank and provides no suitable crevices where the timbers join, as these are secured with metal plates. Gaps in the soffits on the northern and southern elevations of the building and a gap at the gable apex on the western elevation provide potential access points for bats into the roof void. The void has strip lighting and is accessed via a staircase from the workshop below. It is used for storage of household items and houses the water tank for the buildings. Due to the lighting and staircase the main void is considered likely to be quite frequently disturbed.</p> <p>The lean-to structure to the western elevation of the building has a typical joist and rafter construction with timber sarking (Photograph 10). No potential access points into the void via the roof structure were noted. However it was not possible to fully access the roof void as no loft hatch was present. The void is unlit, but is exposed to some disturbance from the ground floor of the building due to the hole in the ceiling.</p> <p>The 1.5 storey pitched roof extension (Photograph 11) has a collar beam construction and is lined with modern breathable roofing membrane (although the original timbers appear to have been retained, unlike in the main void). Potential access points into the void for bats include gaps in the soffits and missing</p> | <b>Moderate</b> |

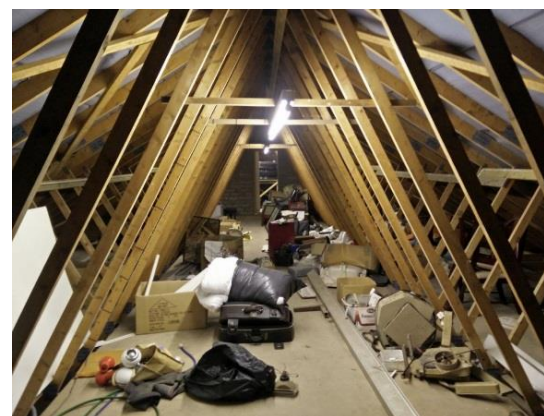
No evidence of bats was found in any of the roof voids. Evidence of bird roosting was noted in the main void against the western gable wall.

**Photograph 9: Main roof void east**

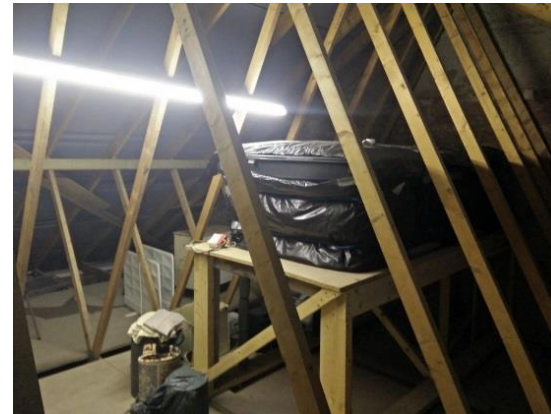
**Photograph 10: Main roof void west**

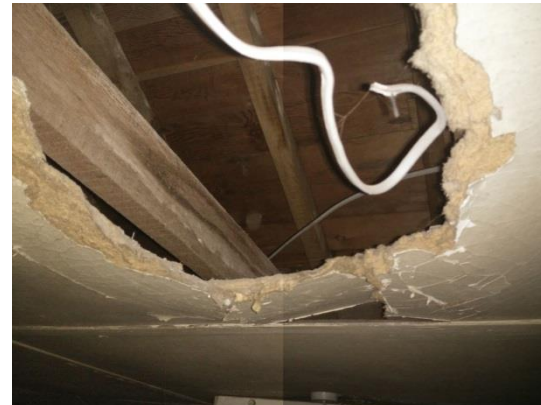
**Photograph 11: Roof void, lean to structure to W**

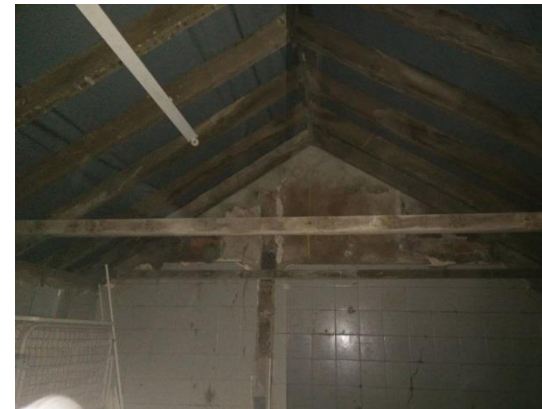
**Photograph 12: Roof void, 1.5 storey extension to W**

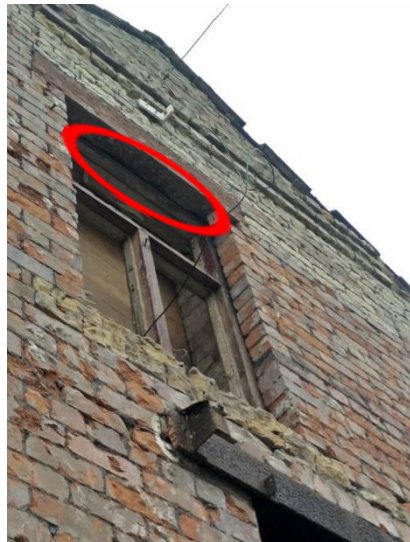
**Photograph 7: Window to N elevation**

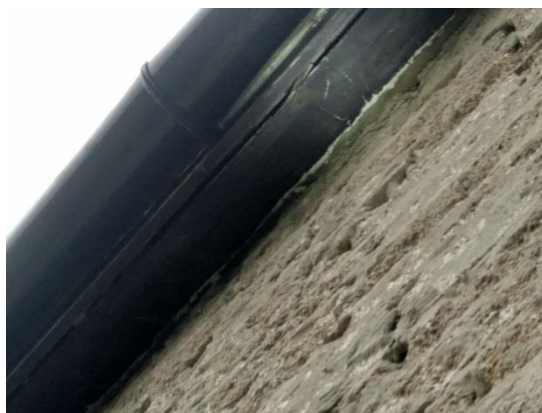
**Photograph 8: Soffit to N elevation**

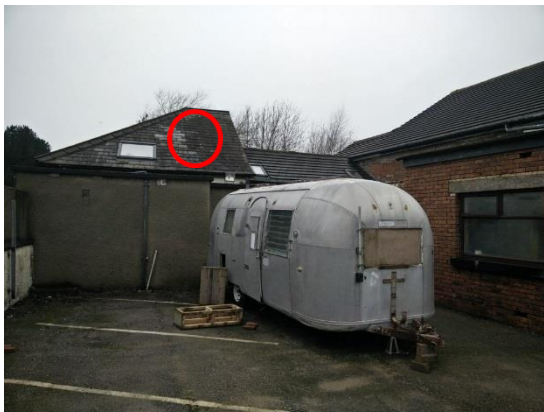
| Building Ref | Description | | Bat Roost Suitability |
|---|--|--|---|
| <b>B2</b> | <p>Building B2 comprises a single storey building, with a hipped slate roof to the southern elevation and a gable to the northern elevation, two single storey flat-roofed stores and a single storey building with a pitched concrete tile roof connecting to the main workshop building (Photographs 13, 14 &amp; 15). The slate-roofed building, stores and the eastern elevation of the pitched roof building are rendered, with the western elevation of the pitched roof building has exposed brickwork.</p> <p>Potential access points for bats are present via lifted slates to the eastern elevation (Photograph 13), missing mortar/brickwork to the eastern elevation (Photograph 14). The barge boards associated with the north-facing gable (Photograph 15) could potentially provide additional opportunities for bats but could not be fully inspected from the ground.</p> <p><b>Photograph 13: E elevation</b></p> | <p>Internally, two connected voids are present within the hipped slate roof and the concrete tiled roof. The flat-roofed stores lack roof voids.</p> <p>The southern hipped roof has a queen post type construction, the northern pitched roof has a king post construction. Both voids show evidence of fire damage to the roof timbers. The joints between the timbers in both parts of the void provide potential roost features for bats. However, there were no apparent access points into the void from the exterior of the building.</p> <p>The undersides of the slates have been completely sealed with expanding foam (Photograph 16). The rafters in the northern part of the void have been packed with insulation. The void is lit by strip lighting and access via a hatch. However nothing is stored in the void and is considered likely to remain relatively undisturbed most of the time.</p> | <b>Low</b> |
