Arboricultural Method Statement

For Trees On

Land Adjacent To Preston Street,

Whitehaven

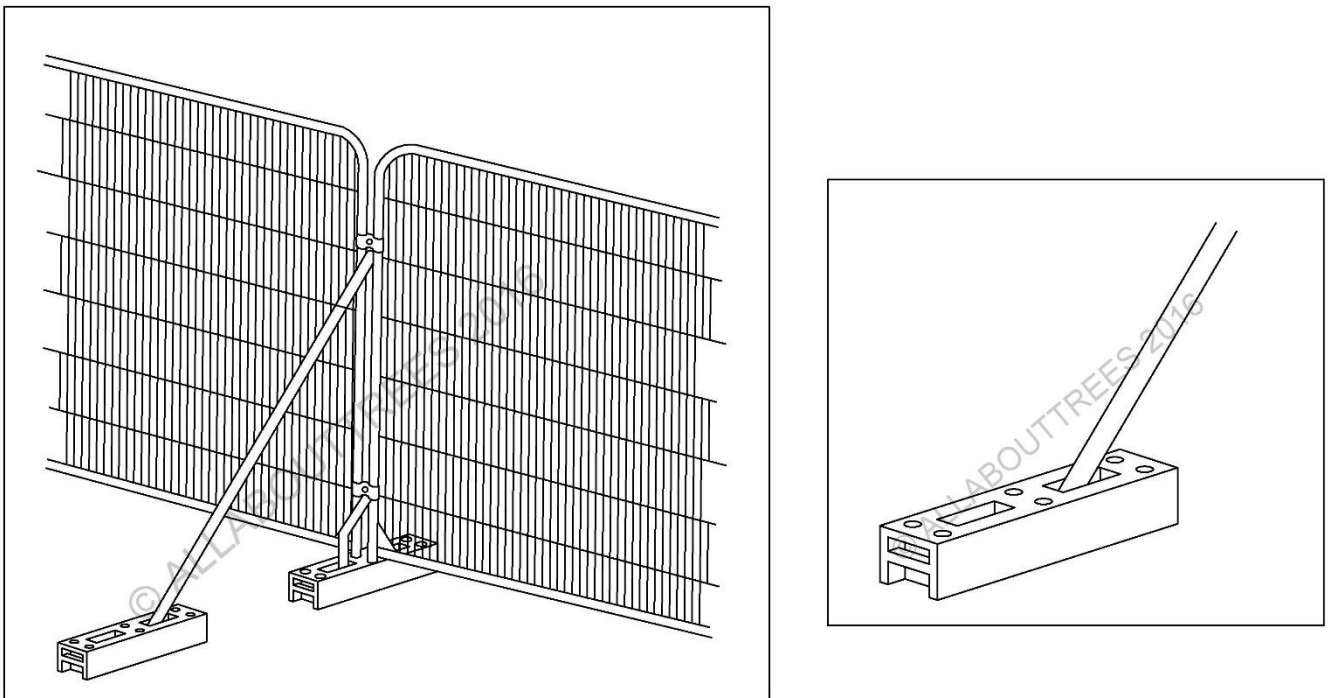
Figure 1 - Stabiliser strut mounted on block tray.

3.3.4 The barrier should consist of proprietary 2m tall welded mesh panels mounted on rubber or concrete feet. The panels must be joined together with a minimum of two anti-tamper couplings situated at least 1m vertically apart and installed uniformly throughout the barrier so that they can only be removed from inside the barrier. The panels must be supported on the inner side by stabilising struts mounted on a block tray.
