PLOT C INVESTIGATION PLATES

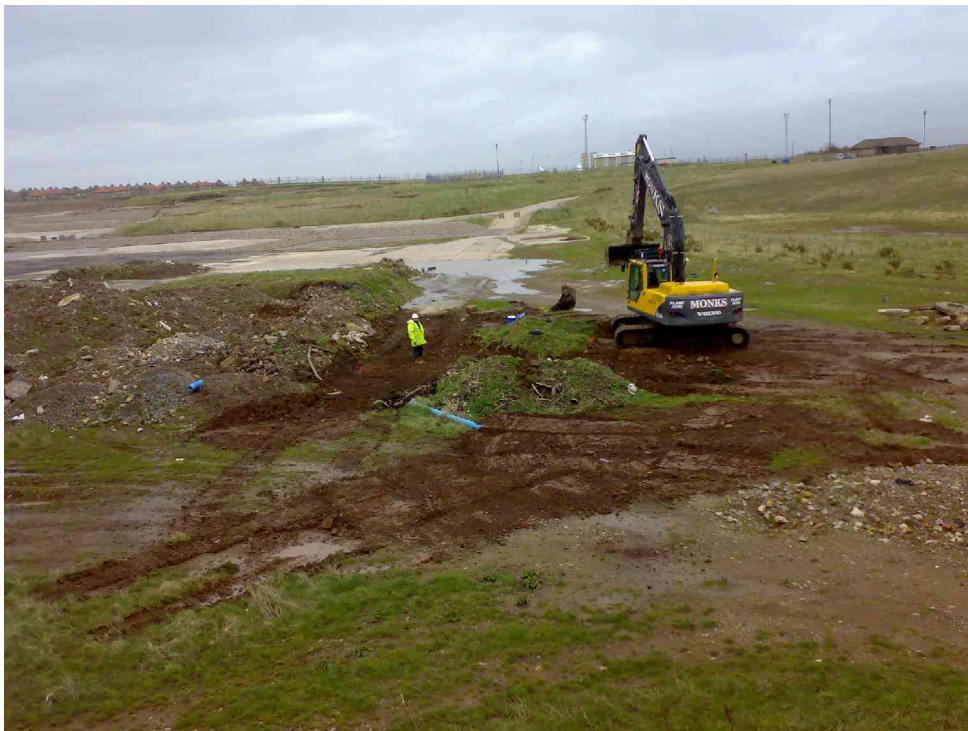
Plate 2 – Area of potential arsenic contamination- View east.

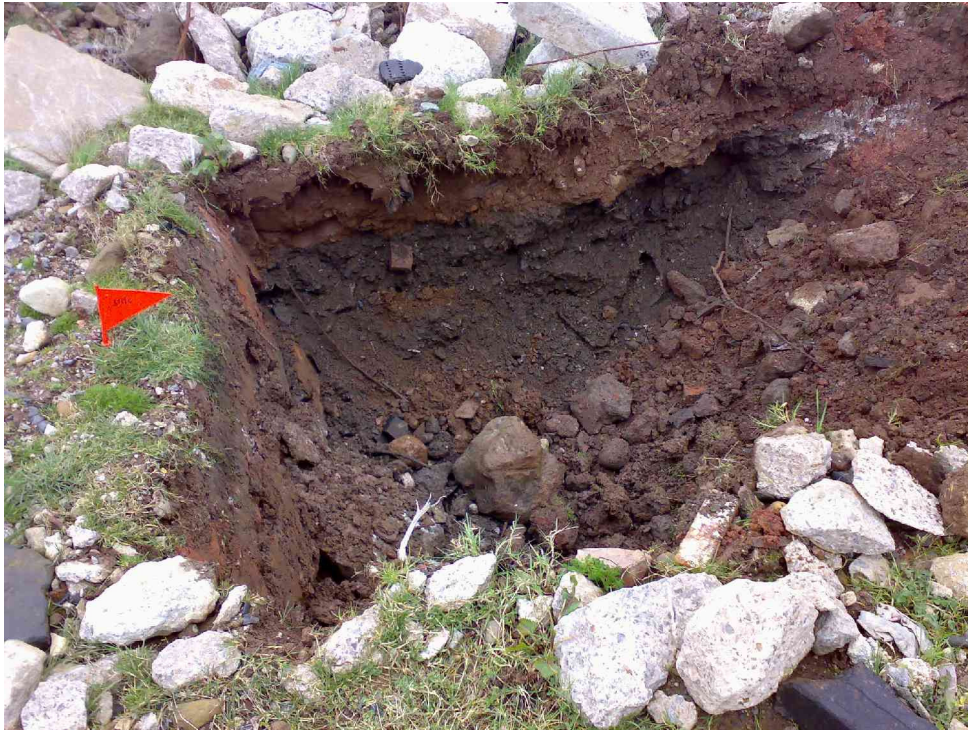
Plate 5 – TP118C (0.5m) Red-brown topsoil followed by grey-brown clayey soil with metal, bricks, and occasional red clay.
