Nethertown Road Percolation Test

PLOT 1

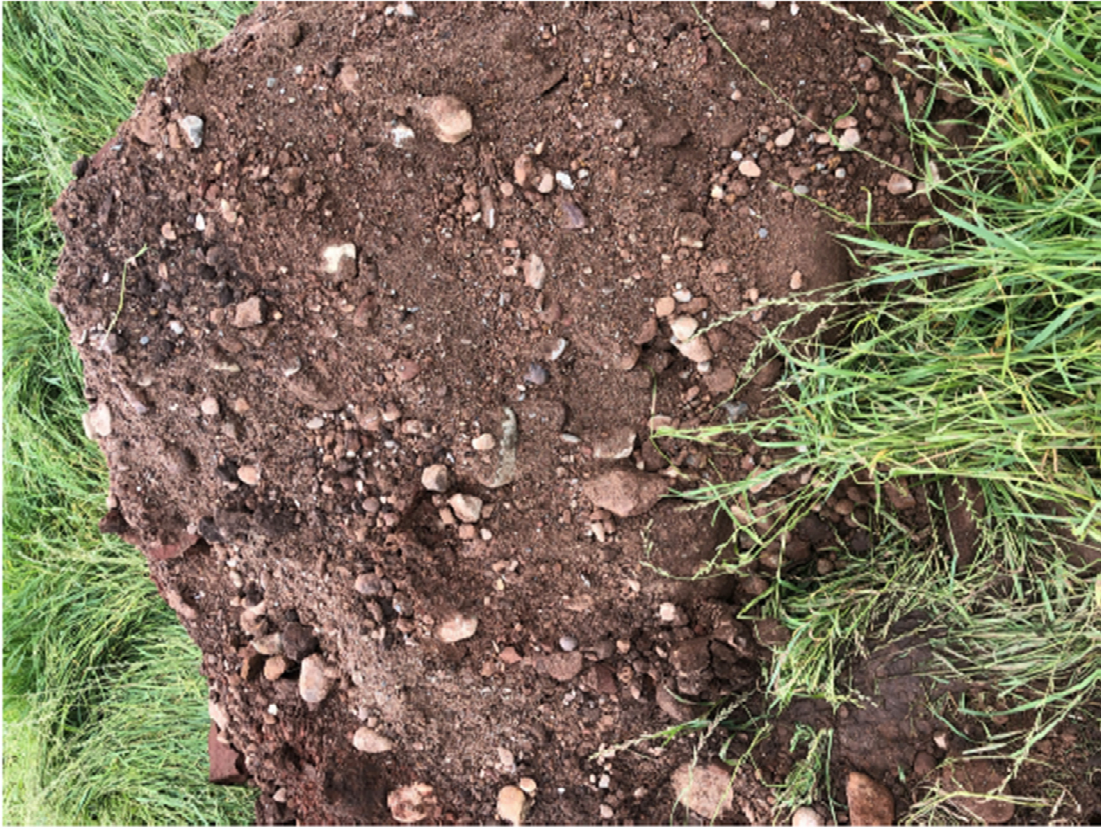
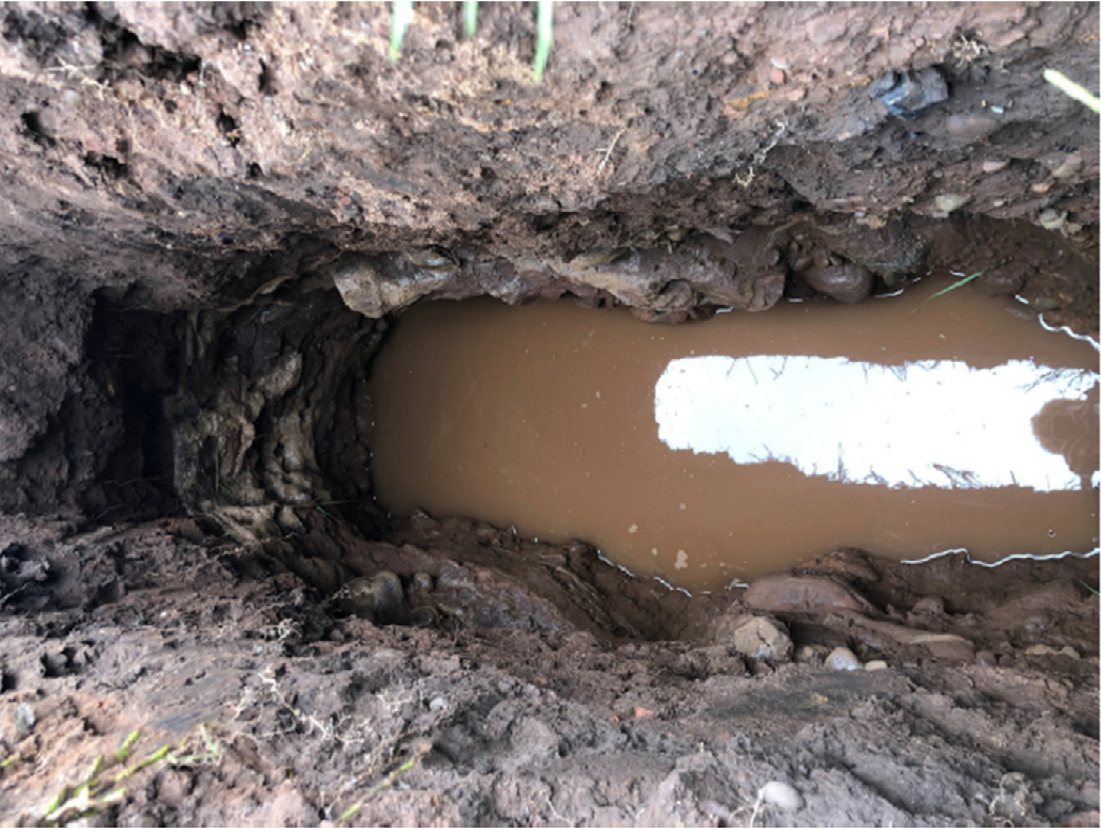
Tests carried out during heavy rain

Hole excavated 2000mm x 1000 x 300. No groundwater was encountered during excavation.

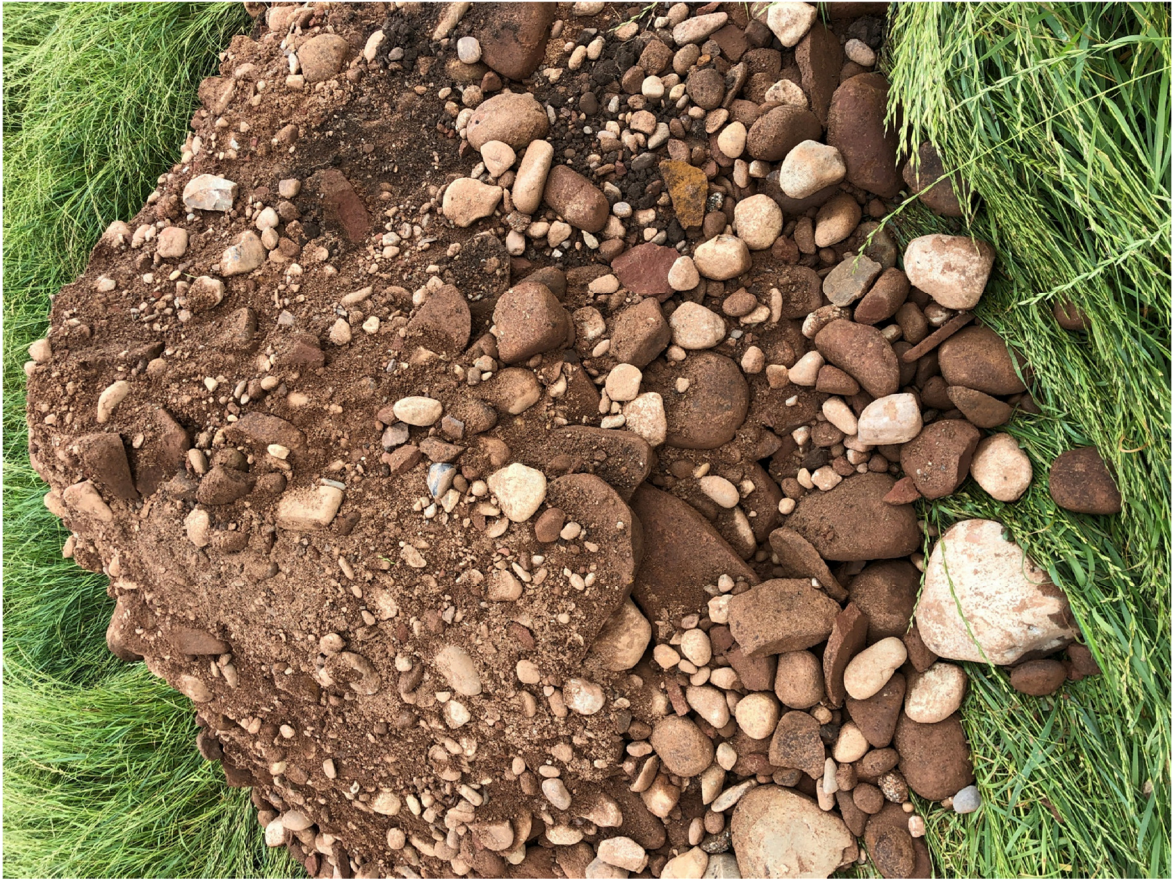
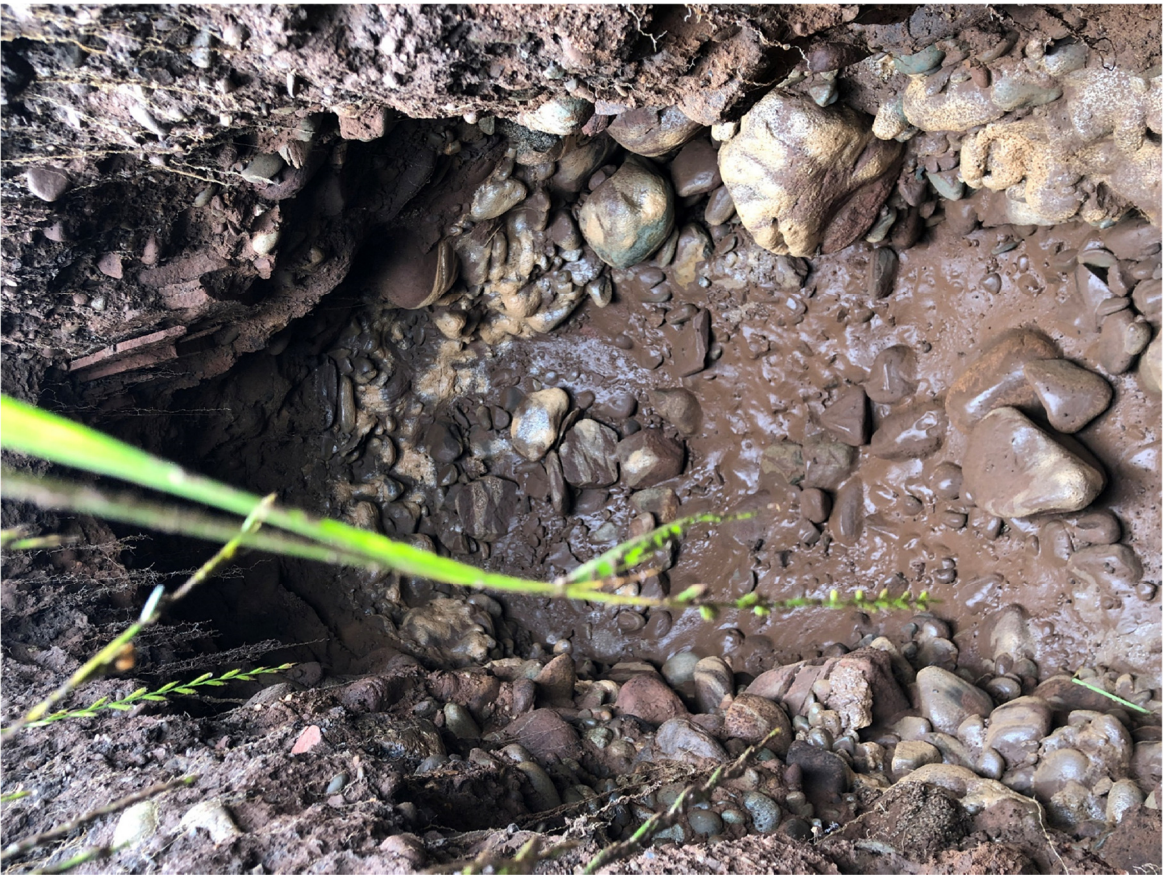
PLOT 2

Tests carried out during heavy rain

Hole excavated 2000mm x 1000 x 300. No groundwater was encountered during excavation.

Note: test 1 was started after approx. 0.5m³ water had already drained from the hole. The ground was therefore assumed saturated and only two further tests were completed.

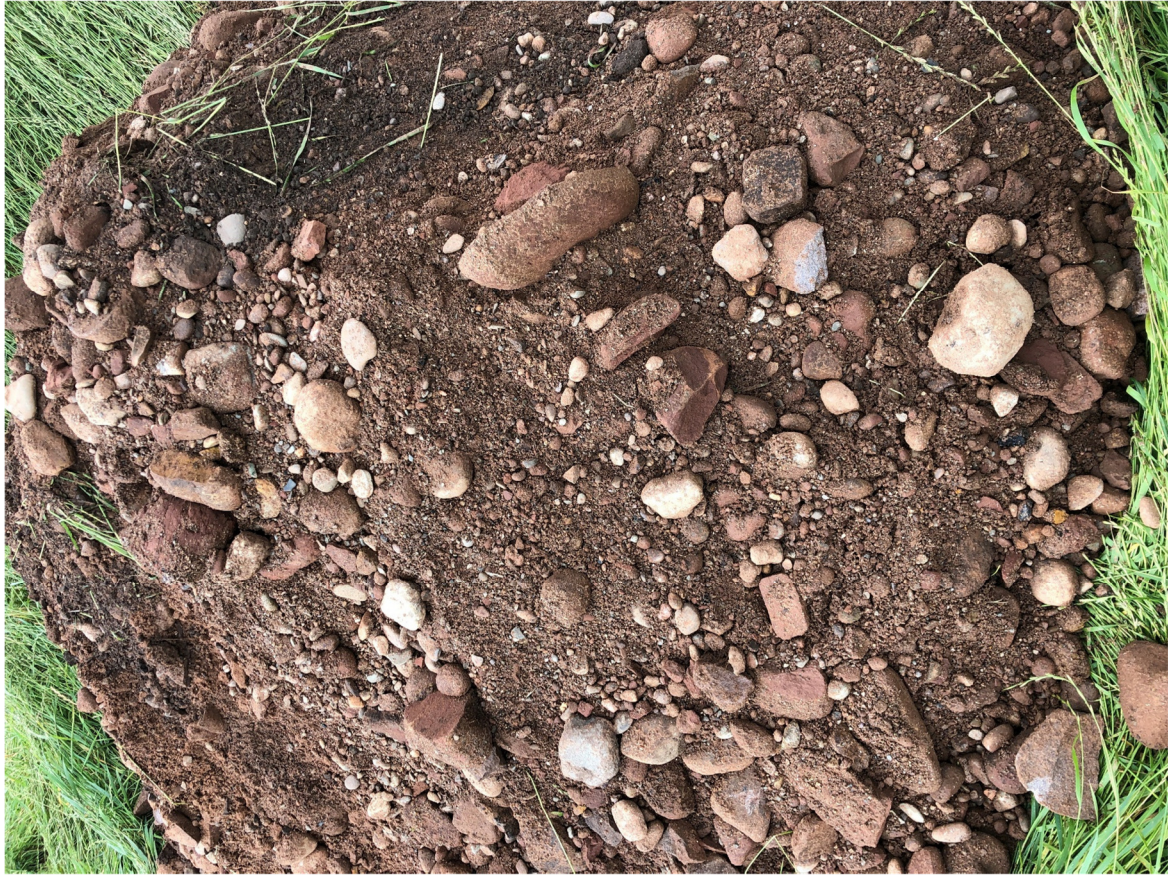
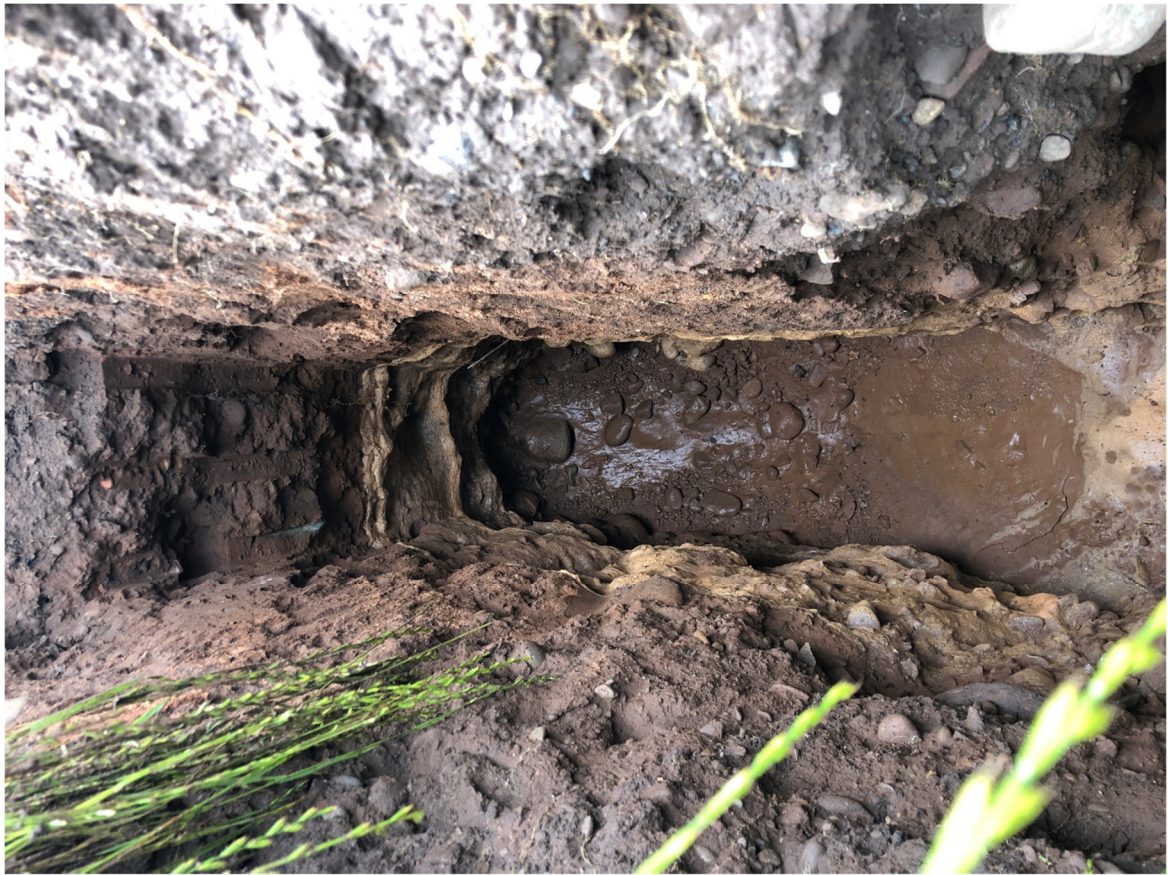
PLOT 3

Tests carried out during heavy rain

Hole excavated 2000mm x 1000 x 300. No groundwater was encountered during excavation.
