**Client:** Genesis Homes Ltd  
**Site:** Land at Parkside Road,  
Cleator Moor, Cumbria

## Arboricultural Impact Assessment for Proposed Development

Prepared by  
Antony Wood Cert Arb RFS  
Yew Tree and Gardens  
For Envirotech NW Ltd

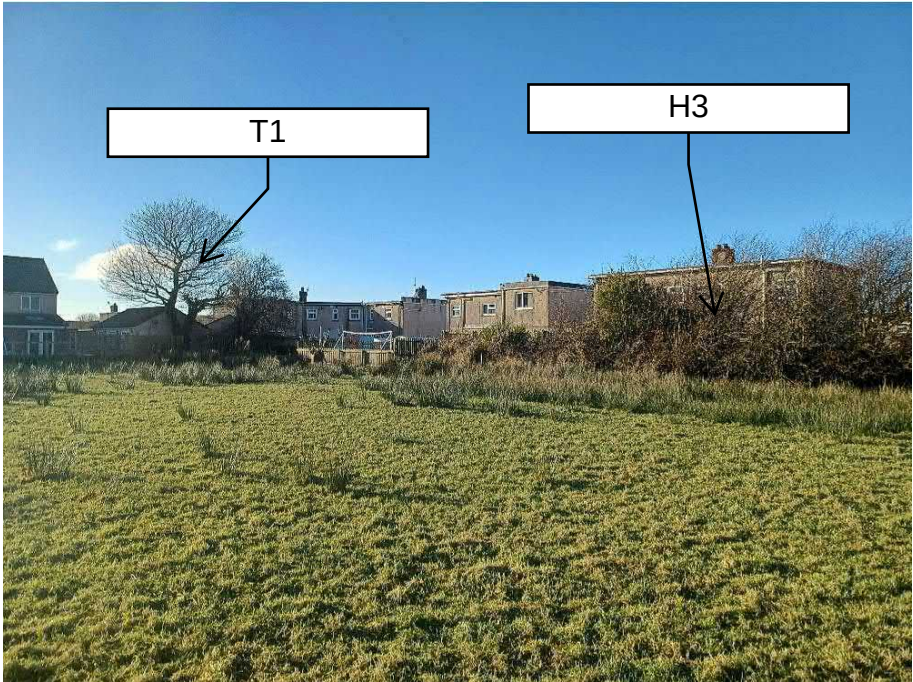
3. Group G1 does not contain any significant tree stock, it is comprised of scrub cover, overgrown hedge species and Ash with advanced Ash Dieback. It is located adjacent to the northeast corner of the site.

4. All other vegetation within and around the site boundaries is comprised of hedges.
5. We have listed these hedges as hedge H1 to H7 within the schedule. Hedges within the site boundaries are of mixed condition. They are indicated by dashed lines, we have made these continuous to indicate the location of the hedge and associated banking but many hedges within the site are not continuous / cohesive.

6. The highway boundary hedge H1 is typical of a highway hedge with a single species, even aged composition.
7. H2 is a garden boundary hedge and a mix of native and non-native species.

8. H3 is an unmaintained field / garden hedge, it does not extend along the entirety of the boundary.
9. H4 is an internal field dividing hedge within the central site. The western section has dissolved into occasional scattered single Hawthorns and clumps of Hawthorns. This section of H4 has lost all cohesion as a hedge.

10. H5 is similar to the eastern section of H4 in that it is no longer a cohesive, viable hedge.
11. H6 forms a section of the southwest boundary of the site, it is largely unmanaged with colonisation with Goat Willow.

12. H7 forms the western edge of the overall site. It is unmanaged and extends into a shallow ditch via Blackthorn sucker growth.
13. No other trees or hedges are located within the sphere of the development.
