CONTENTS

SUMMARY

The Methodist Chapel was largely a utilitarian and modest building serving a growing mid Victorian rural community endowed in 1865. In keeping with the moderation of the religion, there were no architectural or graphic embellishments except a marble tablet dedicated to Robert Lamb.

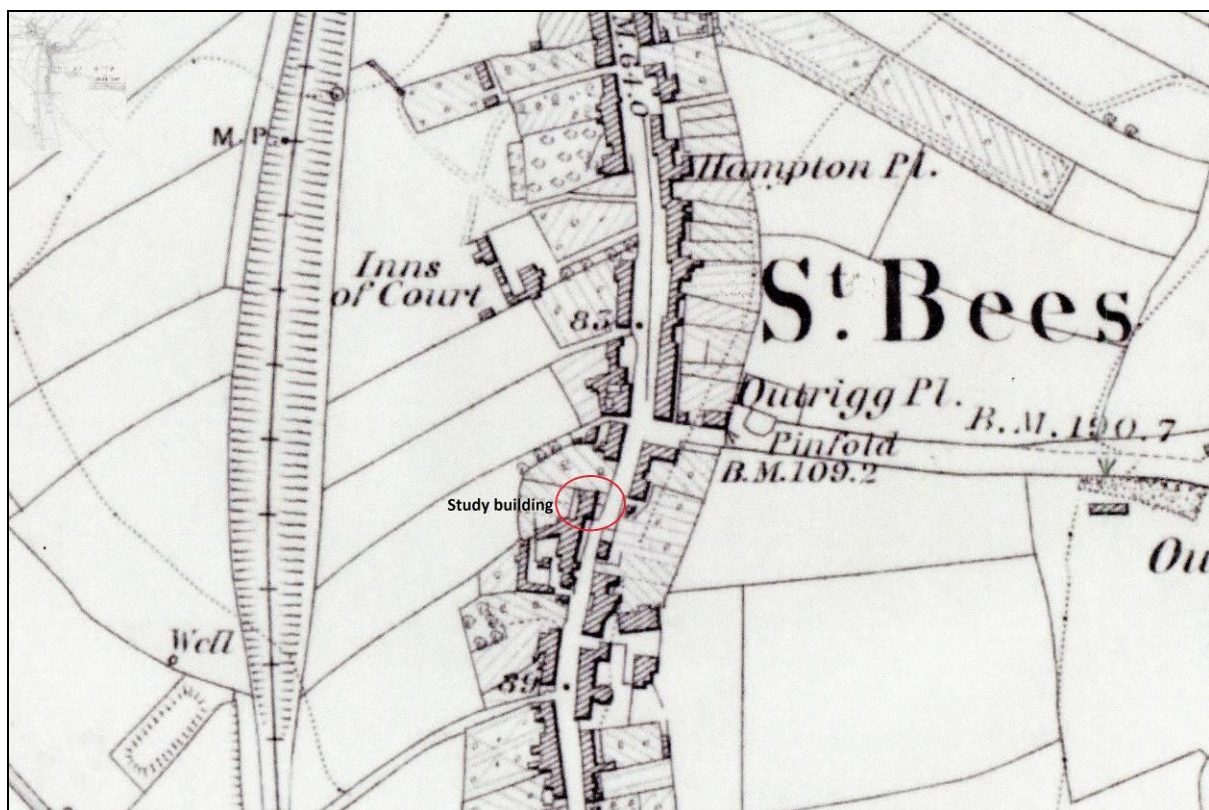
Figure 5. Layout as depicted on the First Edition Ordnance Survey map published in 1867

The study building appears to be illustrated on the first edition Ordnance Survey map as a rectangular building adjacent to Fairladies Farm (figure 5), a late 18th century Grade II listed house formed from an earlier cottage and house. Interestingly, Dawson Place is not illustrated to the rear, although it bears the hallmarks of a double pile house that would have been extant around 1800.

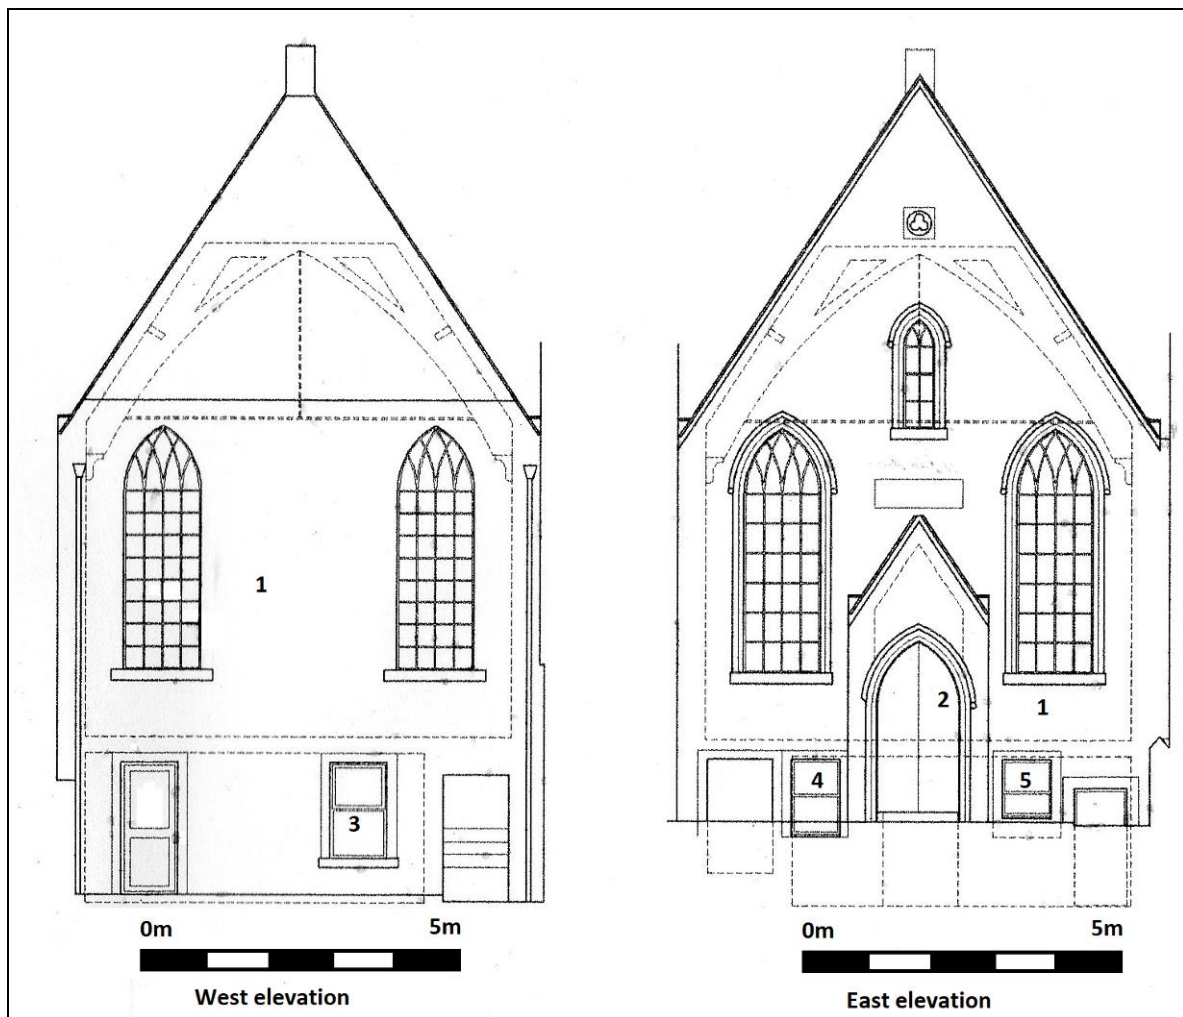
Figure 9. Front and rear elevations to the Chapel

The east elevation (figures 9 and 10) was composed of concordant red sandstone blocks of varying sizes pointed by a cream mortar. The elevation comprised of the gable end of the Chapel where worship was conducted (1), a porch (2) and in the lower ground floor a toilet (4) and kitchen (5), a breadth measuring 7.64m and height of 11.76m.

The west elevation (figures 9 and 12) was finished in pebble-dash roughcast applied to coursed red sandstone blocks of varying sizes. The elevation comprised of the rear gable end of the Chapel where worship was conducted (1) and within the lower ground floor a function room, probably the old school room (3), a breadth measuring 7.64m and height of 12.79m.

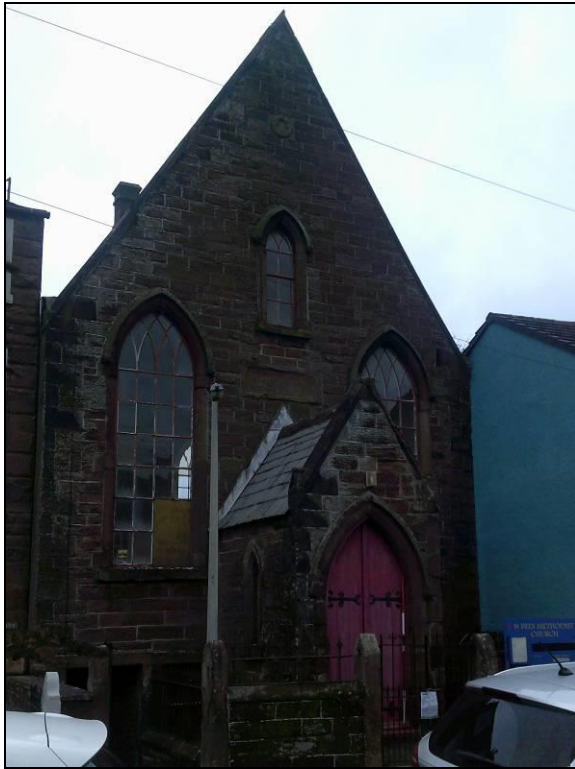
Figure 10. Front elevation to the Chapel

The roof was Cumbrian slate. A cartouche on the gable end was illegible (figure 10), the sandstone having been weathered beyond comprehension. It probably represented the foundation stone, albeit moved from its original provenance in on August 7th 1865.

The facade was dominated by two perpendicular-style windows measuring 3.90m in height and 1.18m in width formed from 24 panes of glass measuring 0.28m x 0.47m set in wooden muntins (figure 10). Stylistically, these windows were typical of 19th century Gothic Revival.

A central porch measuring 4.02m in height, 2.20m in width and 2.44m in length accessed the Chapel through a probable original wooden door measuring 1.34m in width and 2.79m in height through a perpendicular-style door jamb. The door jamb was 0.18m in thickness seriously damaged by erosion. The right side masonry had been replaced relatively recently but the left side was in poor repair, missing a stone corbel.

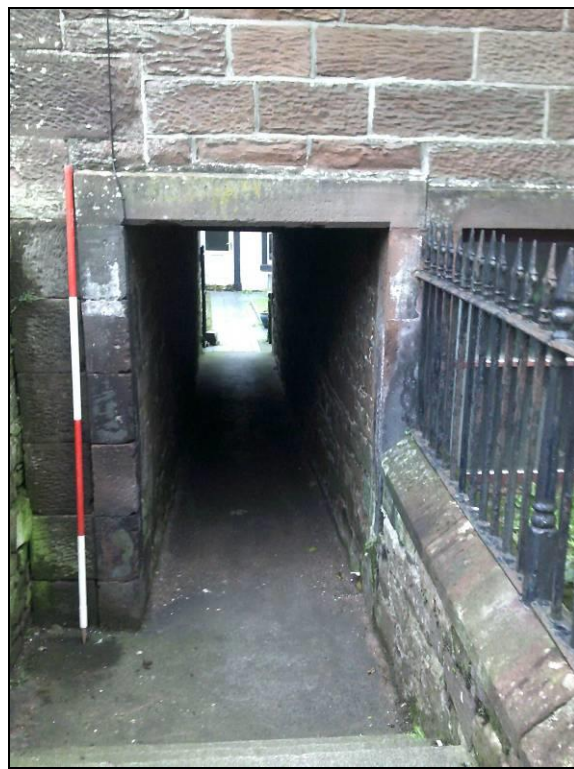
Figure 11. Ginnel to Dawson Place

An alley or ginnel was evident on the southern side of the elevation accessing Dawson Place to the rear. Framed with red sandstone jamb and lintel with a rebate measuring 0.18m in thickness, the threshold measured 1.08m in width and 1.82m in height (figure 11).

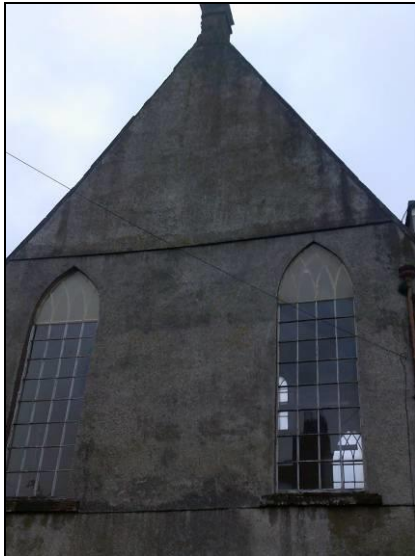
Figure 12. Upper west elevation

The facade was dominated by two perpendicular-style windows measuring 4.05m in height and 1.20m in width formed from 32 panes of glass measuring 0.27m x 0.36m set in wooden muntins (figure 12). Stylistically, these windows were typical of 19th century Gothic Revival.

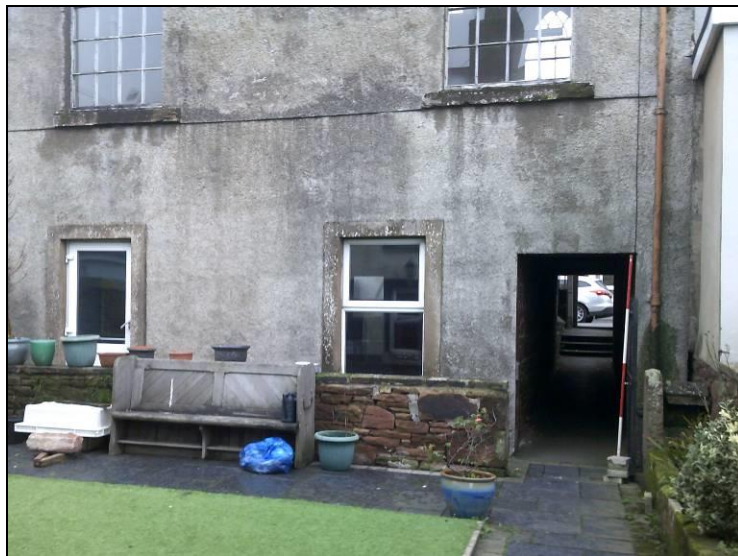
Figure 13. Lower west elevation

The following two architectural elements were observed within the elevation (figure 13):

- A plain glazed, rectangular UPVC window serving the lower ground floor (5) measuring 1.52m in height and 0.89m in width. The sill and window jamb was formed from red sandstone with cement render.
- A UPVC doorway that entered the lower ground floor (5) measuring 2.20m in height and 0.90m in width replete with a stone surround 0.18m in thickness. The sill and door jamb was formed from red sandstone with cement render.

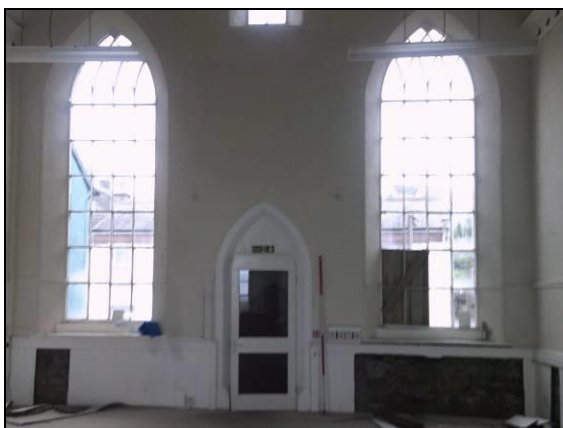
Figure 15. Worship area (1), eastern end

Entry was from the porch (2), through a modern door within a Gothic arch measuring 2.48m in height and 0.92m in width flanked by two Gothic windows described above (figure 15).

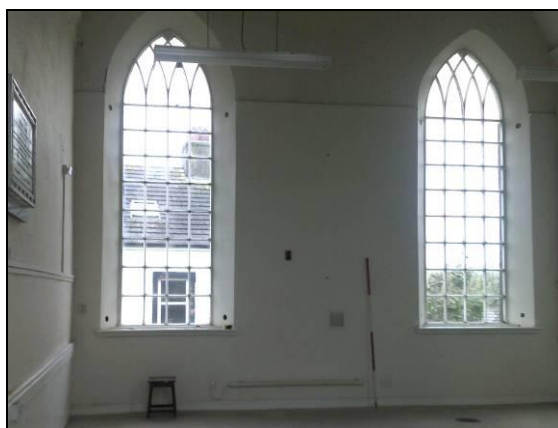
Figure 16. Worship area (1), western end

The floor was formed from timber floorboards formerly overlain by carpet with panelling to a height of 0.89m above the floor on the north, east and southern sides, the remaining walls painted off-white. The western end was dominated by two large windows described above (figure 16). The room was plain with the only embellishment a marble tablet measuring 0.92m in width and 0.62m in height dedicated to Robert Lamb (figure 17).

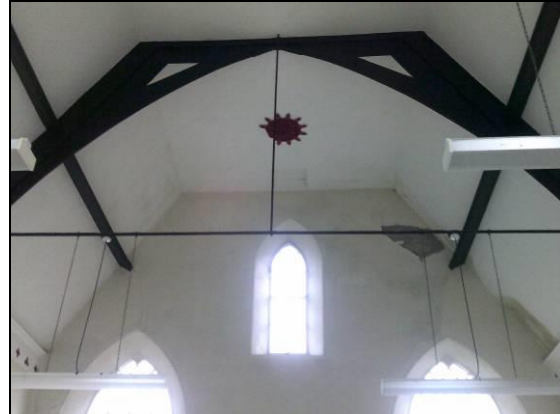
Figure 18. Roof truss, cross-bar and air vents

On February 22nd 1889 the Chapel suffered storm damage, the outer west wall next to Johnston's Yard bulging out. It was decided to prevent further damage to "bind the lower ends of the principals inside of the Chapel with a perpendicular or cross bar of iron with central supports from above". It was also decided to "put a man-hole through the ceiling above the door where the ceiling had fallen down and that Mr Graves attend to the repairs".

Two roof trusses with two iron cross-bars supported the roof probably established as remedial action taken in 1889. The roof also bore a manhole and three decorated air vents (figure 18).

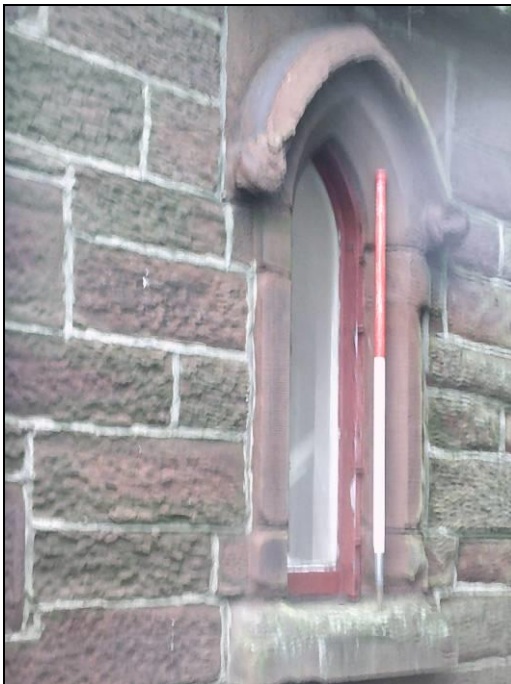
Figure 19. Gothic style window to porch

The porch measured internally 2.44m in length, 1.42m in width and stood to a height of 4.02m and possessed a Cumbrian slate roof. The Chapel was accessed by six stone steps from the outside and into the Chapel (1) where the porch height was 3.06m. The porch was painted white with two respecting perpendicular-style windows illuminated the room. The windows possessed red sandstone hoods with heavily weathered corbels. The windows measured 0.64m in width and 1.35m in height with lights measuring 0.26m in width and 1.09m in height (figure 19). A tongue and groove door was probably original with three mid-rails (figure 20)

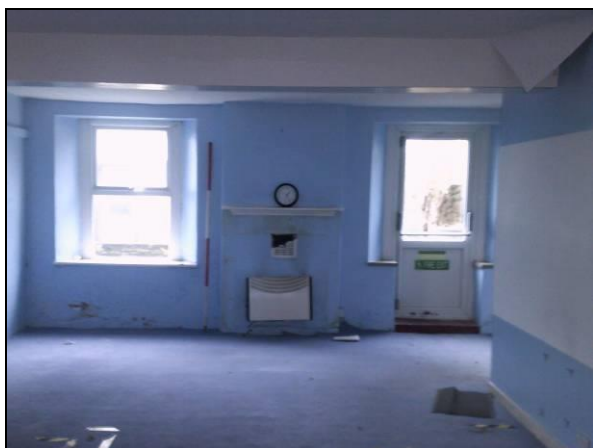
Figure 21. Meeting room looking west

A boxed-in fireplace was evident measuring 1.22m in width and 1.30m in height. The grate measured 0.95m in height and 1.05m in height (figure 21).

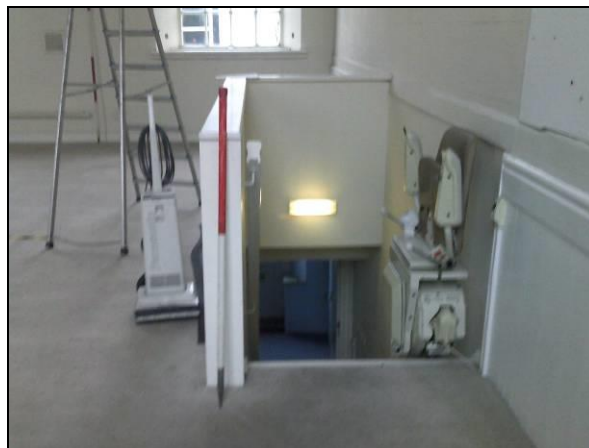
Figure 22. Stairs linking the floors

The room was accessed by a stair well from the Chapel (1) replete with stair lift. Twelve stairs 1.06m in width within stud walls formed the passageway (figure 22).

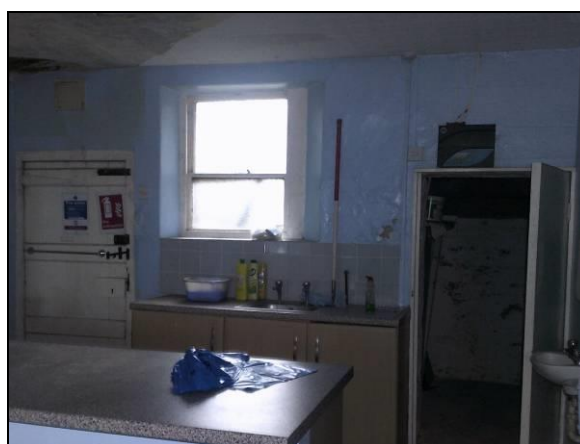
Figure 24. Kitchen (5)

The kitchen measured 3.77m in length and 2.51m in width with a ceiling height of 2.41m. The kitchen comprised modern appliances and surfaces illuminated by an opaque sash window measuring 0.75m in width and 0.96m in height. A tongue and groove door measuring 0.85m in width and 1.86m in height accessed the street (figure 24).

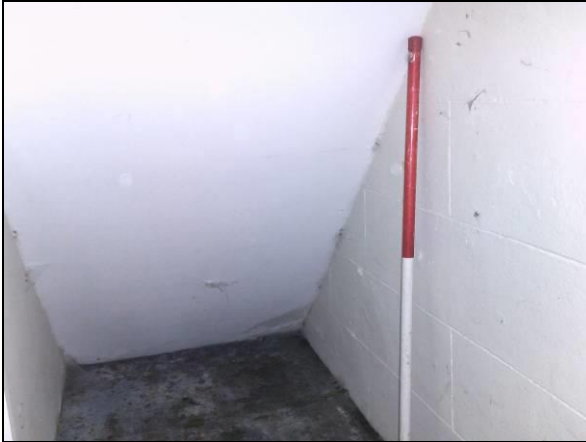
Figure 25. Store (6)

A cupboard formed from stud walls under the stairs measured 0.62m in width, 2.86m in length and was 2.38m in height (figure 25).

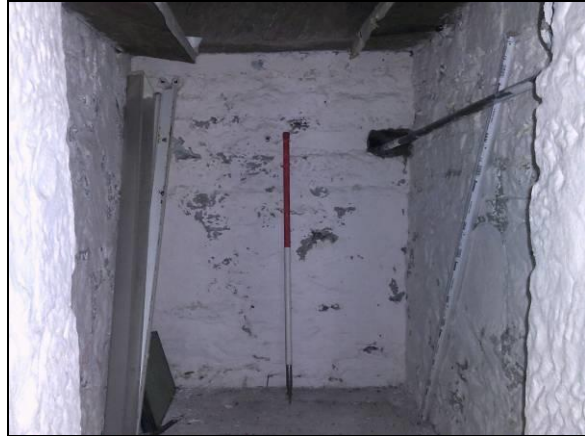
Figure 26 Pantry (7)

Under the porch, a pantry measured 2.23m in length, 1.21m in width and stood to a maximum height of 2.47m (figure 26).
