# **Preliminary Daytime Roost Inspection and Emergence/Re-entry Surveys for Bats at Arlecdon Farm, Arlecdon, Cumbria**

Survey to determine use of the buildings on site by bats

**Project:** Arlecdon Farm Survey

**Document Ref:** OP-ArlecdonFarm–BAT162v1

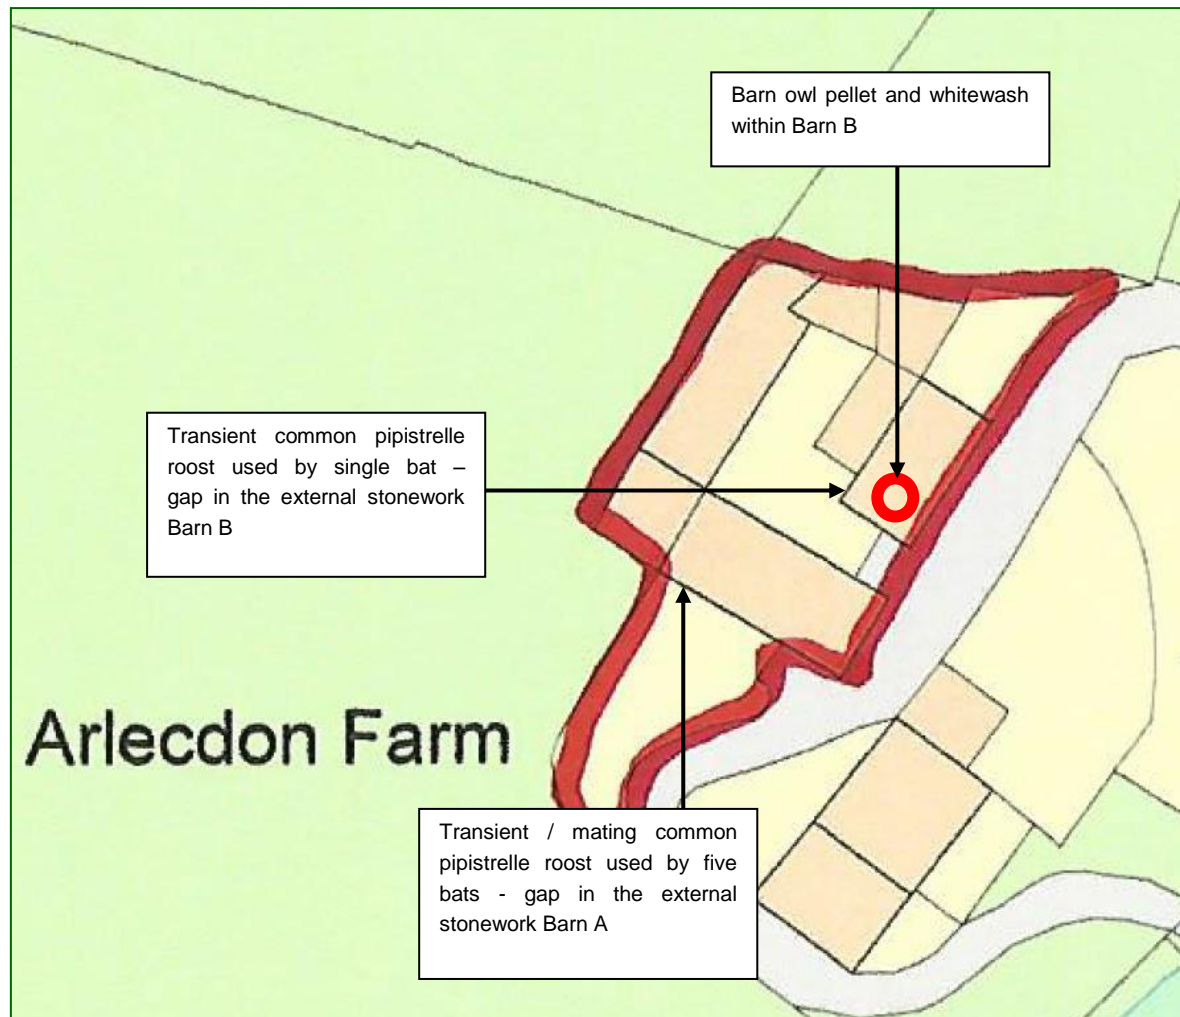
**Figure 3.3. Showing field evidence**

A single and very old, desiccated barn owl pellet and small amount of whitewash (droppings) were discovered within Barn B. No other field signs to indicate use of the buildings by barn owl were found.

Numerous old bird nests were observed within both main barns on site. An active swallow's nest *Hirundo rustica* was observed within the lower section of Barn B during the day survey. Starlings *Sturnus vulgaris* were observed entering gaps at the wall top to the Barn A and old jackdaws *Corvus monedula* nests were present throughout.

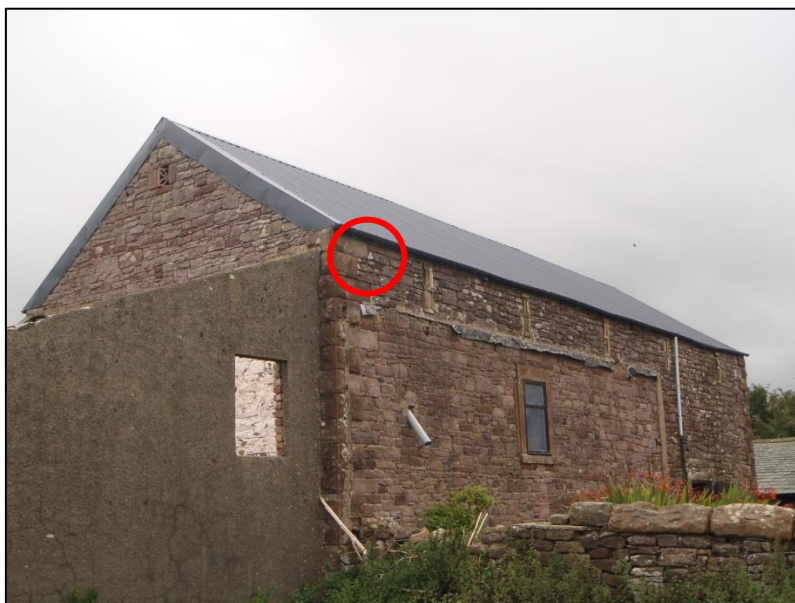
**Photo 1. Common pipistrelle bat roost – Barn A south elevation**

Between 19.09 and 19.44, five common pipistrelle bats **emerged** from the gap in the stonework south elevation Barn A. After a short period of activity on site, bats dispersed south / southwest.

The roost at Barn A (south elevation) was used by five common pipistrelle bats and the behaviour of the bats at this time of year indicates this may have been used as a mating roost. The roost was only used on one occasion (during the dusk survey) and so is considered to be a transitional roost.

- The identified roosts (crevices) must be retained. If pointing around these gaps is required this must be done under the guidance of a licenced ecologist.
- Any pointing works must commence during the bats' active season (1<sup>st</sup> April – 1<sup>st</sup> October) to avoid harming hibernating bats.
- Wall tops, crevices and wall cavities should be exposed with care.
- During any works to the buildings – along wall tops and during any stabilising / crack stitching etc any holes, crevices or cracks MUST be checked with a torch for any signs of bats.
- If the back of any cavity / crevice cannot be seen then the area should be left for 3 days in good weather (dry, calm, 10+°C) before the cavity is covered / filled.
- If bats are seen or suspected all work must pause and the acting ecologist be contacted immediately.

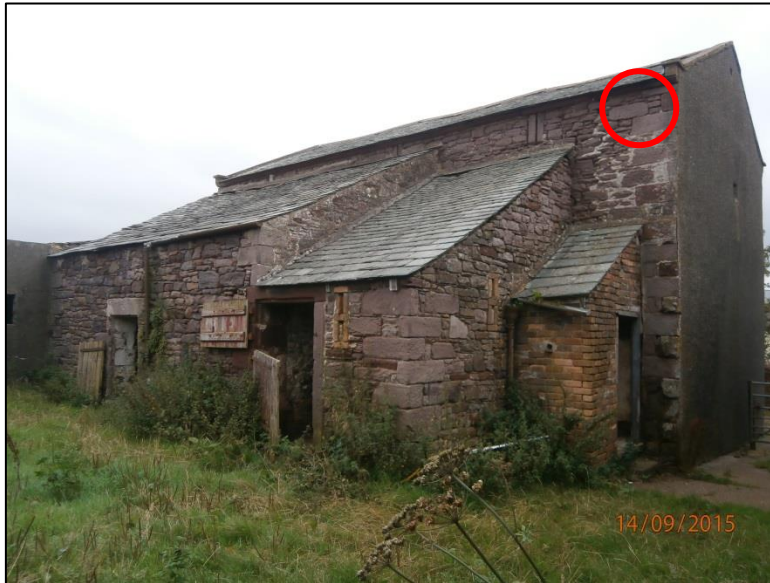
**Photo 2. Common pipistrelle bat roost – Barn B east elevation**

At 19.39, a common pipistrelle bat **emerged** from a gap in the stonework east elevation of Barn B.

The roost in Barn B was used by a single common pipistrelle during the dusk emergence survey (no entering bats were observed during the dawn survey) and it is considered to be an autumn transient roost.

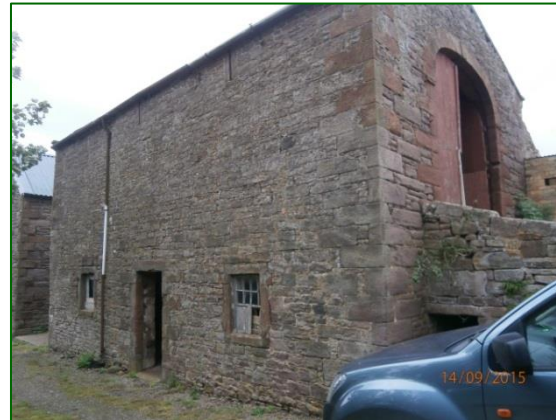
**Photo 2.** Barn B east elevation – potential in crevices throughout

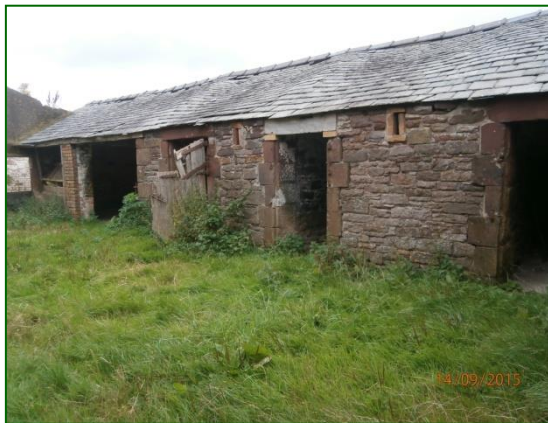
**Photo 3.** Potential in crevices and lintels to the byres – minimal works should be conducted and methodology adhered here

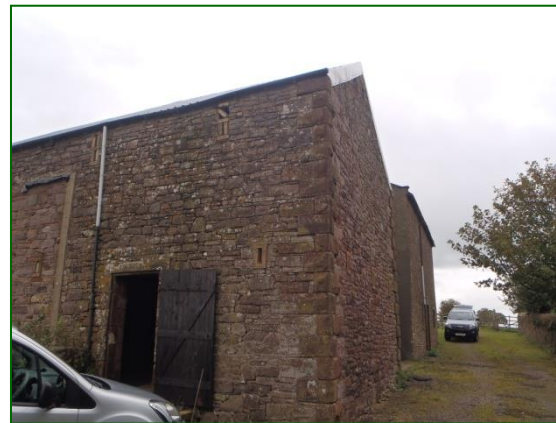
**Photo 4.** East gable to Barn A and track at east – used by commuting brown long eared bats (possible roost in farmhouse)
