# Cleator Moor Innovation Quarter

## INVASIVE NON-NATIVE SPECIES MANAGEMENT PLAN

784-B029668 - Rev 2

October 2021

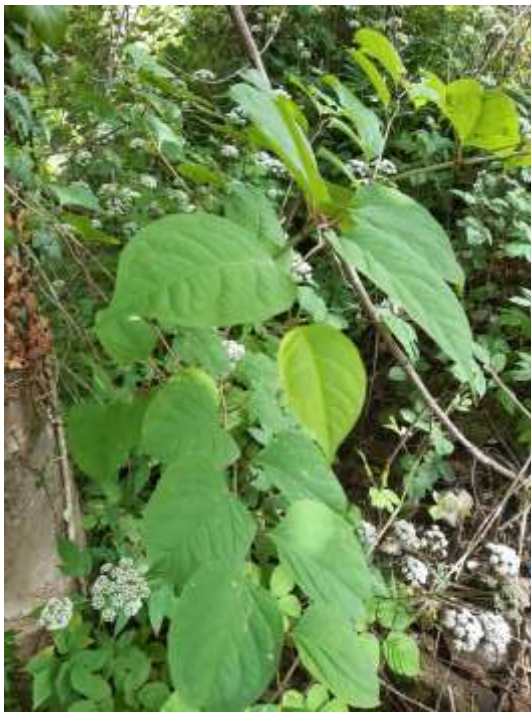
| Target Note | Description | Photograph |
|---|---|---|
| 1 | <p>Japanese Knotweed <i>Reynoutria japonica</i></p> <p>Identified on the bund near the fence and spreading down the bank including behind the sycamore tree. Grid reference NY 01536 15370</p> <p>Also identified on the edge of track with potential to spread into woodland. Grid reference NY 01527 15379</p> <p>A bare area was identified where Japanese knotweed has been sprayed treated. Some regeneration found, with small plants spread to the bare ground opposite the initial area. Grid reference NY 01522 15381</p> | |

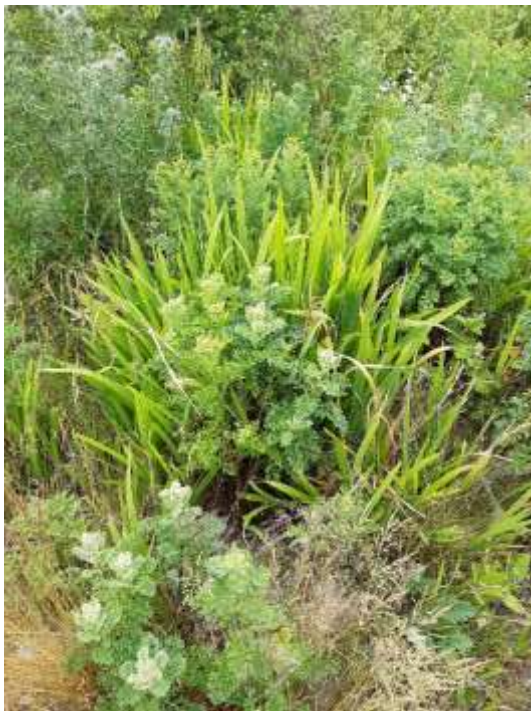
| Target Note | Description | Photograph |
|---|---|---|
| 2 | <p>Montbretia <i>Crocasmia x crocosmiiflora</i></p> <p>Montbretia had spread within other flora of at least 8 plants. Grid reference NY 01542 15369</p> <p>Several stands spreading down the slope into woodland area. Grid reference NY 01541 15364</p> <p>One stand currently not flowering. Grid reference NY 01565 15369</p> <p>Identified within the woodland. Grid reference NY 01541 15376</p> <p>Several plants located near building to the west of Site A. Grid reference NY 01360 15601</p> <p>Several plants located on a pile of soil to the west of Site A. Grid reference: NY 01385 15586</p> <p>Several plants on mound of refugia to the west of Site A.<br/>Grid reference: NY 01415 15580</p> | |

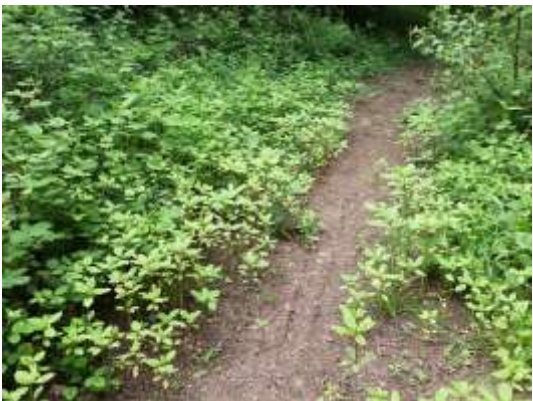
| 3 | <p>Himalayan Balsam <i>Impatiens glandulifera</i></p> <p>Extensive stand located at grid reference NY 01474 15678</p> <p>Additional strand located at grid reference NY 01435 15665</p> | |

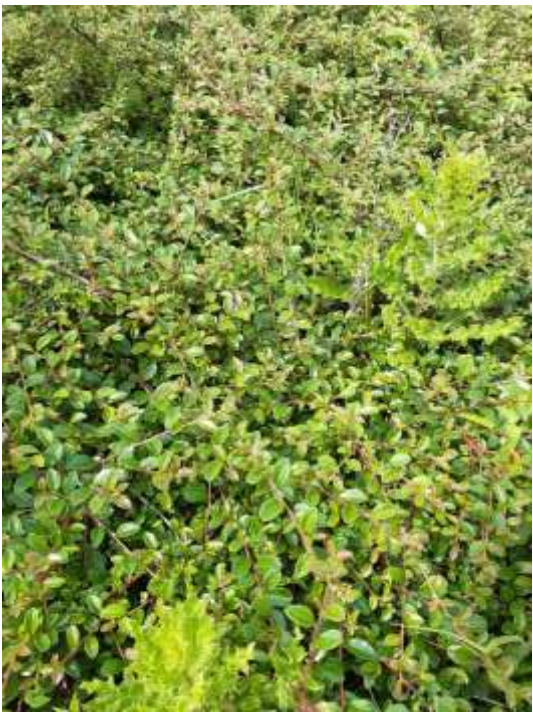
| 4 | <p>Cotoneaster Hollyberry <i>Cotoneaster bullatus</i></p> <p>Multiple strands identified located at, grid references: NY 01630 15585, NY 01712 15594.</p> <p>Additional strand identified on the edge of the building located to the west of Site A, grid reference: NY 01412 15578</p> | |

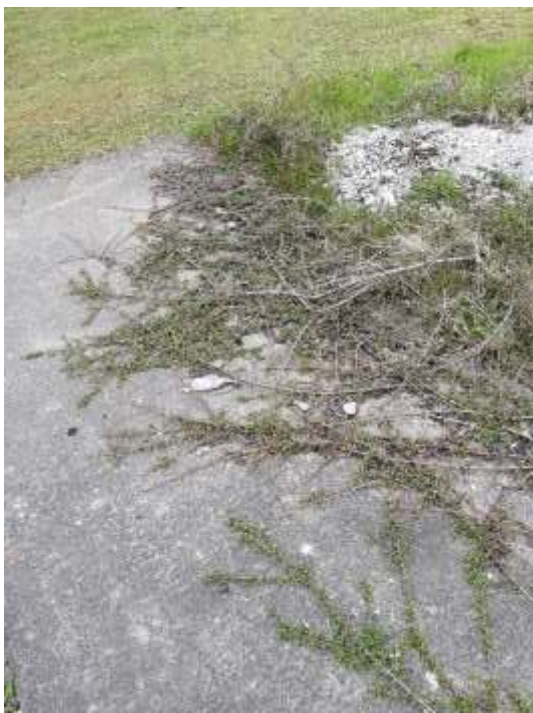
| 5 | <p><i>Cotoneaster horizontalis</i></p> <p>Multiple strands identified located at grid references:<br/>NY 01724 15566,<br/>NY 01736 15553,<br/>NY 01743 15510</p> | |
