Cleator Moor Innovation Quarter – Unit 1A

BAT ROOST ASSESSMENT REPORT

784-B034942 Rev 2

Copeland Borough Council

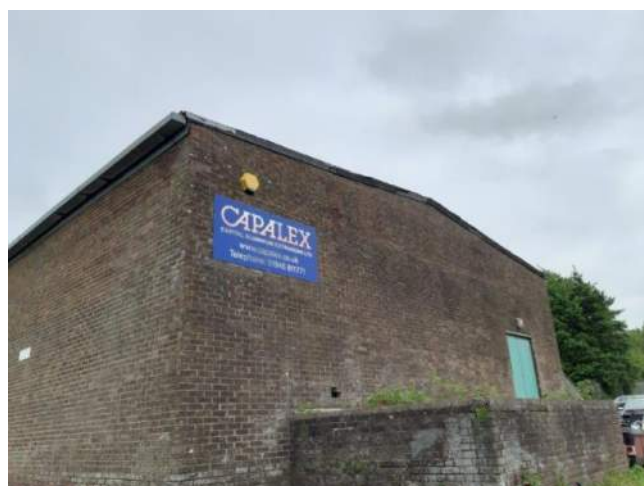
Photograph 1 – Western corner of Unit 1A on Leconfield Street

Unit 1A comprised a tall brick-built building with a slight double pitched roof finished with bitumen (see Photograph 1).

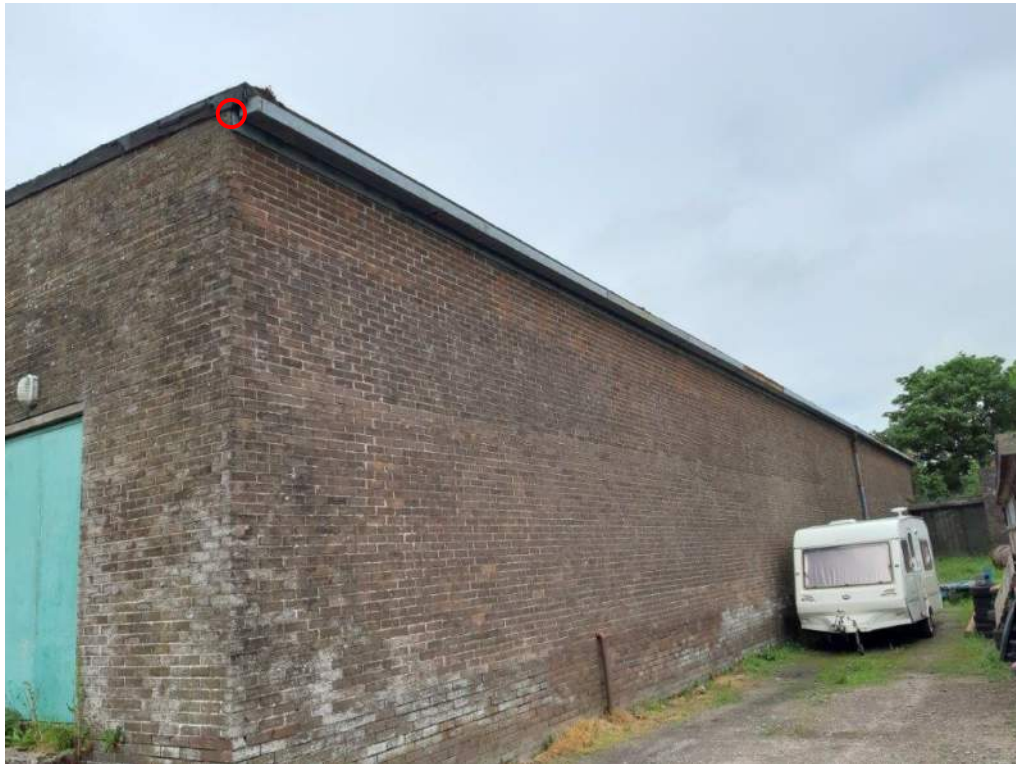
Photograph 2 - Roost 1, Unit 1A

During the dusk emergence survey, a single common pipistrelle bat was observed emerging from the gap between the brick wall top and the wooden fascia / bitumen roof overlap on the southern corner of Unit 1A at 21:42, (22 minutes after sunset. (See Figure 2, Roost R1 and Photograph 2 below)).

During the dawn re-entry survey a single common pipistrelle re-entered a gap along the southern corner of the roof of building Unit 1A at 06:09 (12 minutes before sunrise). This was the same roost location as identified during the dusk emergence survey on 29th July (Figure 2, Roost R1).

Roost R1 was located at the southern roof corner to B6, with a single egress point gap between the brick wall top and the bitumen roof overlap. A single common pipistrelle was observed using this roost on two occasions (during the dusk emergence survey on 29th July 2021 and during the dawn re-entry survey on 10th September 2021) (see Photograph 2 and Figure 2).

The development proposals, in particular the recladding of the roof will directly impact on Roost R1 through destruction of the roost resulting in permanent loss of a low conservation significance roost (of a common, widespread species).

As the proposed works will result in the destruction of one common pipistrelle day roost (R1) within Unit 1A, an EPSML must be obtained from NE to permit the refurbishments works to Unit 1A and compensate for the roosting feature lost.

The roost will be subject to a pre-check with endoscope prior to any works commencing on site. Following the inspection, the identified bat roost will be subject to destructive search under the close supervision of the EPSML Named Ecologist or an Accredited Agent. The bitumen roof overlap to Unit 1A will be removed by hand in anticipation that bats may be present.

It is also recommended that cladding and re-roofing activities conducted on the south-eastern elevation of Unit 1A are conducted under the supervision of a licensed bat ecologist under the EPSML. As compensation, one bat box such as Schwegler 1FF (or equivalent) will be installed in a similar position to the existing roost (i.e. south west corner of Unit 1A). This must then be retained intact and in situ for a minimum of five years.

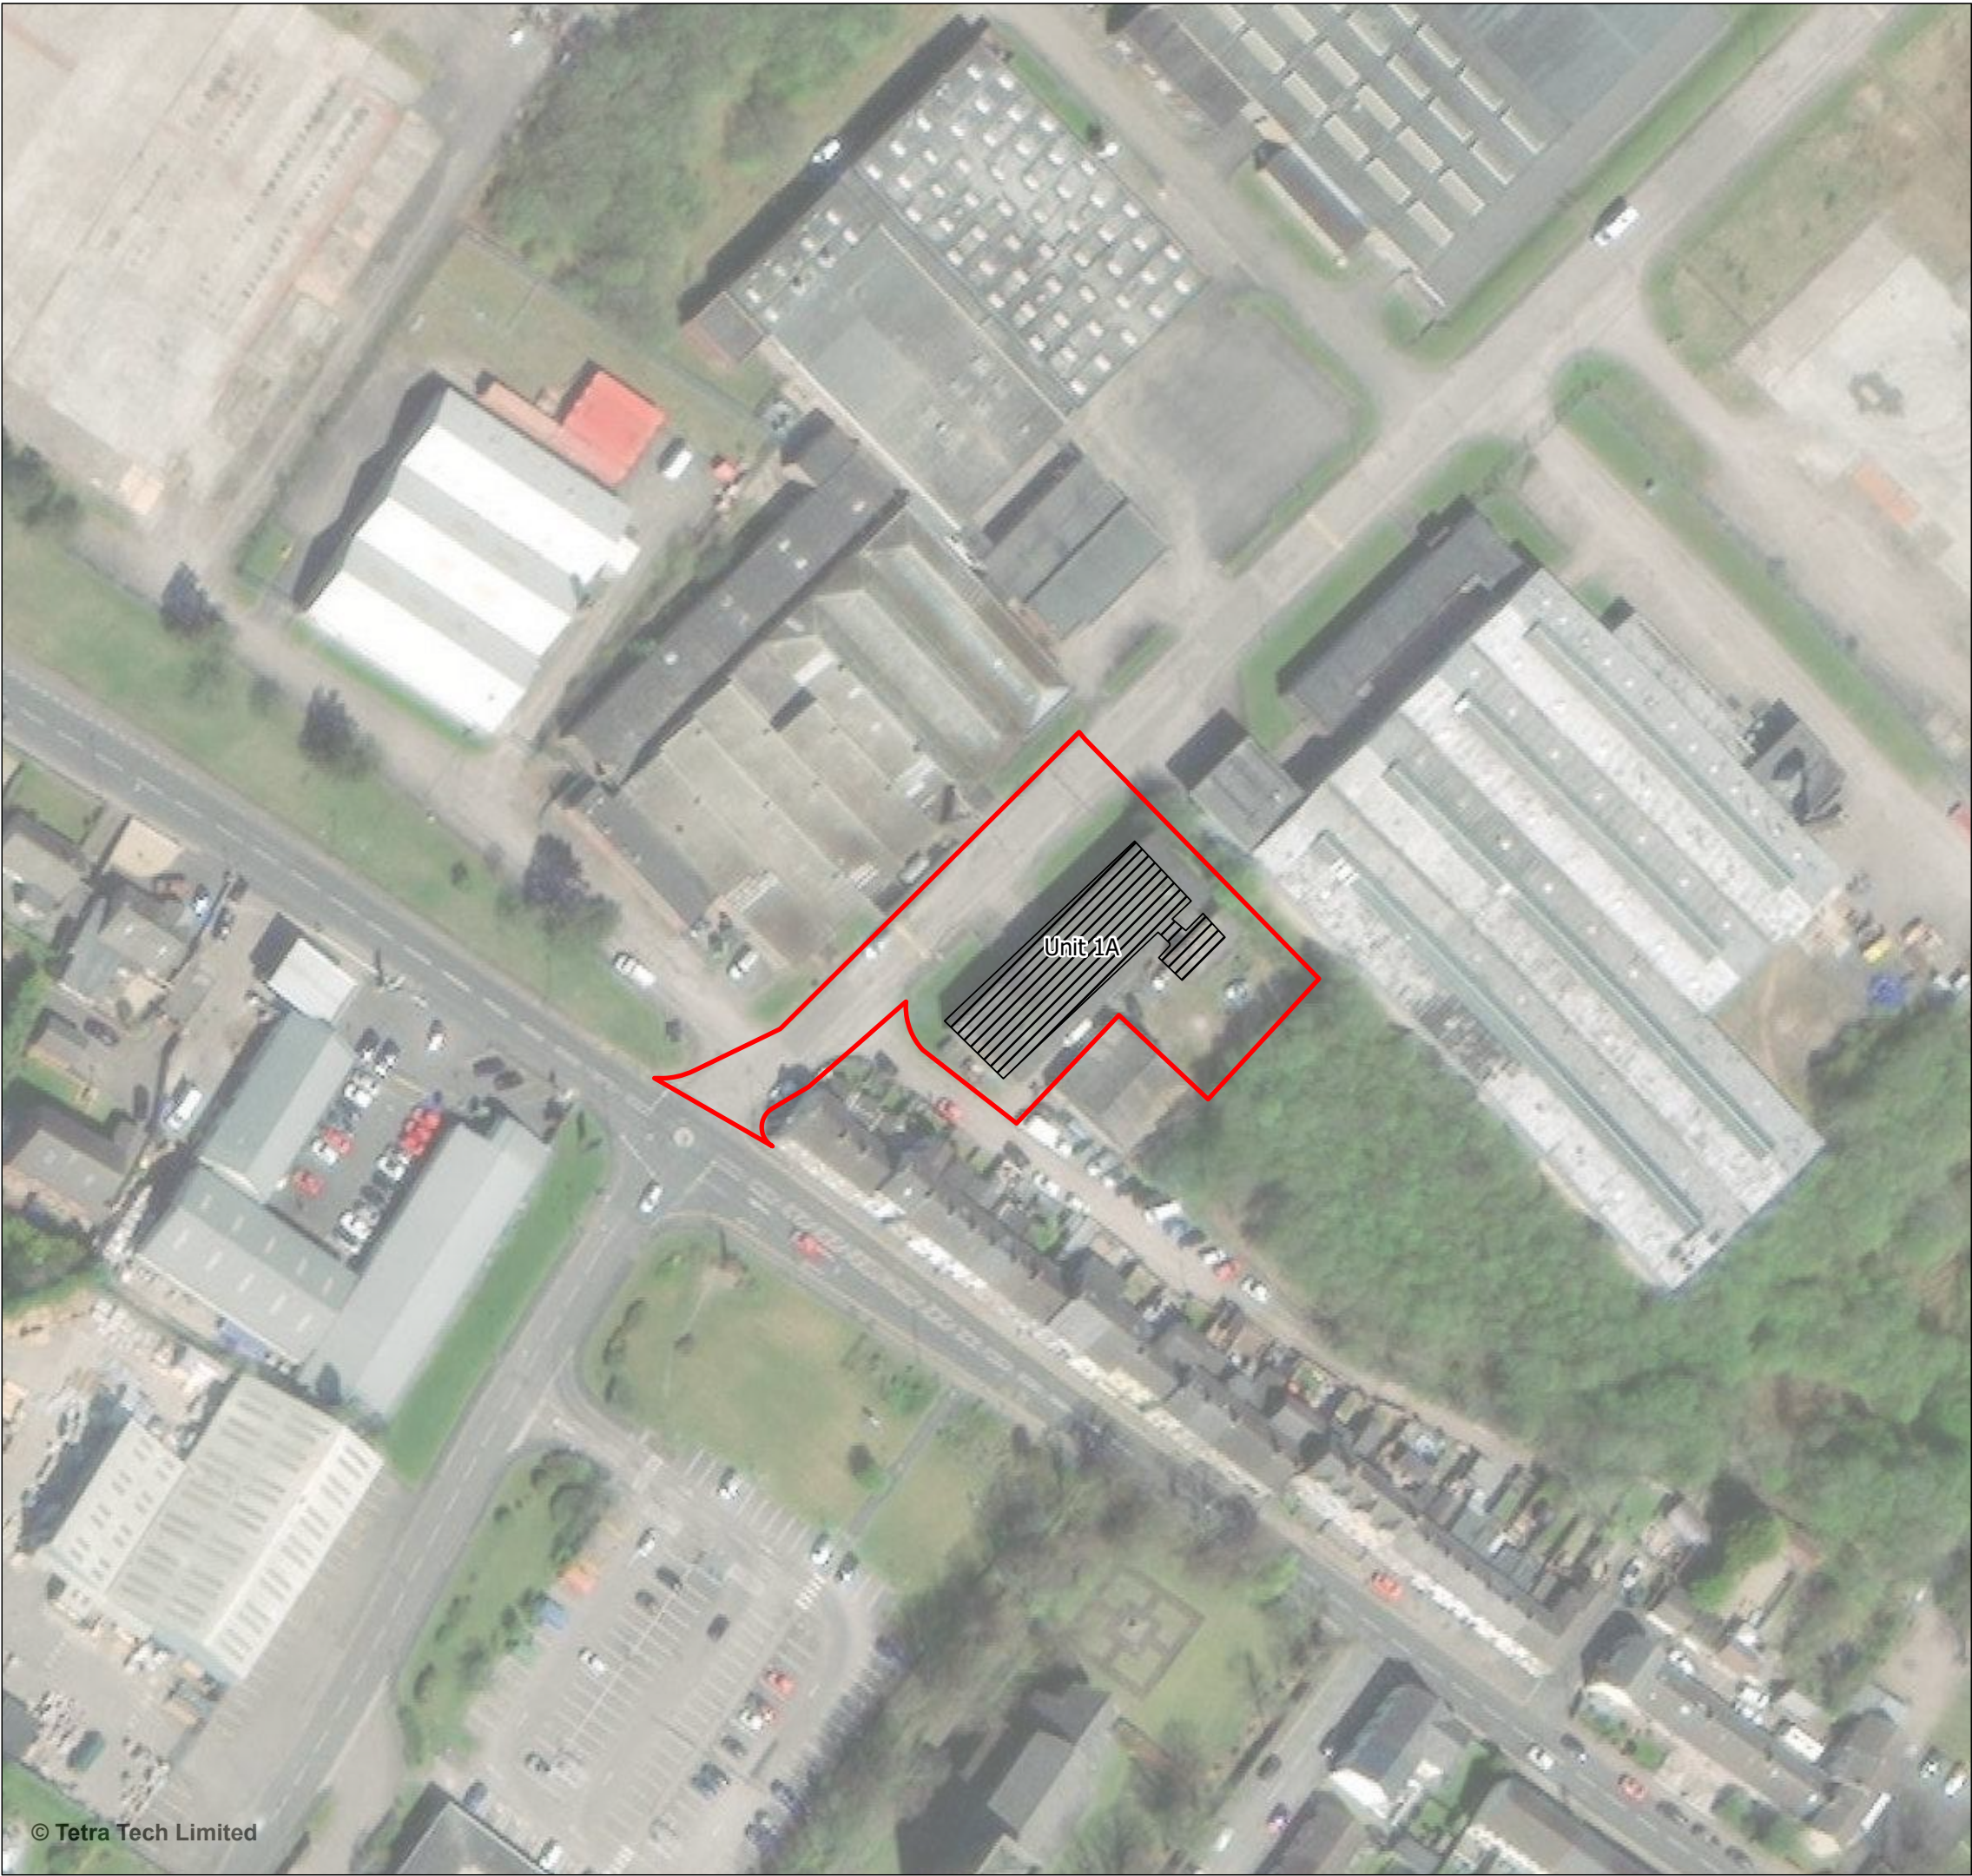
Site Location Plan

CMIQ Proposed Hub - Unit 1A

Unit 1A is located in Cleator Moor and is centred at Ordnance Survey National Grid Reference NY 01491 15430 – see Figure 1 for site location plan.

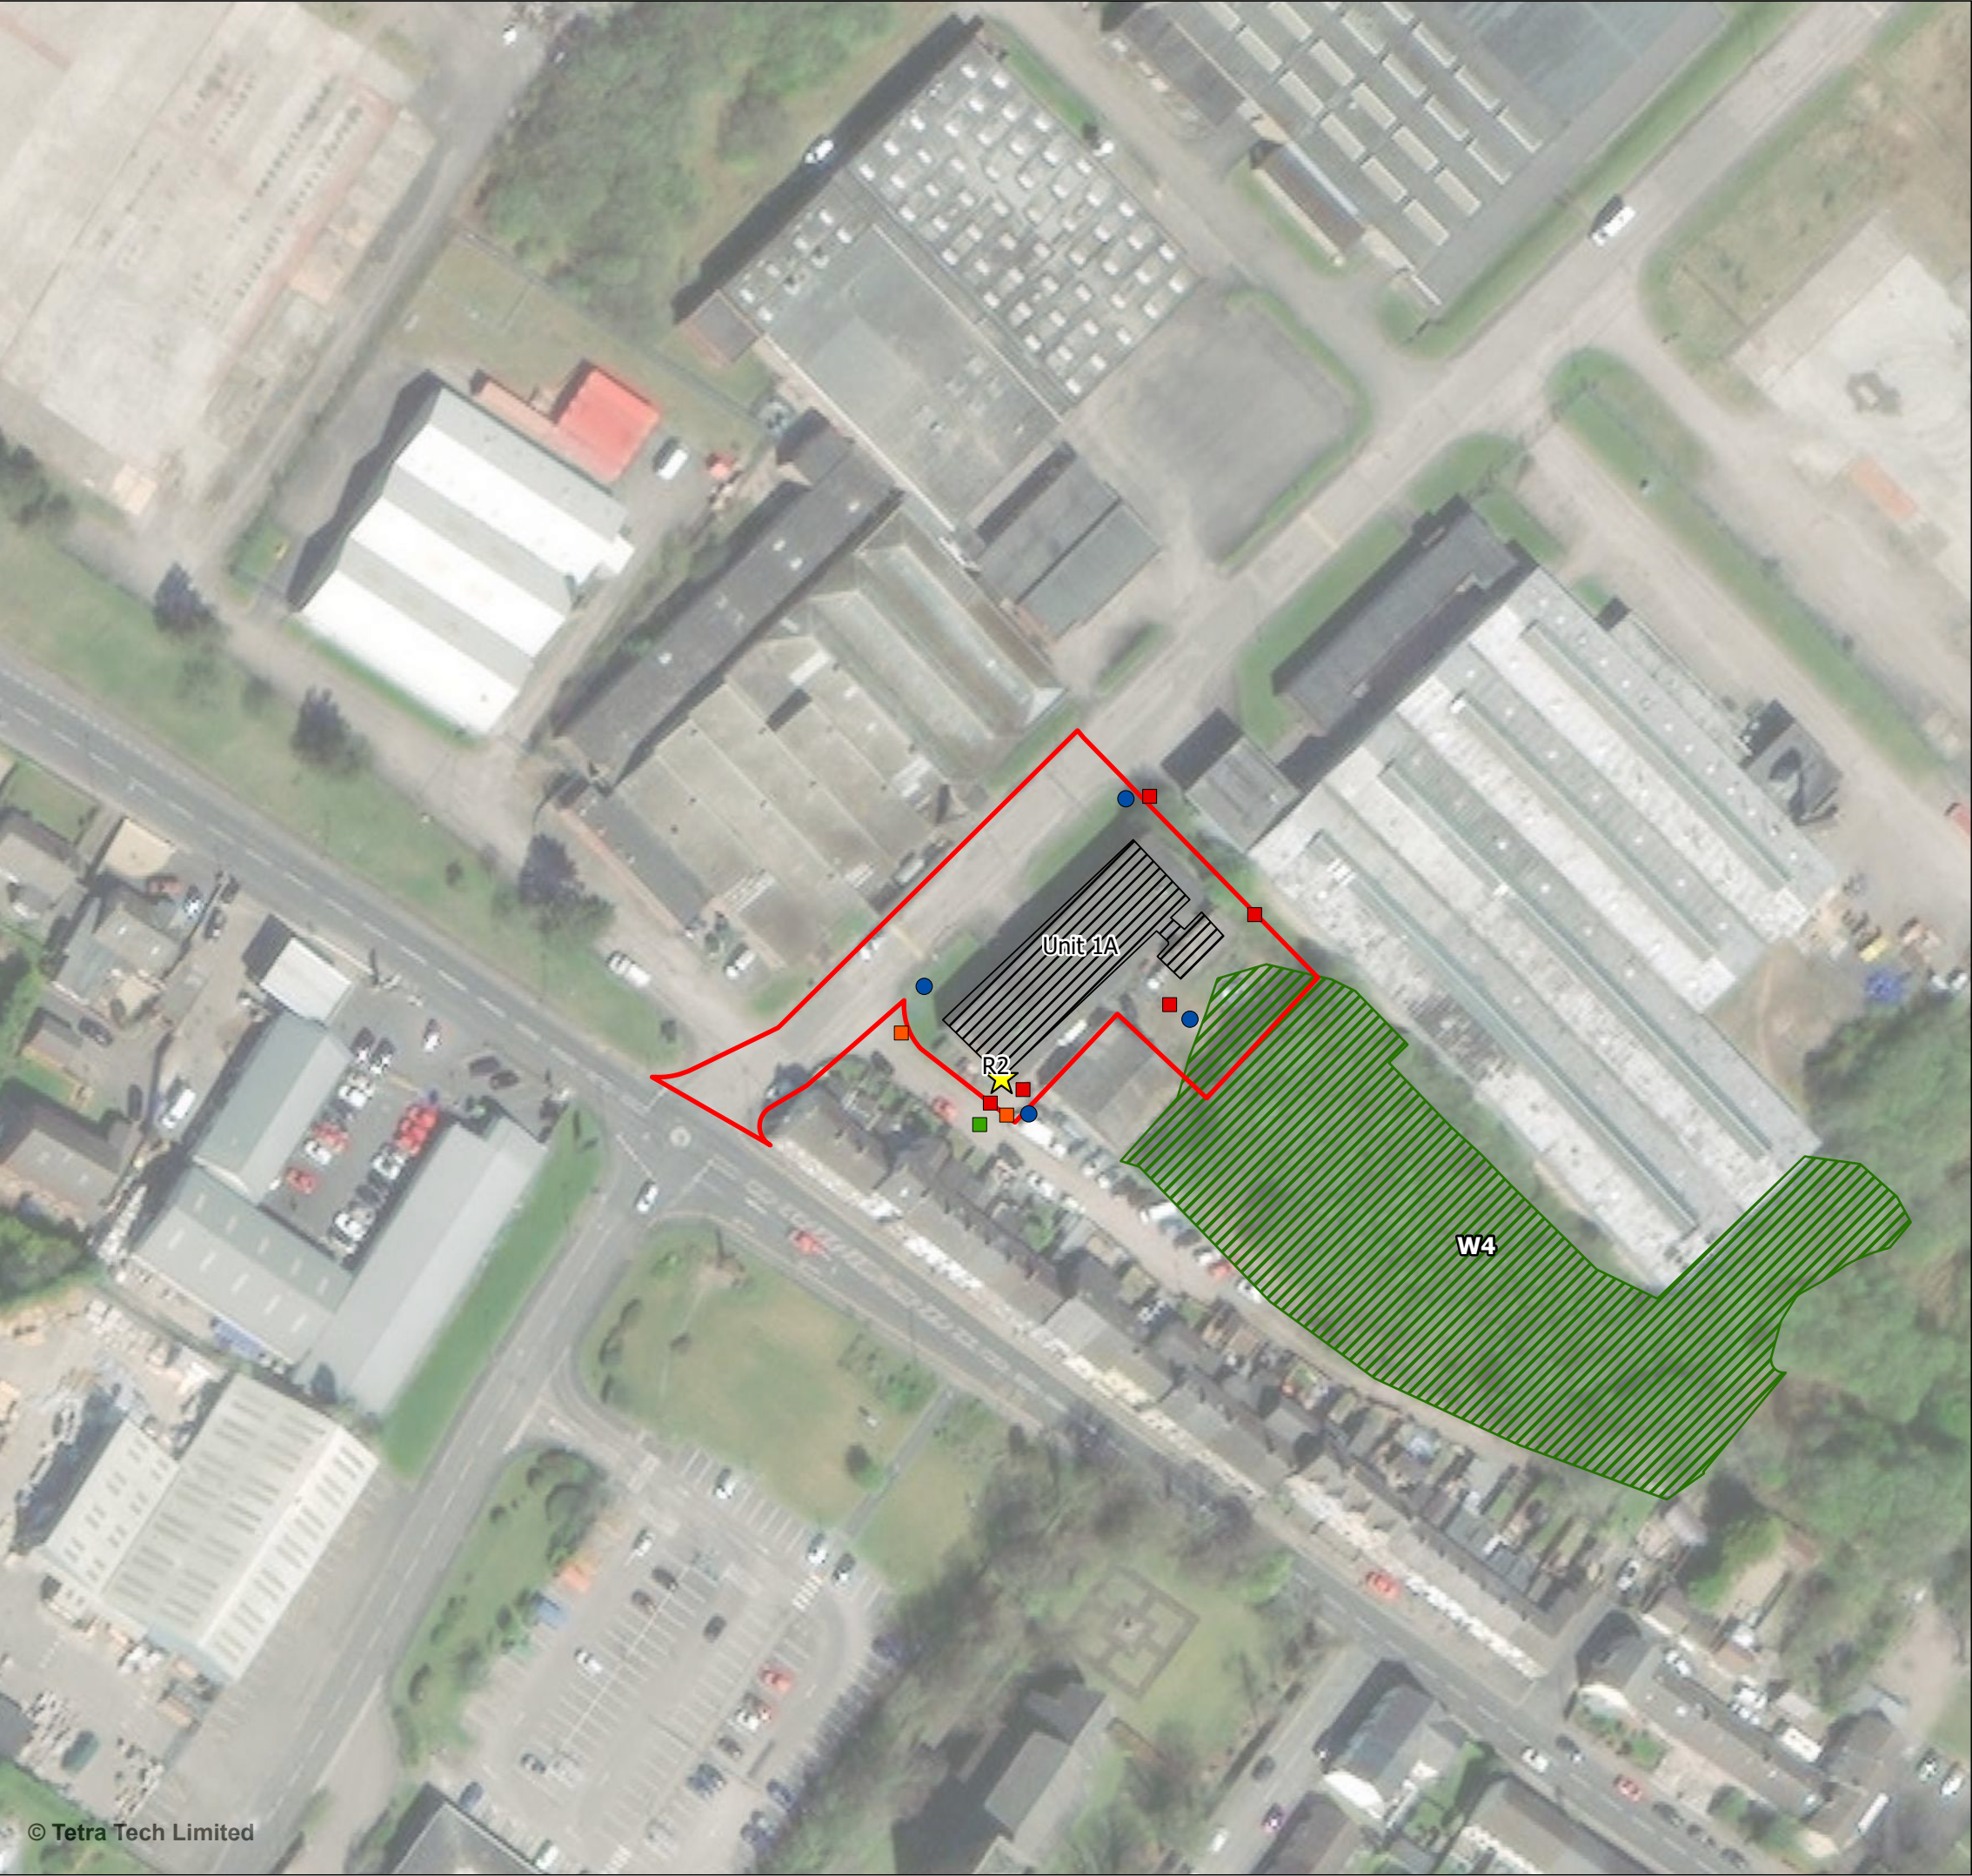
Figure 2 – Bat roost and ground level bat tree assessment summary map

The dusk emergence survey commenced 15 minutes before sunset and continued for 1.5 hours after sunset. The date, type and personnel involved in each of the surveys are provided in Table 1. Table 2 summarises the survey times and weather conditions. Surveyor locations are shown on Figure 2.

Bat roost and ground level bat tree assessment summary map

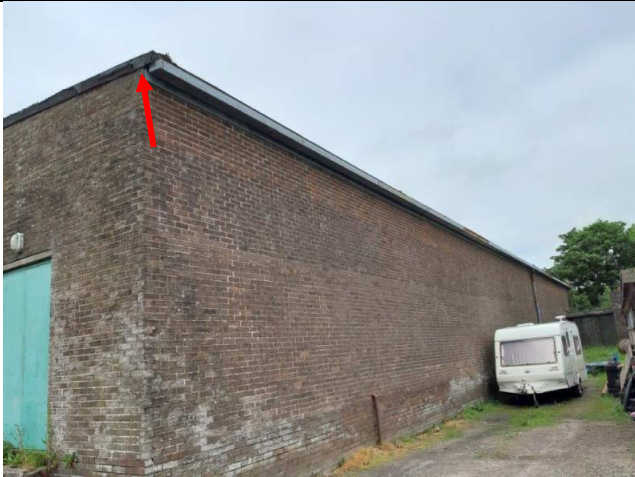
Building Reference	Roosting Features / Description	Photo
1A	Gaps behind wooden fascias and bitumen roof overlaps; occasional gaps in the brickwork – all elevations. Low suitability.

Other PRFs identified during the building assessment survey (gaps in brickwork, etc) will be lost following repairs to the brickwork.

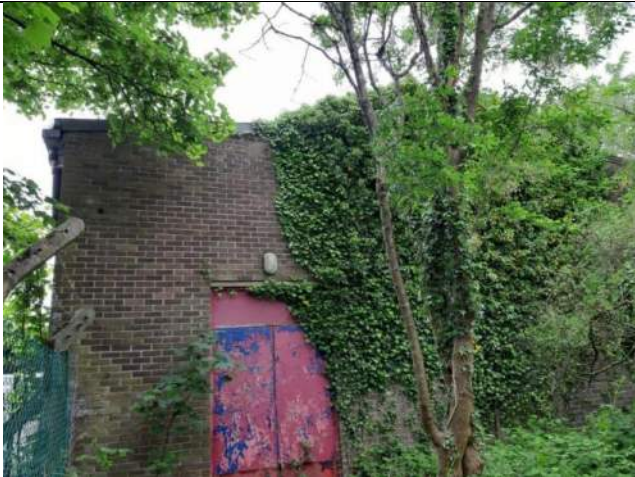
1A	Potential gaps in the brickworks / roof top concealed by ivy along the northern elevation. Low suitability

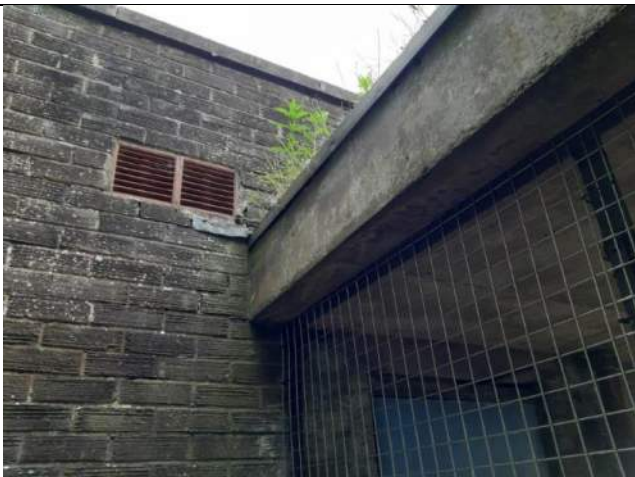
1A	Small extension to the east. Occasional gaps in the brickworks and above the doors; ventilation gaps and few areas with gaps behind flashing overlap. Low suitability.
