# Meadow Road, Whitehaven

## Phase 2 Ground Investigation Report

Curtins Ref: 067983-CUR-00-XX-RP-GE-001

Issue Date: 02 July 2018

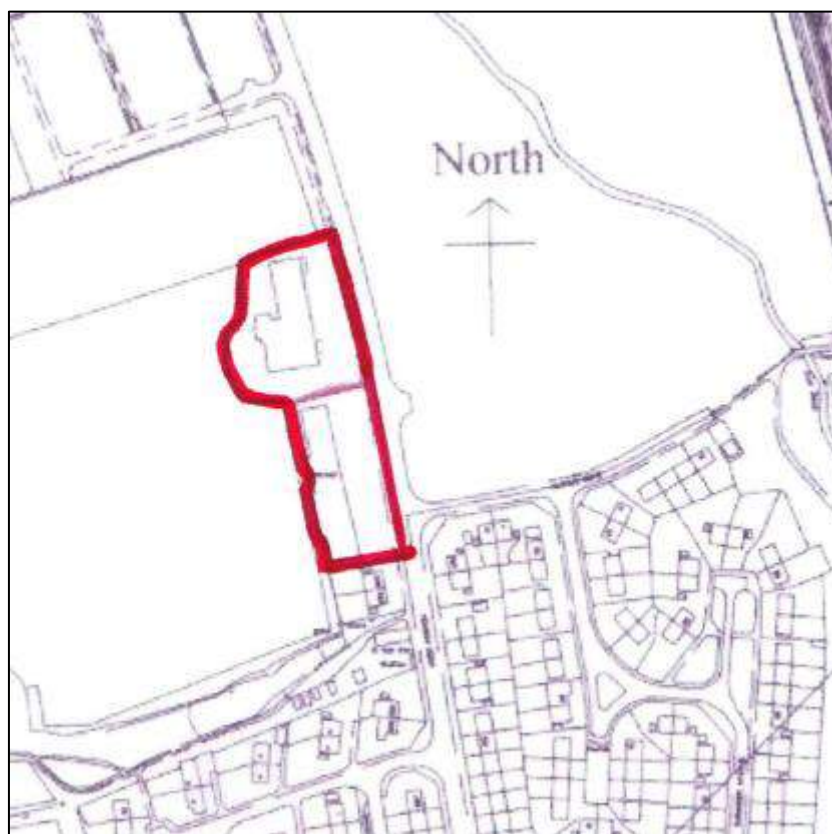
**Figure 2.1** Site Location Plan.

*Approximate development site boundary identified in red.*

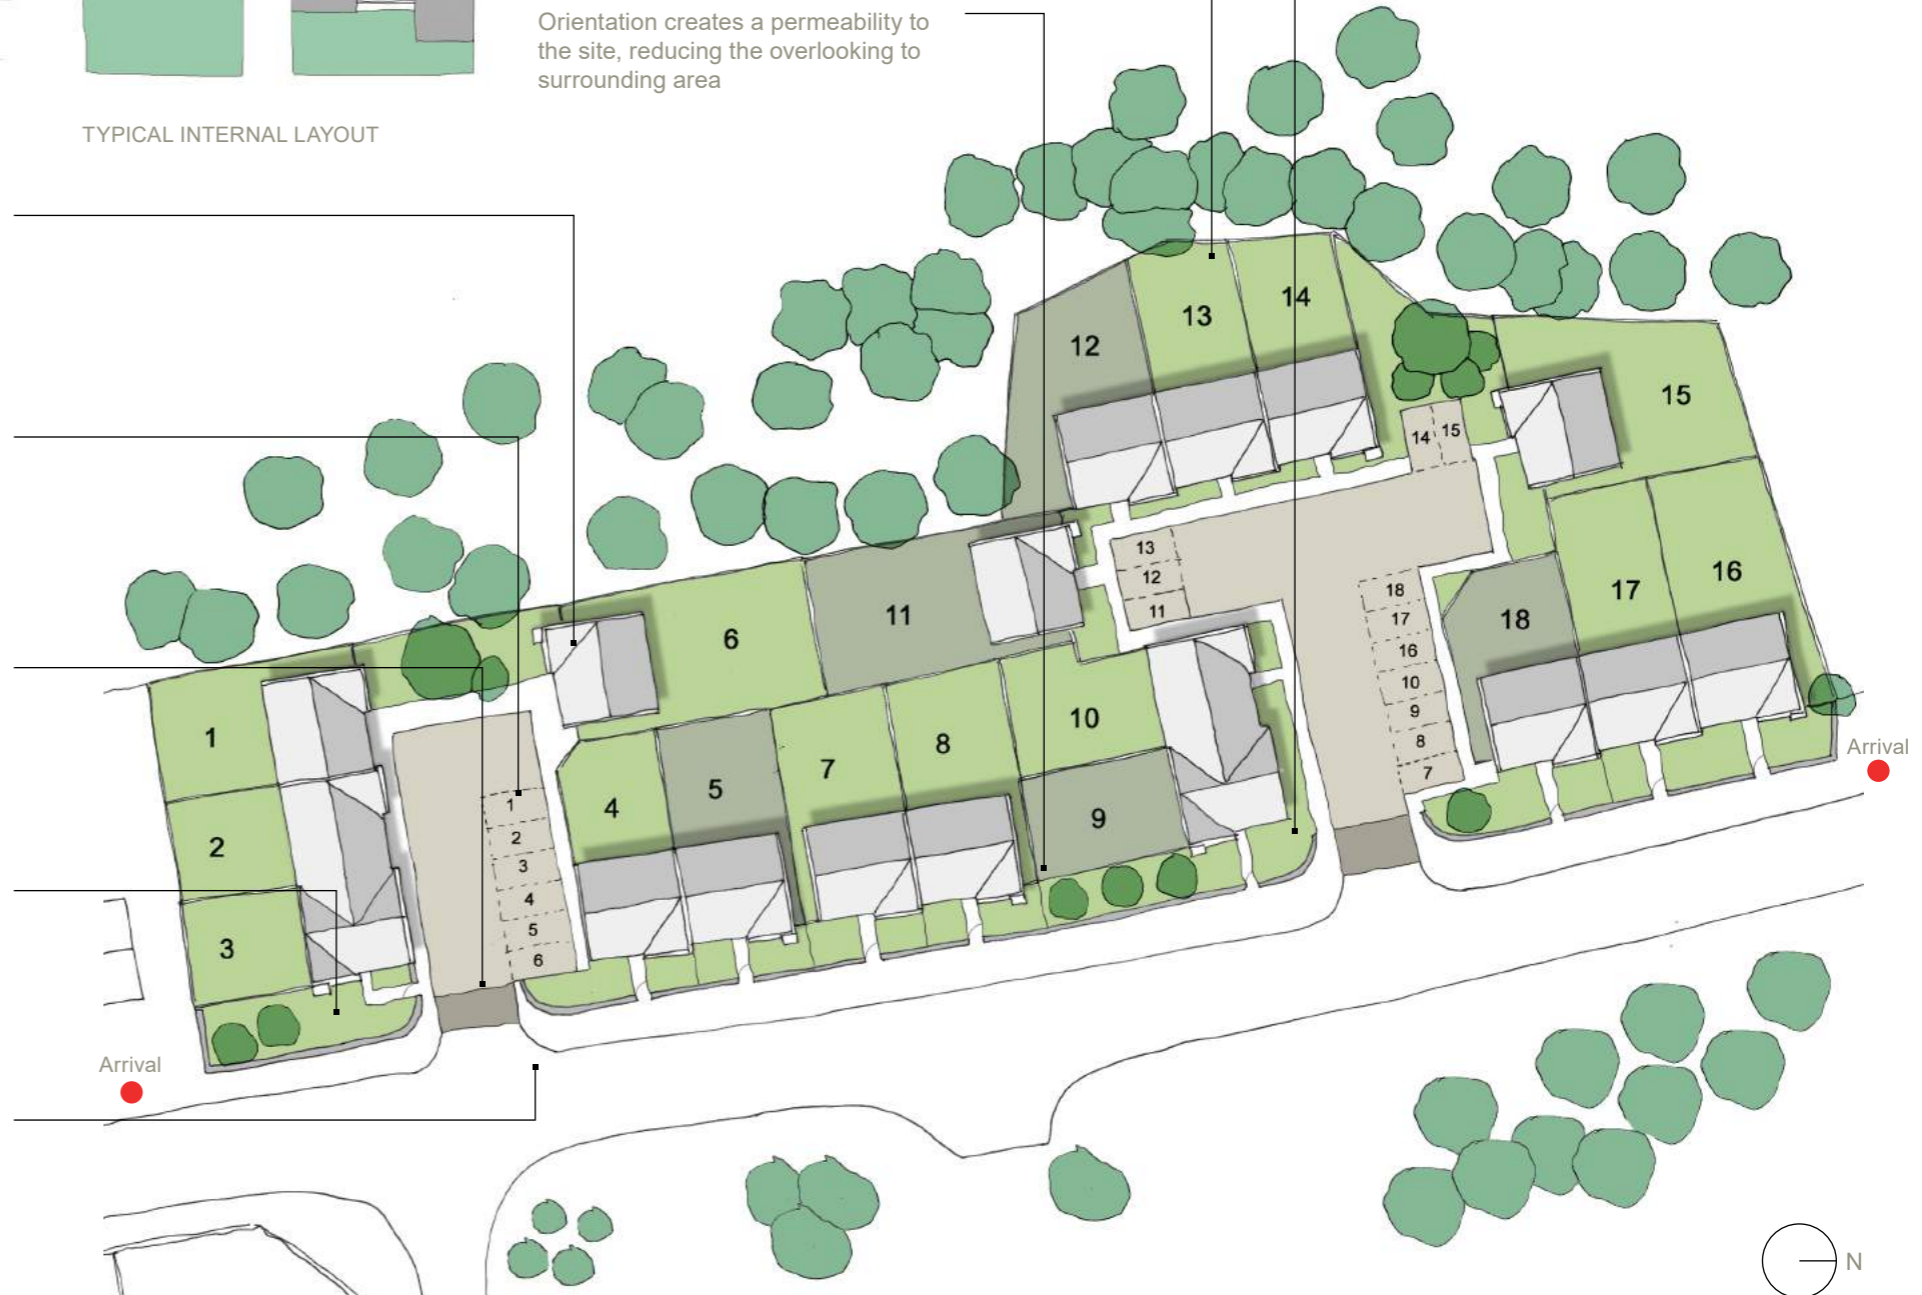
SITE LAYOUT PLAN

Orientation creates a permeability to the site, reducing the overlooking to surrounding area

Positioning of dwellings re-activates the street frontage enhancing the visual appearance of the site and surrounding landscape
