# **Protected Species Survey:** **Bats and Barn Owls**

Barwickstead  
Beckermot  
CA21 2YA

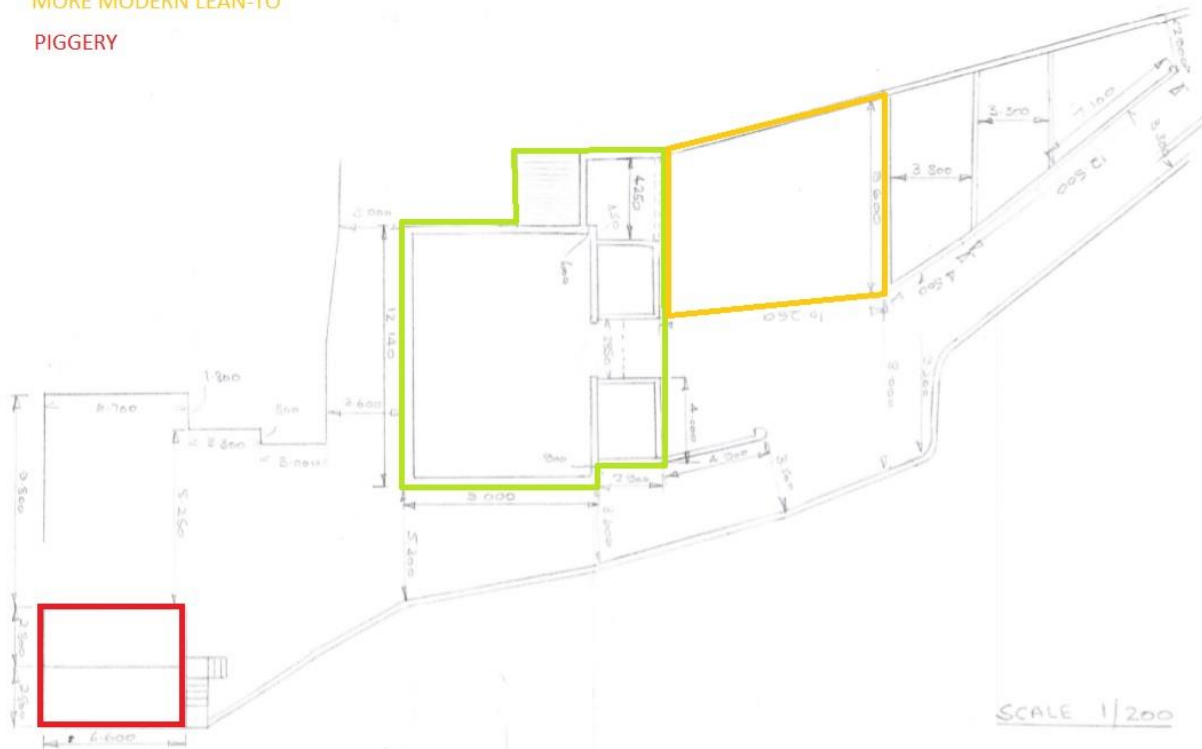
## A1) Plan of Site:

MAIN BARN, BYRES AND  
WASHHOUSE  
MORE MODERN LEAN-TO  
PIGGERY

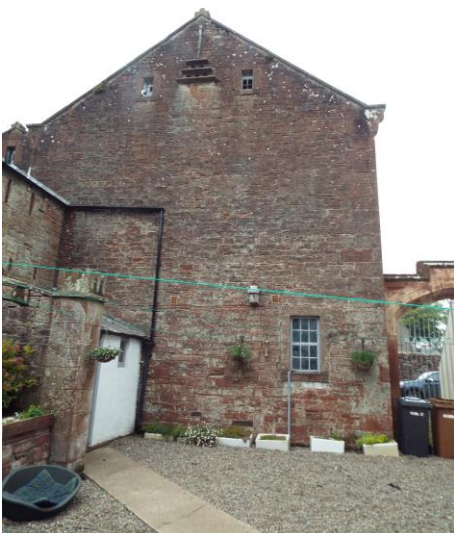
**Rear Gable of Main Barn**

This is a two-storey sandstone-built bank barn. It is well pointed with a slate roof and daubing. The barn faces north-east towards the road. There is a large pigeon loft incorporated into the southern end of the roof space. The lower storey consists of byers, stables and a washhouse.

Although the roof of the large bank barn appeared to be suitable habitat, no signs of bat use was found. The roofs of the other two buildings had less areas of suitable habitat.

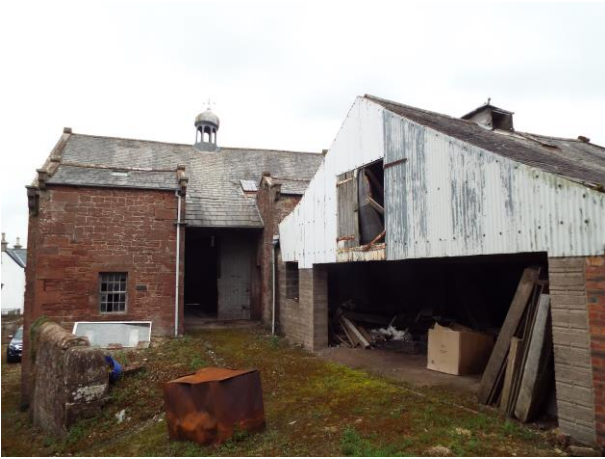
## Lean-to on Rear of Barn

This building faces north-west and has three aspects which are the original sandstone walls. The front aspect is breezeblock and tin-sheeting. It has a slate roof with daubing.

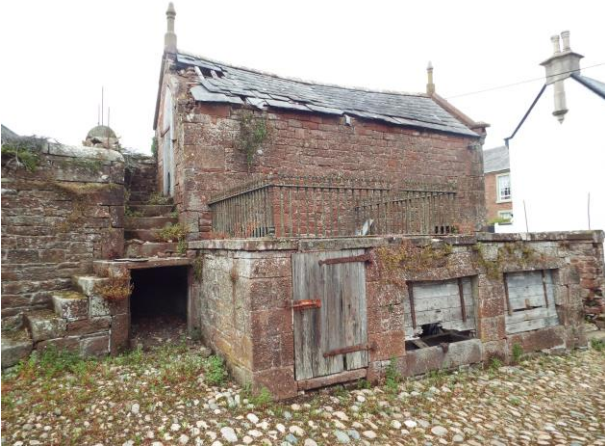
## The Piggery – Front

This is a small, sandstone-built building which faces south-east in to the yard. It is rendered on the north-eastern gable and well pointed on all other aspects. It has a slate roof with daubing which is in a state of disrepair.
