# **BAT, BARN OWL AND NESTING BIRD SURVEY REPORT**

**Gill House Farm, Egremont**

**Preliminary Roost Assessment and Presence / Likely Absence  
Surveys for Bats, Barn Owls and Nesting Birds**

**July 2026**

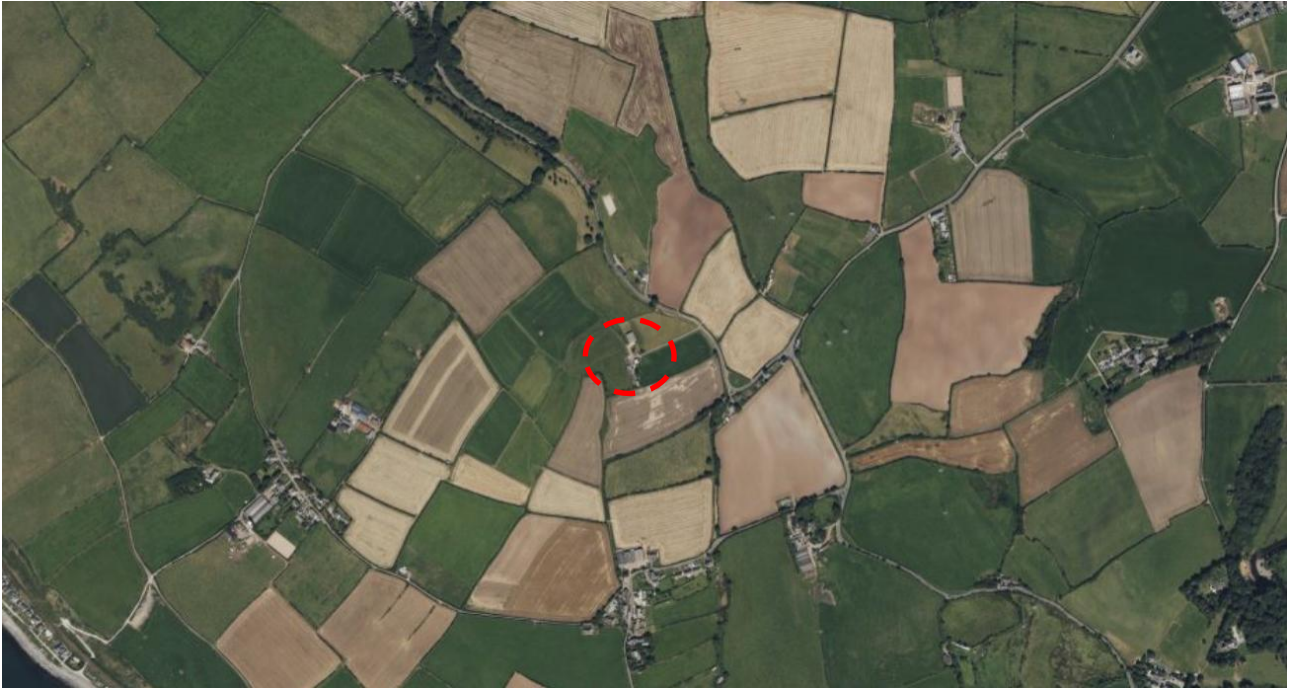
**Figure 4** *Habitat on and adjacent to the site*

The site is in an elevated and exposed location amongst open agricultural fields and in close proximity to the West Cumbrian coast. The surrounding landscape is a mosaic of pastoral and arable fields and whilst there are small hedgerows and scattered trees offering limited potential, there are no high quality foraging habitats or strong linear features

The habitat on and adjacent to the site identified from satellite images was ground-truthed. Details of the habitats found on and adjacent to the site are detailed in Figure 4.

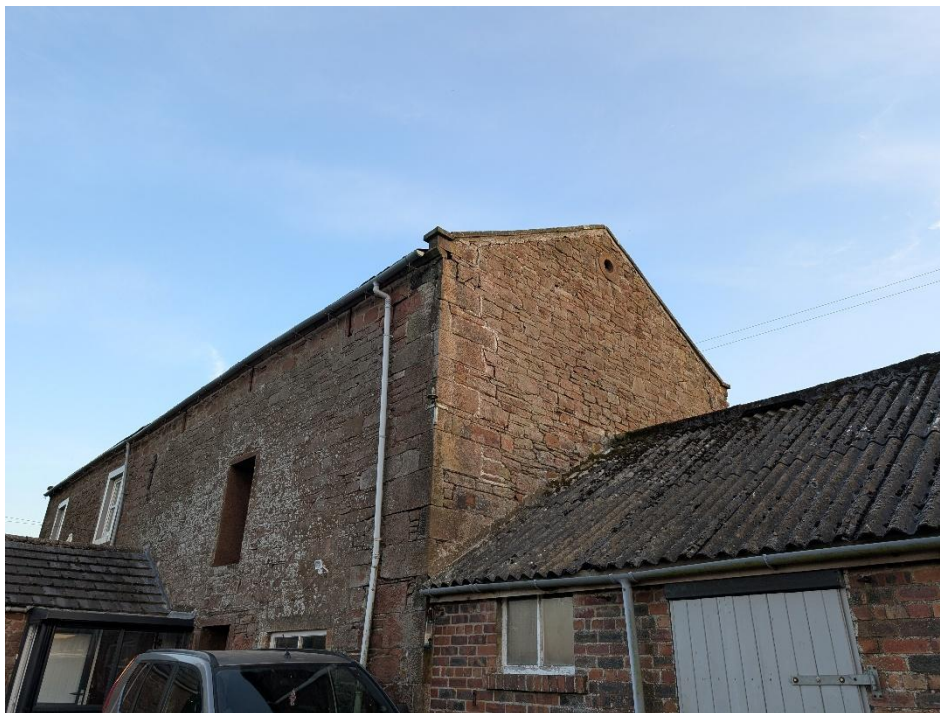
Building 1 is an agricultural barn constructed of red sandstone under a pitched slate roof. The ridgeline is orientated approximately North-South. The building adjoins a farmhouse to the South which is not subject to alteration under the proposals. The walls of the farmhouse are rendered and the roof is constructed of concrete tiles which are very tightly fitted. Whilst the farmhouse was not surveyed comprehensively, it does not appear to offer significant roosting potential for bats. To the North, Building 1 adjoins a single storey agricultural building, Building 2, which is considered in the subsequent section.

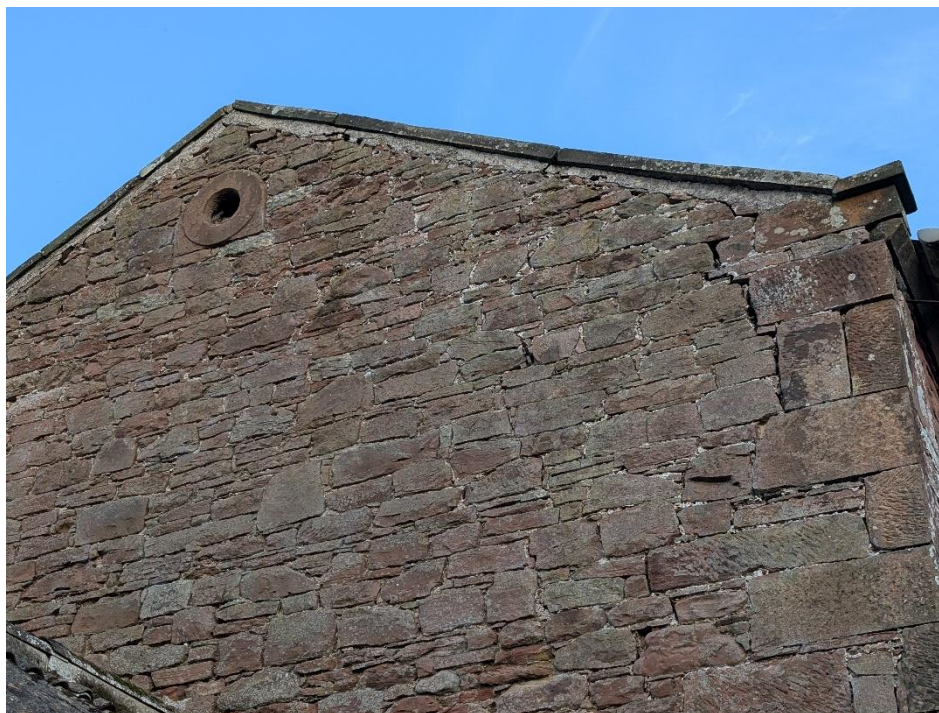
The building is built from red sandstone and is unrendered. The lime pointing is missing or recessed in numerous places to leave crevices of varying size, some of which would be suitable for crevice dwelling bats. There are also several large cracks in the North-facing gable end which

would provide further potential roosting locations. Inspection with a high powered torch found no internal or external indications of use, such as droppings or staining.

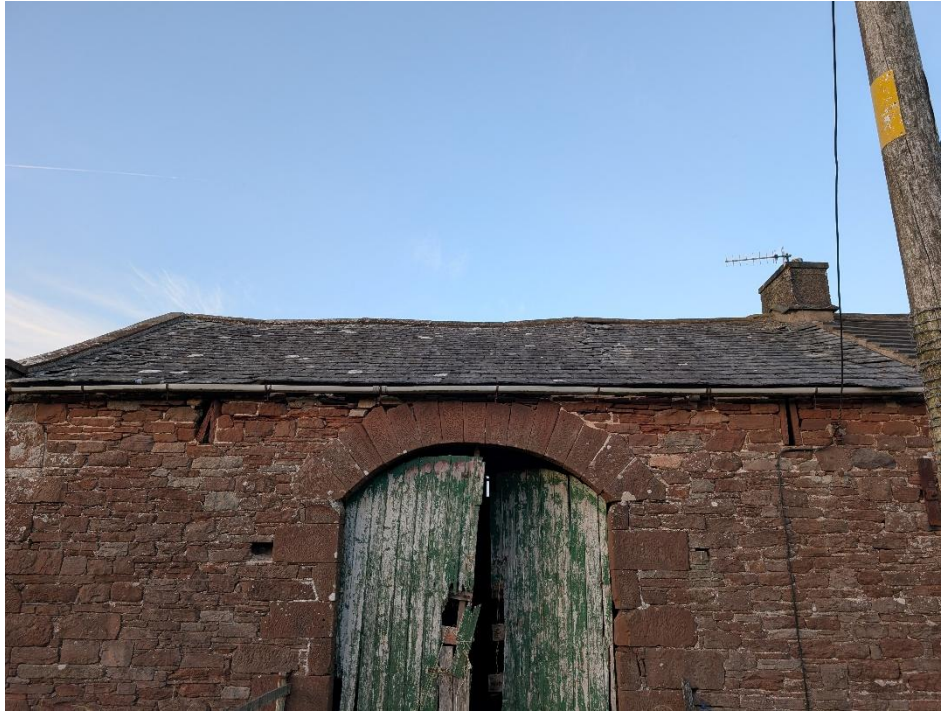
The roof of the building is pitched and made from slate. The roof is in poor condition with numerous raised or missing slates which create small gaps beneath that could accommodate individual or low numbers of crevice-dwelling bat species.

- Roof coverings on Building 1 should be stripped by hand and checked to ensure no bats are present beneath, or under the underside of slates.
- If it is necessary to remove a bat to avoid it being harmed, gloves should be worn. It should be carefully caught in a cardboard box and kept in the dark in a quiet place until it can be moved to an undisturbed part of the building, with outside access, and placed in a location safe from predators.

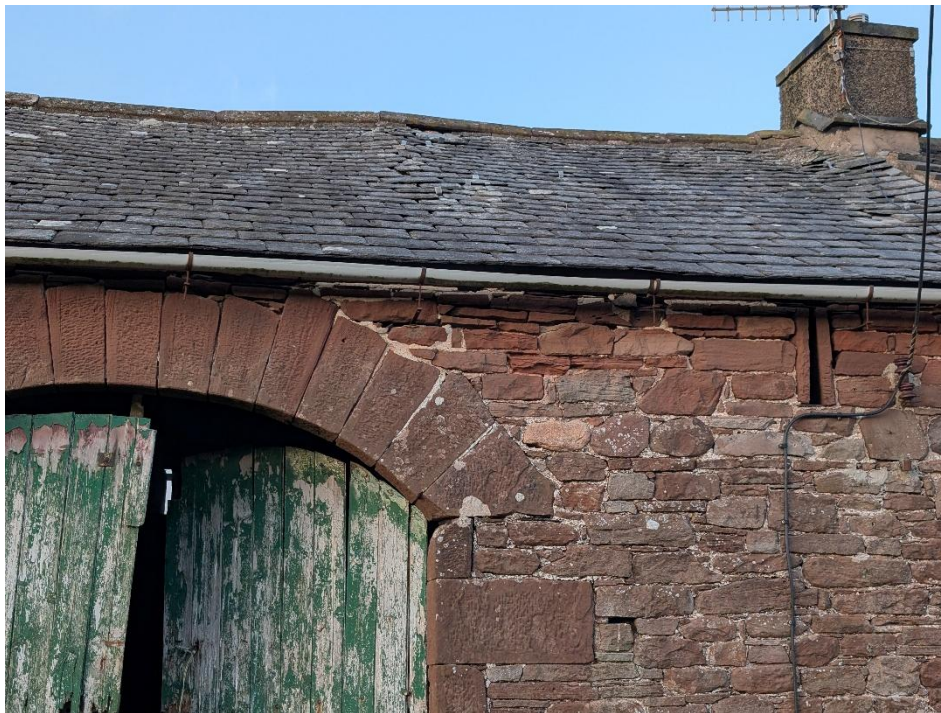
There are also several gaps beneath ridge tiles where the mortar is missing. The West-facing pitch could be comprehensively inspected using a high powered torch and binoculars due to the topography of the adjacent field. No bats or indications of their presence could be found,

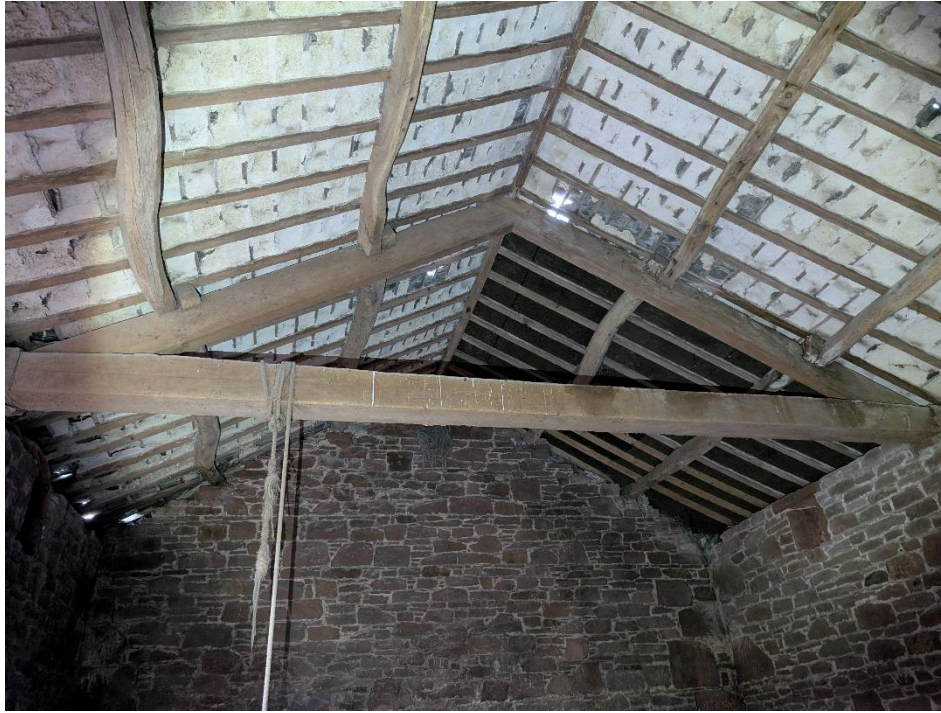
There are no enclosed voids within the building though there is a large hayloft accessed through a doorway to the West. The roof structure is exposed throughout and the timbers are seen to be in good condition with no rot.

A low number of cracks and holes were noted within some of the timbers, but these could be inspected using a torch and binoculars and showed no evidence of use by bats.

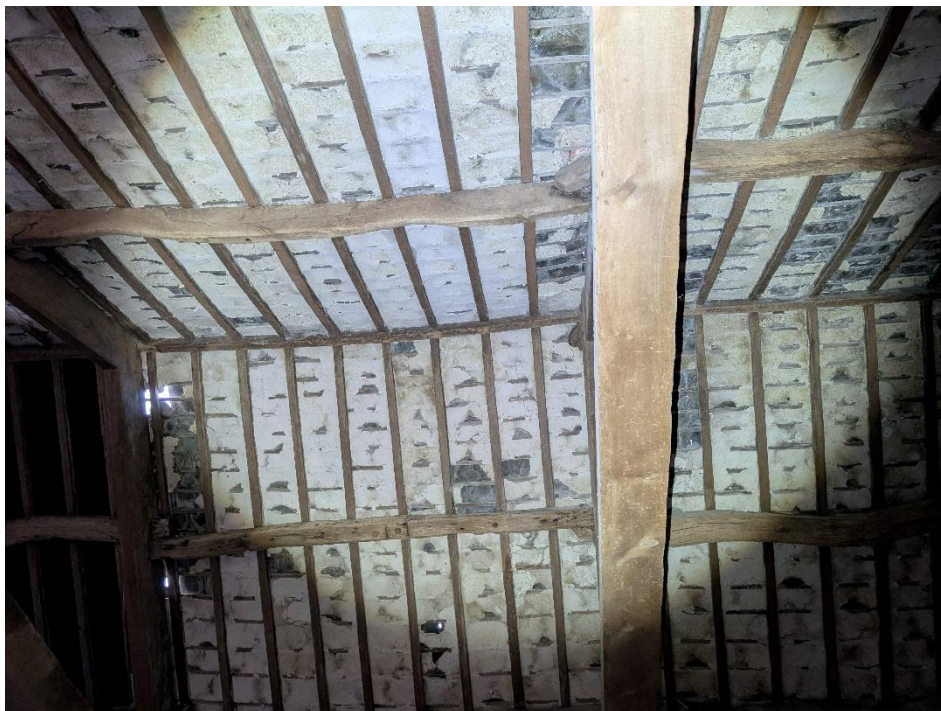
The floor of the hayloft was thoroughly searched and a very small number (<5) of old bat droppings were noted. These were scattered throughout and not associated with any particular features, suggesting occasional exploratory foraging behaviour rather than indicating the presence of a roost.

An active Barn Swallow (*Hirundo rustica*) nest was noted on one of the roof timbers. A low number of old Barn Owl pellets were also found; [this is discussed in a subsequent section](#).

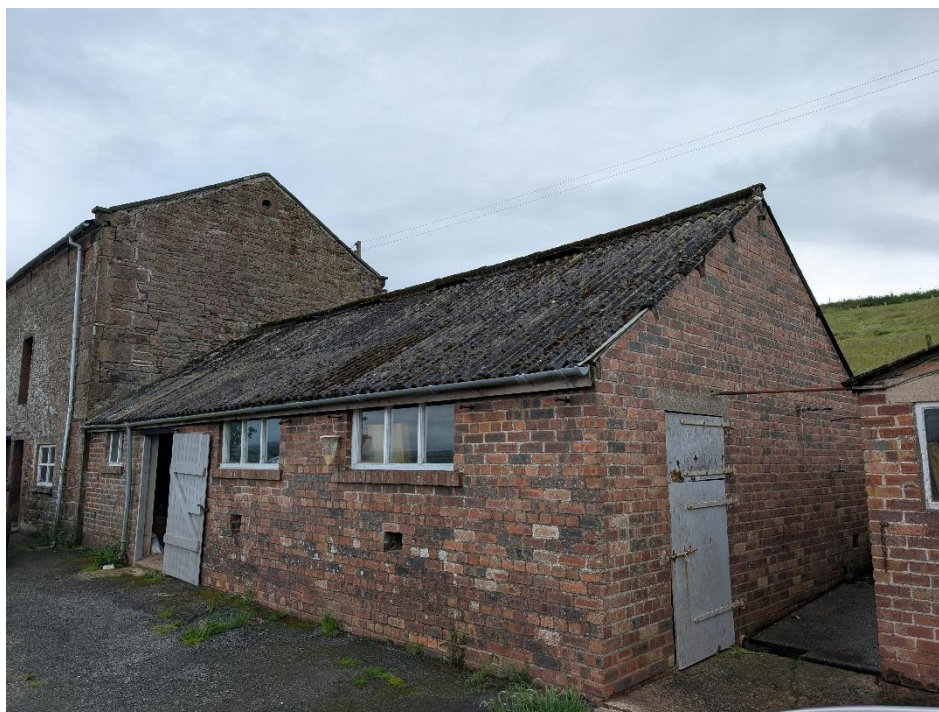
A single storey agricultural building formerly used as a milking shed. The building is constructed of red brick, under a pitched, corrugated cement fibre roof. Building 2 abuts Building 1 to the South.

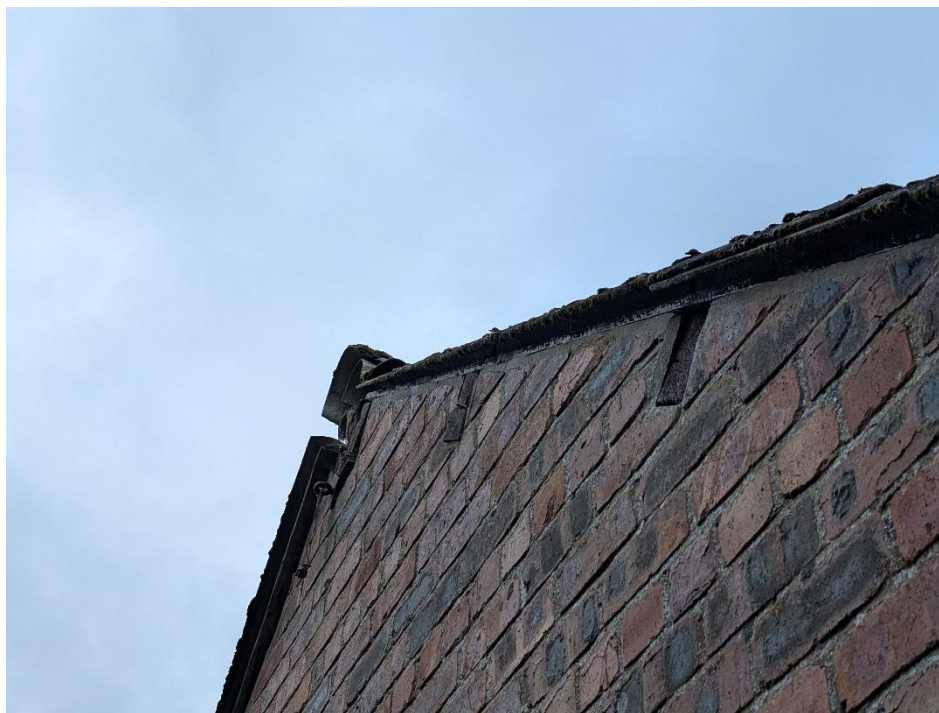
The building is built from red brick and is well pointed. Ventilation bricks are present low on the East facing elevation; these are obstructed and offer

neither access points nor roosting opportunities.  
To the South, the building adjoins a larger red-sandstone barn.

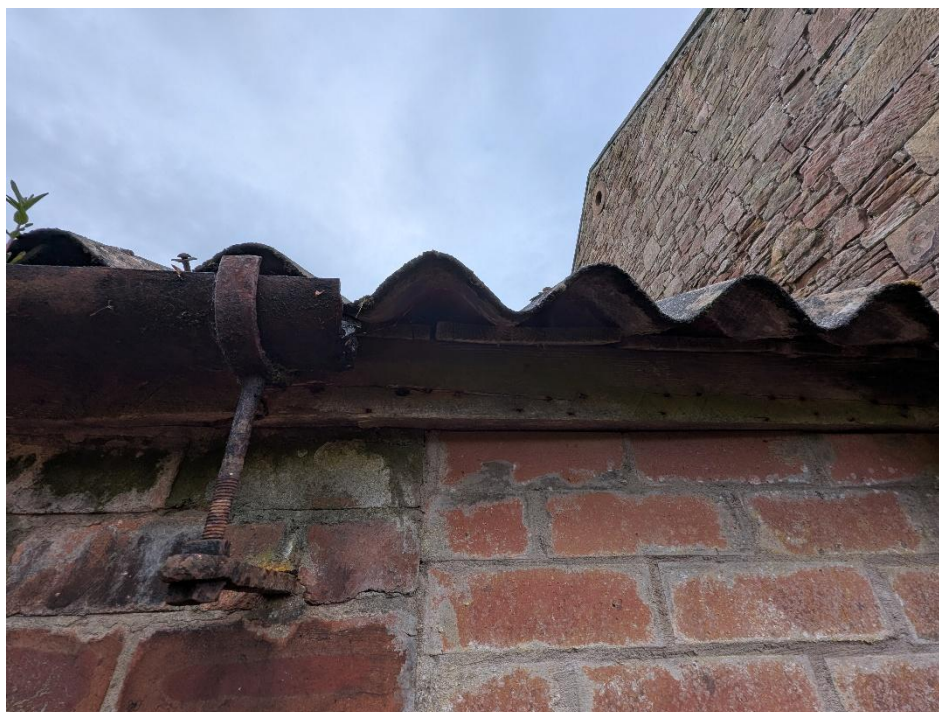
The roof verge on the North facing gable end has a low number of large gaps around the purlins. These are too open and exposed to be used by crevice dwelling bats but would allow access to the building interior. No droppings or other indications of the presence of bats were found in these areas.

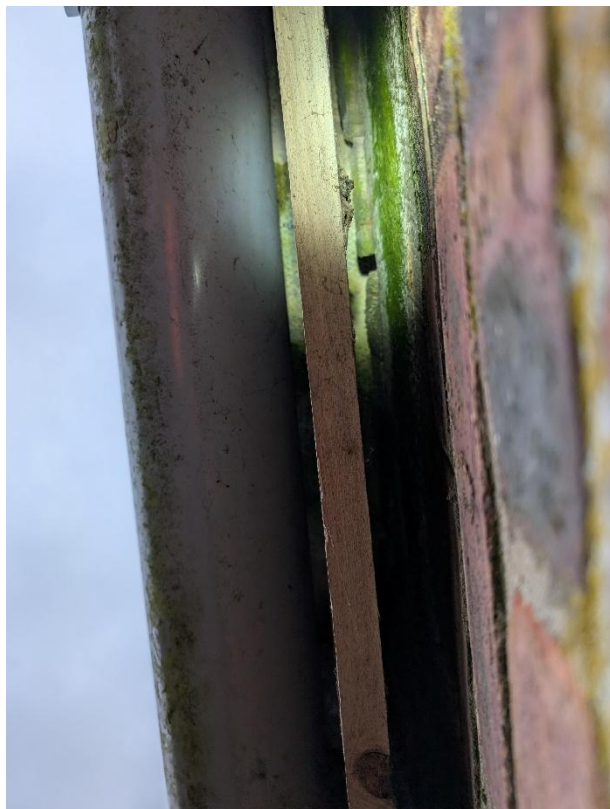
There are loosely fitted fascia boards at the eaves to the East and West, on which the gutters are mounted. The gaps between the fascias and the brickwork is c.750mm and too spacious to be suitable for use by bats. Due to the low height of the eaves, these areas could be thoroughly inspected which found no evidence of use.

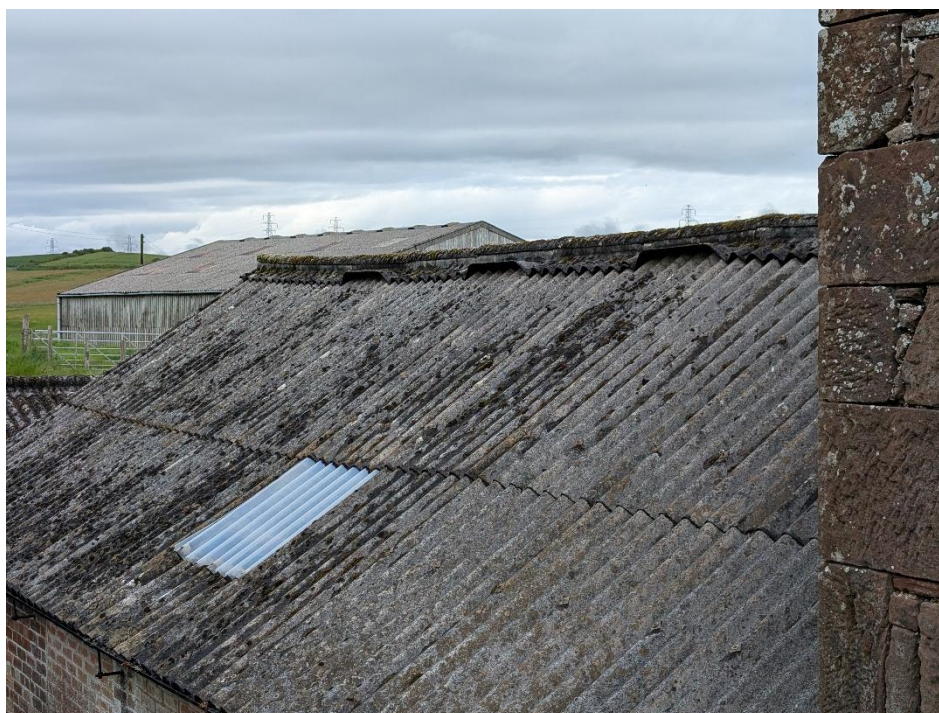
The roof of the building is pitched and made cement-fibre corrugated sheeting with corrugated plastic skylights. The corrugated sheets are fitted tightly and do not offer roosting potential. The sheets are fixed flush to the sarking in the furrows and the peaks sit too proud of the boards to provide suitable potential roost sites.

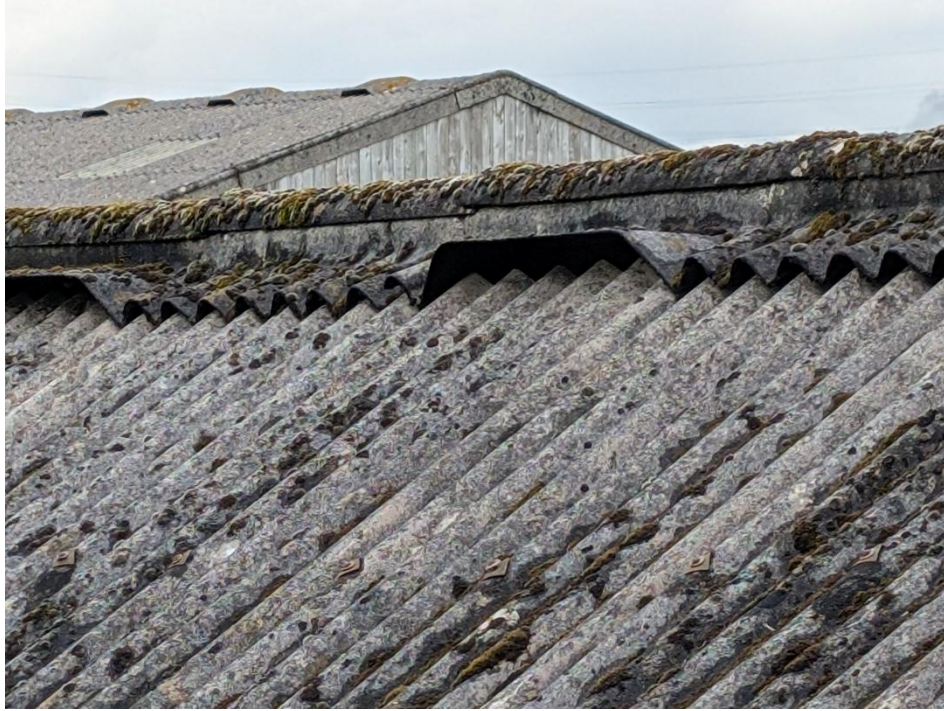
Large ventilation holes are present along the ridgeline. Whilst these would be potential access points, they are too large and exposed to be used as roost sites.

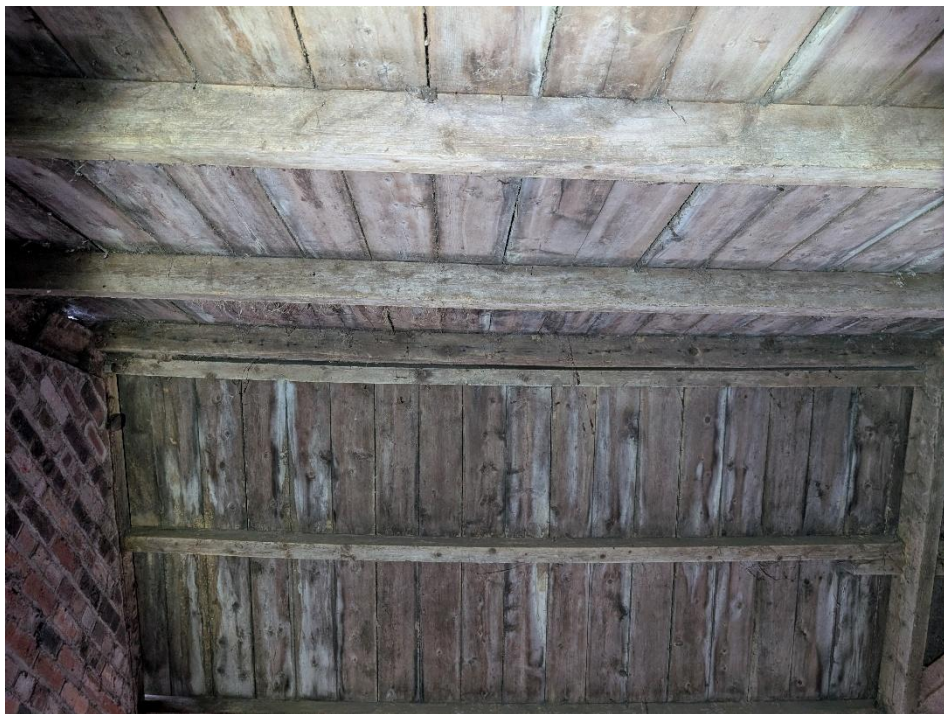
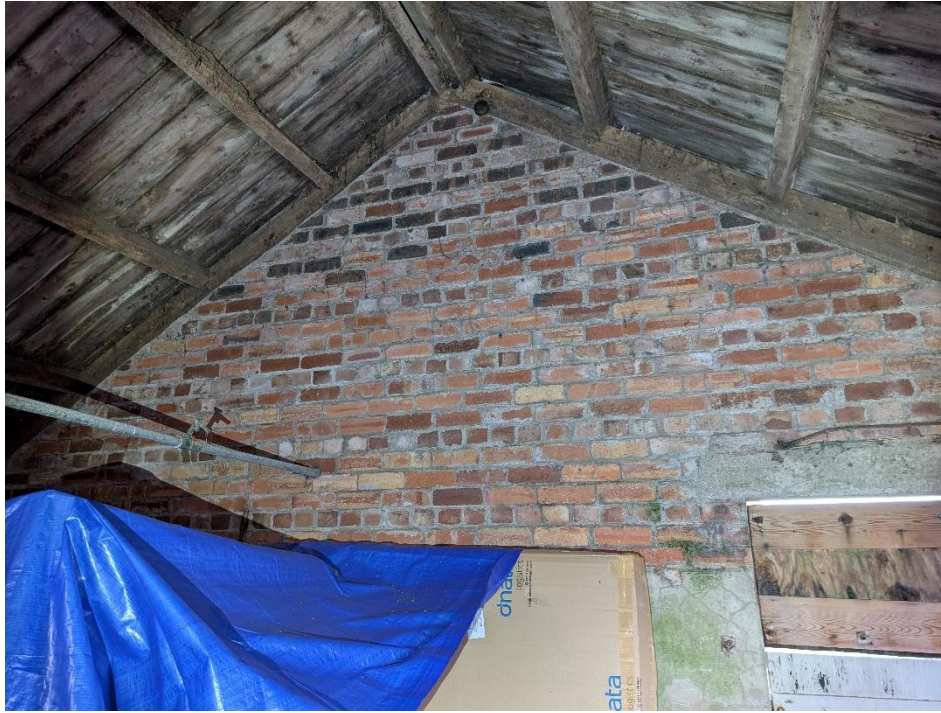
There are no enclosed voids in the building but the roof structure is exposed internally. There are wooden sarking boards beneath the corrugate sheets which is in good condition and free from rot or gaps which could be exploited by bats.

There roof timbers are also in good condition and do not contain any cracks, gaps or other features suitable for use by bats.

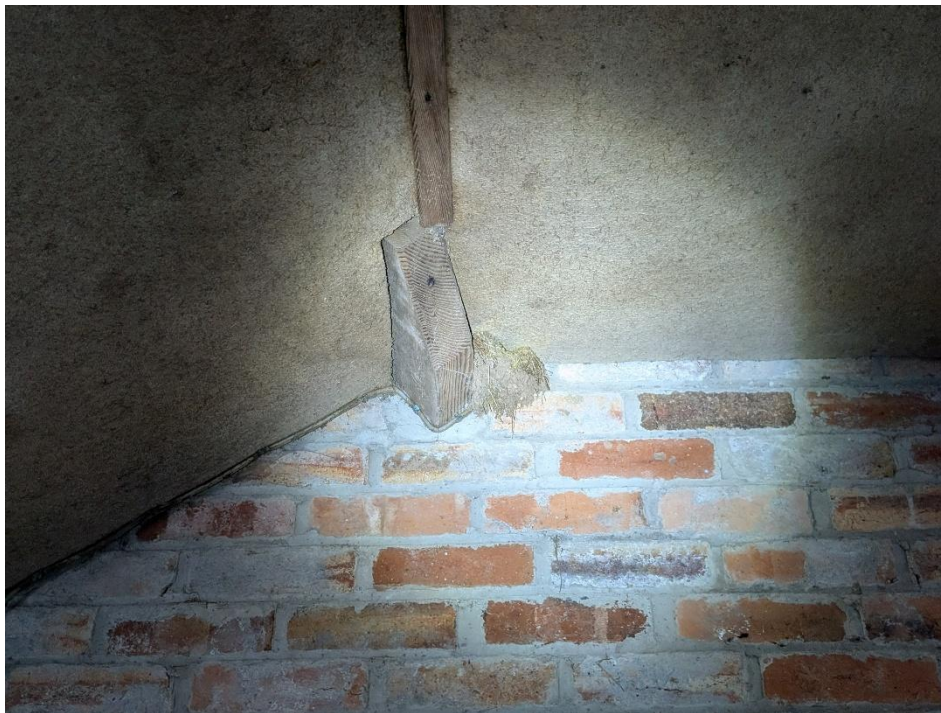
The internal space is open, exposed, and well illuminated by natural light. It is not considered likely that this space would be used by bats, though a low number of old Barn Swallow nests were noted. These did not show signs of recent use.

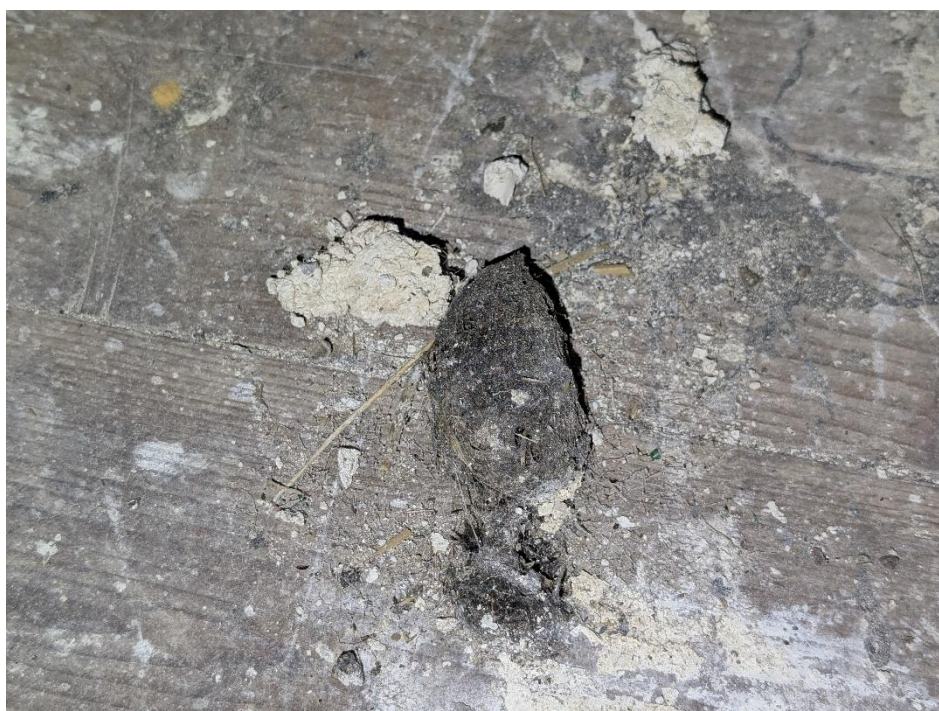
Beneath two of the rafters were small accumulations (<10) of pellets which were judged to be over a year old, along with small amounts of 'whitewash' on the beams and floor beneath. These are assessed as being inactive Temporary Roost Sites.

Prior to works commencing, a Barn Owl nest box should be installed inside one of the portal-framed barns on the site, at a minimum height of 3m and with suitable provision to access the building (e.g. a hole c.130mm x 130mm). Barn Owls boxes can be brought pre-fabricated or built to the [specifications provided by the Barn Owl Trust](#). Recommendations for positioning of boxes can be found via the same link.

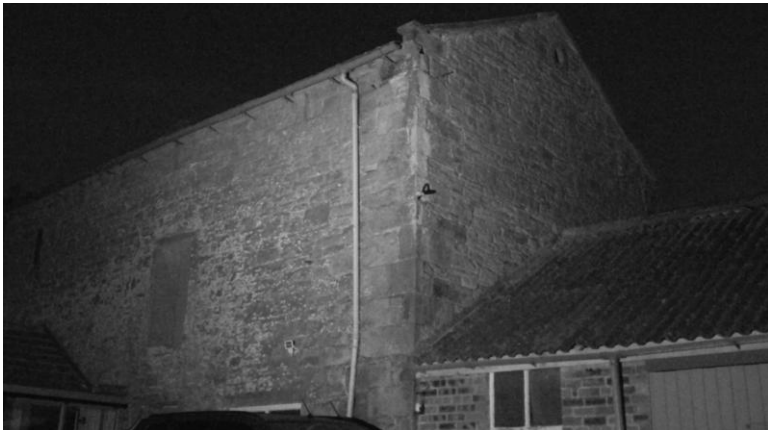
| Survey Number / Date | NVA Type | Image |
|---|---|---|
| 1 - 09/07/2026 | Canon XA11 NIR | A black and white NIR photograph showing the corner of a stone building. The stone is light-colored, and a dark vertical pipe runs down the side. A tiled roof is visible on the right. |

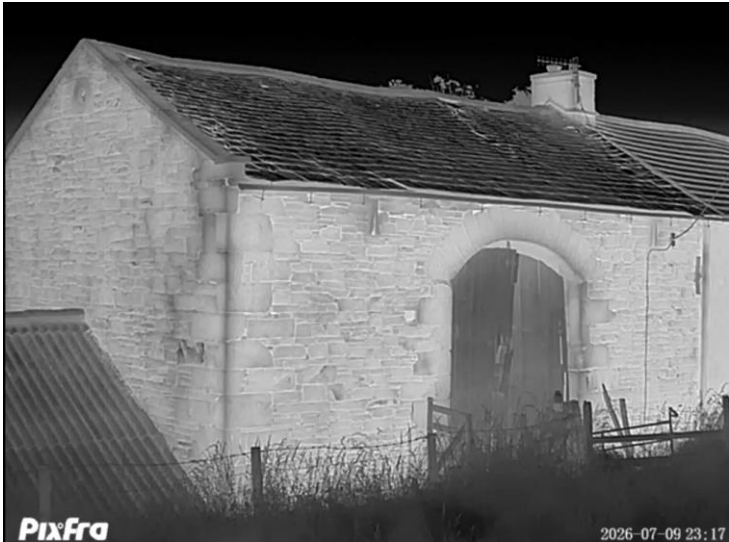
| Survey Number / Date | NVA Type | Image |
|---|---|---|
| 1 - 09/07/2026 | Pixfra Arc A613 | A black and white NIR photograph of a stone building with a gabled roof and a large arched doorway. The Pixfra logo and timestamp '2026-07-09 23:17' are visible at the bottom. |

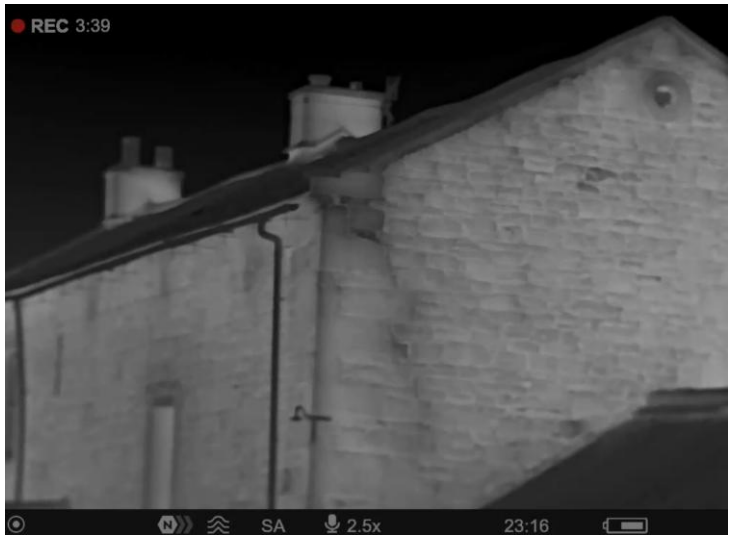
| Survey Number / Date | NVA Type | Image |
|---|---|---|
| 1 - 09/07/2026 | Pulsar Axion 2 XG35 | A black and white NIR photograph of a stone building with two chimneys. The image has a video player overlay at the bottom showing 'REC 3:39', 'SA', '2.5x', '23:16', and a battery icon. |
