## BAT, BARN OWL & NESTING BIRD SURVEY AT

Petersburgh Farm, Beckermest, CA21 2XW

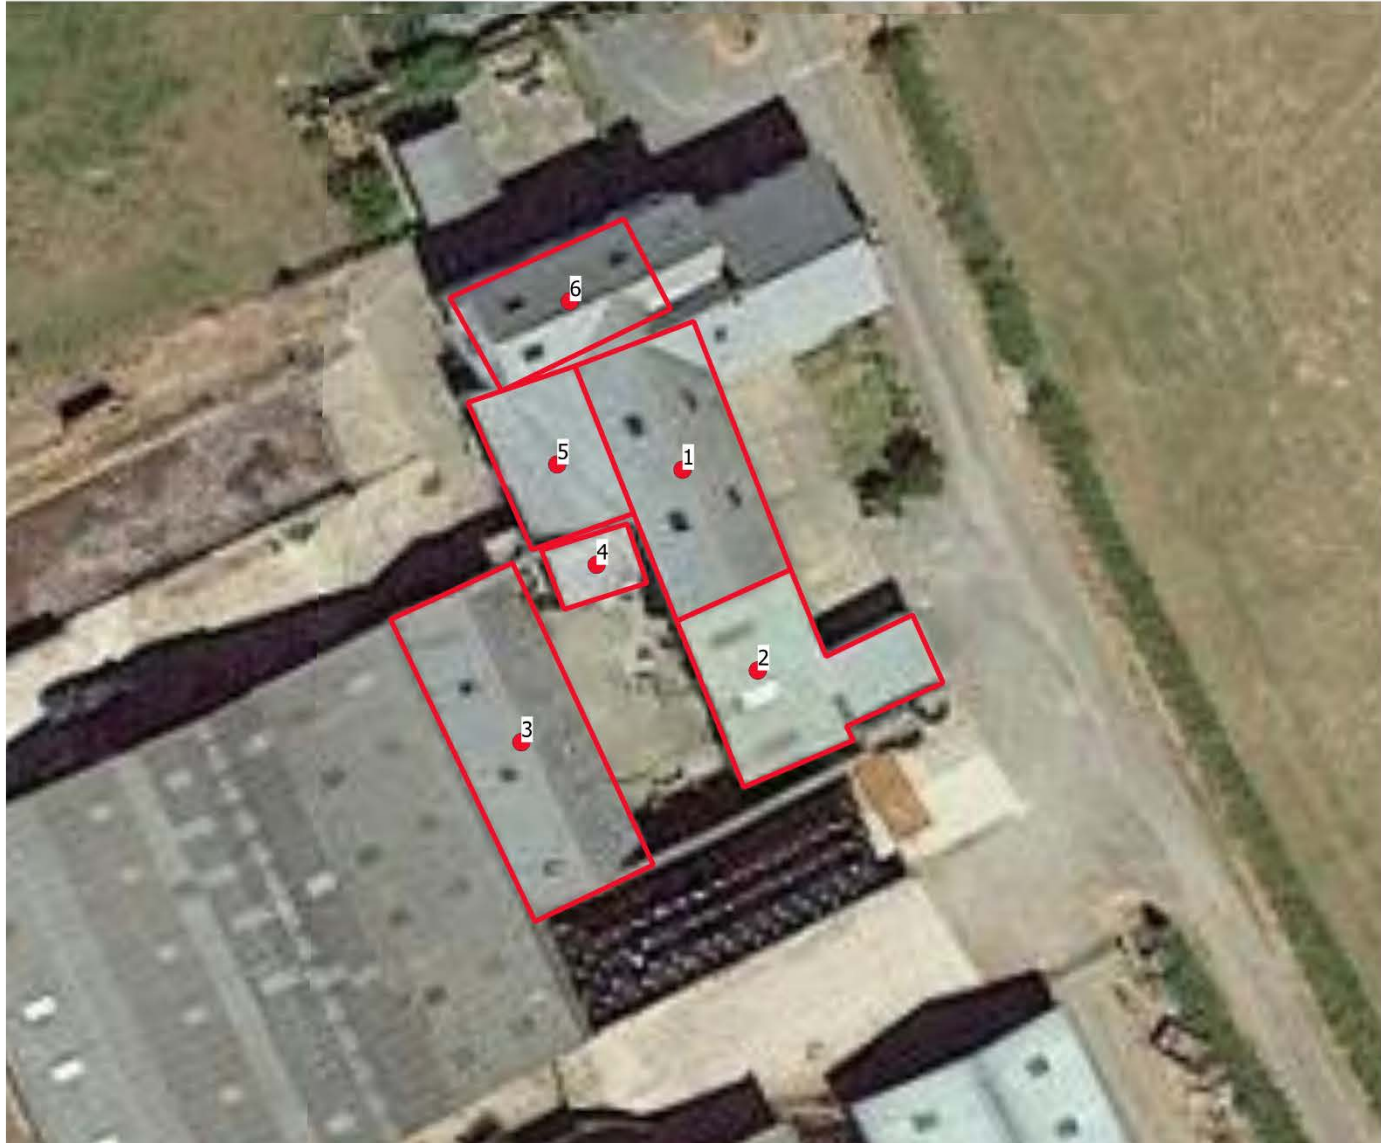
Figure 2  
Site Boundary

- Site Boundary
- Building Number

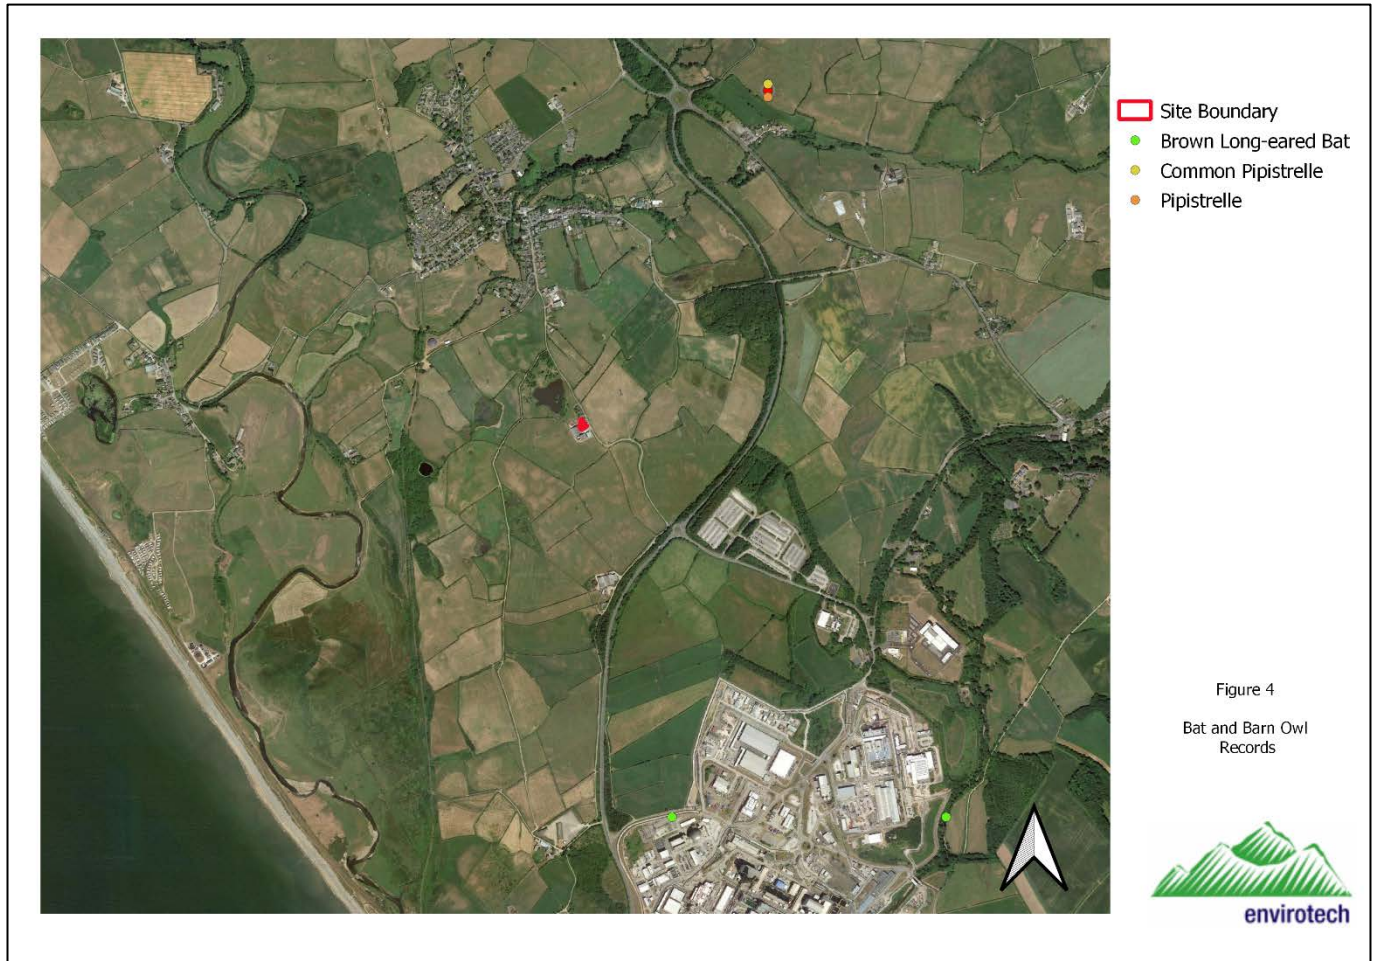
A search of the Envirotech dataset returned four records of three bat species within 2km but no records for the site.

Records are shown on Figure 4.

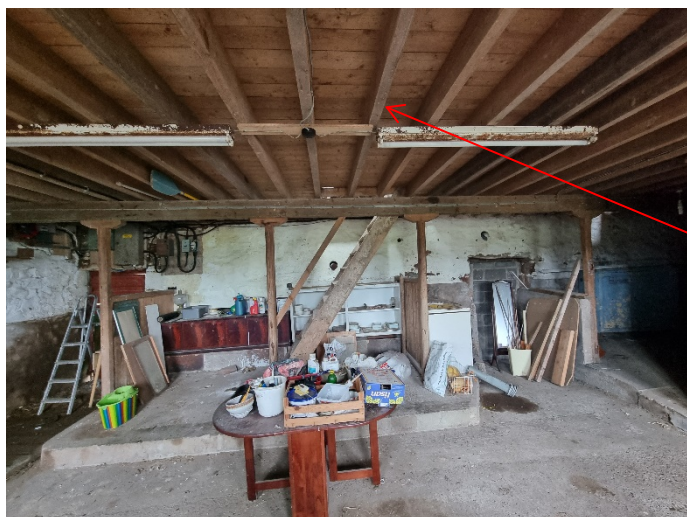
and non were raised over either roof pitch. The ridgeline was also in excellent condition with no gaps. The roof was assessed from the ground with close focus binoculars and a 1,000,000-candle power torch. Some bat droppings were observed scattered throughout the first-floor of the building. These could not be correlated to a roost site but were too numerous to be solely from flight droppings/ foraging bats.

Evidence of bats (droppings) birds and barn owls (feathers and white-wash) on first floor

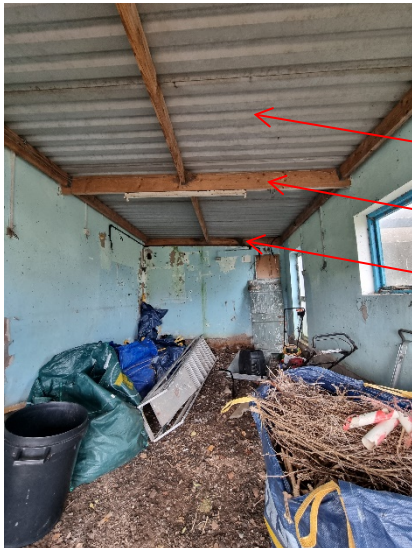
### Building 2

Walls in excellent condition

Small gaps under corrugations extending into roof

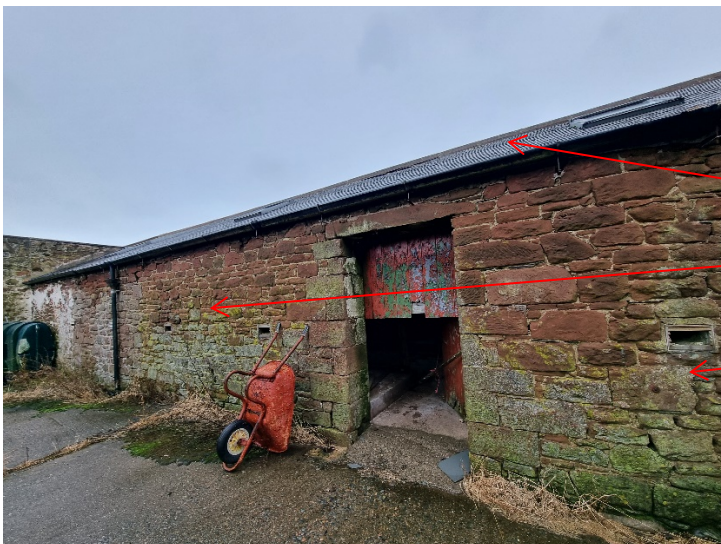
Several swallow nests were found around the site in all the buildings. The nests were all found to be vacant at the time of the survey.

- Flat corrugated roof
- Wooden beams in excellent condition
- Birds' nests on beams

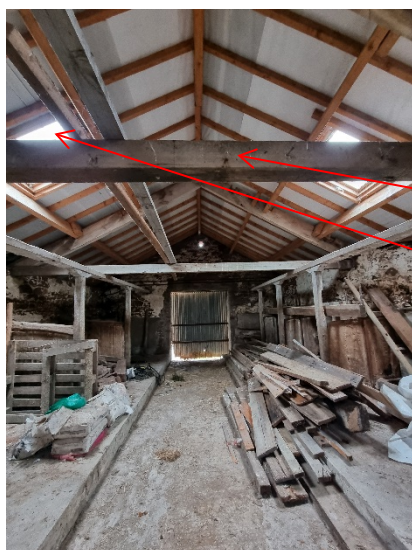
The walls of the building are made from natural stone and are in good condition. There are some gaps between the stones where the mortar is missing. There are evenly spaced gaps along the East-facing wall which are likely for ventilation.

- Building 3**
- Slates in excellent condition
  - Some gaps between stones where mortar is missing
  - Evenly-spaced ventilation gaps

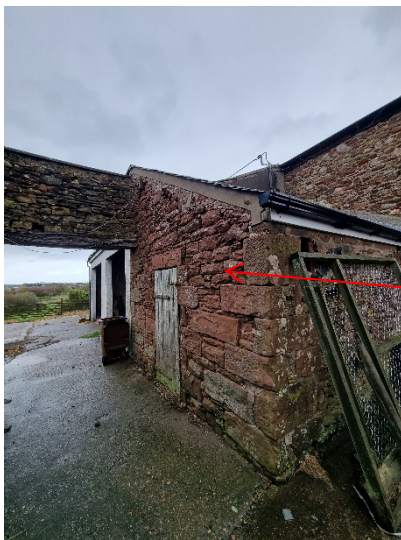
Aside from the nesting box, one other roost site was identified through “white wash” and significant collections of fresh barn owl pellets on the floor and on surfaces inside the building, confirming that barn owls have an active roost site within the buildings. A small amount of white was observed in the North end of building 1, along with some barn owl feathers.

Evidence of barn owl roost at South end of building

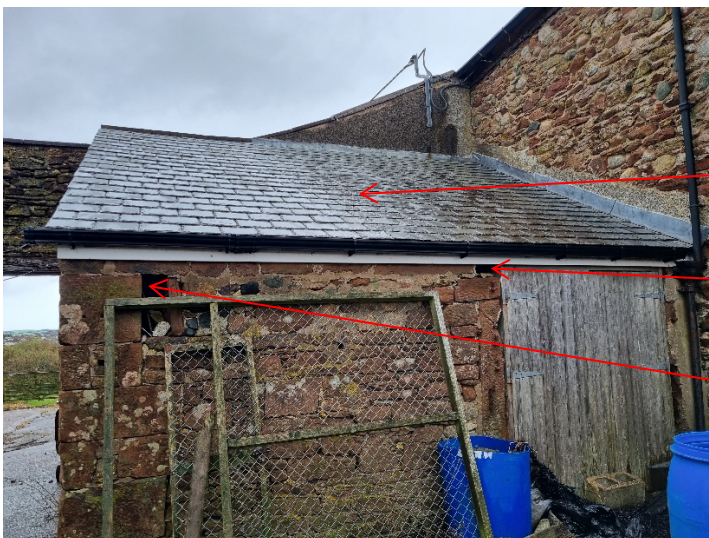
#### **Building 4**

The walls of the building are stone and are in moderate condition with gaps and cracks between the stones where the mortar is missing. There is a gap/window with no glass, and a gap at the top of the door. There were no indications of roosting by bats in these areas.

Walls in moderate condition with some gaps and cracks where mortar is missing

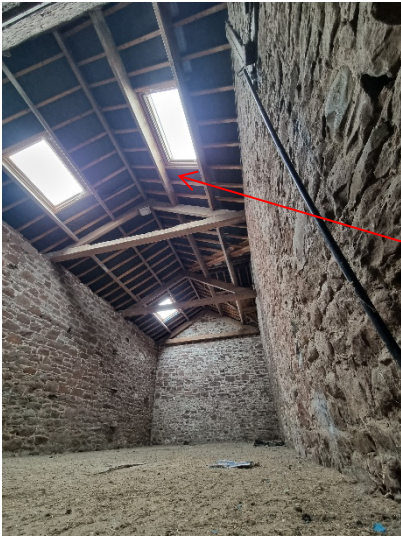
The walls of the building are rendered and are in excellent condition with no gaps or cracks.

The roof of the building is slate and in excellent condition. It is lined, and there are no raised tiles. The roof was assessed from the ground with close focus binoculars and a 1,000,000-candle power torch. No indications of use by bats could be found.

<p><b><u>Building 6</u></b></p> <p>Roof coverings in excellent condition with no raised slates</p> <p>Rendering in excellent condition with no gaps or cracks</p>
