## **BAT, BARN OWL & NESTING BIRD SURVEY AT**

Petersburgh Farm, Beckermest, CA21 2XW

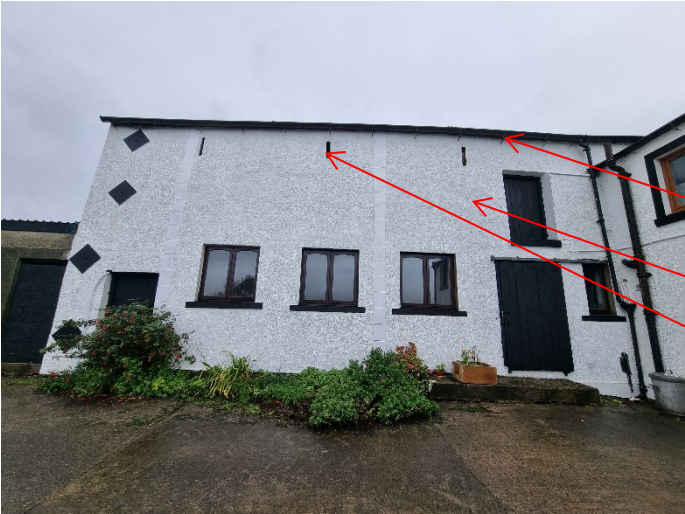
| Photograph | Notes |
|---|---|
| | <p><b><u>Building 1</u></b></p> <ul style="list-style-type: none"> <li>Roof verge well-sealed</li> <li>Well-sealed walls</li> <li>Decorative gaps</li> </ul> |

The walls of the building are rendered and are in excellent condition with no gaps or cracks in the rendering. There are decorative spaces in the walls on the upper storey which may act as access points for bats and small nesting birds, such as swallows.

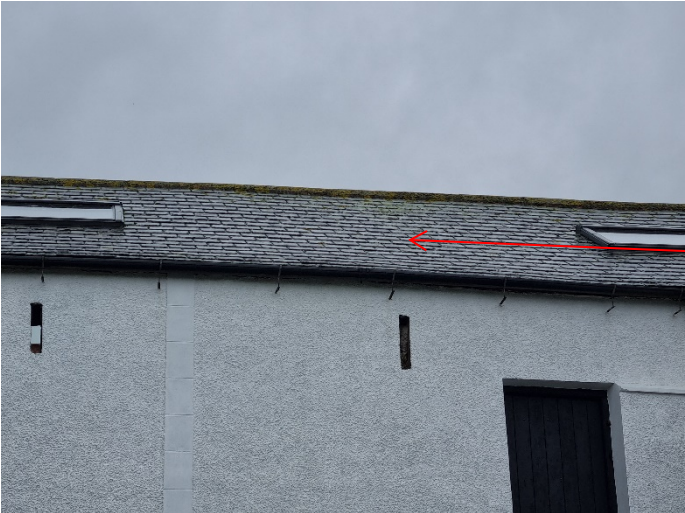
| Photograph | Notes |
|---|---|
| | <ul style="list-style-type: none"> <li>Roof coverings in excellent condition with no raised slates</li> </ul> |

The roof of the building is made from slate and is lined. The slates were in excellent condition

and non were raised over either roof pitch. The ridgeline was also in excellent condition with no gaps. The roof was assessed from the ground with close focus binoculars and a 1,000,000-candle power torch. Some bat droppings were observed scattered throughout the first-floor of the building. These could not be correlated to a roost site but were too numerous to be solely from flight droppings/ foraging bats.

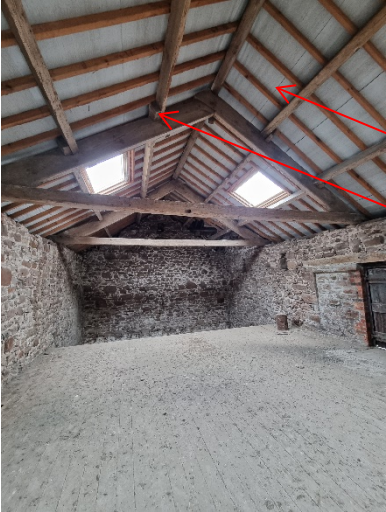
| Photograph | Notes |
|---|---|
| | <ul style="list-style-type: none"> <li>Roof lining in excellent condition</li> <li>Wooden beams in excellent condition</li> </ul> |

There were no roof voids in the building. The timber beams in the roof were found to be in excellent condition with no rot, splits or gaps suitable for roosting or hibernating bats. The roof of the first floor is flat and wooden as it is the floor of the first floor. No bats were observed to be roosting within the building on either floor at the time of the survey.

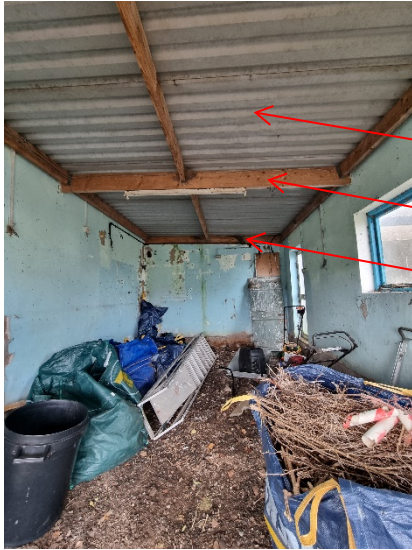
Flat corrugated roof

Wooden beams in excellent condition

Birds' nests on beams

The roof of the building is flat, made from corrugated material, and is unlined. The roof was assessed from the ground with close focus binoculars and a 1,000,000-candle power torch. No indications of use by bats could be found. As the roof is unlined any use of the roof would also result in droppings being deposited internally.

Due to the flat roof, there are no roof voids. The timber beams in the roof were found to be in excellent condition with no rot, splits or gaps suitable for roosting or hibernating bats. Due to

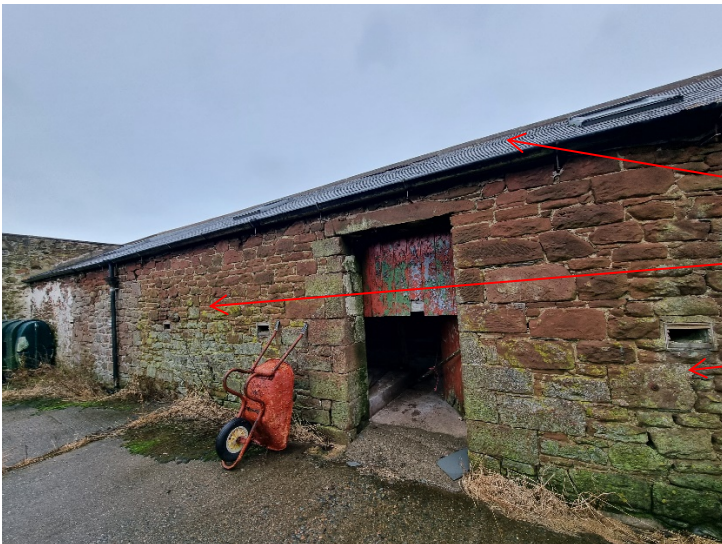
### **Building 3**

Slates in excellent condition

Some gaps between stones where mortar is missing

Evenly-spaced ventilation gaps

The walls of the building are made from natural stone and are in good condition. There are some gaps between the stones where the mortar is missing. There are evenly spaced gaps along the East-facing wall which are likely for ventilation.

The roof of the building is made from slate and is lined. There are several raised slates over both roof pitches, and there is a large gap under a section of the ridgeline where the mortar is missing and it appears that the ridgeline has risen and the slates slipped. The roof was assessed from the ground with close focus binoculars and a 1,000,000-candle power torch. Several bat droppings were observed scattered intermittently over the floor throughout the building, indicating use of the barn for feeding rather than roosting.

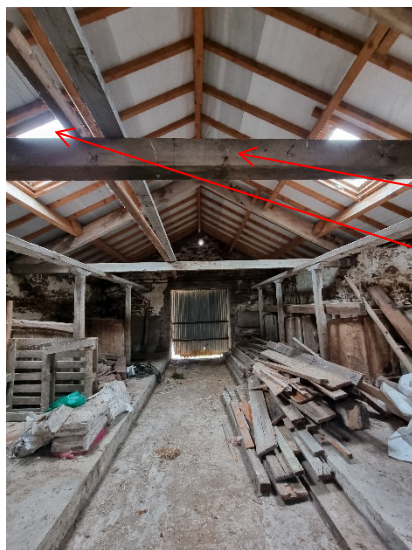
Timber beams in excellent condition

Skylights in roof make barn light and airy

There are no roof voids. The timber beams in the roof were found to be in excellent condition with no rot, splits or gaps suitable for roosting or hibernating bats. No indications of use by bats could be found.

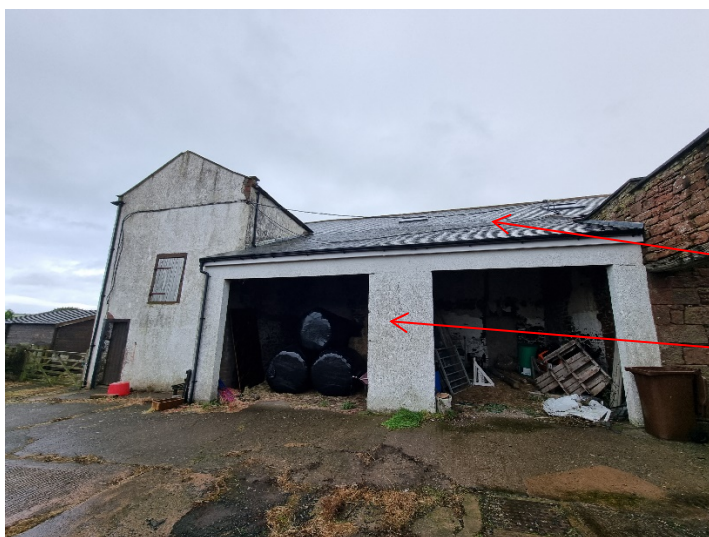
### **Building 5**

Roof in excellent condition

One crack which is not suitable for use by bats

The walls of the building are rendered and are in excellent condition. There is one crack on the pillar between the two entrances which is not wide enough or deep enough for use by bats.

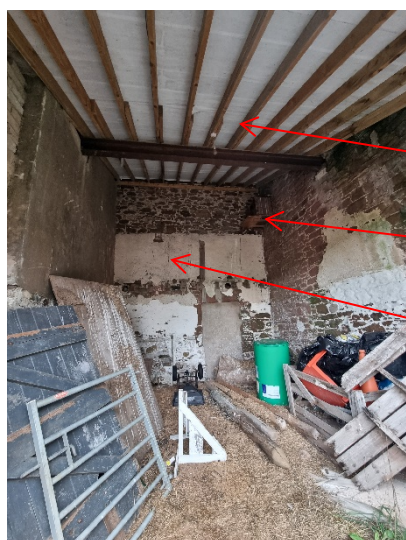
Timber beams in excellent condition

Barn owl box known to be used by breeding barn owls

Internal walls not suitable for roosting bats

Building 5 has a low potential for use by bats, a high potential for use by barn owls, and a moderate potential for use by nesting birds. An owl box is situated in the Southern part of the building. Bird nests, not barn owl, were observed in both sections of the building.

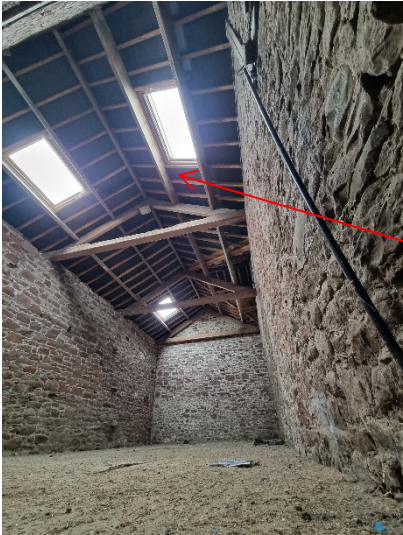
| | <p>First floor of building 6</p> <p>Roof lining and timber beams in excellent condition</p> <p>Floor too unstable to assess properly</p> |

There are no roof voids. The timber beams in the roof were found to be in excellent condition with no rot, splits or gaps suitable for roosting or hibernating bats. The roof of the ground floor is flat and wooden as it is the floor of the first floor. No indications of use by bats could be found on either floor.
