# batreport

including  
preliminary roost assessment  
and dusk activity, emergence survey

Abbots Court  
St Bees  
Cumbria  
CA27 0EG

August 2025

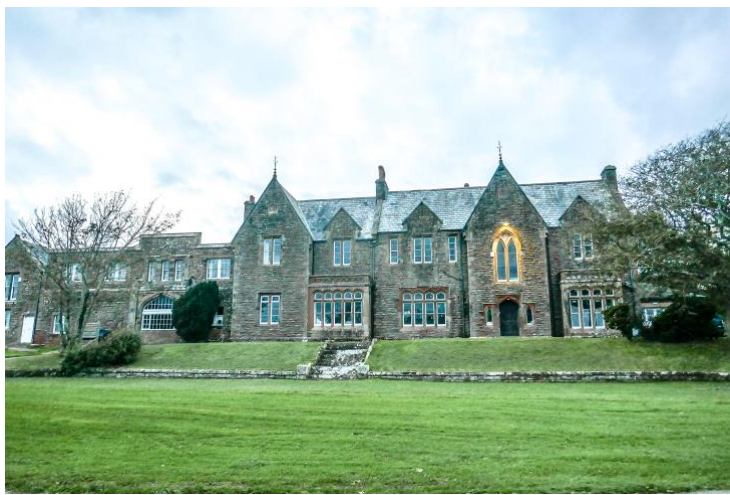
1. Abbots Court, Front elevation

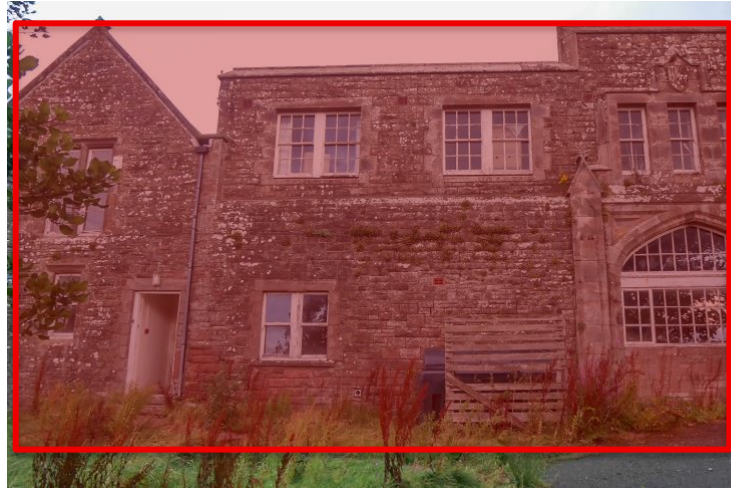
2. This part of the building will be removed which includes the large area of flat roof.

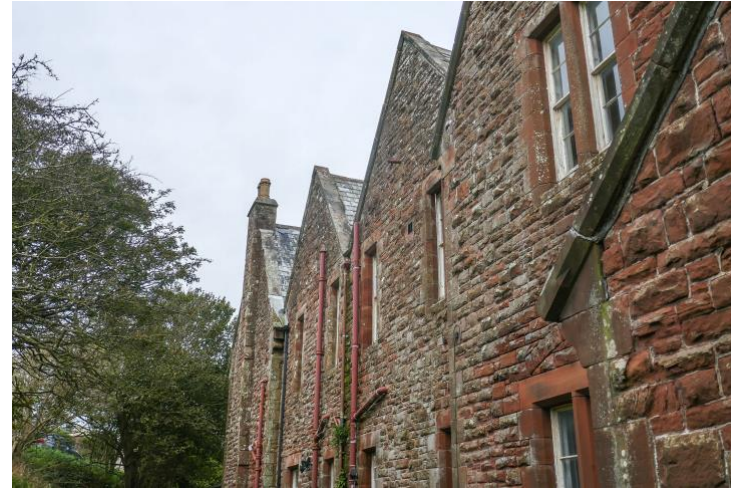
3. Front and side elevation

3. Side elevation to be removed. All tile areas were carefully inspected using binoculars and location details noted so roof space over tiles could be thoroughly inspected during roof space inspections

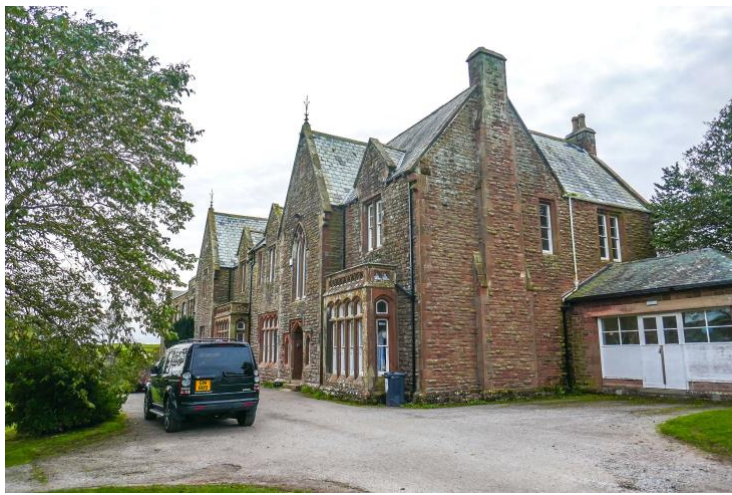
4. Front and side elevation

4. Images of tile condition were later checked on Imac high definition screens to ensure all areas within the roof spaces had been checked

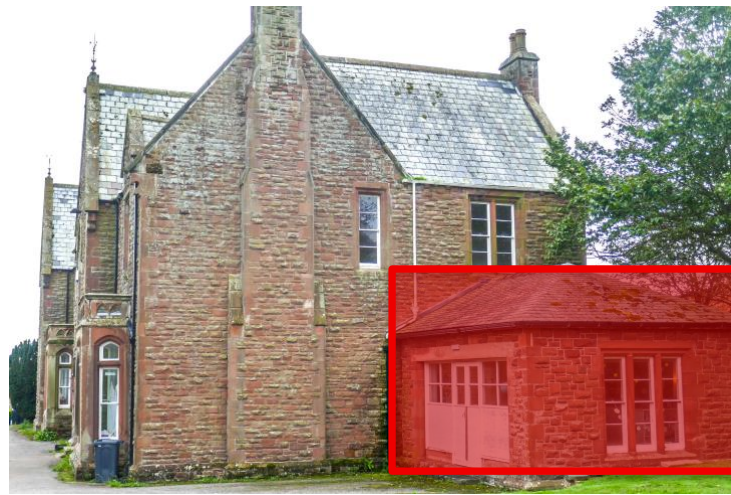
5. Side elevation with extension to be removed

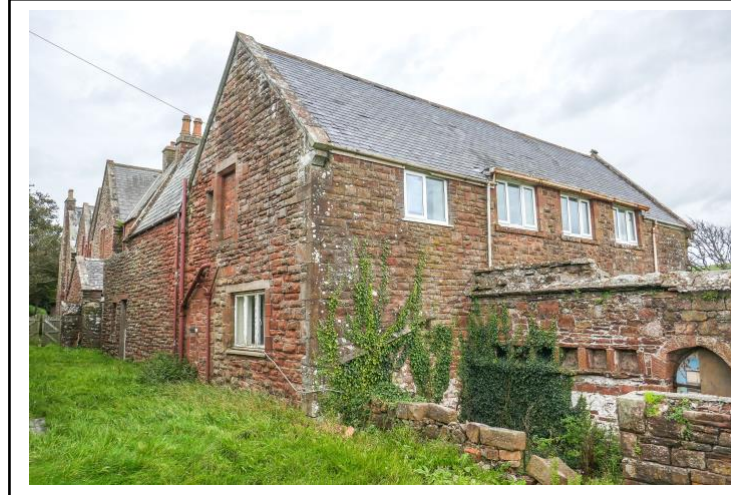
6. Side and rear elevation

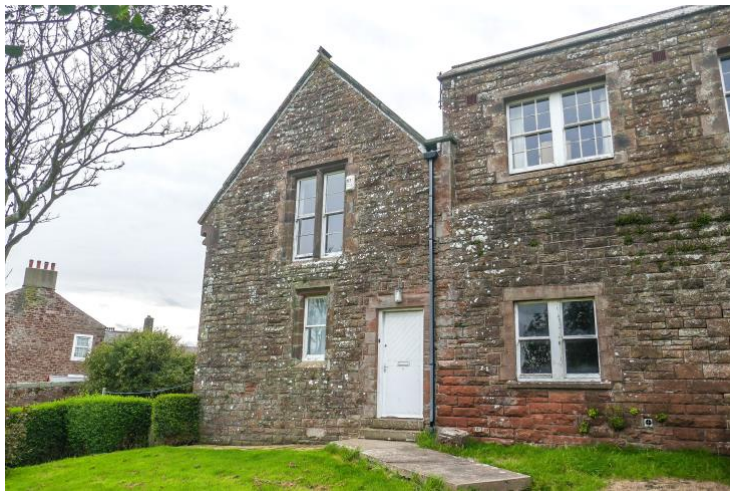
1. Front elevation with later flat roofed extension to be removed

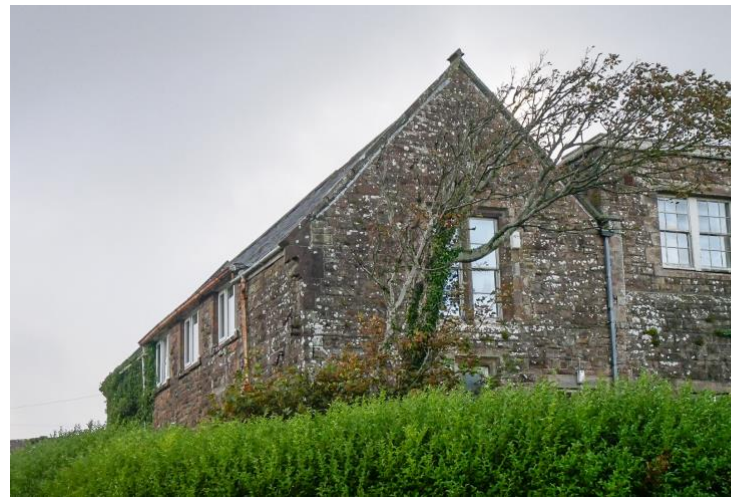
2. All wall elevations carefully inspected for ant cracks, splits or areas of missing mortar that could provide access opportunities for bats. None were recorded. All walls were in very good condition.

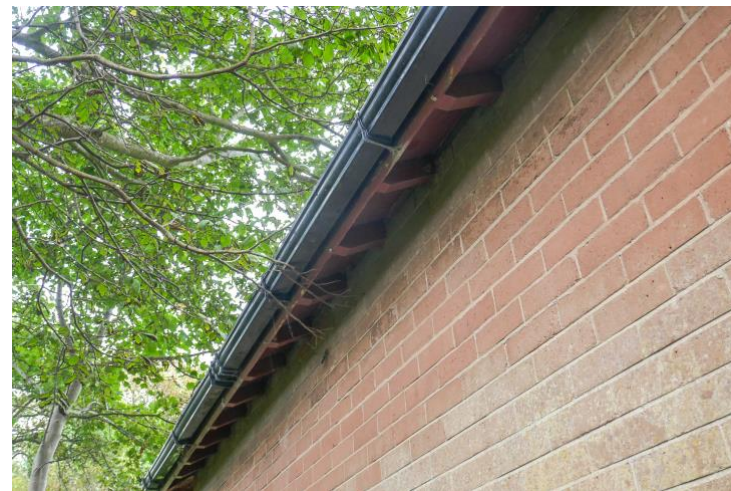
5. Extended eaves detail – no opportunities for bat access

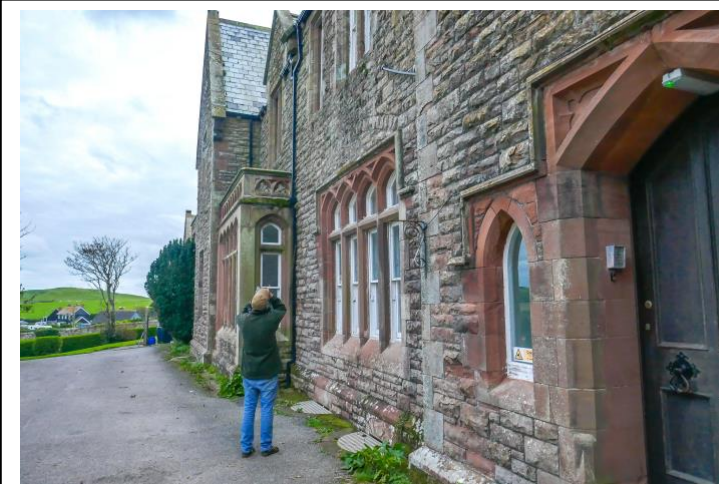
6. Using binoculars to thoroughly check all roof and roof join areas

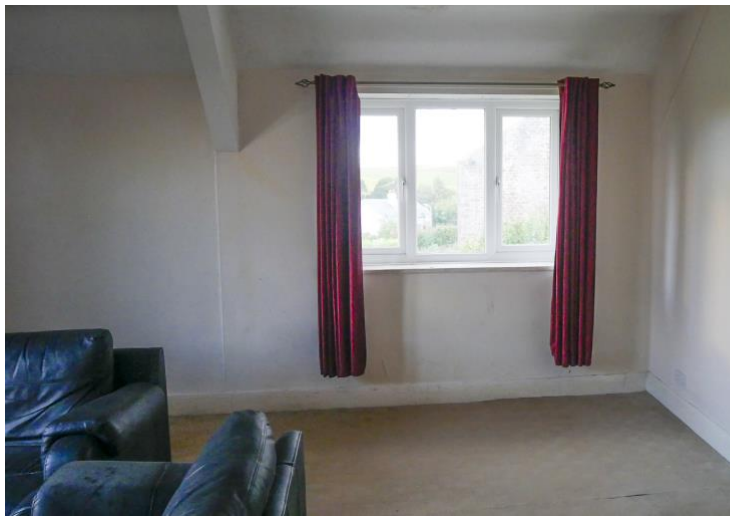
1. Example of interior windows

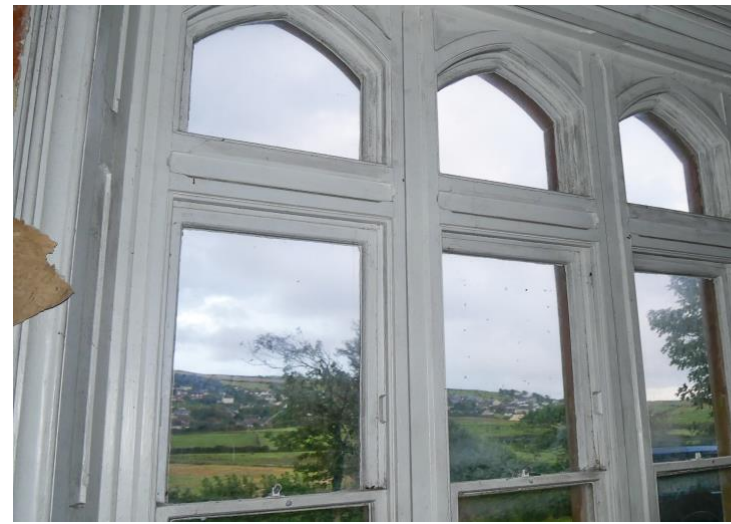
2. All rooms and window sills and glass checked for any evidence of bat activity. The window glass on the exteriors were all checked as it is quite normal that if bats are active in the vicinity for faeces to adhere to window panes

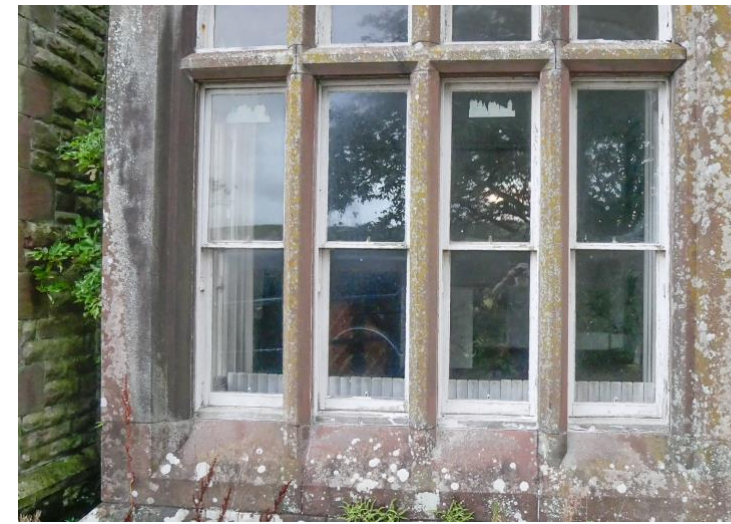
3. Exterior windows checked for evidence of bat activity

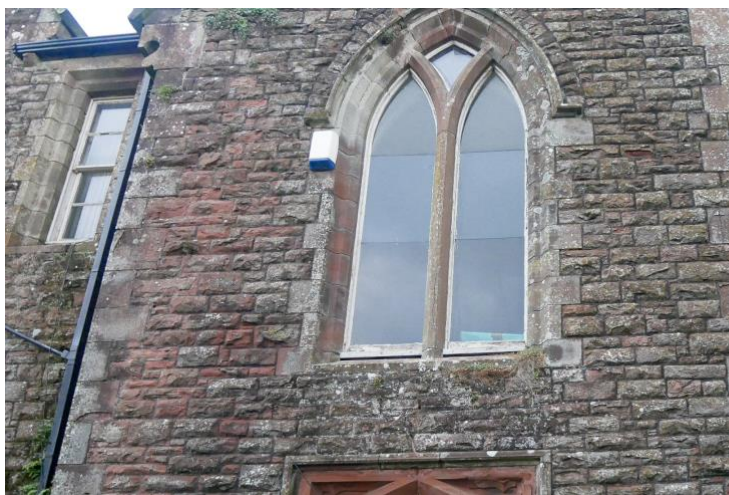
4. Detail of window surrounds and wall mortar. All external walls, door and window surrounds were inspected for any areas of potential roost fe

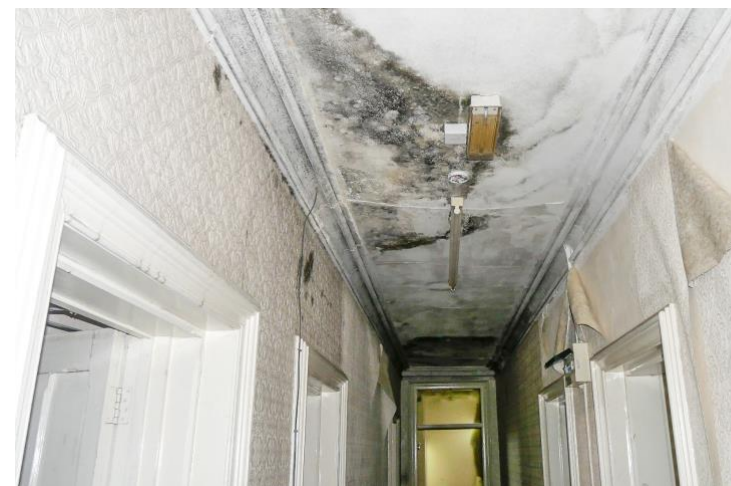
5. Damp was present in most first floor rooms and corridors

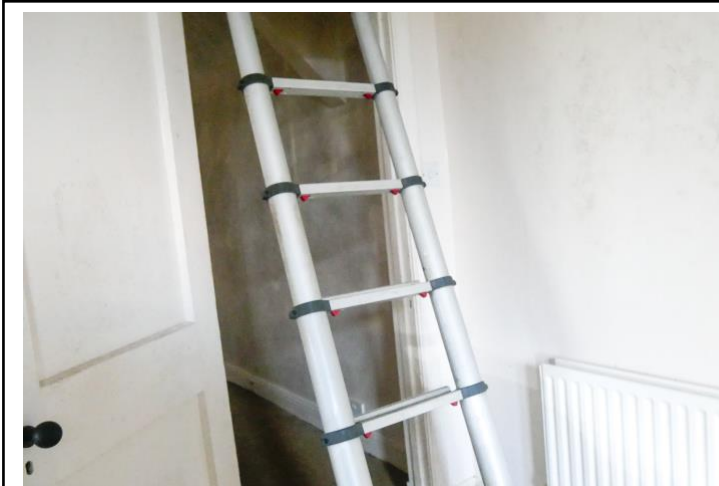
6. Every room was inspected for access to roof spaces or attics. Every roof space was entered and thoroughly searched for any evidence of bat roosting or flight activity signs.

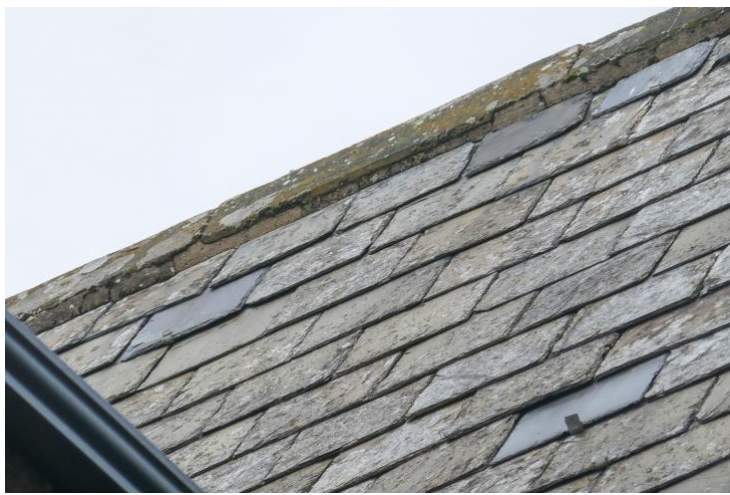
1. Example of roof and ridge tiles. Existing roof will be retained on most of the building apart from the areas to be removed. So ridge and roof tiles will be repaired, repositioned or replaces where necessary

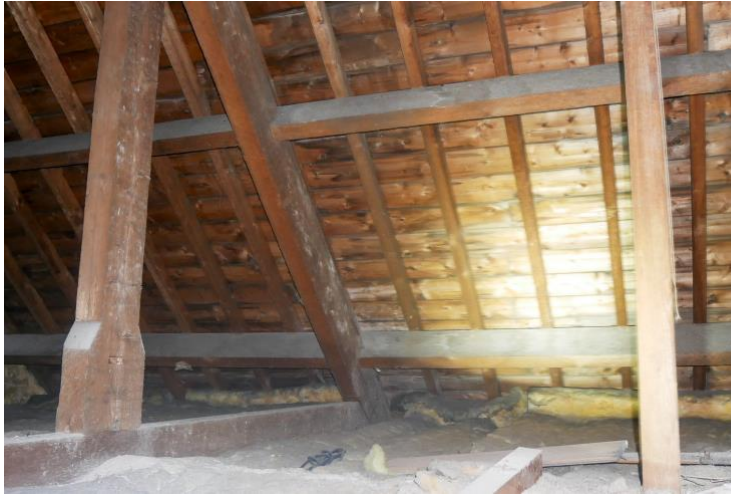
2. Every area of the loft was inspected for any evidence of bat activity or occupation

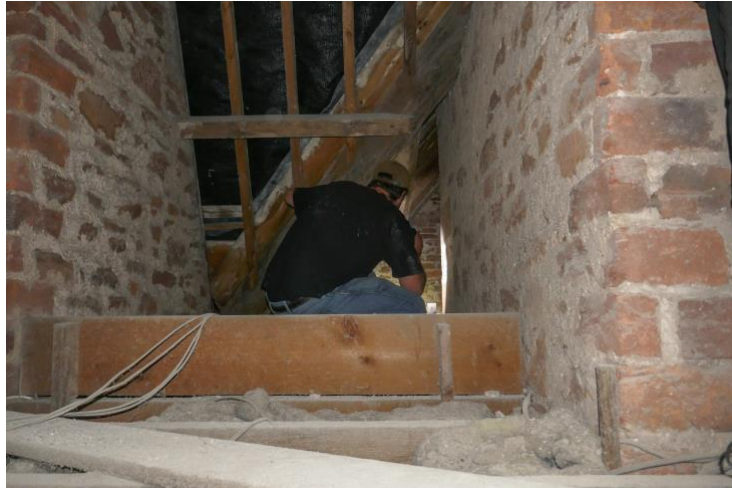
3. Using specialist LED lighting to search all floor areas for evidence of bat activity

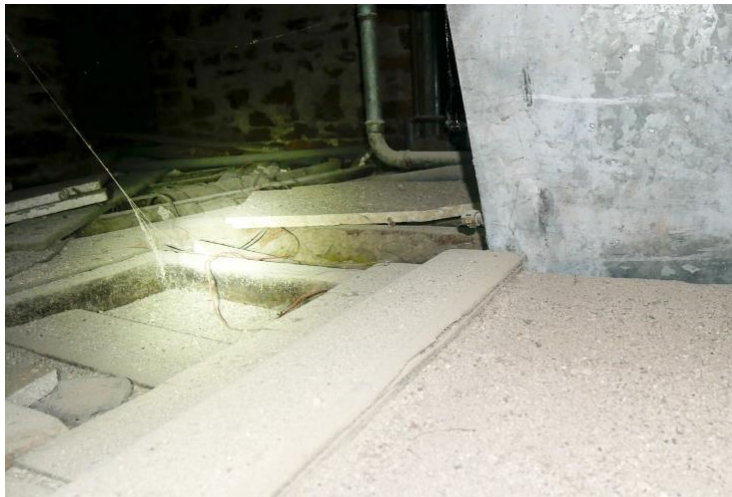
4. All floor surfaces were thoroughly searched moving boards, planks when necessary for any evidence of bat activity. The undisturbed floor surfaces in the roof spaces would have made any evidence of bat activity very obvious

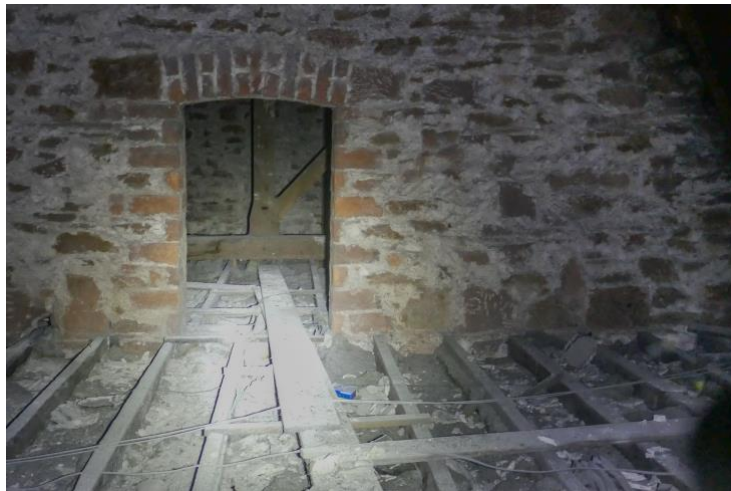
5. The roof space is divided into a number of smaller rooms. Each room was entered and checked for any evidence of bat roosts or bat activity. No evidence was recorded in any of the roof spaces.

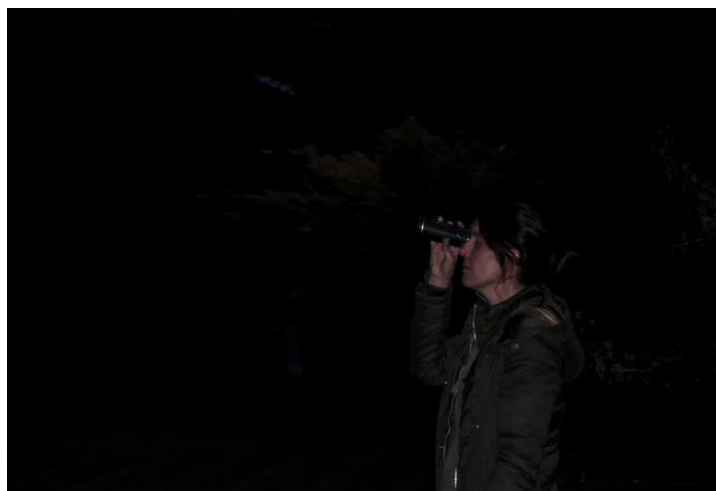
6. Using handheld Thermal Imaging equipment to search all roof space areas. This allows all small cracks, areas behind boarding etc to be accurately inspected for any bats that could be roosting in areas otherwise inaccessible to searching.

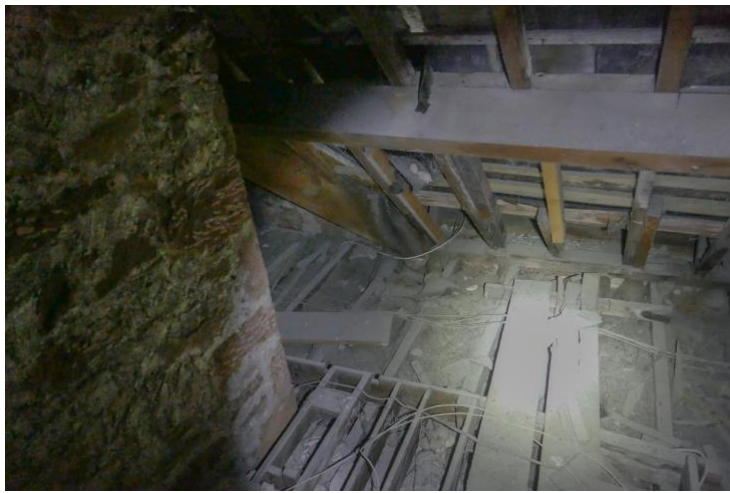
1. All floor surfaces were thoroughly inspected for any evidence of bat roosting or activity. Any feeding remains such as moth or butterfly wings would have been very obvious on the undisturbed floor surfaces

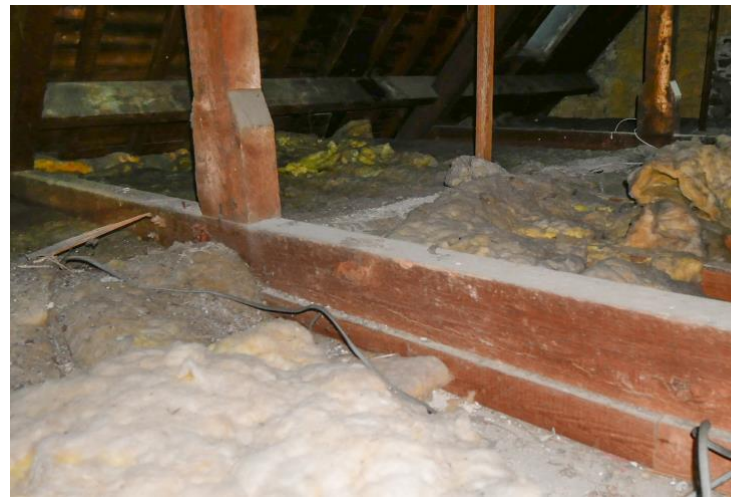
2. All surfaces where rock wool type of insulation were thoroughly inspected for any evidence of bat roosting or activity. Any feeding remains such as moth or butterfly wings would have been very obvious on the insulation surfaces

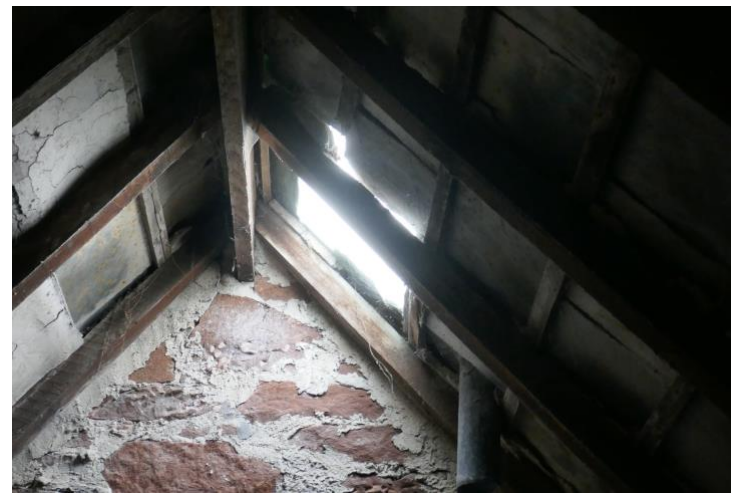
5. Clear Plexi glass panels allowing light into one area within the loft space

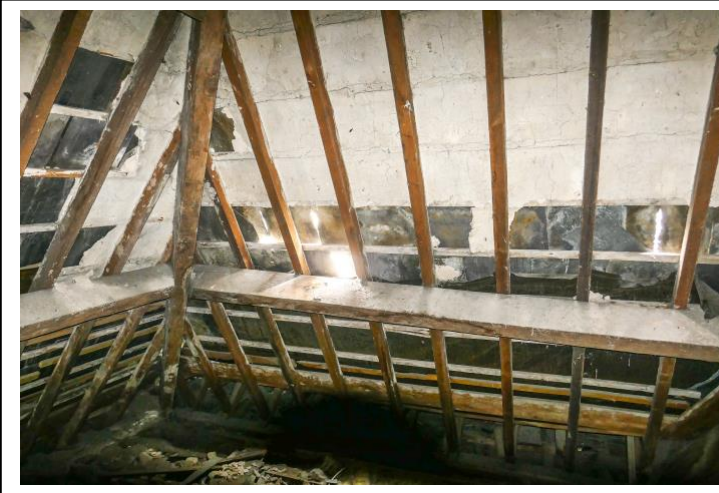
6. Given the size and complexity of the roof only a small number of slipped or cracked tiles were recorded. A thorough and careful evidence search was undertaken in every area of the roof. In some areas this required crawling on hands and knees by the Principal Ecologist and licensed bat consultant to ensure everywhere had been inspected

- 8.4 There were some slipped or cracked tiles on some areas of the roof. The locations of these slates were noted and under roof areas checked to see if any opportunities for access were available – the underneath of the tiled areas were all boarded removing any access potential for bats to use the loft area of the building through the slipped tiles but no evidence of use or activity in any area of the loft was recorded.

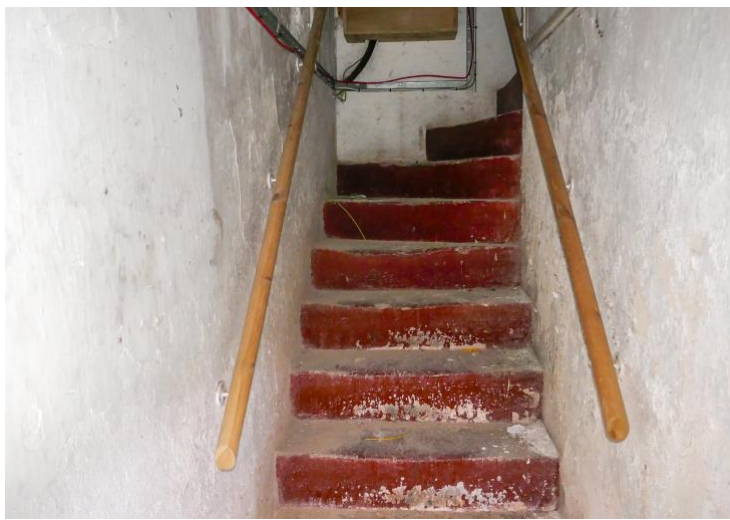
1. Access to cellar is by a descending stone stairwell

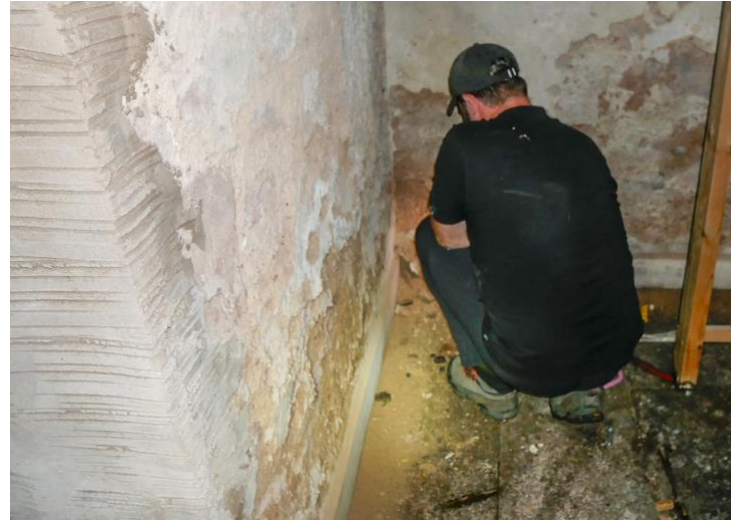
2. Specialist LED and UV lighting was used to search all cellar room floors and surfaces for evidence of bat activity.

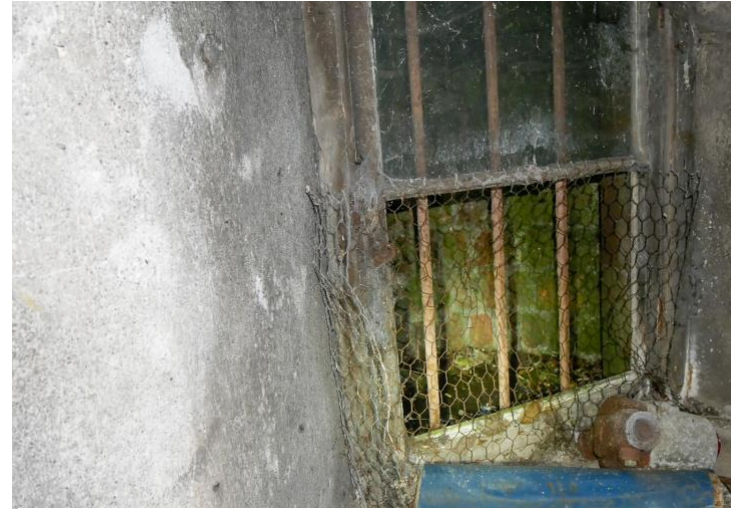
3. Fine chicken wire mesh on access to cellar from external opening. This opening has been sealed shut

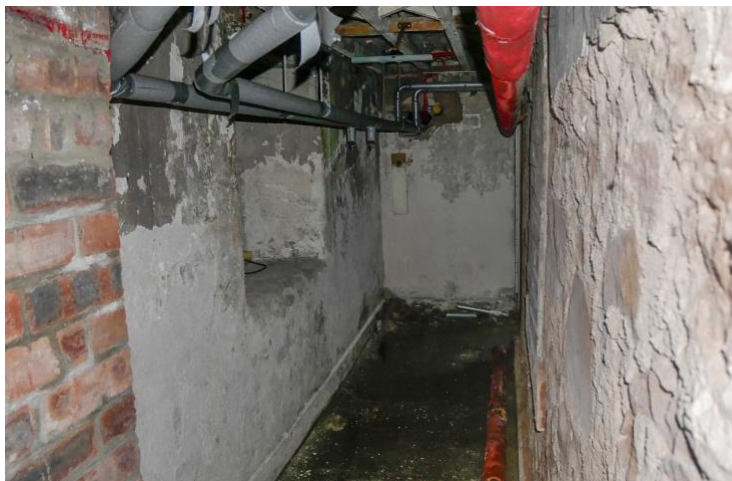
4. All rooms were accessible which allowed thorough and detailed searching of all floors and surfaces to be carried out

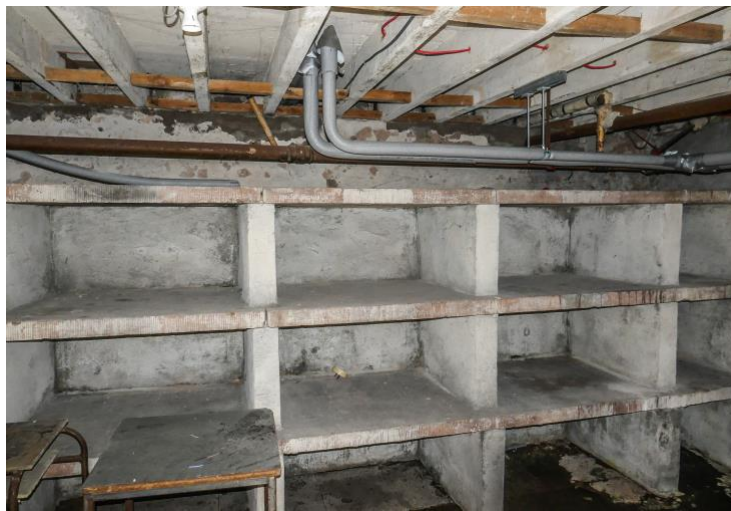
5. Storage shelving in end room of cellar

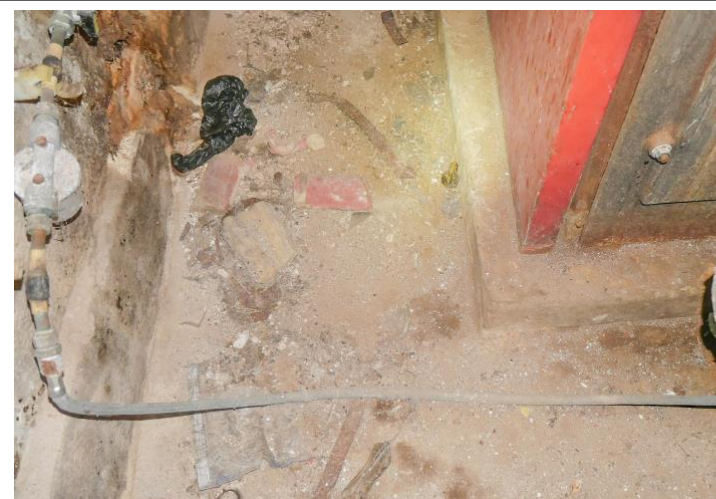
6. All floor surfaces were subjected to thorough and detailed searching for any evidence of bat activity. None was recorded in any are of the cellar.

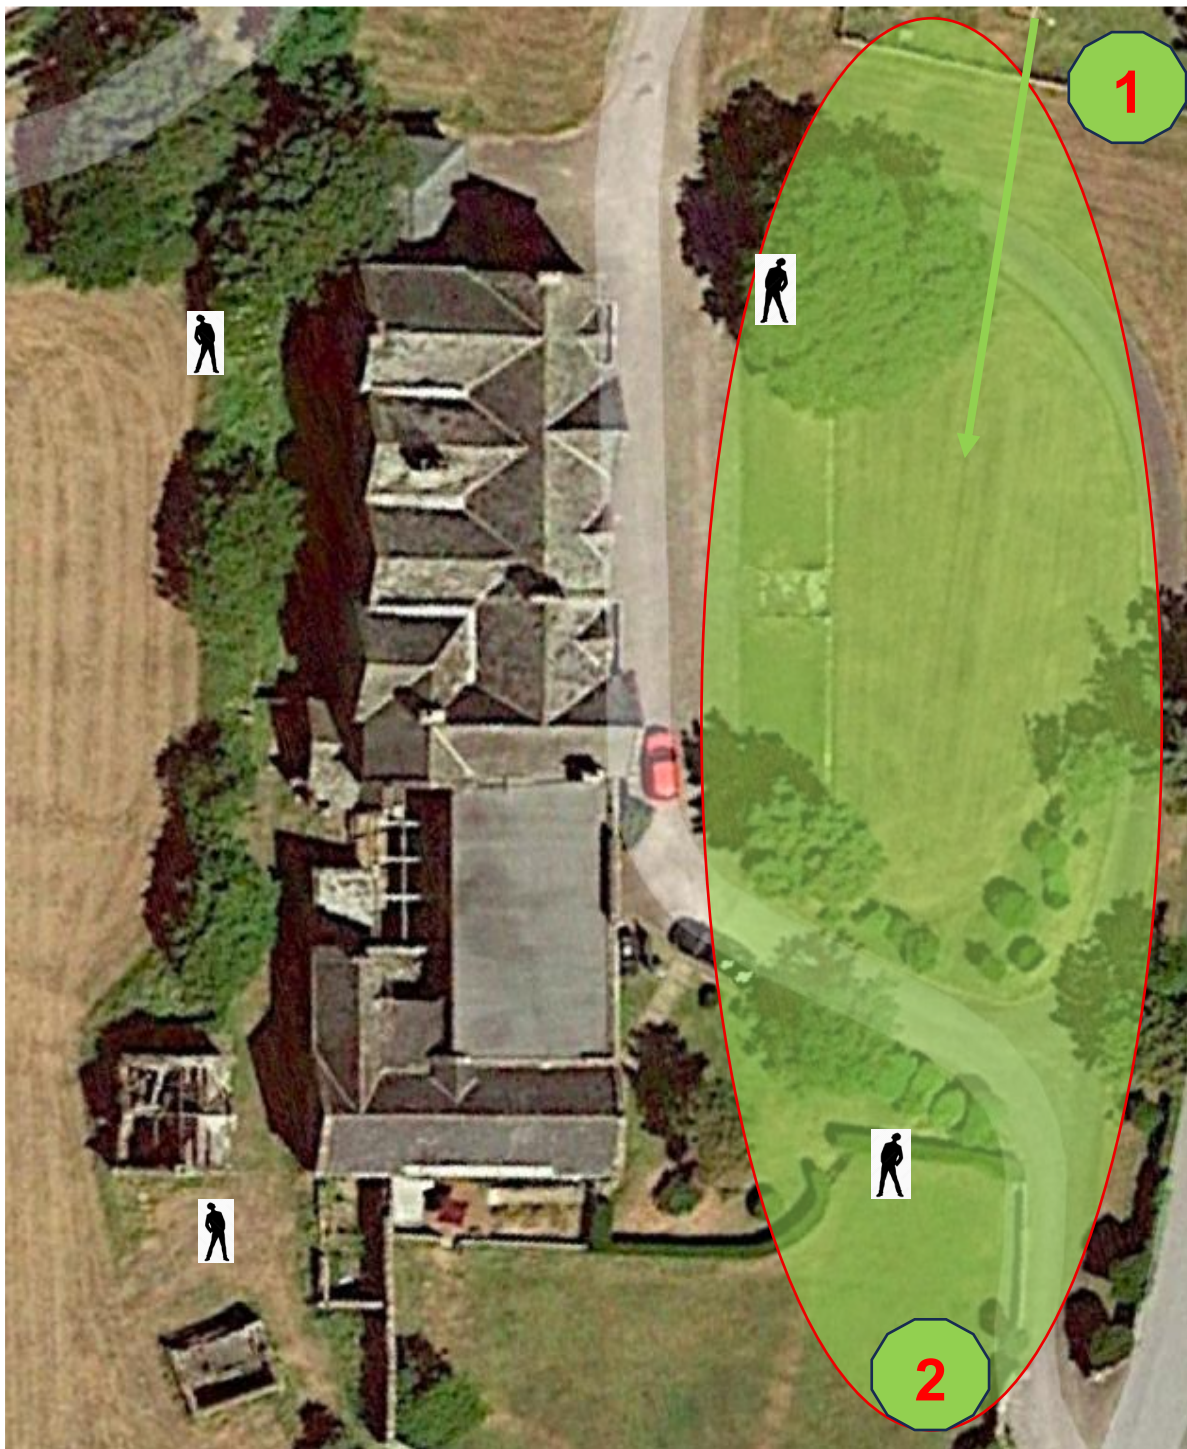
Approximate locations of surveyors during 4 point Dusk Emergence Survey. These positions allowed all elevations of the building to be covered.

All surveyors had bat recording equipment and night vision equipment (Infra-red or Thermal Imaging) which was employed after dusk to record any emergence or re-entry activity. No emergence or re-entry was recorded in/on any area of the building
