**Site Inspection (Bats) - Former Magistrates Court/Doctors Surgery, Catherine Street, Whitehaven, Cumbria, CA28 7QT**

**Our Ref. No.: GB21BAT27**

**Date: 06 June 2021**

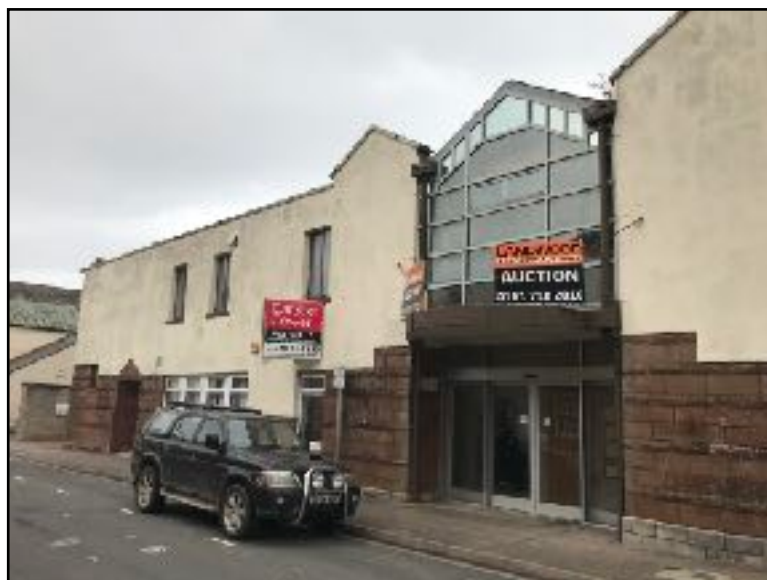
**Figure 1:** Showing the front (south eastern elevation) of the Former Courts.

The Former Courts building appears to have been erected in 1987 and is constructed of block, with a dressed sandstone facade on the ground floor frontage and rendered above. The building is primarily 'flat' roofed, but with pitched slate clad sections in the centre and at the extreme north eastern end. Gable wall tops are capped with coping stones and no exposed verges exist anywhere on the building. The external walls are in a good state of repair and do not offer any gaps or crevices which could be used by bats. All door and window openings are secure and no internal access for bats or birds is available. Internally some 'stripping out' has occurred. Ceilings throughout have been removed to expose the hot-roof decking above. The hot-roof has been installed with foil coated rigid insulation boards which are very tightly fitted. The pitched roof sections contain vaulted ceilings with no internal roof void above.

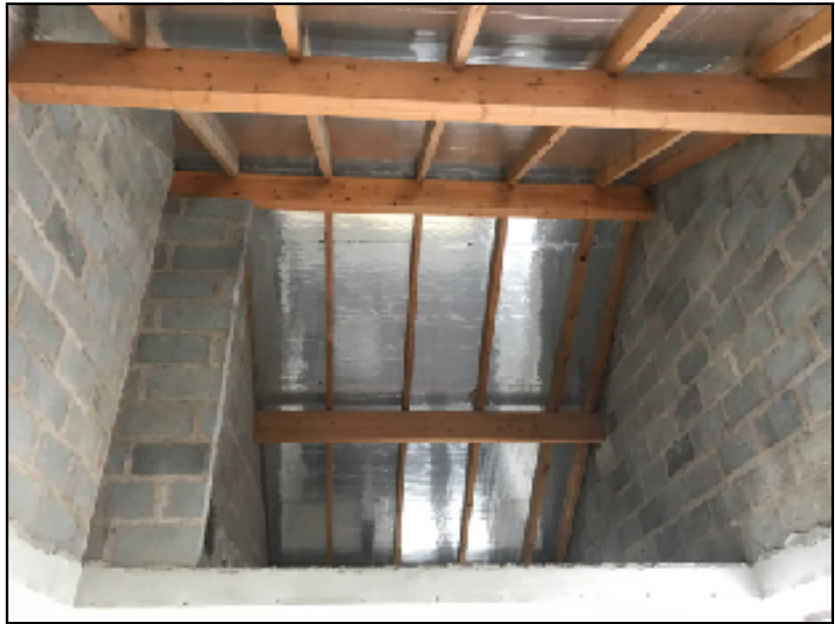
**Figure 2:** *Showing example of the rigid panel insulation.*

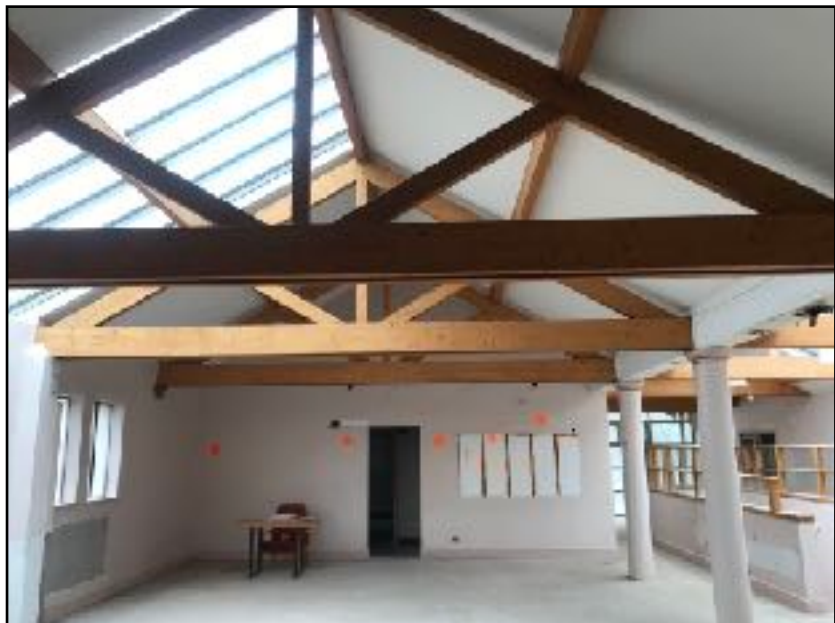
**Figure 3:** *Showing example of the vaulted ceilings.*

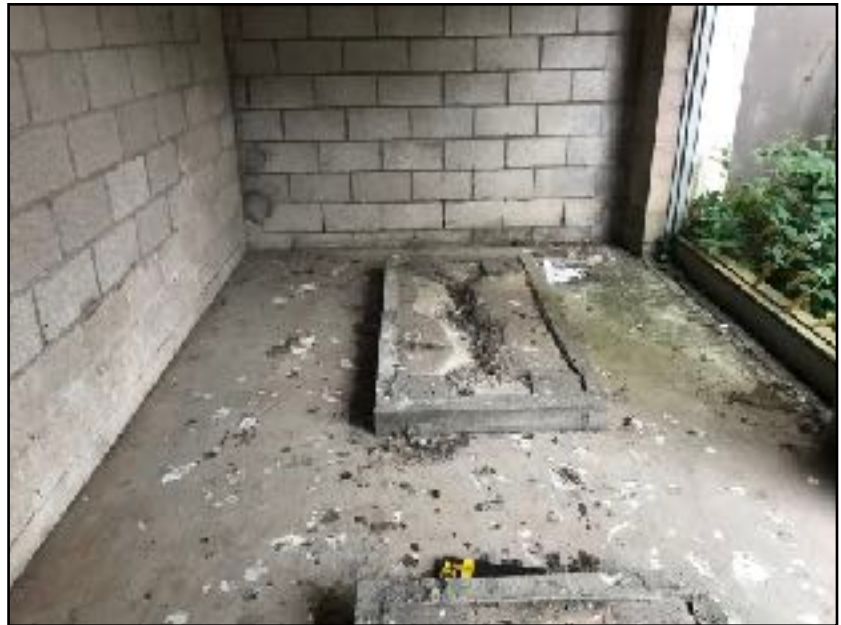
Gull droppings were found to be abundant across the site; the pitched roofs are heavily streaked with droppings and the carpark area to the rear of the building (including the interior of an open storage shed) are heavily soiled. The amount for droppings, along with the pattern of deposition, suggest that gulls have nested either on the building or on adjacent buildings. The presence of droppings within the open storage shed to the rear of the building strongly suggests the presence of pre-fledging juveniles in the rear yard.

**Figure 4:** Showing example of gull droppings in rear yard.

There is considered to be 'high' potential for *Larus* species gulls to nest on the roof of the building. No further surveys are required, but appropriate mitigation measures should be adopted to avoid harm to breeding birds contrary to The Wildlife and Countryside Act (1981).

- No complete nor partial demolition of the building should commence during the bird breeding season (March - August inclusive).
- The building should be maintained in a secure state between the present time and any works commencing. Should any access for birds be created, there would be a high risk of pigeons occupying the internal areas.
