## **BAT SURVEY AT**

**Quarry House, Millom**

Author	Andrew Gardner	Date	15.10.2025
Checked by	Andrew Gardner	Date	15.10.2025
Report Version	1		
Field data entered	<input type="checkbox"/>		
Report Reference	9996

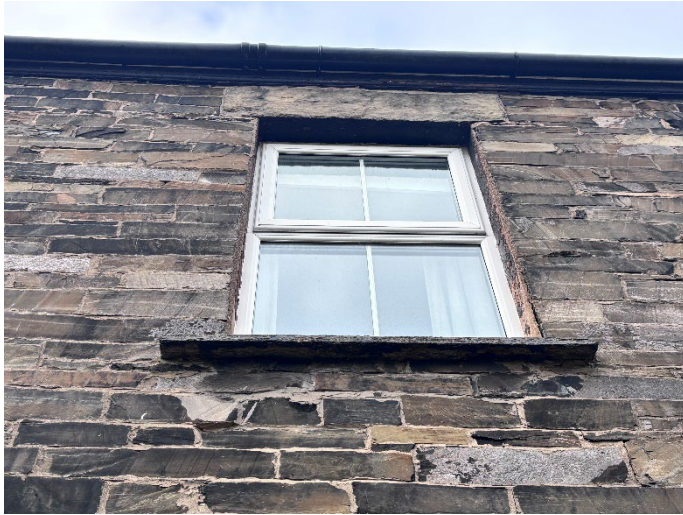
The walls of the building are made from natural stone. On the North, West and South elevation they are rendered. The rendered is in placed cracked but this does not provide potential roost sites. On the East elevation the natural stone is exposed but well jointed and also provides not potential for roosting bats.

Photograph	Notes
 	<p>The East elevation comprises well jointed stone</p>
 	<p>Other walls are rendered which fully seals the wall tops</p>

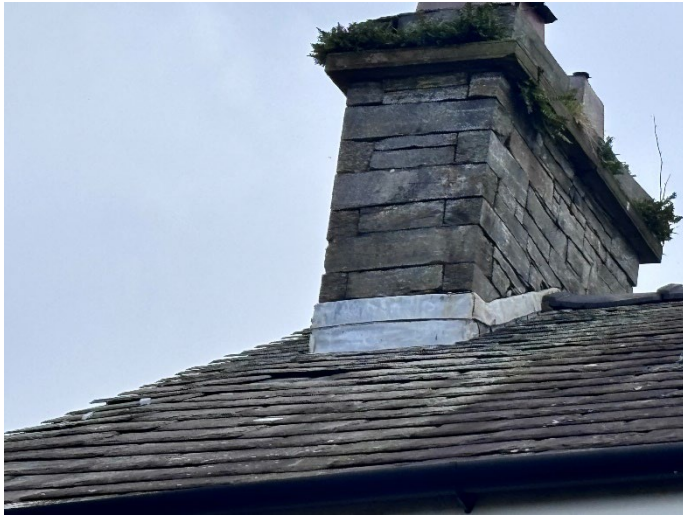
Stone walls are fully sealed

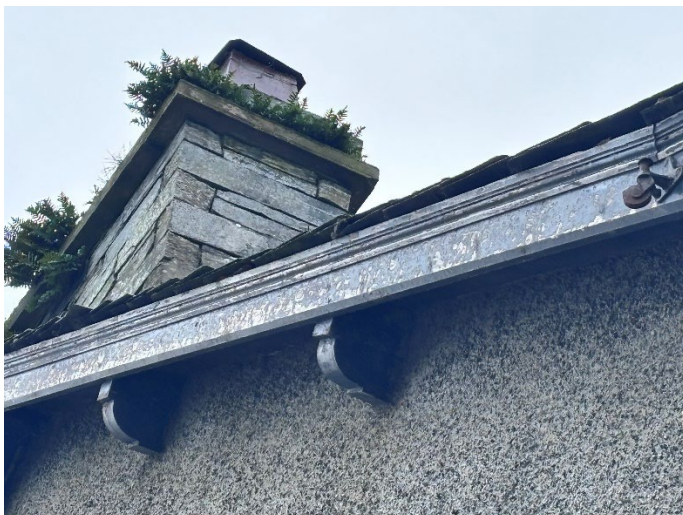
Chimney is fully sealed and well jointed

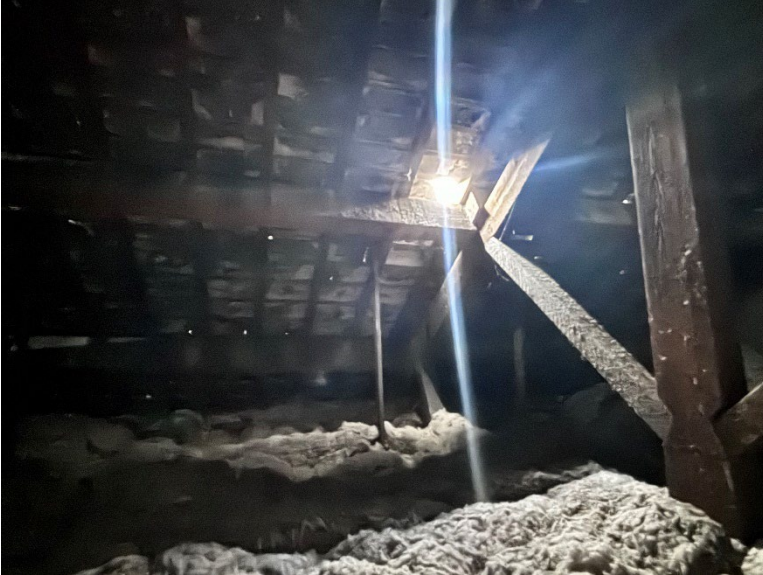
The roof of the building is made from slate and is unlined. There were occasional missing slates from the roof on both roof pitches but as the roof is unlined these do not create suitable roost sites. The ridgeline appears well sealed. The full extent of the roof could be seen from the ground with close focus binoculars and a 1,000,000-candle power torch. No indications of use by bats could be found. As the roof is unlined any use of the roof would also result in droppings being deposited internally.

The roof void is open and light due to missing slates

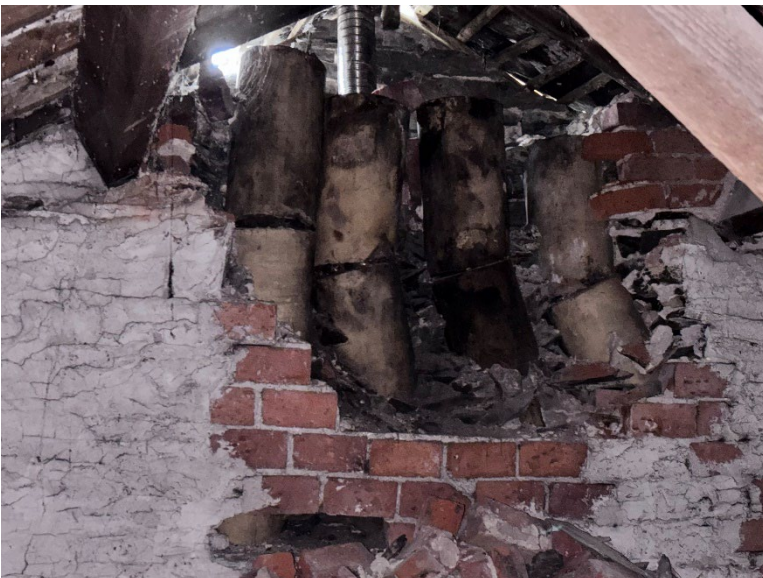
The internal walls of the house are unavailable to roosting bats as they form part of the residence. Within the roof void the North gable was found to be fully sealed. The South gable wall has collapsed into the roof void and is unstable. There was a thick covering of cobwebs and dust in these areas.

The gable walls has collapsed into the roof void and is unstable
