BAT SURVEY AT BRIMFULL, HAILE, EGREMONT, CA22 2PD

Author	Bradley Foster	Date	10/06/2022
Checked by	Andrew Gardner	Date	14/06/2022
Report Version	2		
Field data entered	<input checked="" type="checkbox"/>		
Report Reference	7967

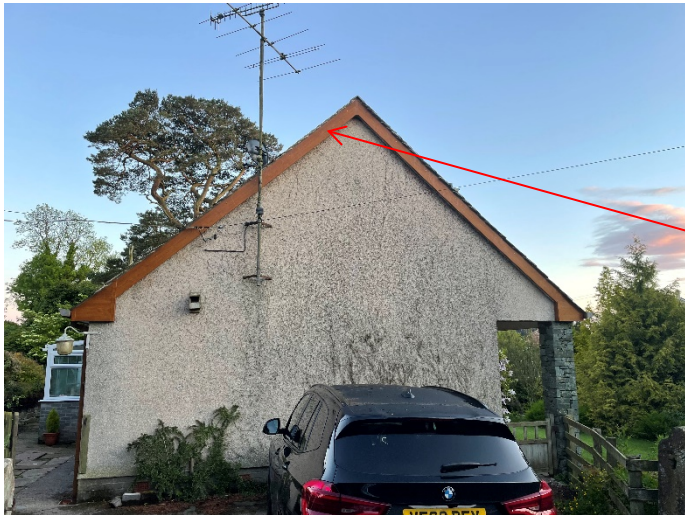
The north north-eastern gable. All bargeboards sat flush with the walls and were well-sealed.

The barge boards at both gable ends are also in good condition, remaining flush against the external walls.

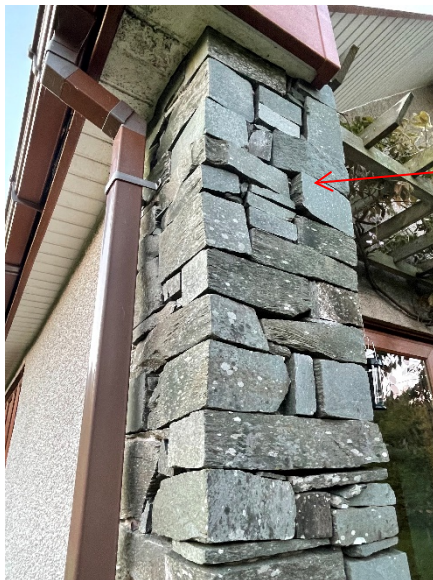
Gaps between the natural stone of the porch columns.

A number of gaps were however noted between the natural stone of the porch columns around the front of the property. This is not impacted by the proposal.

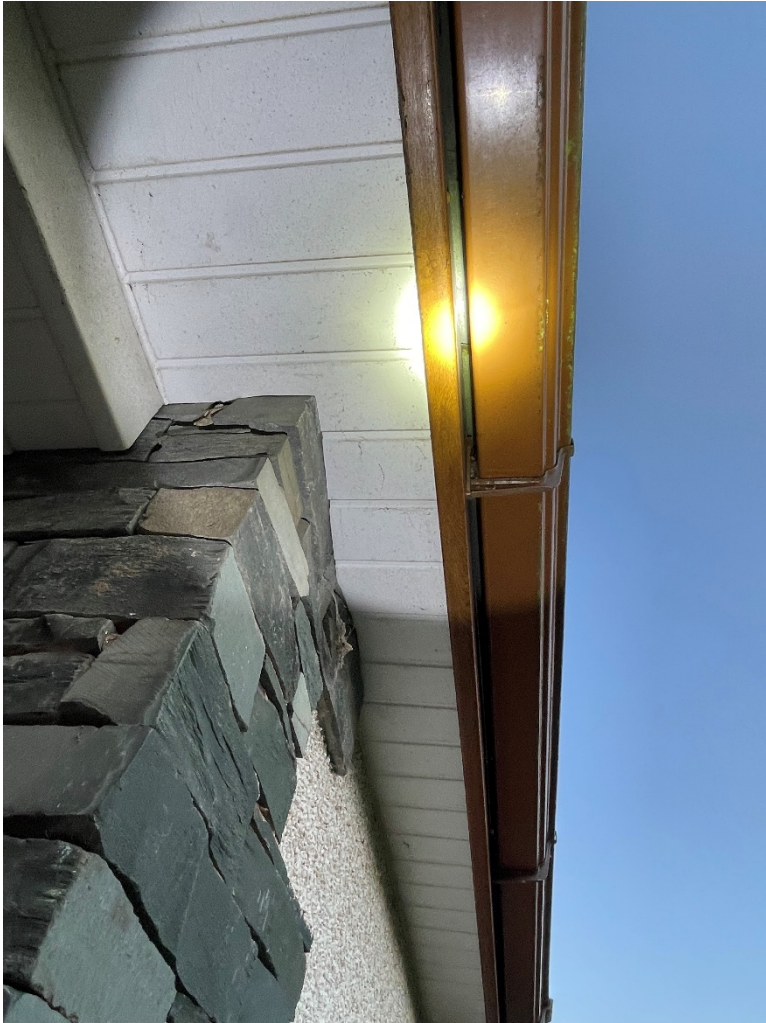
All soffit boards were in excellent condition around the full perimeter of the property.

The eaves are well-sealed around the entire perimeter of the house, with no gaps or cracks noted in any of the fascia or soffit boards. There were no indications of roosting by bats in these areas.

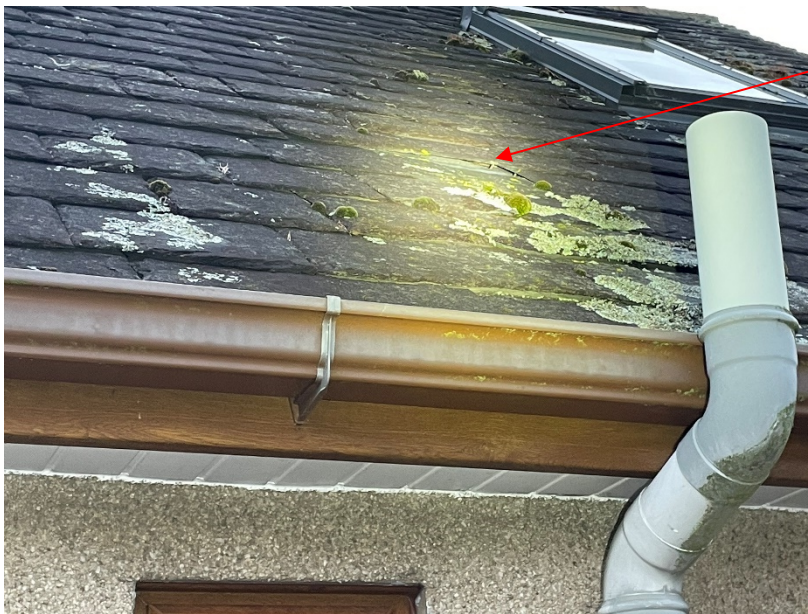
Slipped slate on the eastern roof pitch. Gaps beneath are small and bat entry is unlikely

The roof of the building is made from slate and is lined. There were a number of raised and slipped slate tiles along the bottom of the eastern/rear roof pitch. A few cracks were also observed in some of the hanging tiles around the dormers to the rear of the property. The ridgeline is however well-sealed with mortar. The full extent of the gaps could be seen from the ground with close focus binoculars and a 1,000,000-candle power torch. No indications of use by bats could be found.

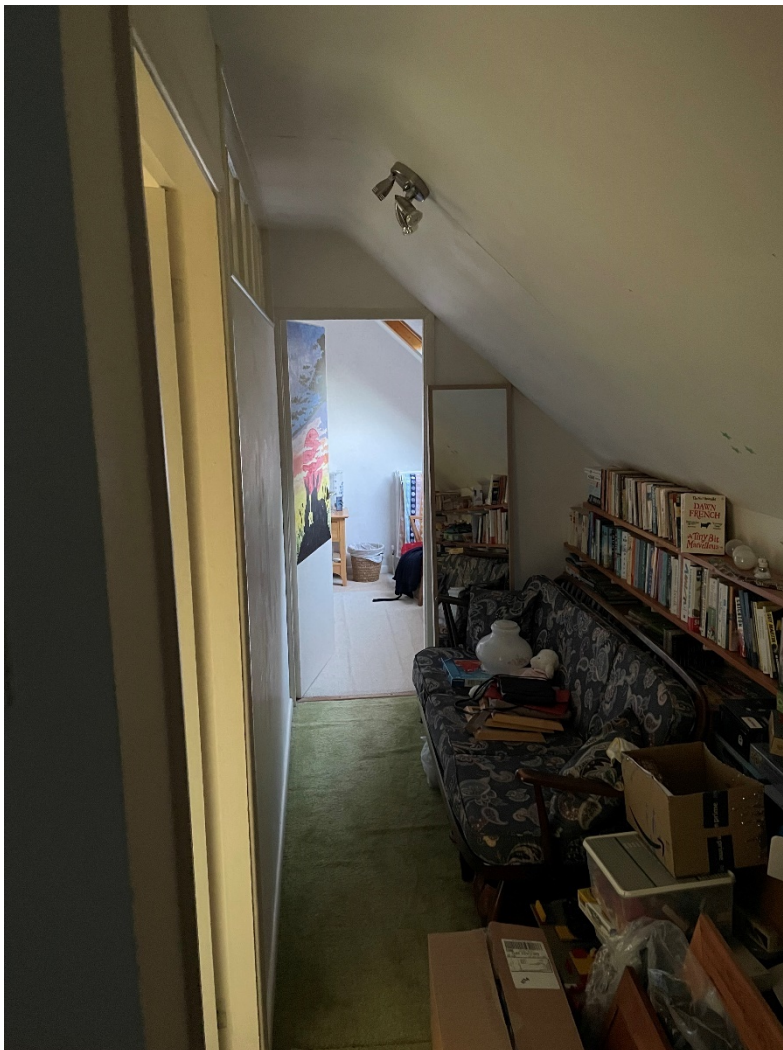
The majority of the property's roof void space was converted by the previous owners.

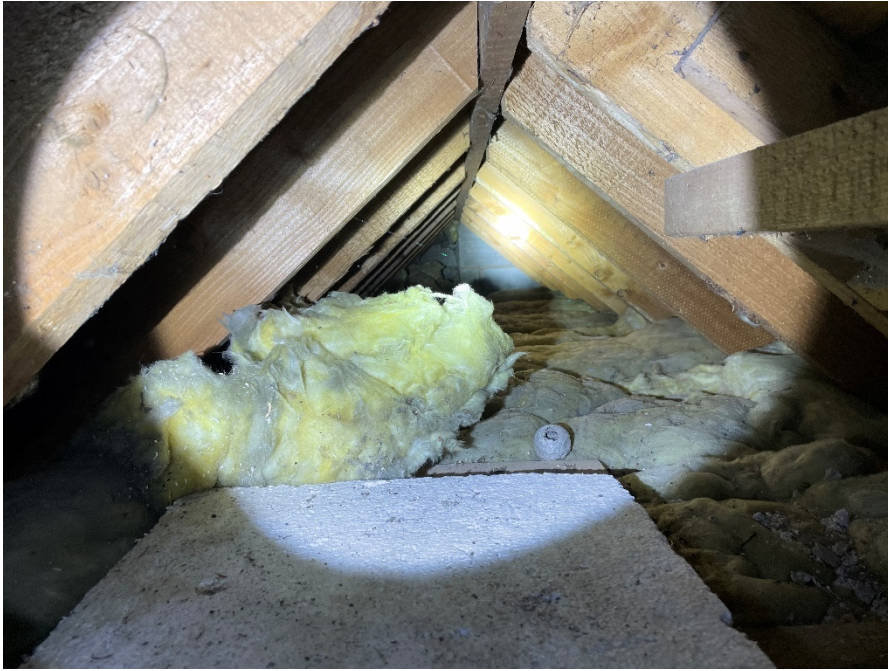
Remaining roof void space beneath the ridge of the roof is small and cluttered

The timber beams in the roof were found to be in excellent condition with no rot, splits or gaps suitable for roosting or hibernating bats. They comprise modern machine cut timbers. To the apex of the roof in the roof void there was a good covering of cobwebs under the roof and spanning the internal space which would suggest bats have not flown within it. Rockwool insulation is present.

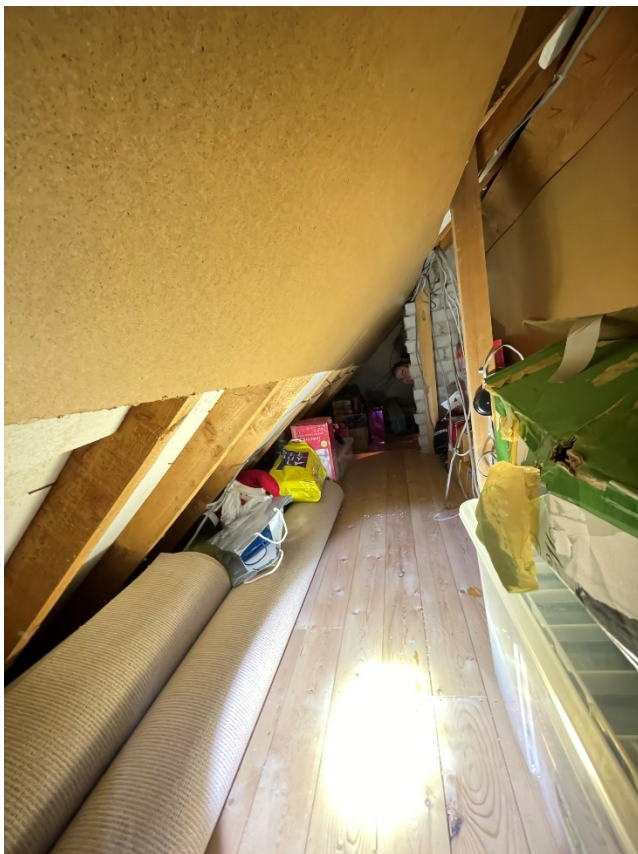
The eaves cupboards are boarded out and used for storage.

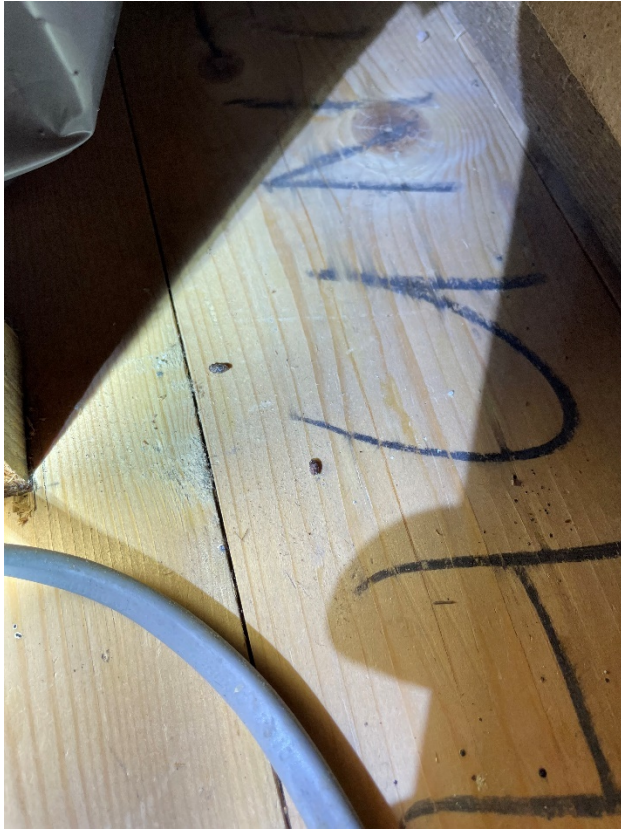
To the eaves are small cupboards which have been board out of the occupied/ converted former roof void. A scattering of old, grey bat droppings were found. These did not appear to be fresh and no potential access points to the eaves cupboards could be found. It is considered the bat droppings are from historical opportunistic use. Perhaps pre-dating conversion of the former roof void.

Occasional old bat droppings were found on the floorspace of the eaves cupboard on the east elevation.
