Protected Species Survey: **Bats and Barn Owls**

Property Surveyed:

Barn at Kelmores Hills Farm
Distington
Workington
CA14 4QY

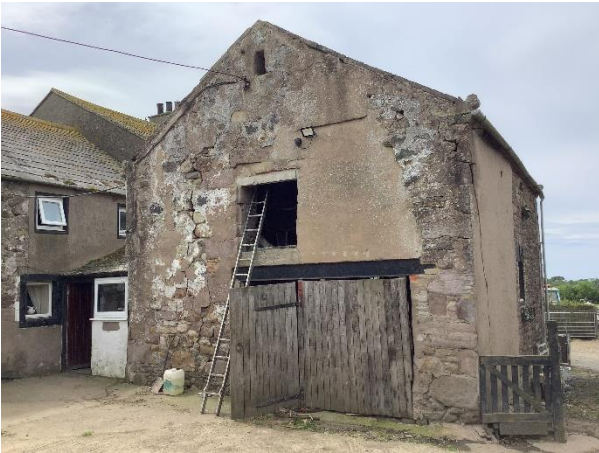
A1) Views of Site: **Front of site**

The site is a sandstone built barn next to the farmhouse. There is a single storey porch between the two. The easterly aspect, which is in danger of collapsing into the yard has a rendered area and some cracks between the stonework. The wall on the northern aspect is well pointed with the eastern half rendered. The western aspect is fully rendered. There is a loft area which is being used for storage with a slate roof and daubing. There are 3 small windows which have tight fitting uPVC frames. There are some single storey calf hulls directly to the north east which are brick built with a slate roof which is in a state of disrepair.

No signs of bats were seen in or around the site and no bats were seen leaving the site during the emergence survey. No bats were seen entering the site during the dawn survey. There was no potential bat habitat in the walls of the northern, southern and western aspects. There was limited potential for bats in the cracks in the wall on the eastern aspect, these were inspected and no signs of bats were detected.

Although no signs of bats were found at the site, great care must be taken when work commences. If bats are seen or suspected then work must stop and further advice be sought from the acting Consultant.

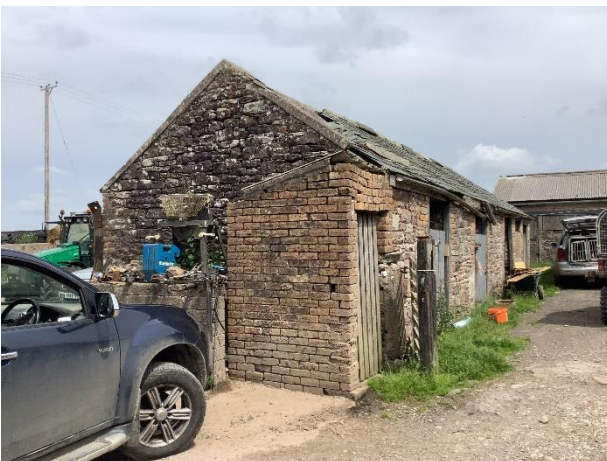
Calf Halls

It is the surveyor's opinion that bats are not using this site. The calf hulls had no potential bat habitat.
