BAT SURVEY AT

Newton Back Barn, near Millom

1. EXECUTIVE SUMMARY

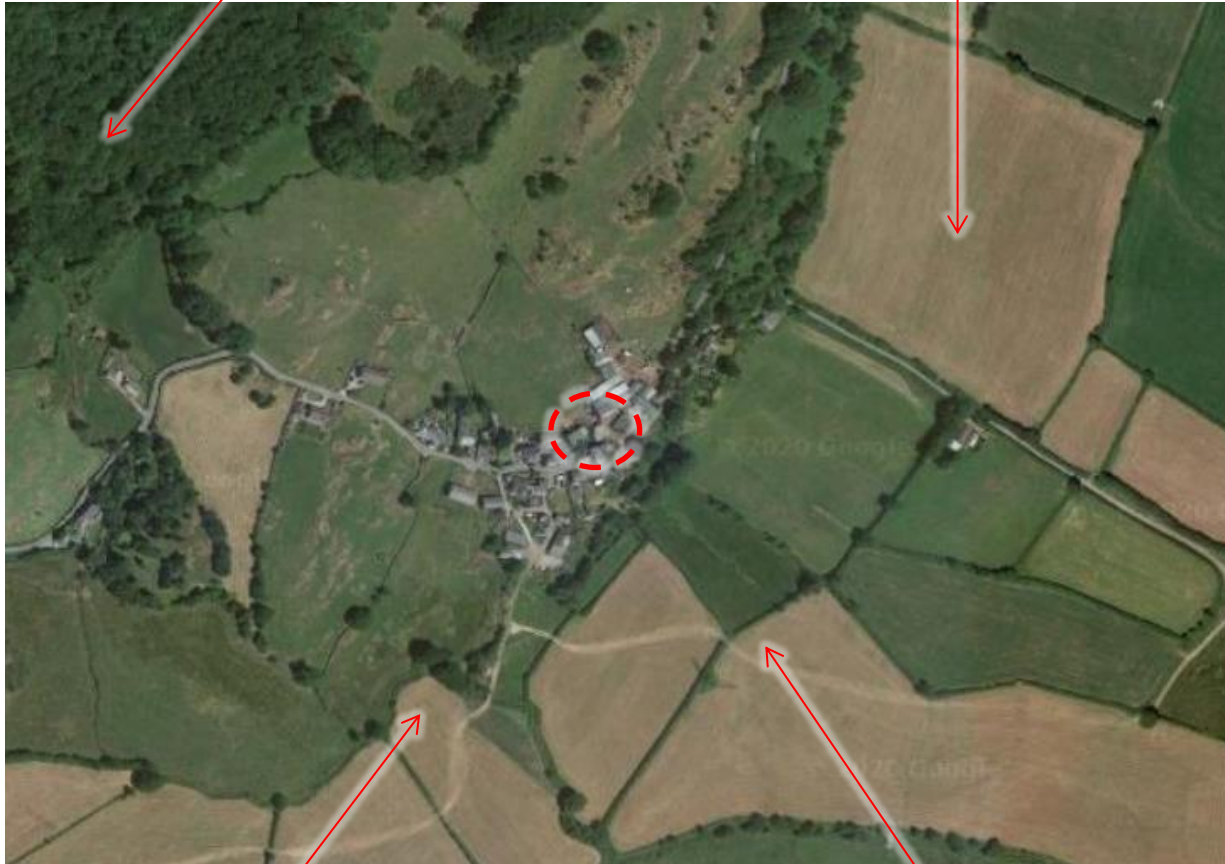
The habitat at and adjacent to the site was assessed from satellite imagery this was then ground truthed, Figure 5.

Connected woodland, likely to offer moderate foraging potential.

Open fields, likely to offer low quality foraging potential

Scattered trees, likely to offer low-moderate foraging to potential

Hedgerows, likely to offer moderate quality foraging potential

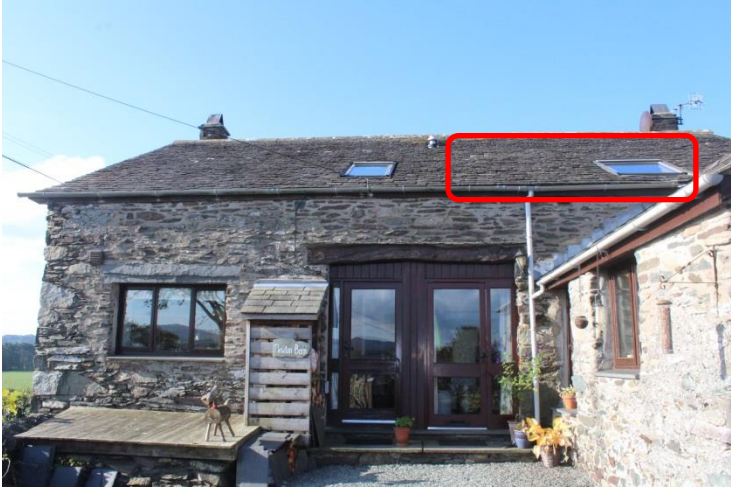
<p>East elevation:</p> <p>Location of proposed roof lights</p> <p>Walls are well sealed</p>

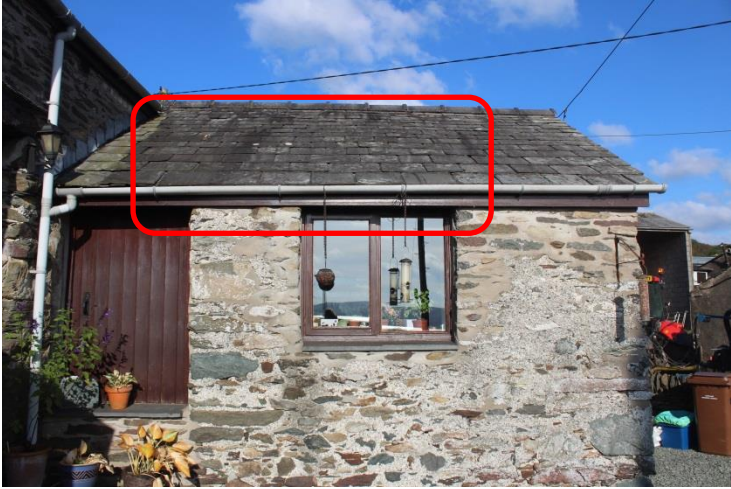
<p>South elevation:</p> <p>Location of proposed roof lights</p> <p>Ridge is well sealed. Lead flashing tightly fitted</p> <p>Walls are well pointed and therefore well sealed</p>

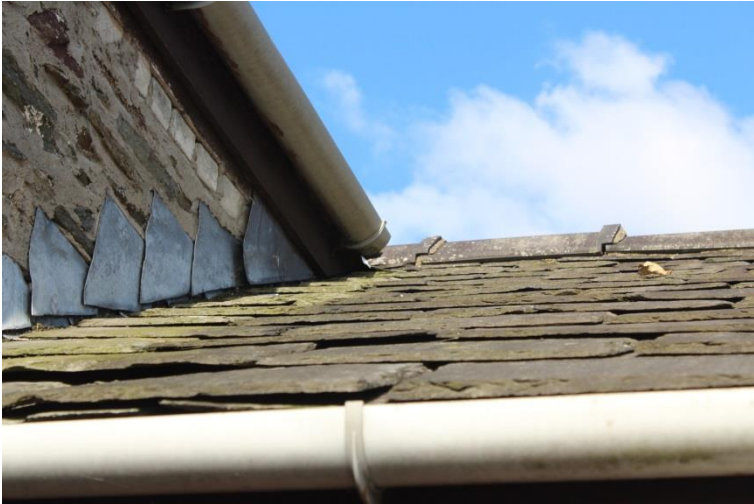
<p>South elevation</p> <p>Lifting slates suitable for roosting bats</p>

1. A bat box should be installed on a mature tree on the South/West elevation of the building where it will not be affected by the building works.
2. The slates to be removed should be removed by hand only. The slates removed should be fully inspected for signs of bats. Bat droppings will crumble to dust if squashed where as mouse droppings will remain solid like a grain of rice.
3. **If bats, bat droppings or bat roosts are found during work, all work should cease.** The site will need to be re-assessed in regard to its use by bats. A Natural England licence may be required if continuing work is, on balance, likely to result in the

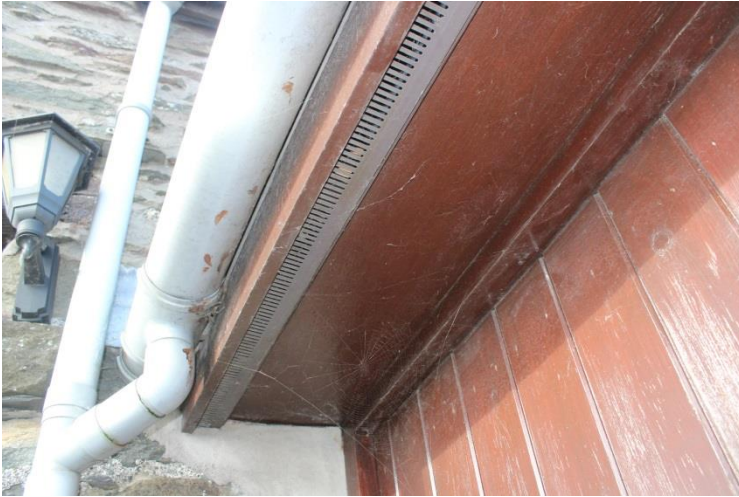
The walls of the building are made from natural stone and are well pointed with mortar. The wooden soffits are in an excellent condition and well sealed.

Wooden soffits are in excellent condition and are well sealed, these offer negligible potential for roosting bats.
