# **Protected Species Survey:**

## **Bats**

Windscale Club  
Gosforth Road  
Seascale  
CA20 1PJ

17/10/2022

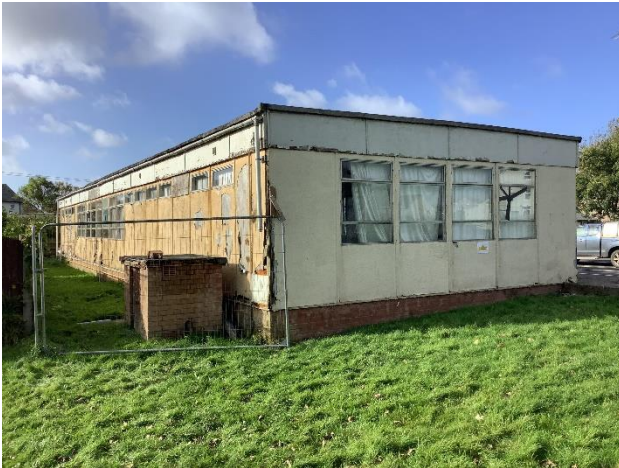
#### **Rear of Site**

The site is a former club house in the village of Seascale. It measures approximately 26 x 8 metres and 3.5 metres to the guttering. It is built with wooden sheets coated with concrete render onto a wooden framework and has tight fitting metal window frames. It has a flat felted roof. The building is in a state of disrepair and has asbestos throughout.
