BAT SURVEY AT

Swimming pool building at Brockwood Hall, near Whicham

Author	Amy Riley	Date	19 th March 2021
Checked by	Andrew Gardner	Date	22 nd March 2021
Report Version	2		
Field data entered	<input type="checkbox"/>		
Report Reference	2691

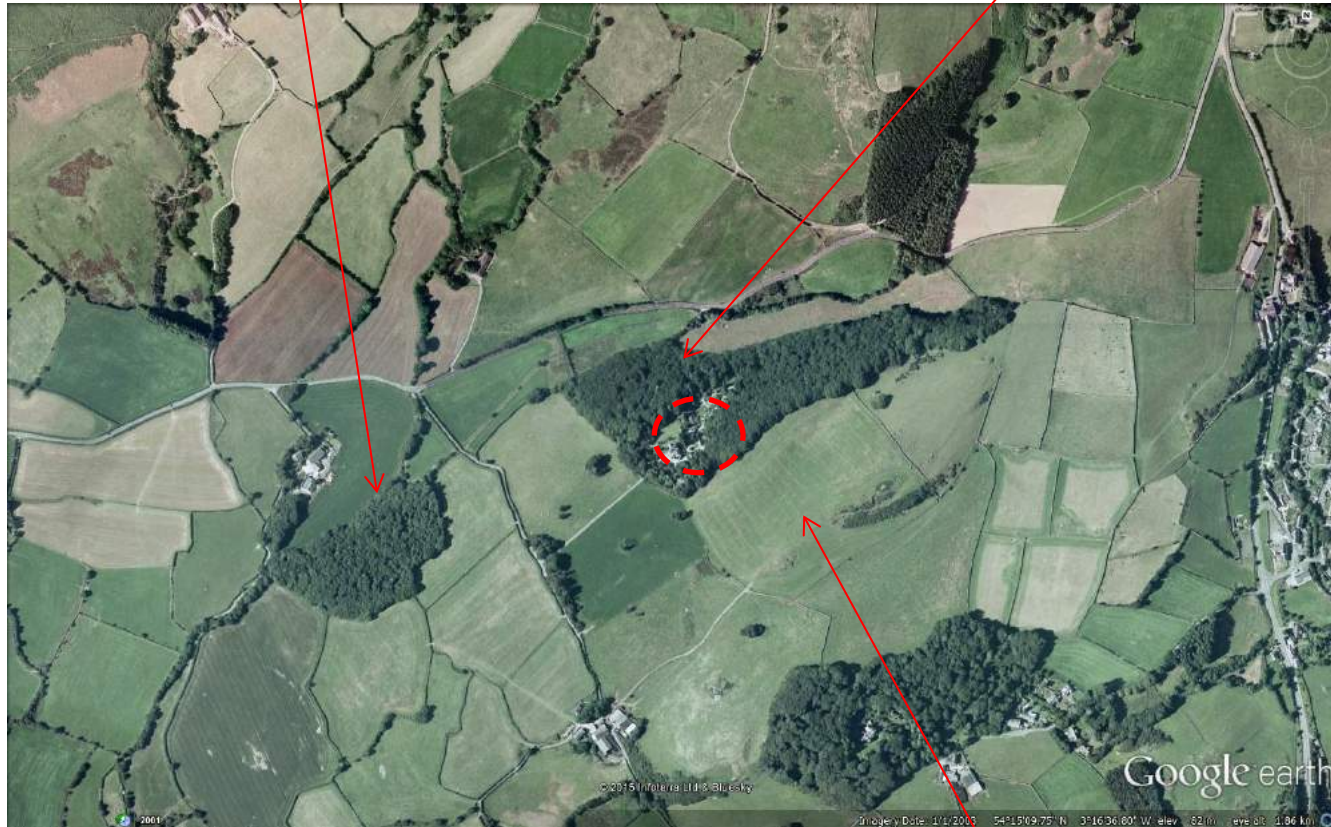
The habitat at and adjacent to the site was assessed from satellite imagery this was then ground truthed, Figure 5.

Other fragments of woodland occur nearby, but these are poorly connected to the site

Mixed woodland which encompasses the site is of high value to bats

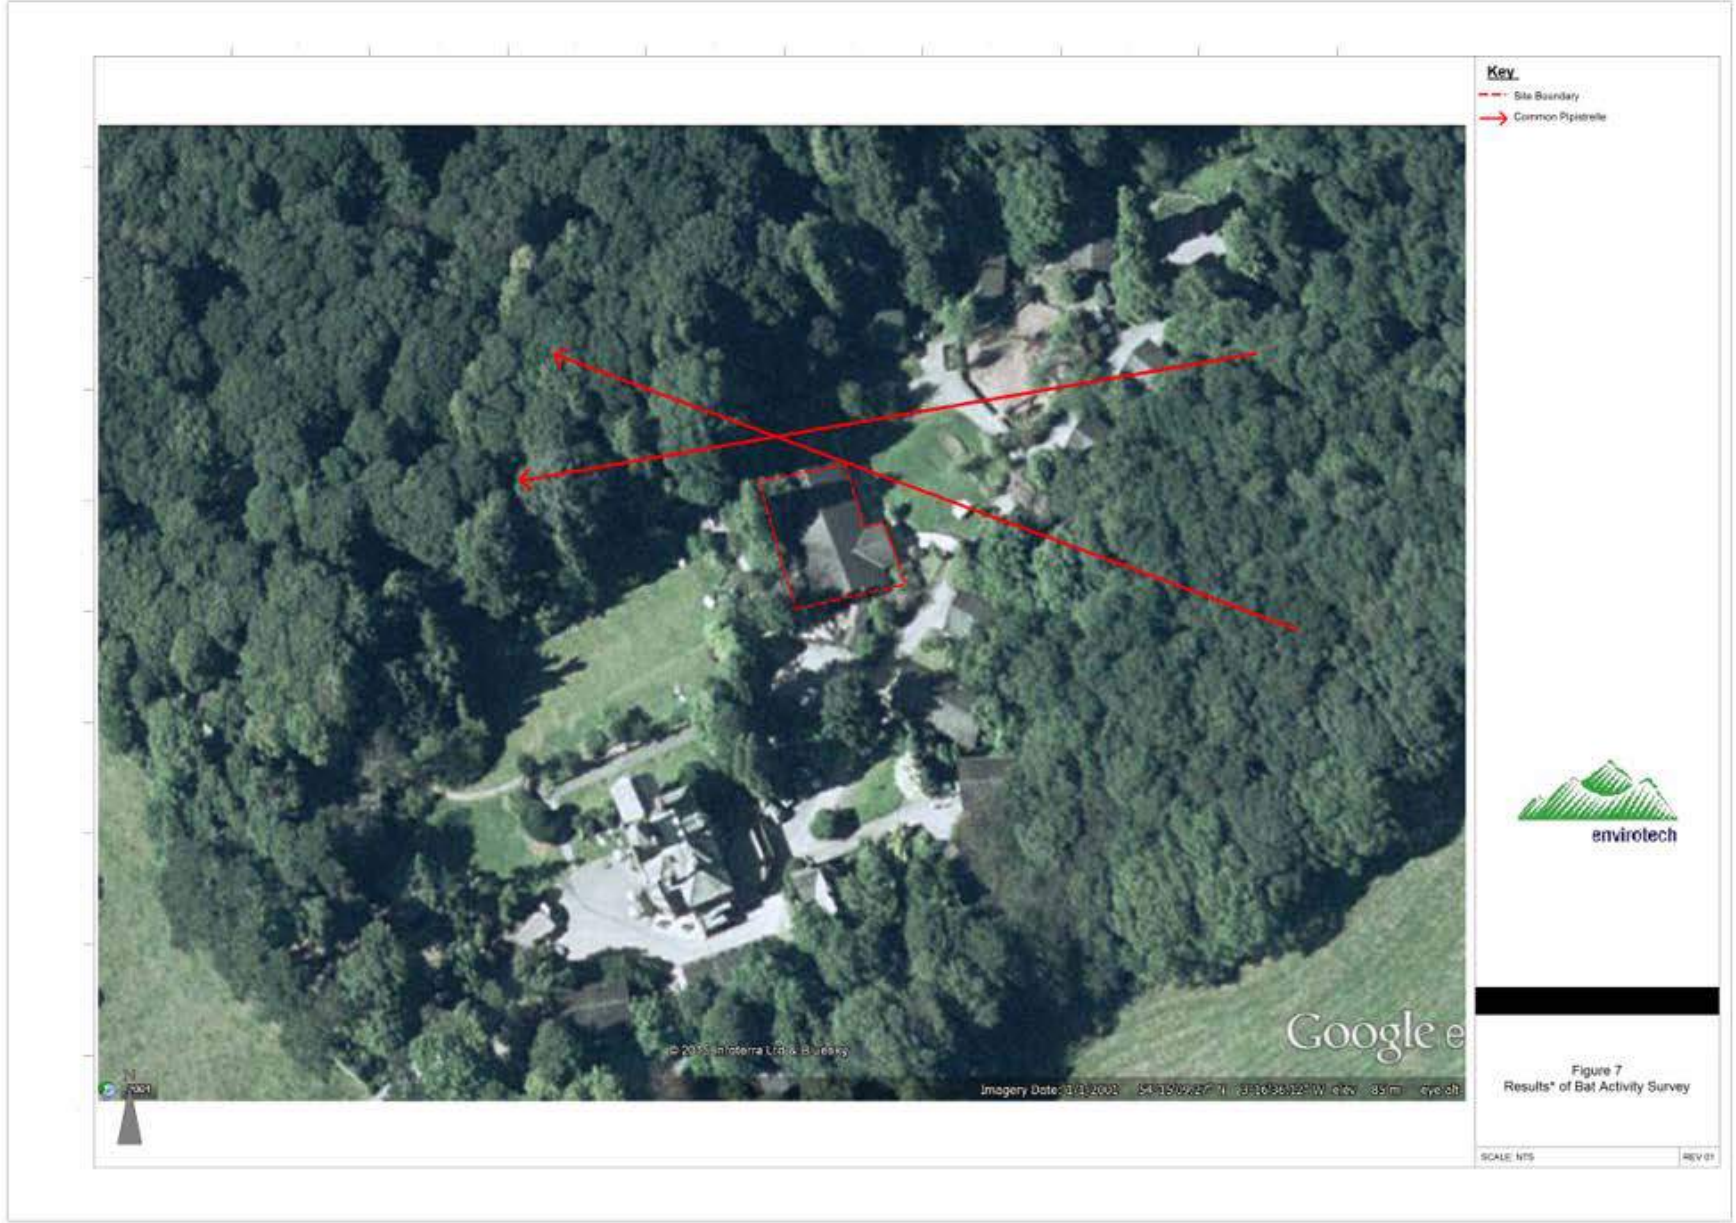
The survey was terminated when light levels reached 0.2 Lux and seeing bats became difficult. Possible use of the site by late emerging species was discounted as possible during the daytime inspection.

Bat activity is plotted on Figure 7.

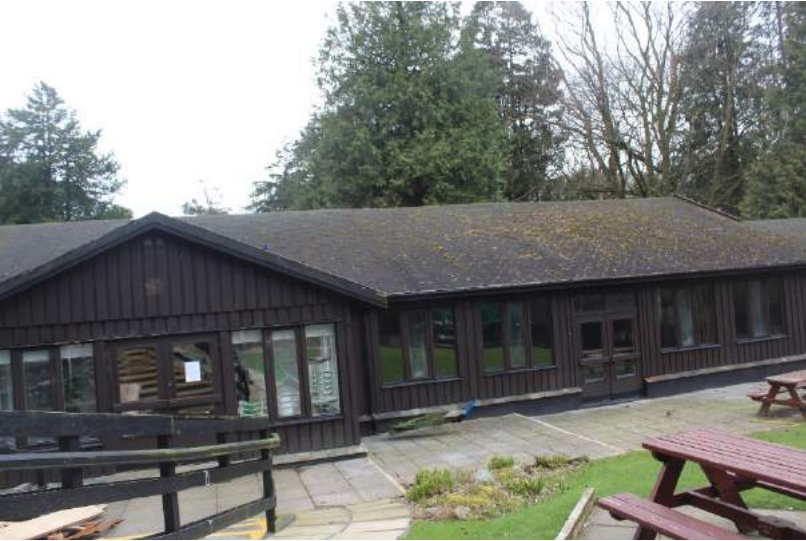
<p>The building is constructed from wood under a bitumen felt tiles.</p> <p>The roof is in excellent condition, tightly fitted and does not offer any roosting opportunities.</p> <p>The building is clad in wooden panels</p>

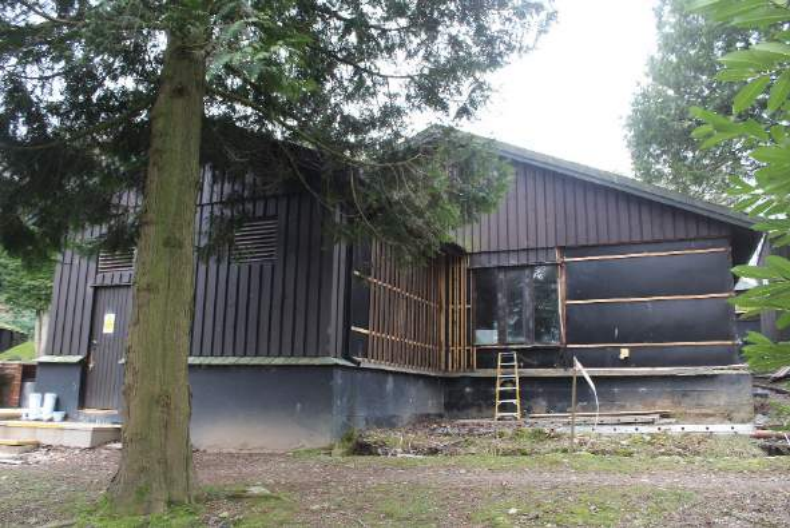
<p>Part of the wooden cladding has been removed on the North elevation revealing a membrane.</p>

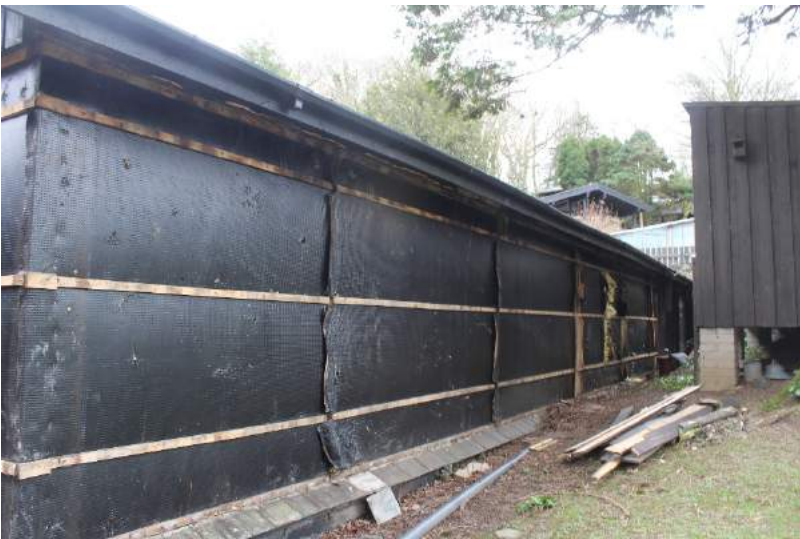
<p>The wooden cladding on the West elevation has also been removed revealing a waterproof membrane.</p>

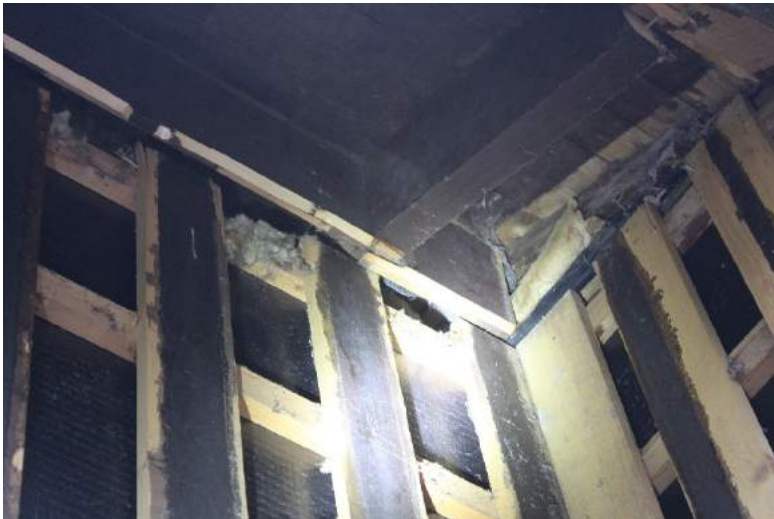
The walls of the building are made from timber boards. These are in a good condition. However sections of the wooden boards have been removed from part of the North West elevation. This has created gaps along the eaves which could be utilised by roosting bats. These boards were removed less than a week before the survey was undertaken. This area of the building is shaded from nearby trees which would result in colder walls. The temperatures at night have been low since the boards were removed which would reduce the activity of any bats that were active. No evidence of bats were found within these areas.

Where the cladding has been removed there are gaps that have formed. However the areas of cladding that have been removed are shaded suggesting these areas would be cold. The cladding was removed less than a week before the survey was undertaken.

Building works had commenced and panels on the North and West elevation had been removed, although this has created gaps there was no evidence of use by bats. This area of the building is shaded and cold which would reduce the likelihood of the gaps being utilised. If signs of bats are found during demolition all works must cease and an Ecologist contacted.

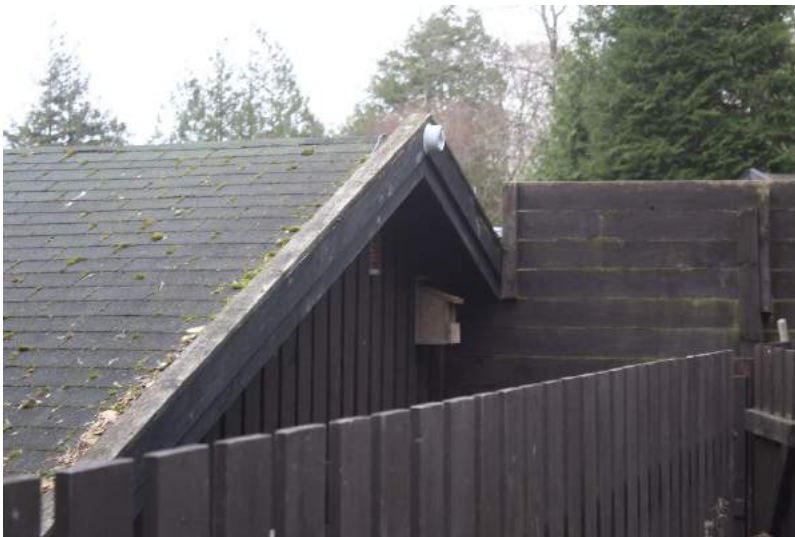
A robin box was found, this was inspected for signs of nesting and was found to be free from nesting birds. The box was advised to be removed immediately after the survey to prevent birds from nesting within the box. Birds are protected whilst actively nesting.

If birds are observed nesting within the box or building a delay in the commencement of works may be required.
