## BAT SURVEY AT

Swimming pool building at Brockwood Hall, near Whicham

Author	Amy Riley	Date	19 <sup>th</sup> March 2021
Checked by	Andrew Gardner	Date	22 <sup>nd</sup> March 2021
Report Version	2		
Field data entered	<input type="checkbox"/>		
Report Reference	2691

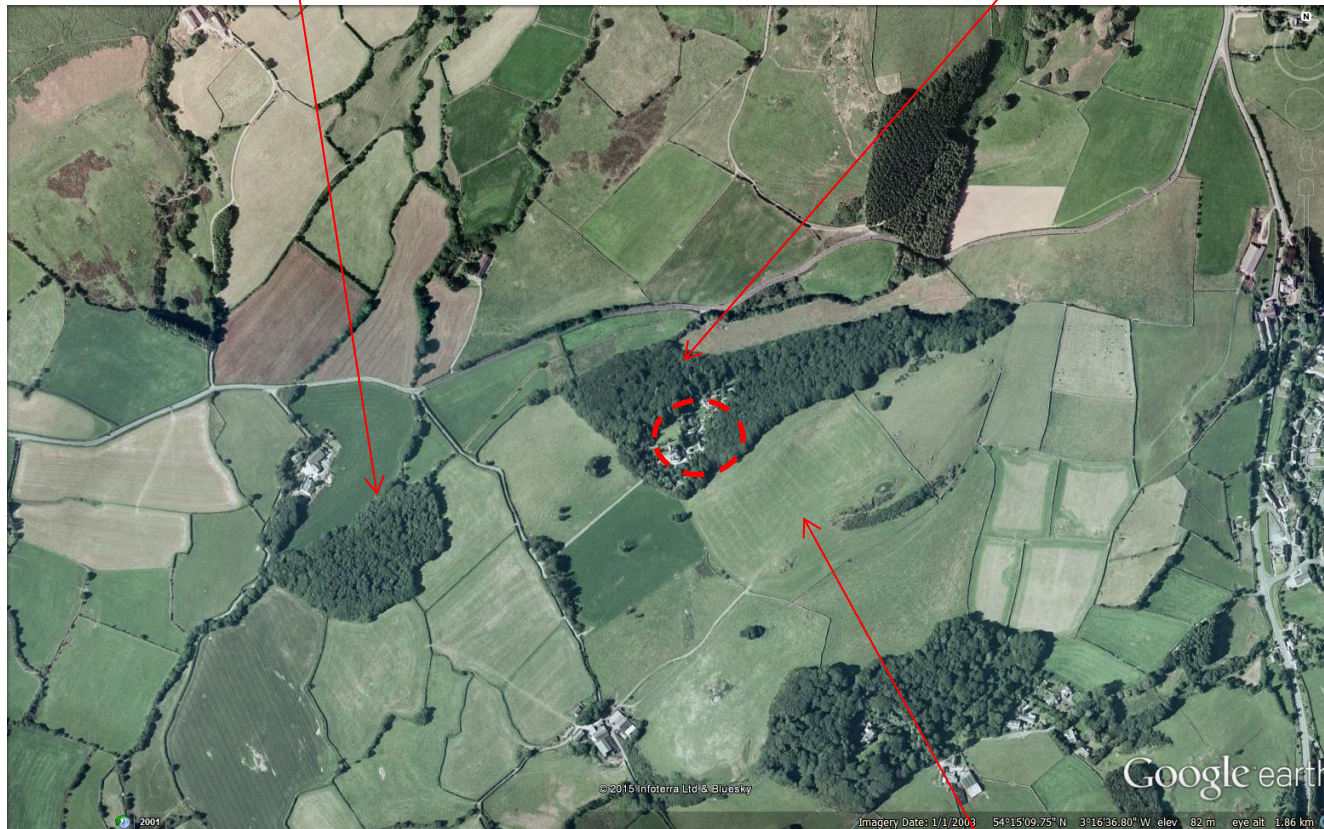
**Key**  
--- Site Boundary

The habitat at and adjacent to the site was assessed from satellite imagery this was then ground truthed, Figure 5.

Other fragments of woodland occur nearby, but these are poorly connected to the site

Mixed woodland which encompasses the site is of high value to bats

The habitat on and adjacent to the site identified from satellite images was ground truthed. Details of the habitats found on and adjacent to the site are detailed in Figure 5.

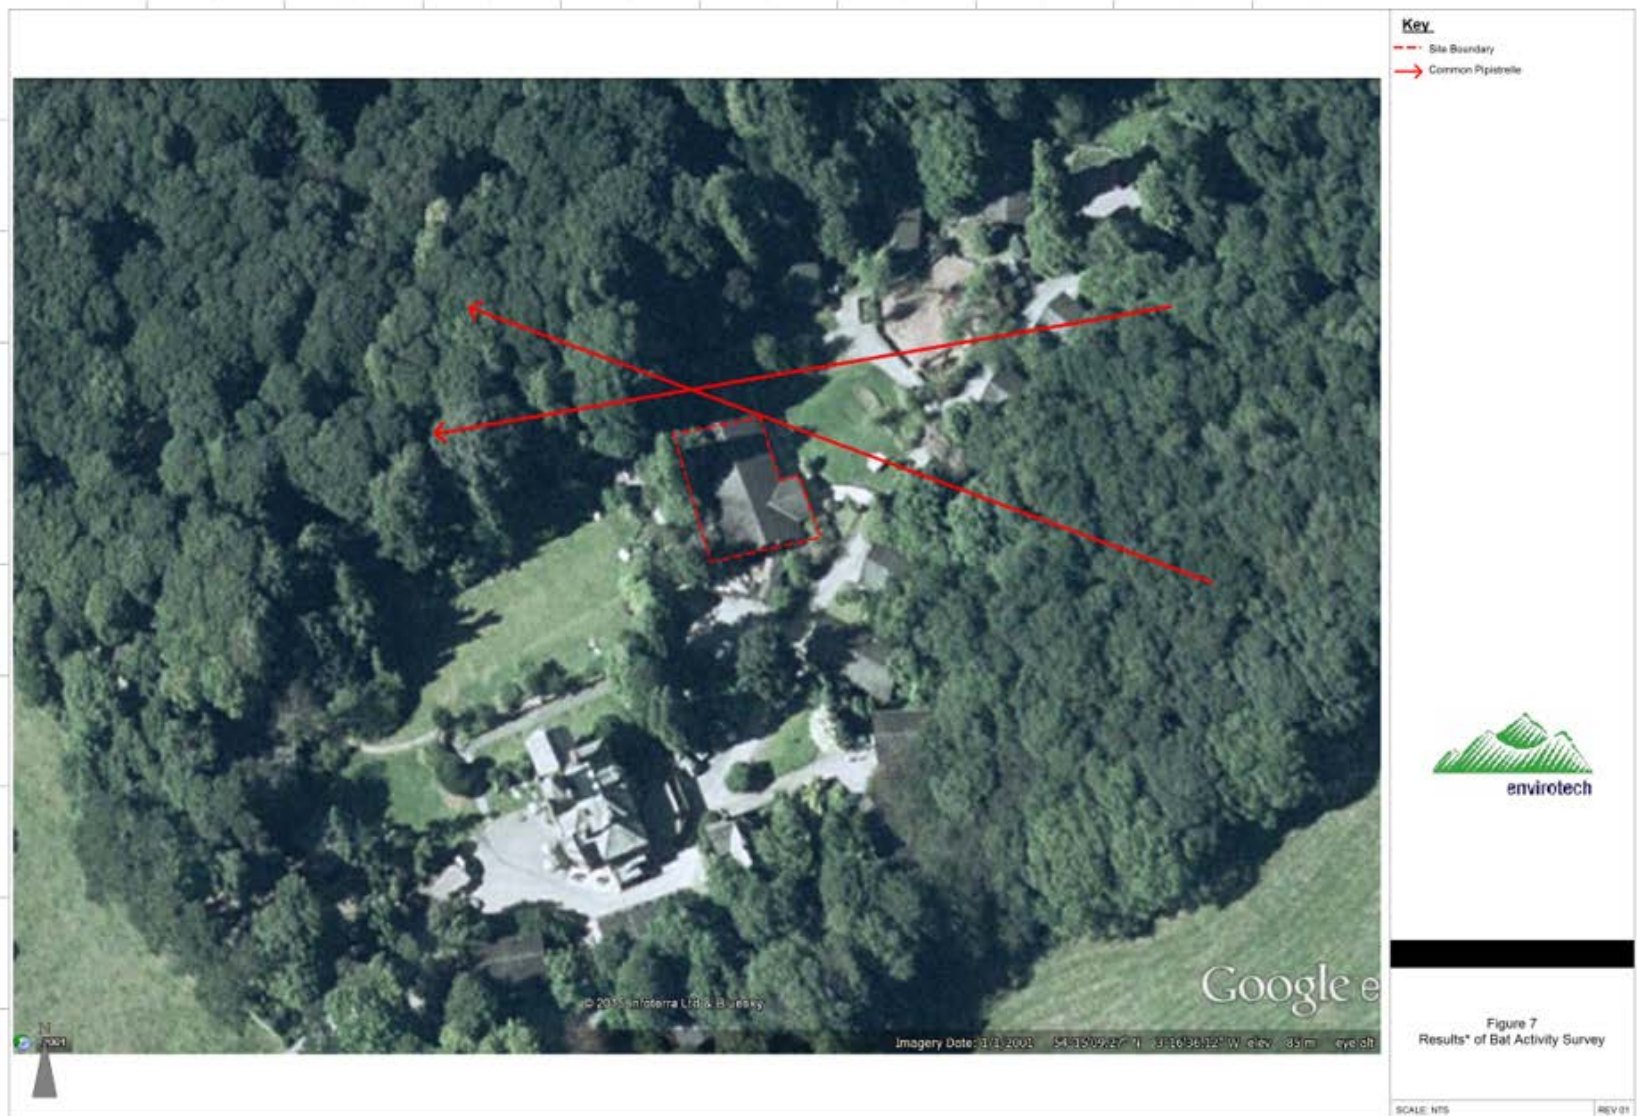
The survey was terminated when light levels reached 0.2 Lux and seeing bats became difficult. Possible use of the site by late emerging species was discounted as possible during the daytime inspection.

Bat activity is plotted on Figure 7.

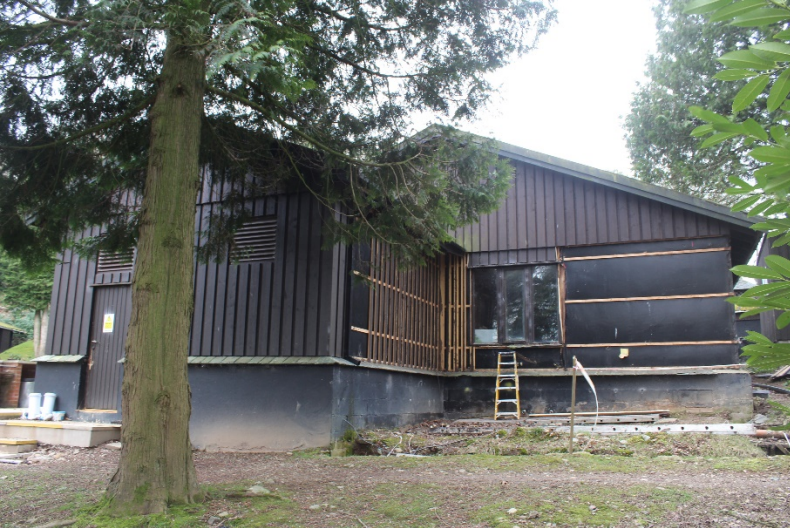
Photograph	Notes
 	<p>The building is constructed from wood under a bitumen felt tiles.</p> <p>The roof is in excellent condition, tightly fitted and does not offer any roosting opportunities.</p> <p>The building is clad in wooden panels</p>

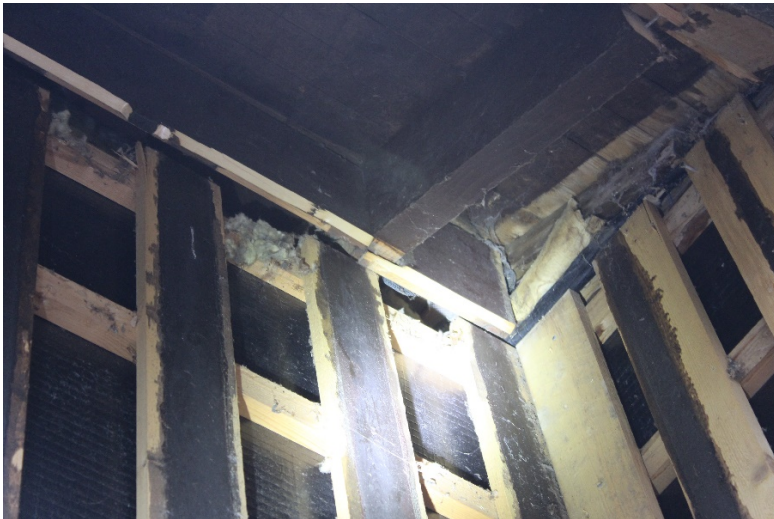
The walls of the building are made from timber boards. These are in a good condition. However sections of the wooden boards have been removed from part of the North West elevation. This has created gaps along the eaves which could be utilised by roosting bats. These boards were removed less than a week before the survey was undertaken. This area of the building is shaded from nearby trees which would result in colder walls. The temperatures at night have been low since the boards were removed which would reduce the activity of any bats that were active. No evidence of bats were found within these areas.

<p>Part of the wooden cladding has been removed on the North elevation revealing a membrane.</p>
 	<p>The wooden cladding on the West elevation has also been removed revealing a waterproof membrane.</p>

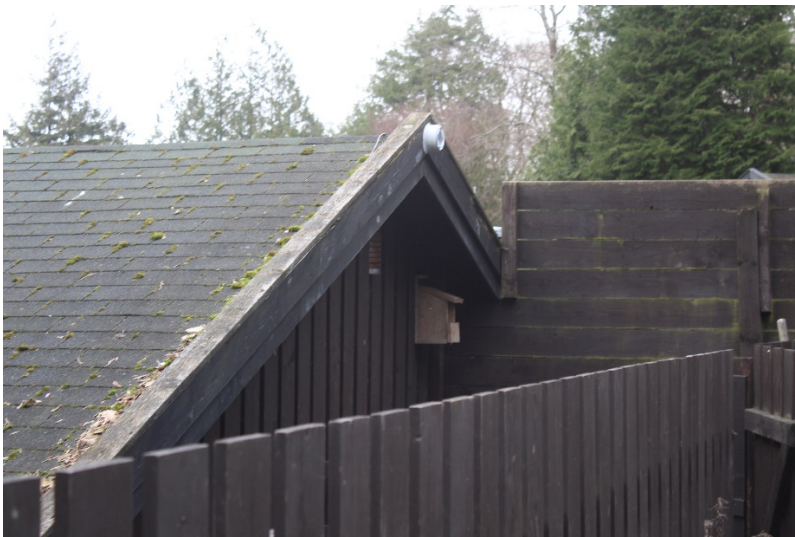
Building works had commenced and panels on the North and West elevation had been removed, although this has created gaps there was no evidence of use by bats. This area of the building is shaded and cold which would reduce the likelihood of the gaps being utilised. If signs of bats are found during demolition all works must cease and an Ecologist contacted.

Where the cladding has been removed there are gaps that have formed. However the areas of cladding that have been removed are shaded suggesting these areas would be cold. The cladding was removed less than a week before the survey was undertaken.
