## Calder Town End, Cumbria

### Update Preliminary Ecological Appraisal (2022)

AVISON YOUNG

24 March 2022

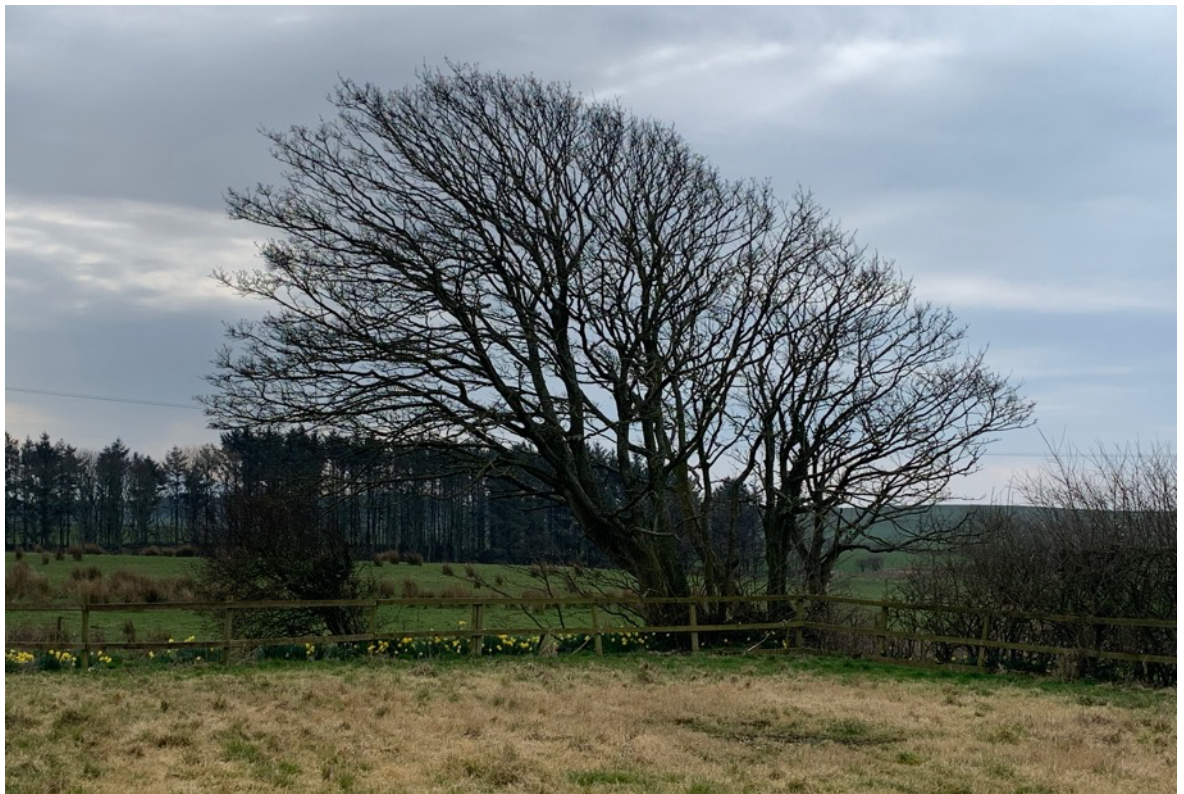
**Photograph 1.** Tree on which Barn Owl box to be sited

- on a tree located approximately 30m south of the Stone Barn (**Photograph 1**), and
- on a tree on the shelterbelt to the north of the site (**Photograph 2**).

Two Barn Owl nest boxes should be erected prior to site works:
