BiOME
CONSULTING

Pelham Walled Garden Cumbria

Bat Survey Report

14 December 2022

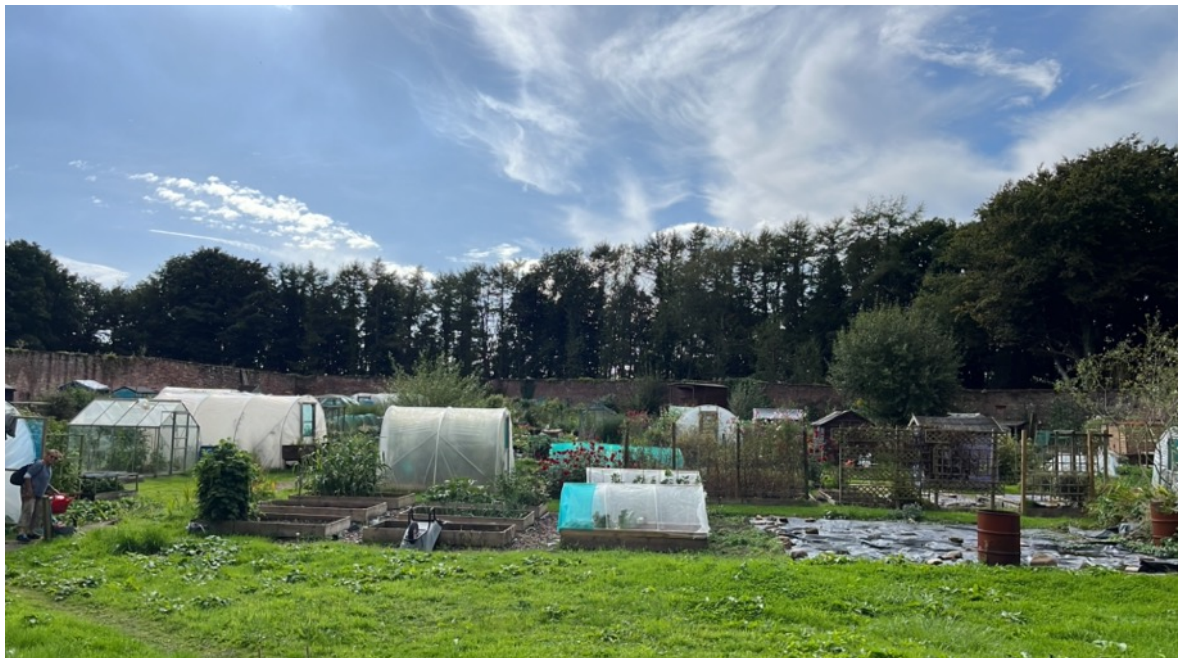
Photograph 1. The site

allotments (**Photograph 1**) with associated buildings. The site layout is shown on **Figure 2**; the following buildings were present within the site:

The garden wall, which formed the perimeter of the allotments, was approximately 3m high constructed of red brick and stone.

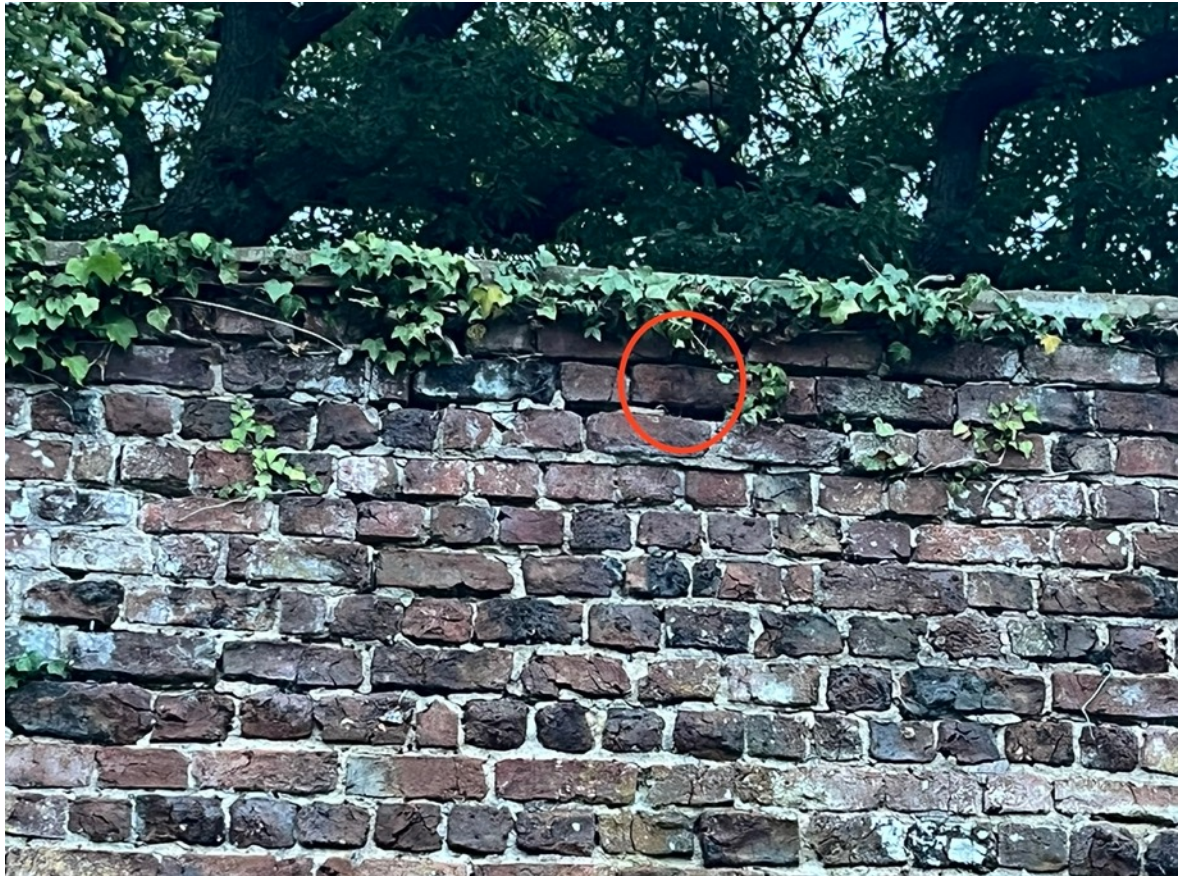
Photograph 2. Day roost location of single Soprano Pipistrelle on 28 August 2022

Endoscope inspection of the wall identified many gaps in mortar leading to often substantial cavities within the wall fabric. PRFs were particularly prevalent on the eastern and northern wall sections, typically near the top of the wall.

No evidence of bat presence was found in any of the PRFs present, although it was impossible to inspect all due to the number of PRFs present and the presence of bee's nests at a number of locations.

Following detailed endoscope inspection, the wall was assessed to be of **HIGH** suitability for roosting bats (**Table 1**).

Surveys focussed on a section of the eastern wall. A SOPRANO PIPISTRELLE day-roosted in a small gap in brickwork (Photograph 2) near the capping stone.

The PRA identified the presence of many, substantial PRFs and the presence of a roosting bat was confirmed during a single survey of a small section of wall.

No works to the wall should be completed until further survey work is completed. This survey work should comprise a minimum of two (maximum of three) nocturnal surveys of all sections of the wall with the potential to support roosting bats to determine roost locations, species present and numbers. These surveys should be completed between May and August (inc.).

The confirmation of a roosting bat within the wall means that a licence from Natural England will be required to enable the proposed works to proceed lawfully. This licence application can only be submitted when all survey data has been obtained.
