Pelham Walled Garden Cumbria

AVISON YOUNG

Update Bat Survey Report; 2023

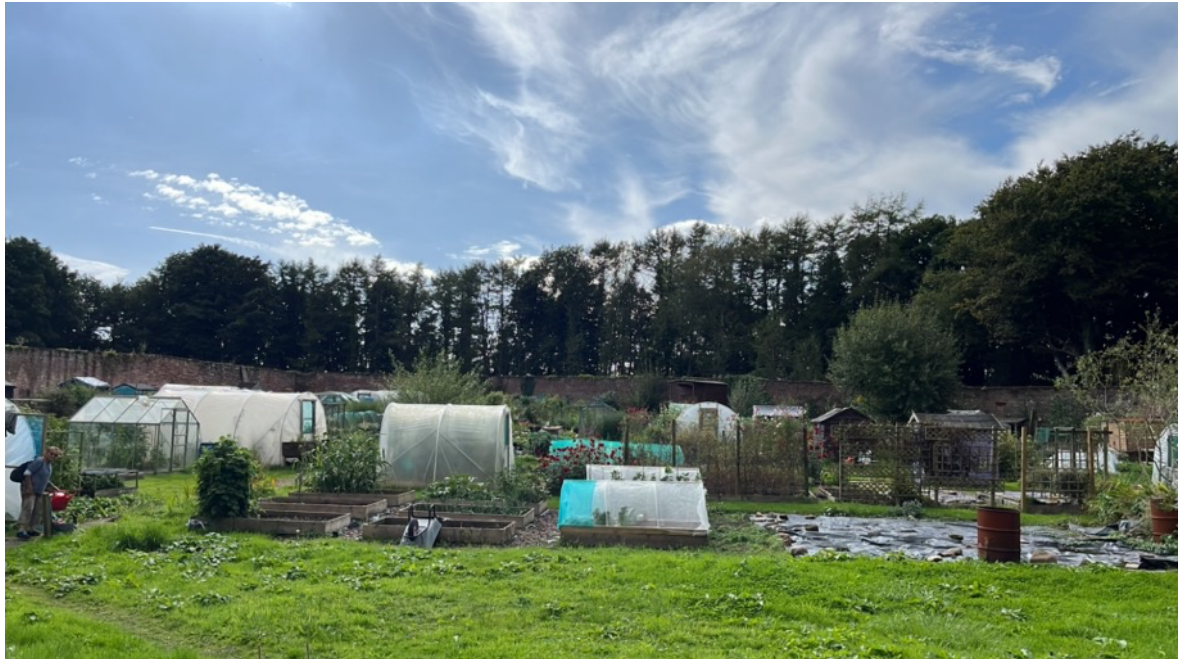
Photograph 1. The site

The site, located to the north of Sellafield Nuclear Power Station in western Cumbria (**Figure 1**), comprised the walled garden of Pelham House and includes allotments (**Photograph 1**) with associated buildings. The site layout is shown on **Figure 2**; the following buildings were present within the site:

The garden wall, which formed the perimeter of the allotments, was approximately 3m high constructed of red brick and stone with a single entrance point.

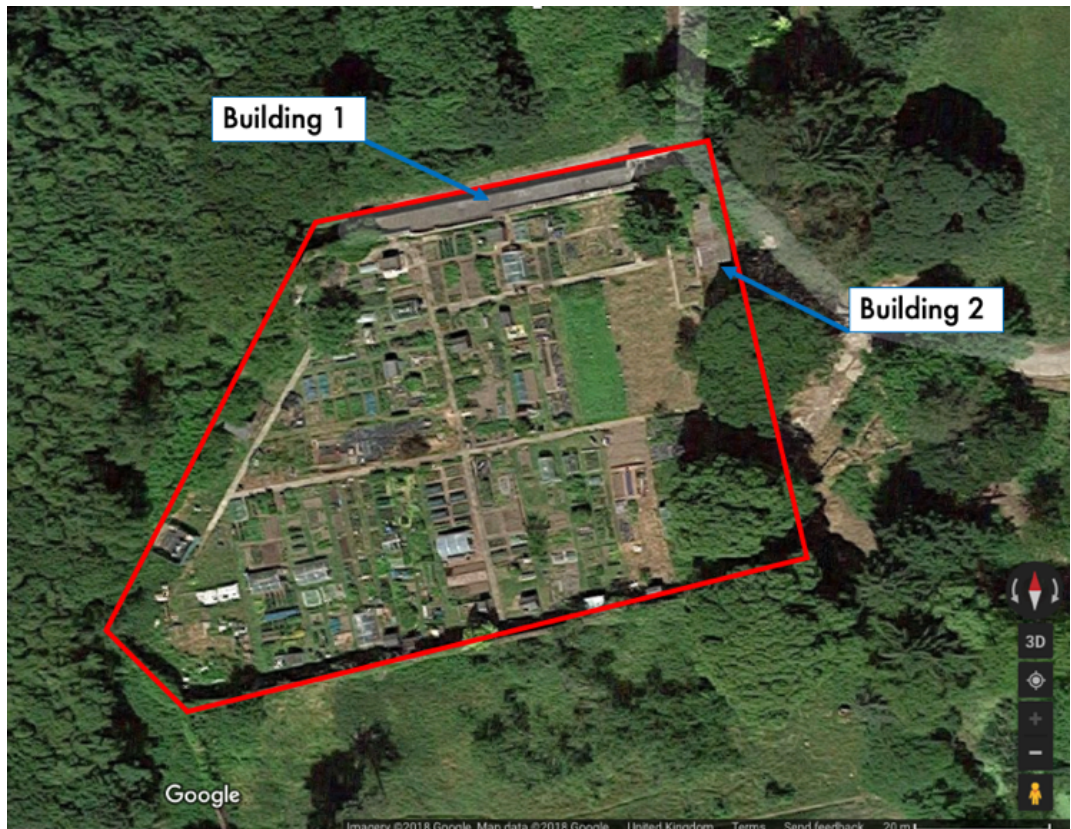
Figure 2. Site layout

- **Building 1**; a long, narrow building adjacent to the northern garden wall. It comprised seven component sections. One of these sections was a former boiler room with the remaining sections used for storage. This building was constructed of red brick and stone, with a single pitched concrete-asbestos sheet roof. A small roof void was present in the former boiler room.
- **Building 2**; constructed of red brick, again with a single pitched concrete-asbestos sheet roof. Within this building a small roof void was present.

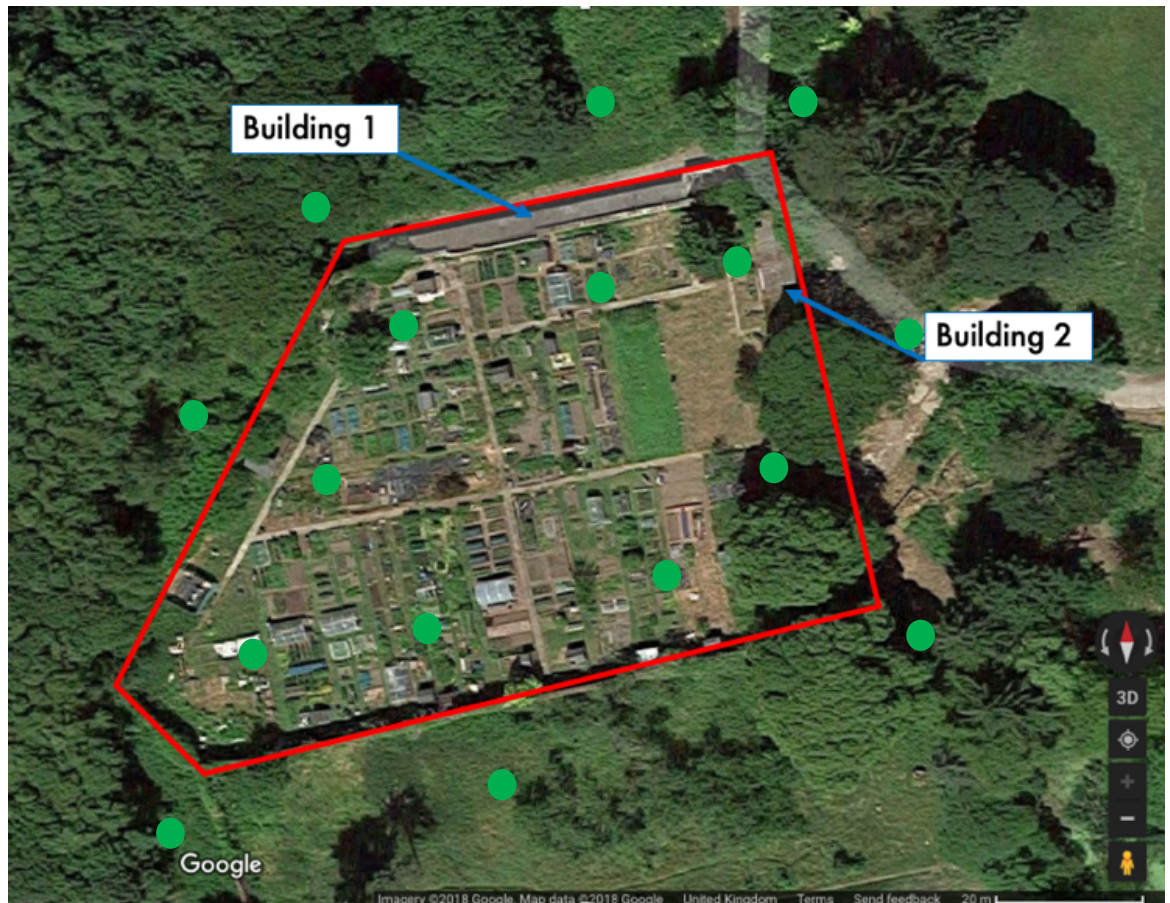
Figure 3. Surveyor locations (green dots)

Two nocturnal surveys of Building 1, Building 2 and the perimeter wall were undertaken.

To ensure coverage of areas which could support bats, each survey was completed over three survey sessions, with coverage achieved from 16 survey locations.

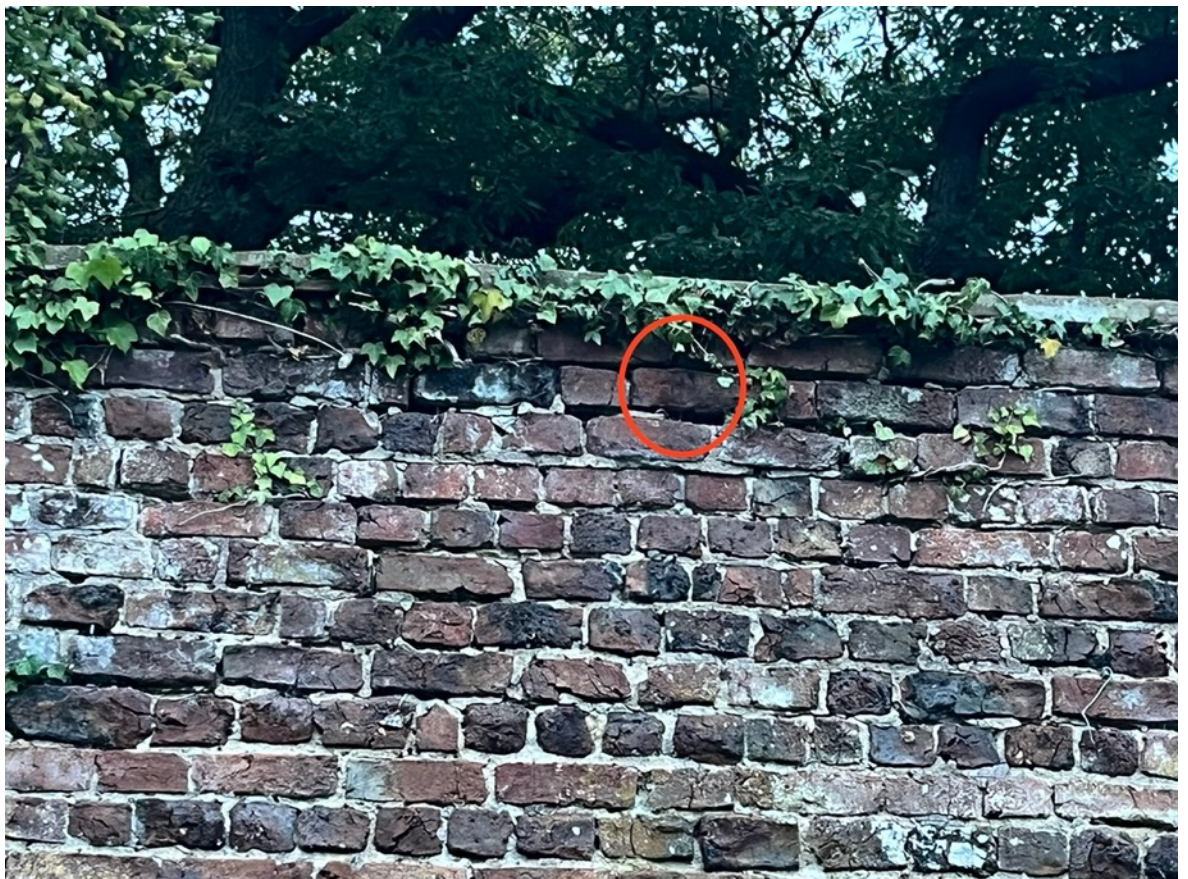
Photograph 2. RAP 1

Two Soprano Pipistrelle roosted within the wall. Both roost locations were on the interior of the wall, with Roost Access Point (RAP 1, **Photograph 2**) on the eastern wall and RAP on the northern wall (**RAP 2, Photograph 3**) (**Figure 3**).

Two Soprano Pipistrelle roosted within the wall. Both roost locations were on the interior of the wall, with Roost Access Point (RAP 1, **Photograph 2**) on the eastern wall and RAP on the northern wall (RAP 2, **Photograph 3**) (**Figure 3**).

The proposed works will result in the loss of both roosts.

The confirmation of a roosting bat within the wall means that a licence from Natural England will be required to enable the proposed works to proceed lawfully. Given the identified roost is of low conservation status, the site can be

Works in the area of the roost (or potential roost sites if the specific location cannot be ascertained) will need to be supervised by an RC (or accredited agent). Prior to works commencing, the RC would provide a 'toolbox talk' to those contractors on site in which details of e.g. best working practices and what to do in the event of discovering a bat would be discussed.

Although there is no requirement for any compensatory roosting features to be installed under the BMCL scheme (favourable conservation status is maintained without any compensation), it is recommended that two Schwegler 2F¹¹ bat boxes with double front panels are installed on trees around the periphery of the site prior to works with two 1FF Schwegler¹² bat boxes installed on the rebuilt wall.
