Pelham Walled Garden, Cumbria

GVA GRIMLEY HOLDINGS LTD

Preliminary Ecological Appraisal

04 January 2019

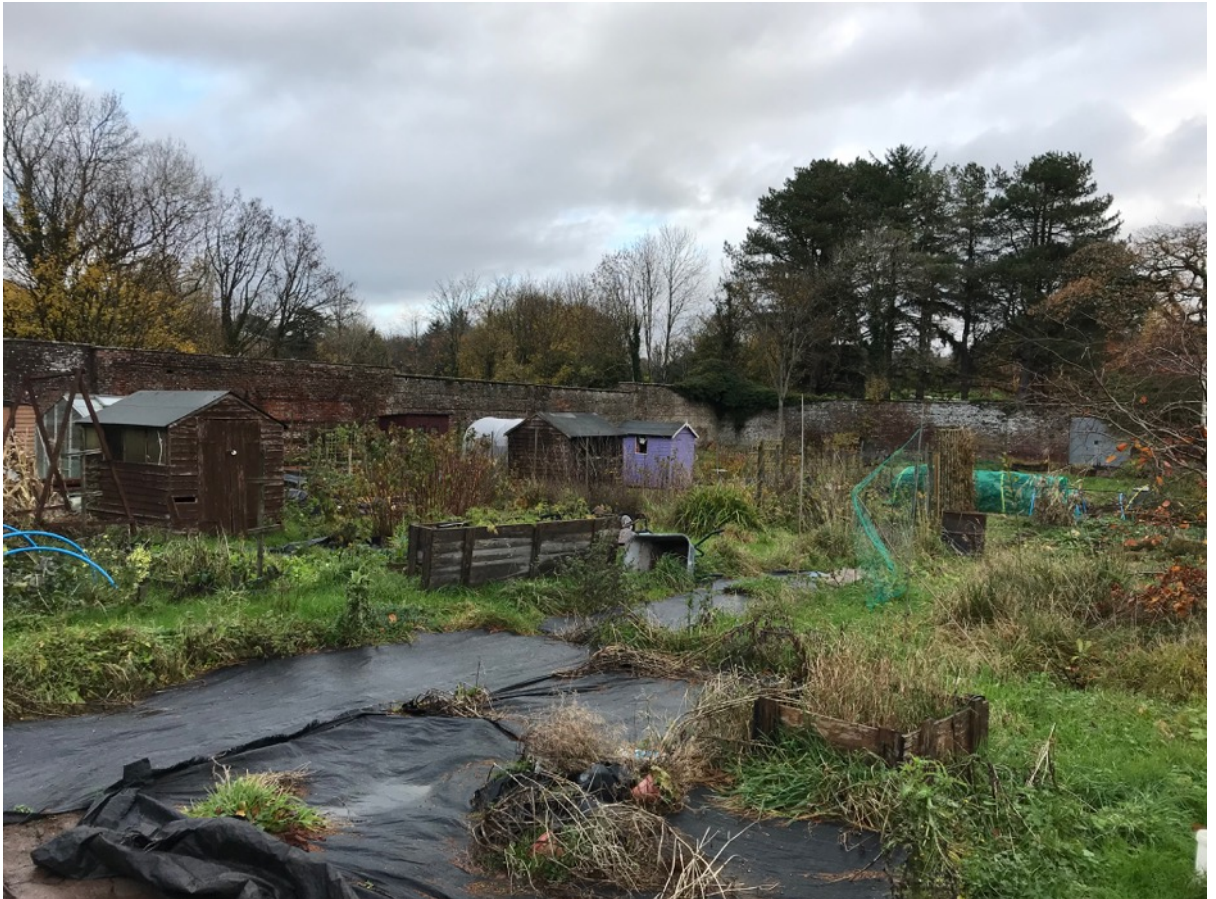
Photograph 1. Interior of Pelham Walled Garden

The site, located to the north of Sellafield Nuclear Power Station in western Cumbria (Figure 1), comprised the walled garden of Pelham House and includes allotments (Appendix A, Photograph 1) with associated buildings. The site layout is shown on Figure 2; the following buildings were present within the site:

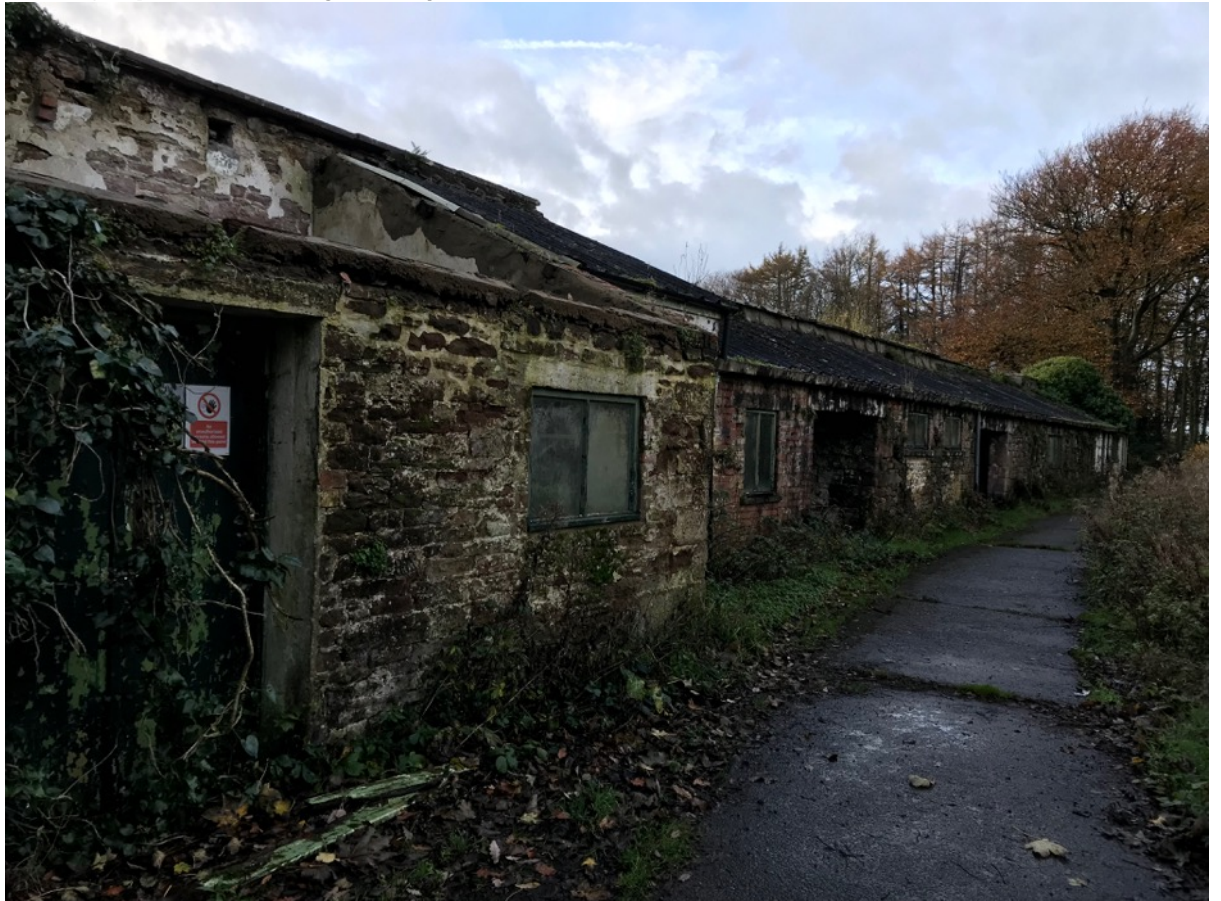
Photograph 2. Building 1, adjacent to northern wall

Building 1 (Photograph 2)

Five scattered mixed-age bat droppings considered to originate from a single Brown Long-eared Bat *Plecotus auritus* flying within the building were found on a staircase in the western section of this building.

Gaps in brickwork were noted, which could support roosting bats.

This building was assessed to have MODERATE potential to support roosting bats (Table 1).

Evidence of bat use (droppings) was identified within both onsite buildings, and the buildings as a whole were considered to possess 'moderate' potential to support roosting bats. However, the proposed works to the two buildings only comprise potential pointing works and bat roosting potential in these areas was considered to be limited. Therefore, an endoscope inspection of these areas to be potentially impacted is recommended in the first instance. This should be completed by an ecologist with the relevant Natural England licence. In the apparently unlikely event that roosting bats are identified nocturnal survey work should be completed. These nocturnal surveys would seek to establish which bat species are present and numbers/type of roosts. All bat survey methods employed should be in line with the latest Bat Conservation Trust (BCT) survey guidance³. The optimal time for emergence/re-entry surveys is between May and August (inclusive). If, following these further bat surveys, the proposed works are determined to likely cause destruction/disturbance to any bat roosts then a EPS licence will need to be sought from Natural England/the site registered by a Registered Consultant (RC) under the Bat Mitigation Licence (BML) scheme (which course of action would be dependent on the status of roosts identified) to enable the re-development works to proceed legally. This licence would need to detail how the works would avoid any harm to bats in addition to potentially providing appropriate compensatory roosting sites.

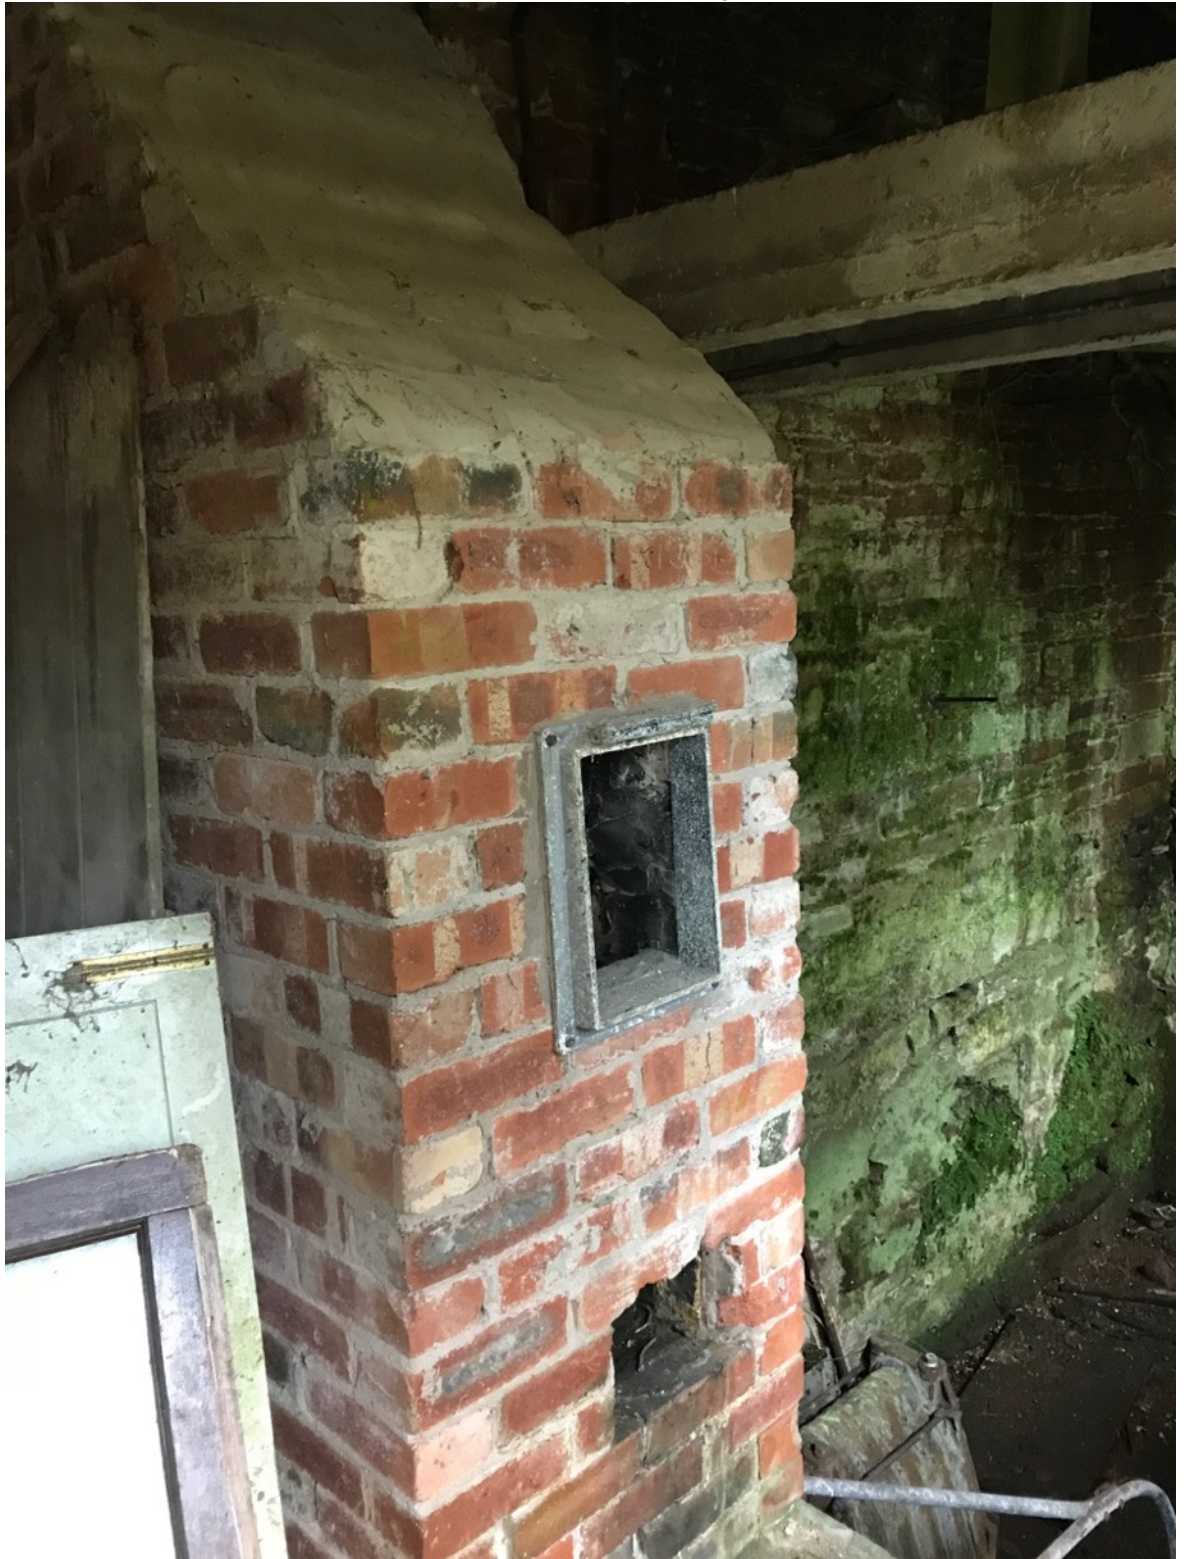
Photograph 3. Former boiler room, within Building 1

- Building 1 (Photograph 2), was a long, narrow building adjacent to the northern garden wall. It comprised seven component sections. One of these sections was a former boiler room (Photograph 3) with the remaining sections used for storage (Photograph 4). This building was constructed of red brick and stone, with a single pitched concrete-asbestos sheet roof. A small roof void was present in the former boiler room (Photograph 5).
- Building 2 (Photograph 6) was constructed of red brick, again with a single pitched concrete-asbestos sheet roof. Within this building a small roof void was present (Photograph 7).

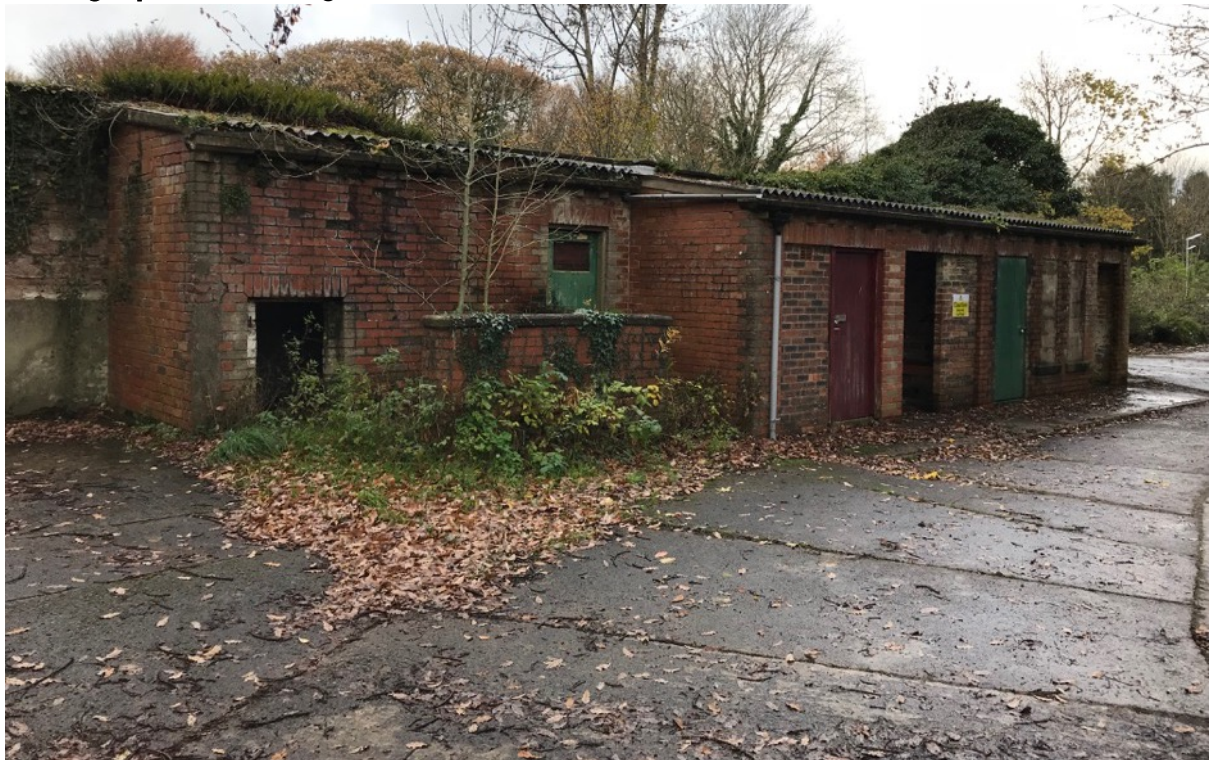
Photograph 6. Building 2

Building 2 (Photograph 6)

Approximately 25 old, scattered bat droppings were present in the southern section of this building. Gaps in brickwork were noted, which could support roosting bats.

This building was assessed to have MODERATE potential to support roosting bats (Table 1).

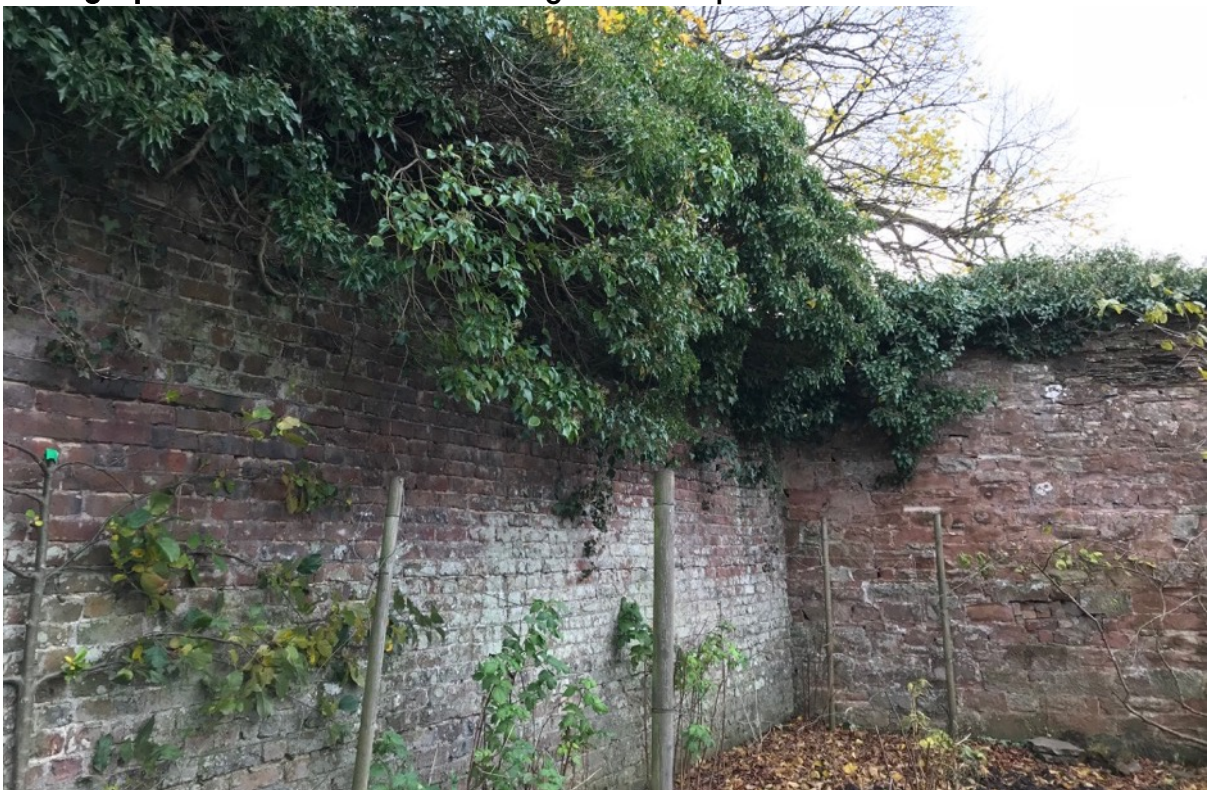
Photograph 8. Interior of wall forming allotment perimeter

The garden wall, which formed the perimeter of the allotments, was approximately 3m high constructed of red brick (Photograph 8) and stone (Photograph 9).

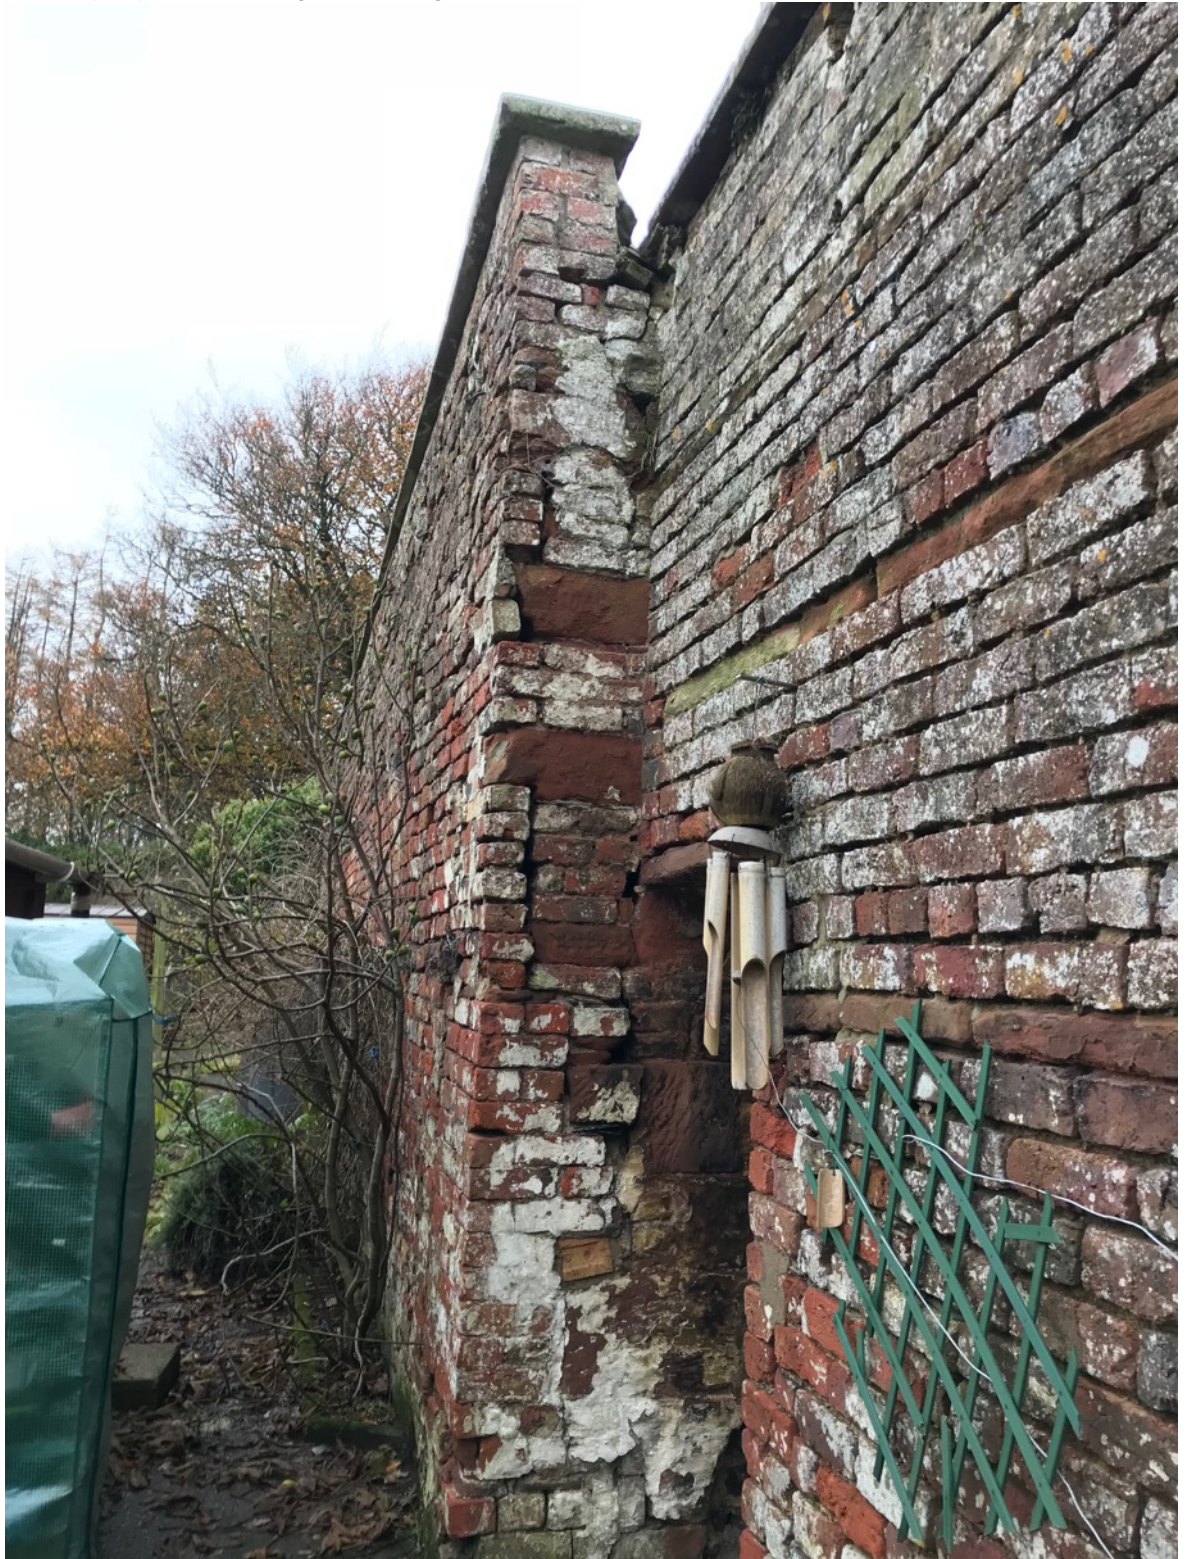
Photograph 10. Gaps within perimeter wall

The perimeter wall was constructed in red brick and stone, no evidence of bats utilising this feature were noted. However, many gaps in mortar/cracks were present (Photograph 10) which could support crevice dwelling bat species (e.g. pipistrelles).

This feature was assessed to have LOW potential to support roosting bats (Table 1).

The perimeter wall surrounding the site also possessed some features with the potential to support roosting bats and was assessed to be of 'low' suitability for roosting bats. Given that potential roost sites were identified in the wall an endoscope survey is recommended prior to pointing works commencing, to search for bats roosting/evidence of bats in the holes/cracks. In the apparently unlikely event that any roosting bats are identified then nocturnal survey work should be completed in-line with the methods described above, prior to a EPS licence being sought/the site registered by a RC under the BML scheme.
