Activity Survey Report – Bats.

Buildings 3 & 5

West Cumberland Infirmary

Prepared for North Cumbria University Hospitals NHS Trust

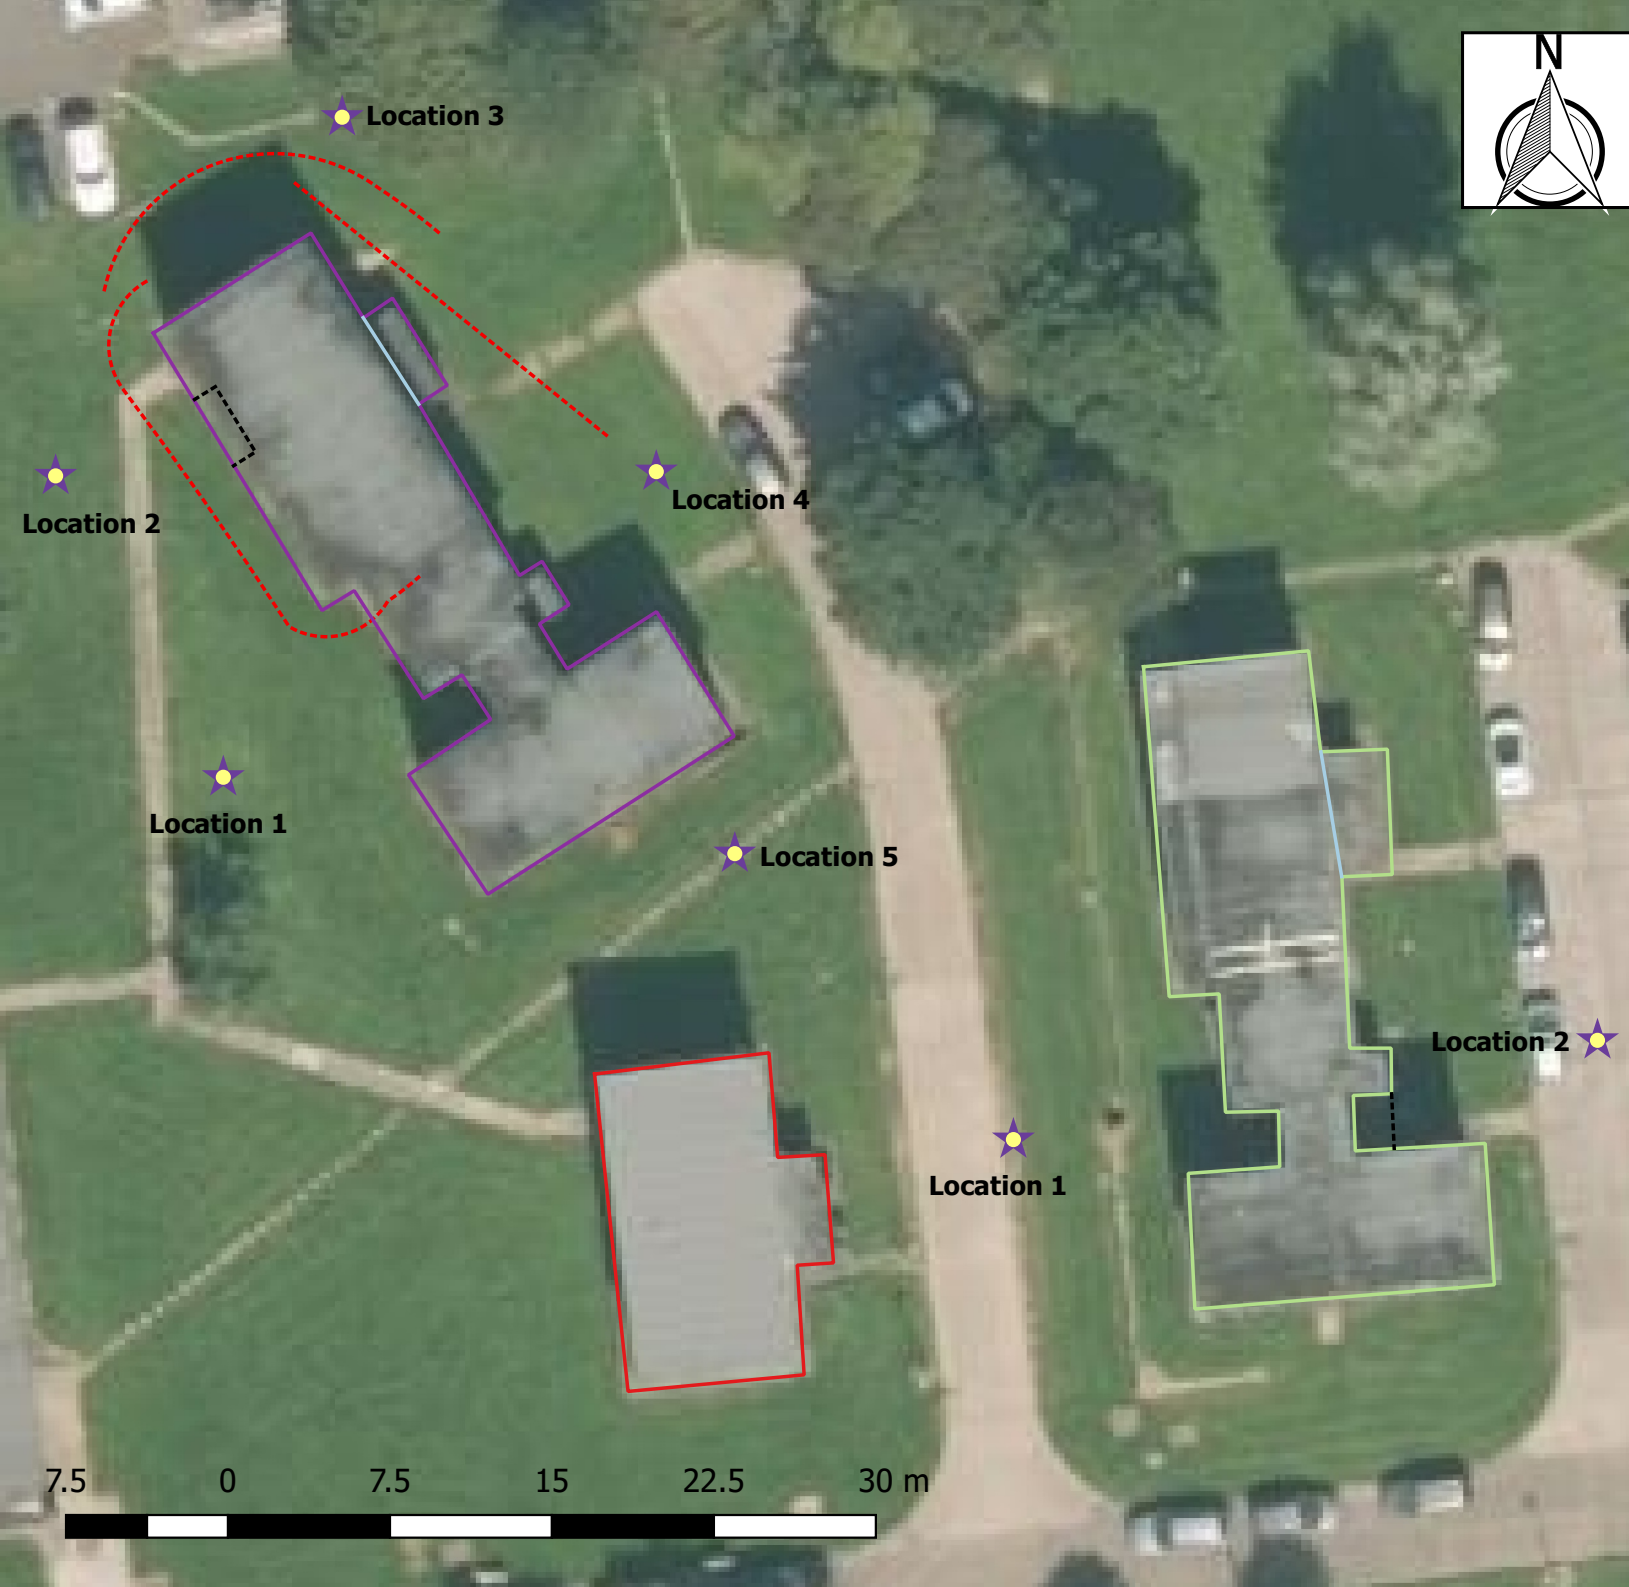
Figure 2: Activity survey results

Ecologists were situated around the buildings (figure 2) ensuring adequate visual coverage of all access/egress points which were identified during the daytime preliminary building assessment.

No bats were recorded to emerge during the dusk survey from building 5. Bat activity during the survey was low, with bats occasionally foraging and feeding past building 5, over the roof and commuting between feeding grounds. Sound analysis demonstrates that the bat species active in the area during the survey were mainly Common pipistrelles (*Pipistrellus pipistrellus*), Soprano pipistrelle (*Pipistrellus pygmaeus*) and occasional *Nyctalus* sp.

No bats were recorded returning to roost to buildings 3 or 5 during the dawn survey. Bat activity during the survey was low, with occasional commuting past the buildings. Sound analysis demonstrates that the species active in the area were common pipistrelles (*Pipistrellus pipistrellus*).

Recordings taken at the time of survey indicate that bats are commuting past building 3 and foraging/feeding and commuting past building 5. Bat activity throughout both surveys was low suggesting a low population of bats in the local area.
