Preliminary Building Assessment – Bats

West Cumberland Infirmary Buildings 1 & 2

Prepared for North Cumbria University Hospitals NHS Trust

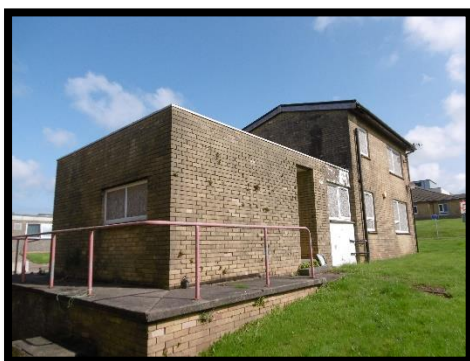
Plate 1: Building one (S aspect).

Building 1 is comprised of a two-storey section with a pitched felt roof and soffit boxes, and single-storey section with a flat roof. Both sections are brick wall construction (plate 1 & 2).

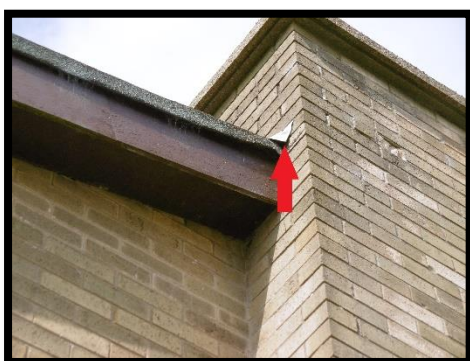
Plate 3: Lifted lead flashing.

Several potential roosting features were recorded on the external of building one which included gaps under lead flashing (plate 3), gaps around door frames (plate 4), gaps in soffit boxes (plate 5) and in window frames.

Building 1 has been assigned a low level of suitability to support roosting bats.

It is recommended that a minimum of **one** activity survey should be carried out during the 2019 bat activity season (May - September inclusive) on building 1 to confirm whether bats are using any of the features highlighted to roost. This survey will take the form of one dusk emergence or one dawn return to roost survey.

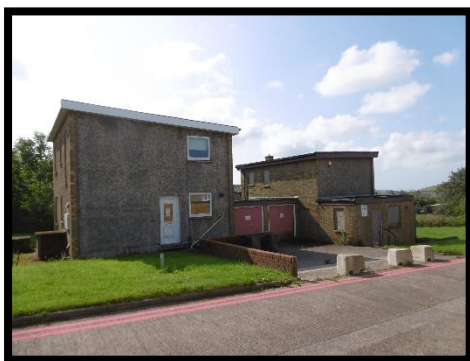
Plate 6: Building 2 (NW aspect).

Building 2 consists of two residential units adjoined by a single storey garage with a flat roof (plate 6). The two-storey sections are comprised of brick, rough-cast render and flat felt roof construction (plate 7). The building has both wooden and plastic soffit boxes.

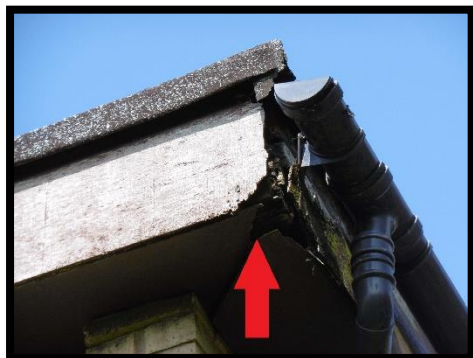
Plate 8: Gap in soffit box.

A number of features including gaps in soffit boxes (plate 8), fascia boards (plate 9), missing mortar (plate 10), gaps at wallheads (plate 11) and under windowsills were recorded.

Due to the features present on this property and the presence of a bat dropping, this property has been assigned a moderate level of suitability to support roosting bats.

It is recommended that a minimum of **two** activity surveys should be carried out during the 2019 bat activity season (May - September inclusive) on building 2 to confirm whether bats are using any of the features highlighted to roost. This survey will take the form of one dusk emergence and one dawn return to roost survey.

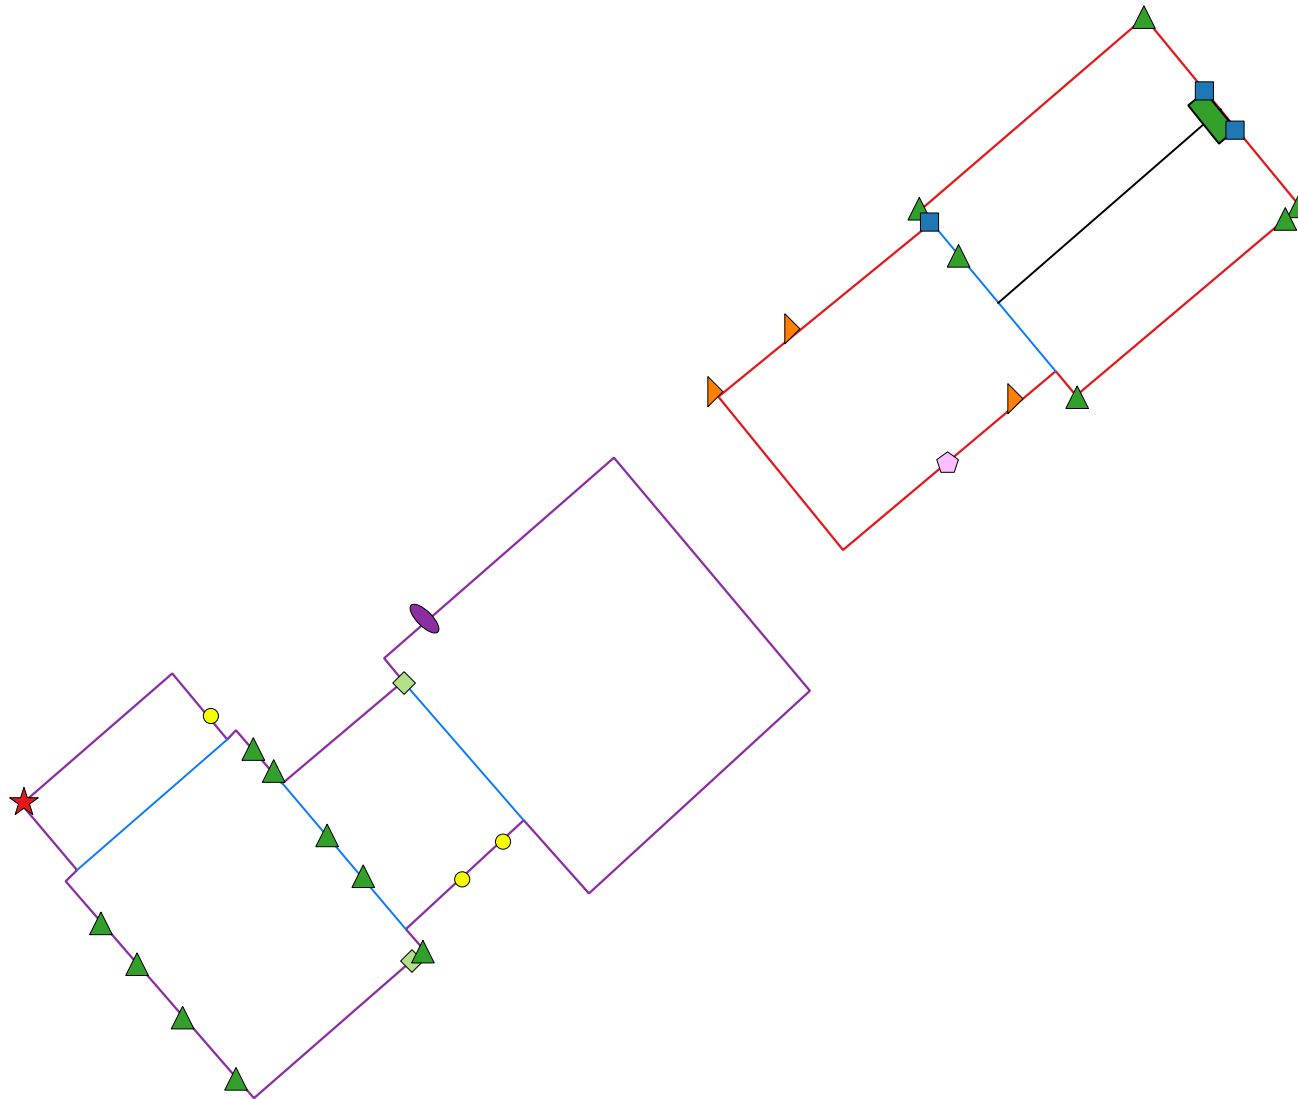
Figure 2: External Survey Results
(Buildings 1 & 2)

- Gap at wallhead
- Missing mortar
- Gap in door lintel
- Gap in soffit box
- Gap in window frame
- Gap under lead flashing
- Gap in fascia board
- Bat dropping
