# **Bat Scoping Survey**

## **Cherry Trees House, The Green**

**4<sup>th</sup> November 2021**

**Report No. 1121/2**

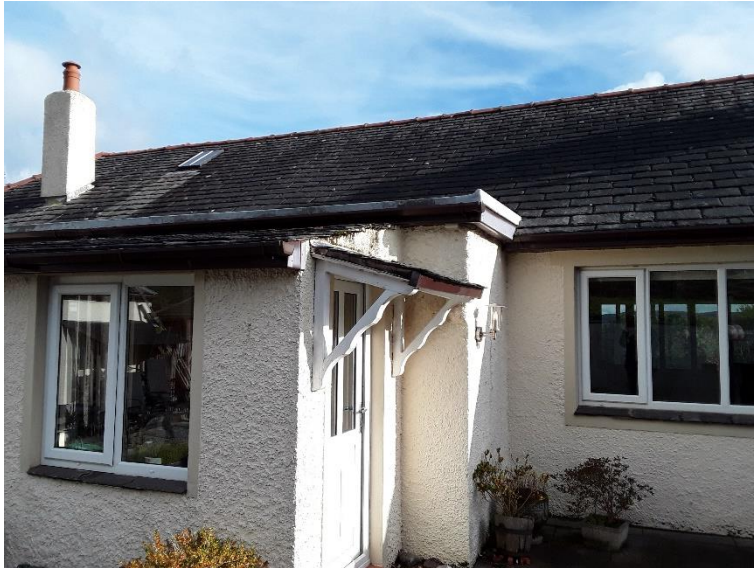
**Image 1.** Front (west) elevation of property, showing small porch and flat roofed area affected by the proposals.

Note the general good condition of render and slates. No significant gaps were seen under the slates in this area.

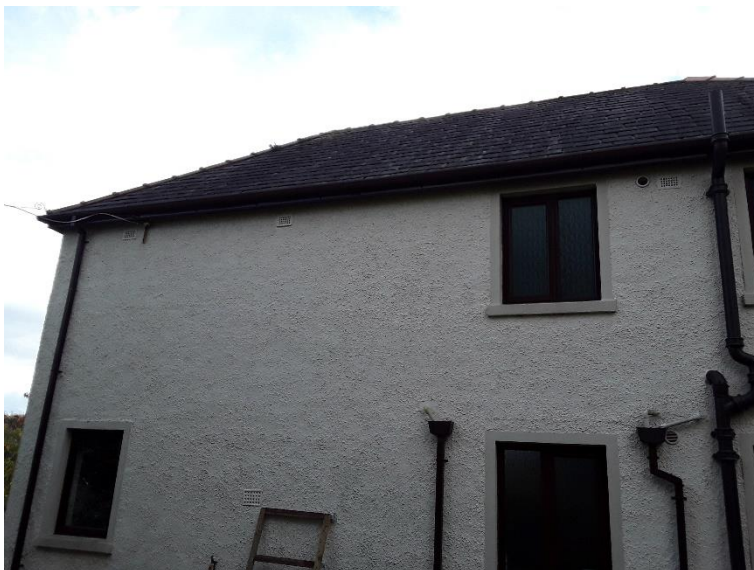
**Image 2.** Side (north) elevation of the property showing hipped roof extension. This area is not directly impacted by the proposals.

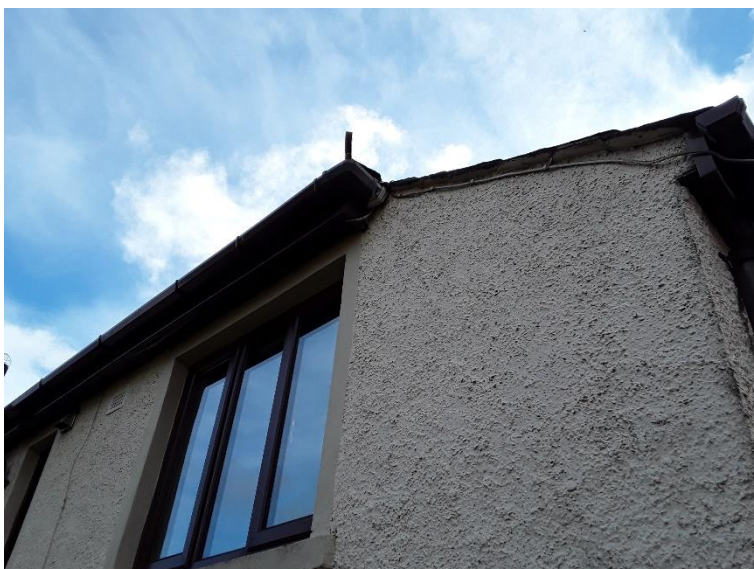
**Image 3.** North-east corner of the property. The mortar is in good condition along the verges and no significant gaps were seen.

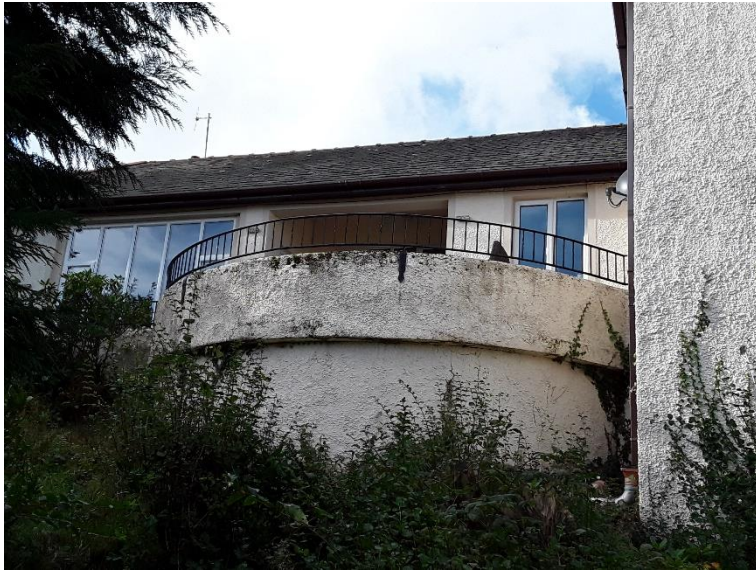
**Image 4.**  
Rear (east)  
elevation showing  
the existing  
veranda.

Note the good  
general condition of  
the roof.

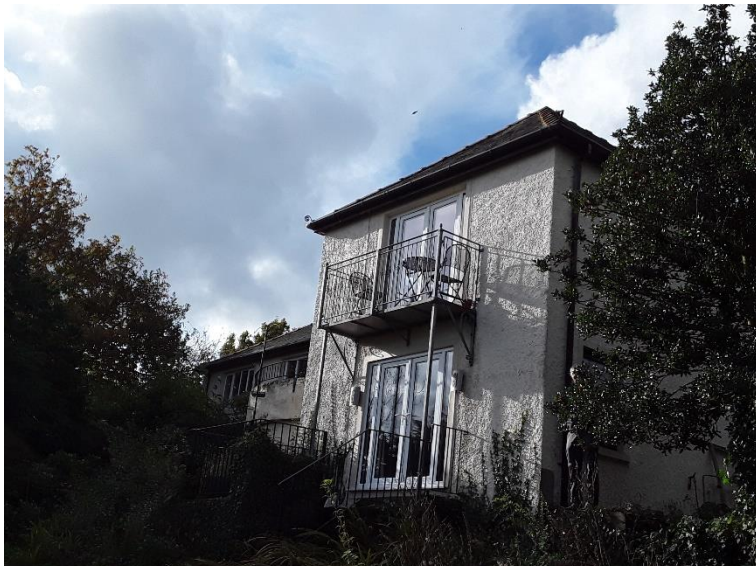
**Image 5.**  
Rear (east)  
elevation of the  
property, showing  
the hipped roof  
extension at the  
northern end of the  
property.

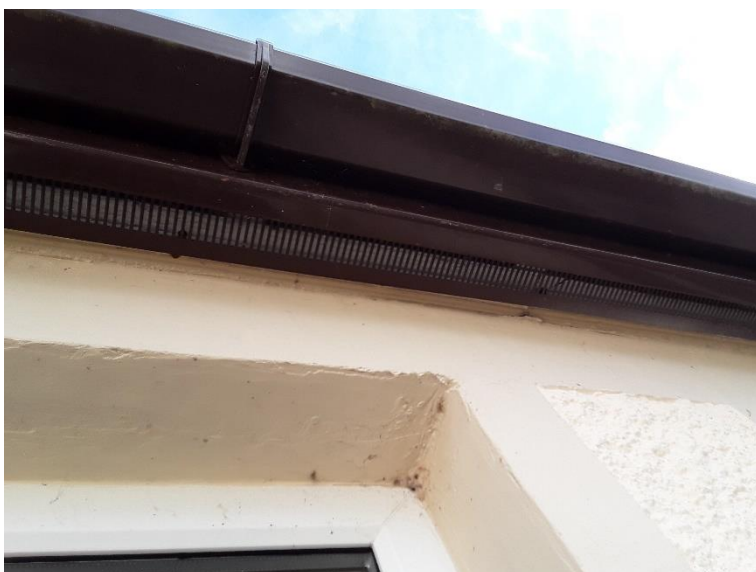
**Image 6.**  
Showing the area  
under the soffits  
of the flat roof  
section on the  
west elevation of  
the property. No  
significant gaps  
were seen  
anywhere along  
the eaves.

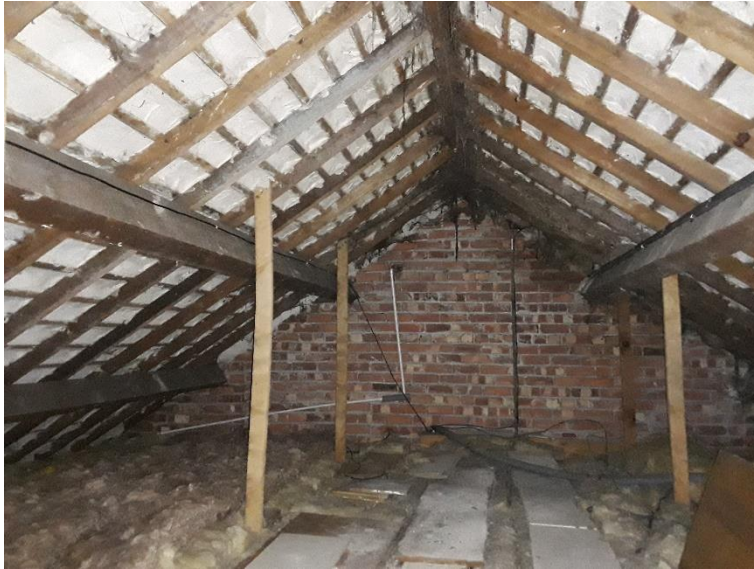
**Image 7.**  
Interior of roof void.  
Note good condition  
of mortar under the  
slates.  
No droppings seen  
anywhere in any of  
the roof voids.

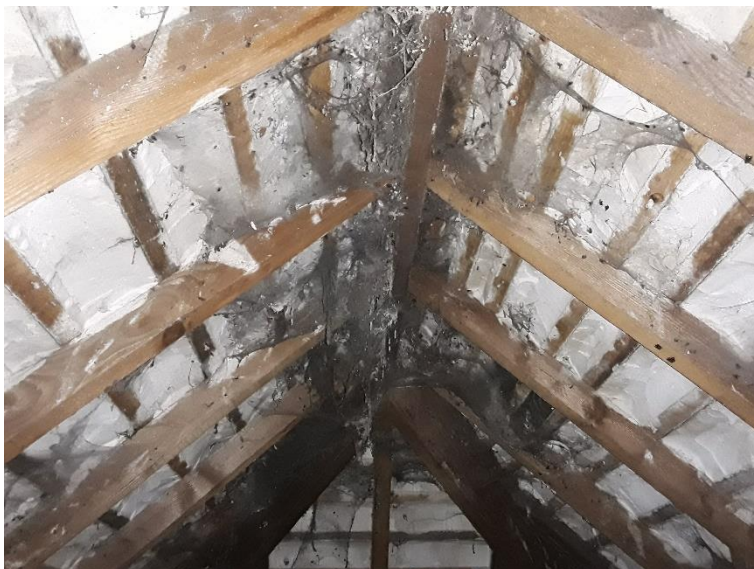
**Image 8.**  
Showing the dense  
cobwebs along the  
ridges typical of all  
the roof voids  
inspected in the  
property. This  
indicates a lack of  
disturbance in the  
loft by animals such  
as bats.
