# Design, Access, and Heritage Impact Assessment

Bigrigg Milestone

COA130886 / Rev 1

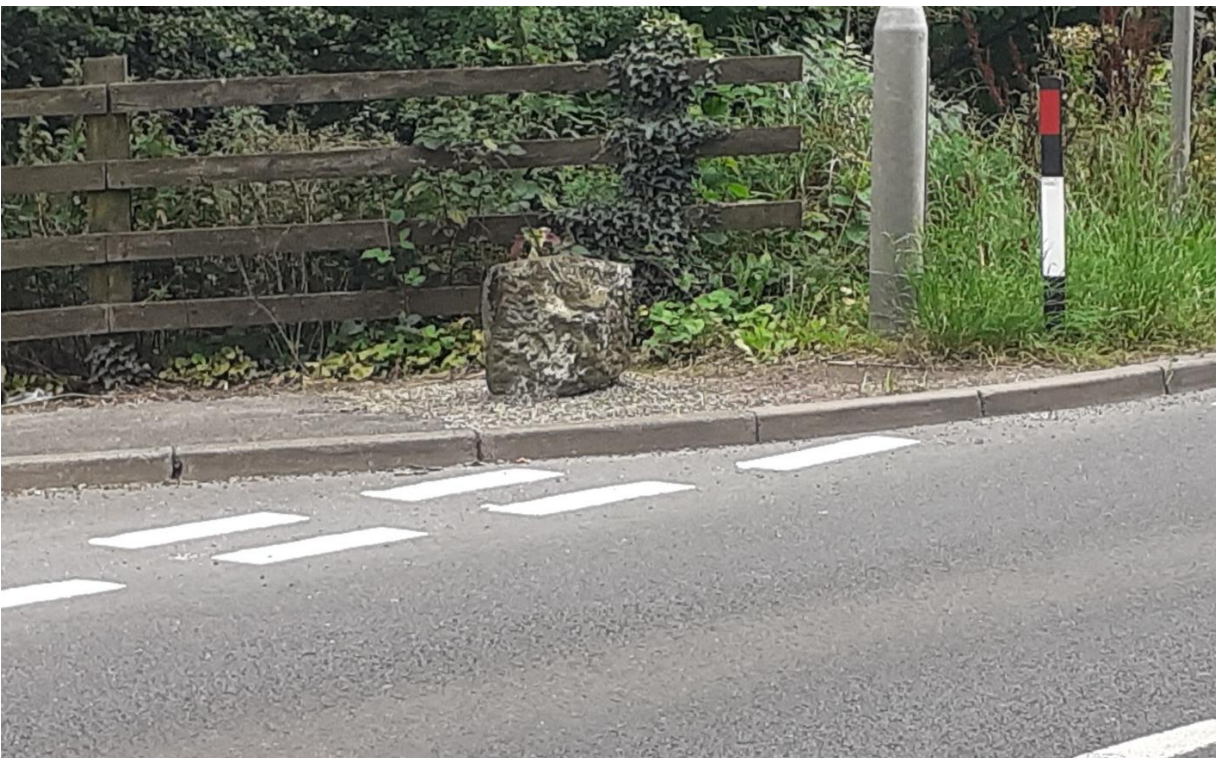
Plate 1: Milestone from north east

- 1.3.1 The Milestone is one of four Milestones listed along the southern portion of the A595, and is located at the junction of Dalzell Street and the A595. Recently, the Milestone was struck by a vehicle and toppled. Over time, the plaques have either fallen off or been removed leaving the stone in a poor condition (see plate 1).

- 1.2.1 The proposed works would look to restore the Milestone by recasting the missing plaques and repainting it to its original white with black detail as shown in Appendix A.
- 1.2.2 The Milestone would be mounted on a plinth measuring 600mm by 600mm and 200mm high being affixed by two steel pins which would also allow a more secure surface for the plaques to be attached.
- 1.2.3 It is proposed that surrounding vegetation will be cut back to the fence line and the gravel area surrounding the stone be extended to improve the setting and limit options for vegetation to cover the Milestone.

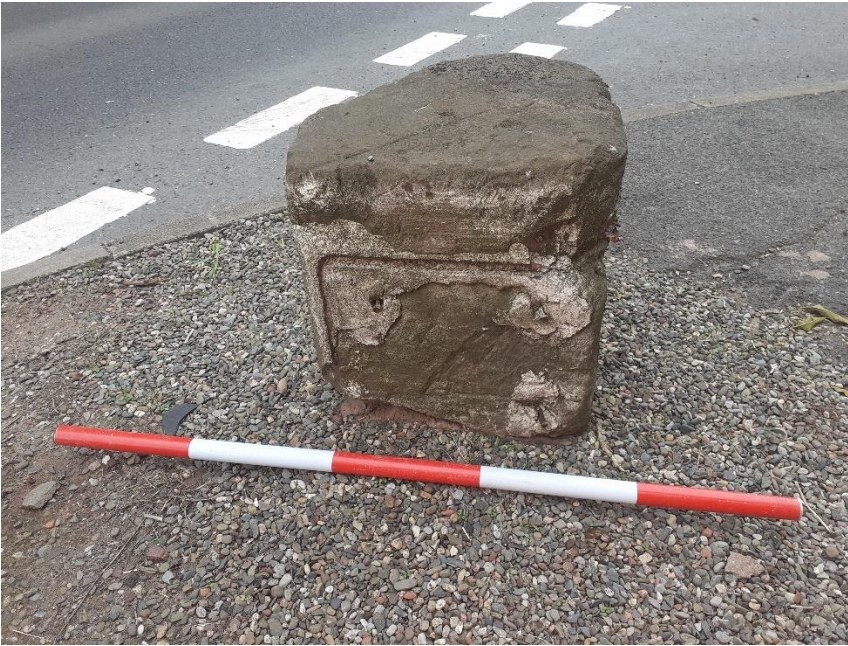
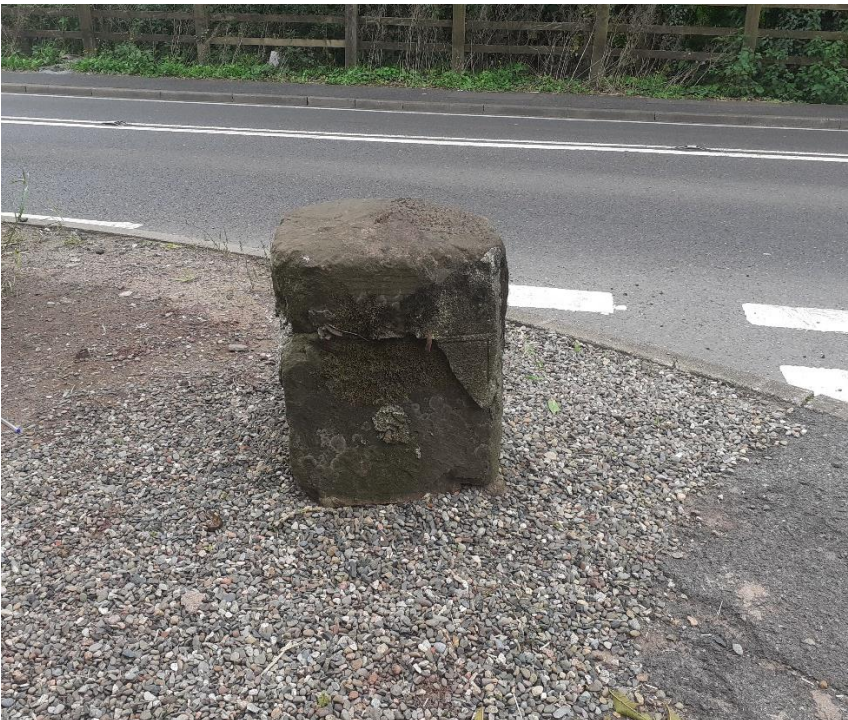
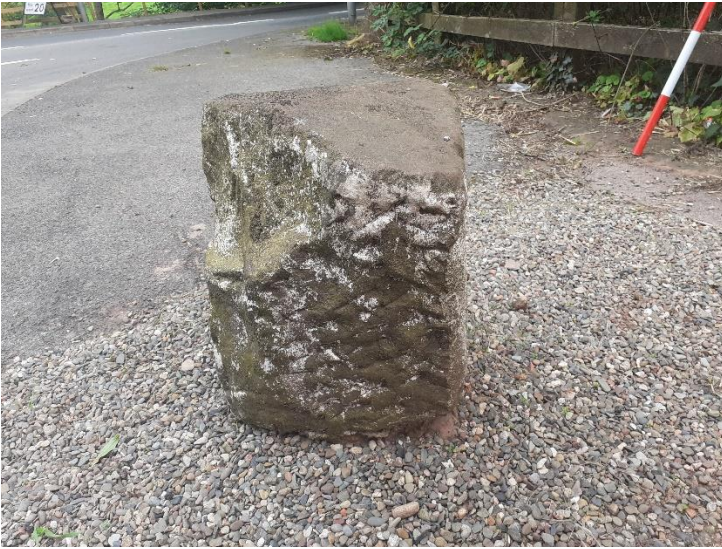
- 2.1.1 The Milestone is a mid-Nineteenth century, sandstone block, broadly triangular in plan measuring 450mm in height sitting on a loose gravel. The stone measures approximately 400mm along each edge with a broadly flat top with chips from historic impacts and weathering present along its edges (see plates 2 – 4).

*Plate 2: Milestone from south east*

*Plate 3: Milestone from north east*

Plate 4: Milestone from north west
