Retention of a Three Storey Modular Building Contaminated Land Risk Assessment

Produced by Sellafield Ltd Contaminated Land Specialist, Land Quality and End States

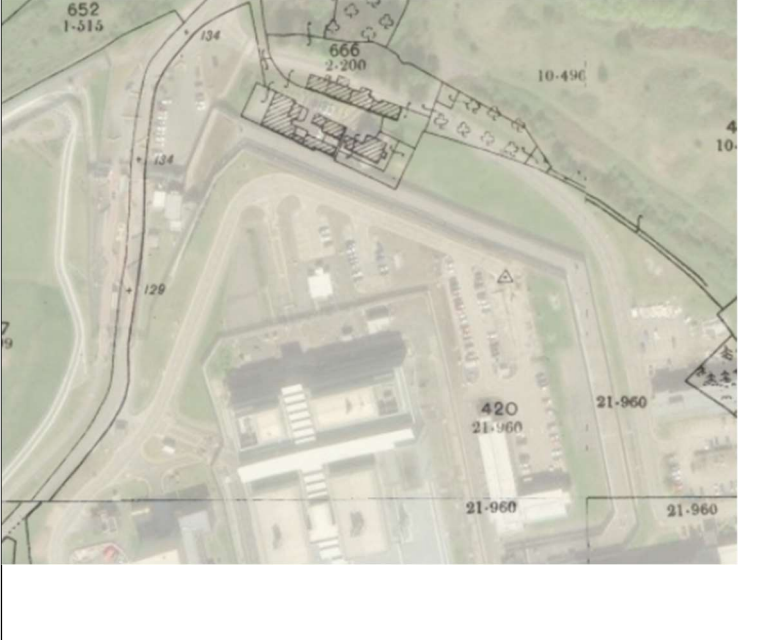
Year		Comments
c. 1900

<p>Before the development of Sellafeld the site was farmland, and the buildings area was within a field with the farm buildings and houses of Yottenfews to the north west. NB. The aerial image was taken before the buildings were in place.</p>
1946

The above images show that the site of the buildings remained undeveloped until the late 1980s when it became a car park. It remained in this use until the installation of the buildings in 2022, apart from a period during the construction of the central lab when it was used as a construction compound and laydown area.

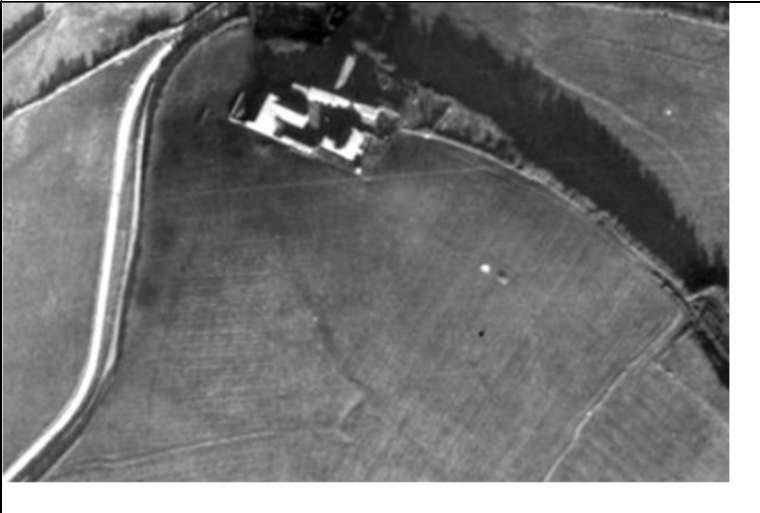
<p>In the 1940s the Royal Ordnance Factory was built on what is now the central Sellafeld site approx. 800m to the south. The area around the buildings remained as farmland.</p>

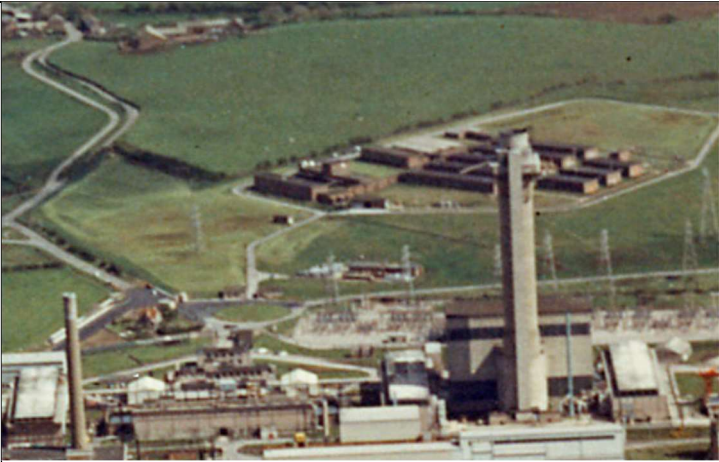
1968

By the late 1960s the wider Sellafield site was well developed and the North Group buildings were present, approx. 200m south of the cabin location. The area of the buildings was still farmland with the Yottenfews buildings visible to the top left of the photo.
1983

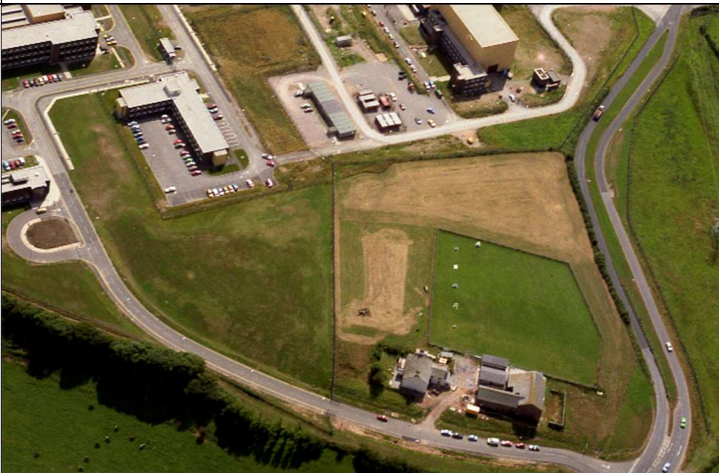
By the early 1980s the North Group area had been further developed. The site of the buildings remained as a grassed area but was no longer used as pasture.
1989

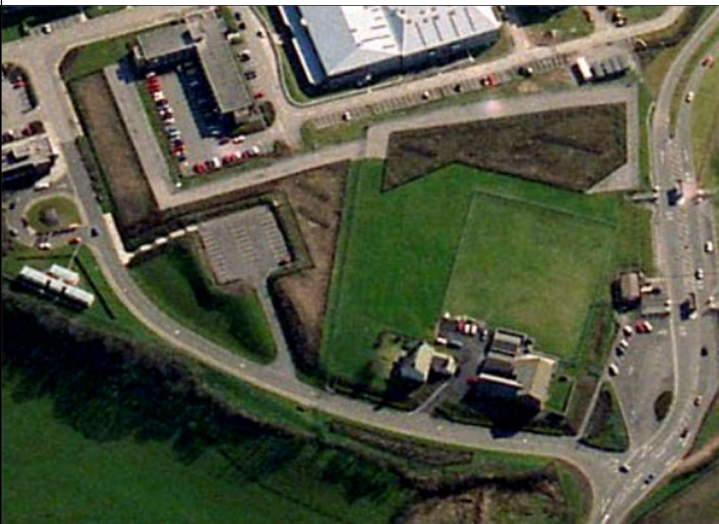
In 1989 the site of the buildings had been developed into a small car park.

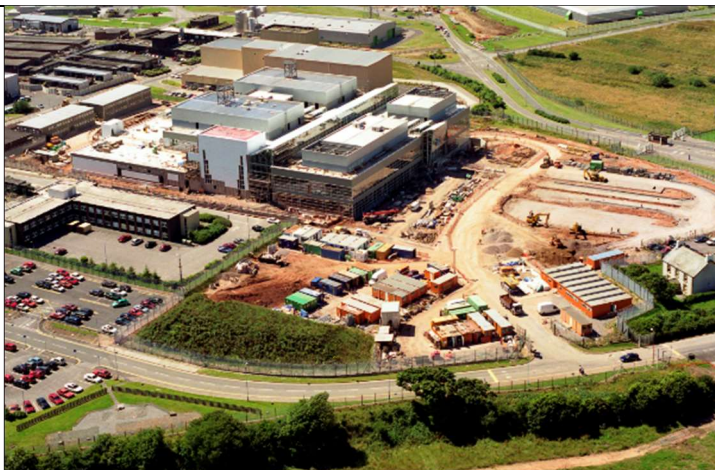
1999

In the late 1990s the area underwent extensive development during the construction of the central lab building. The site of the buildings was part of the construction compound and laydown area.

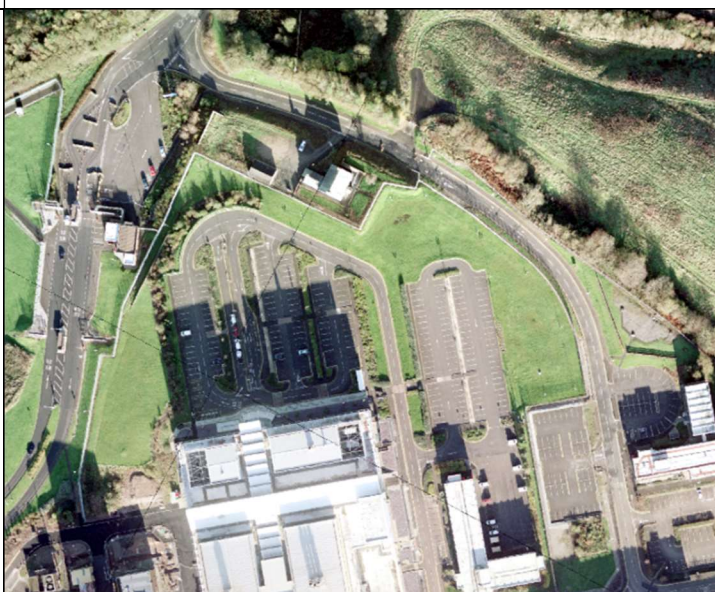
2005

Following the development of the central lab the site of the buildings was reinstated as a larger carpark.

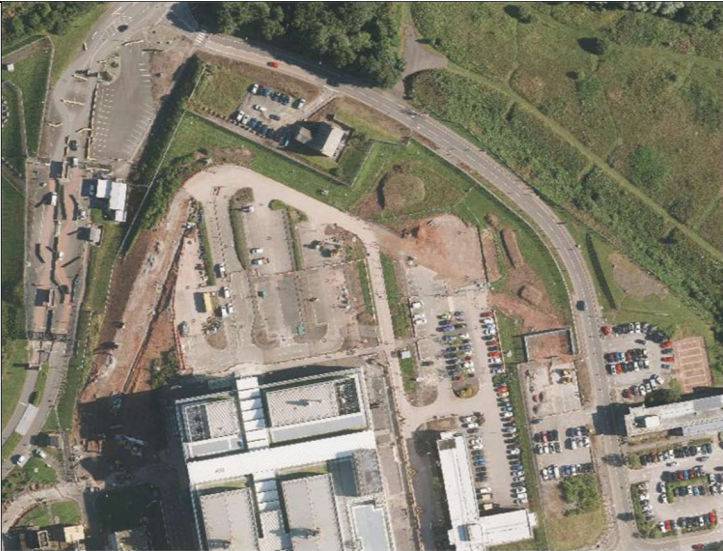
In 2017 the local site roads were repositioned and the car park reduced in size to allow for the new perimeter security fence to be installed.
2023

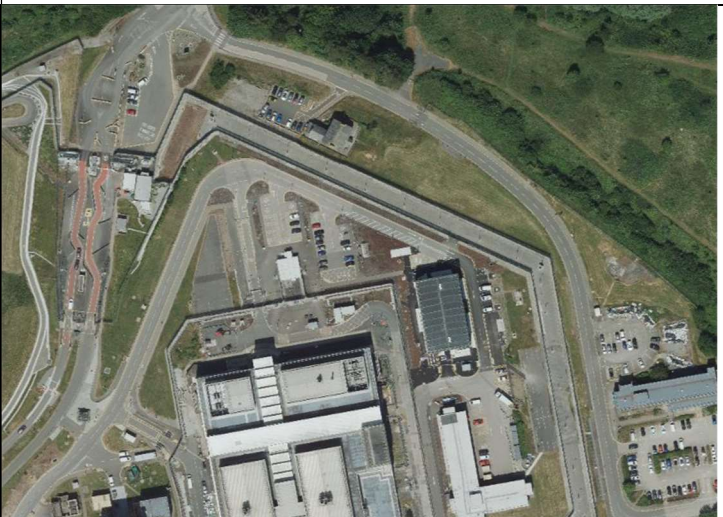
By 2023 the Three Storey Modular Building were installed on the site of the car park.
