## BAT SURVEY AT

Brooklyn Place, Beckermest, Copeland, CA21 2XB

Author	Bradley Foster	Date	01/08/2022
Checked by	Andrew Gardner	Date	02/08/2022
Report Version	1		
Field data entered	<input type="checkbox"/>		
Report Reference	8023

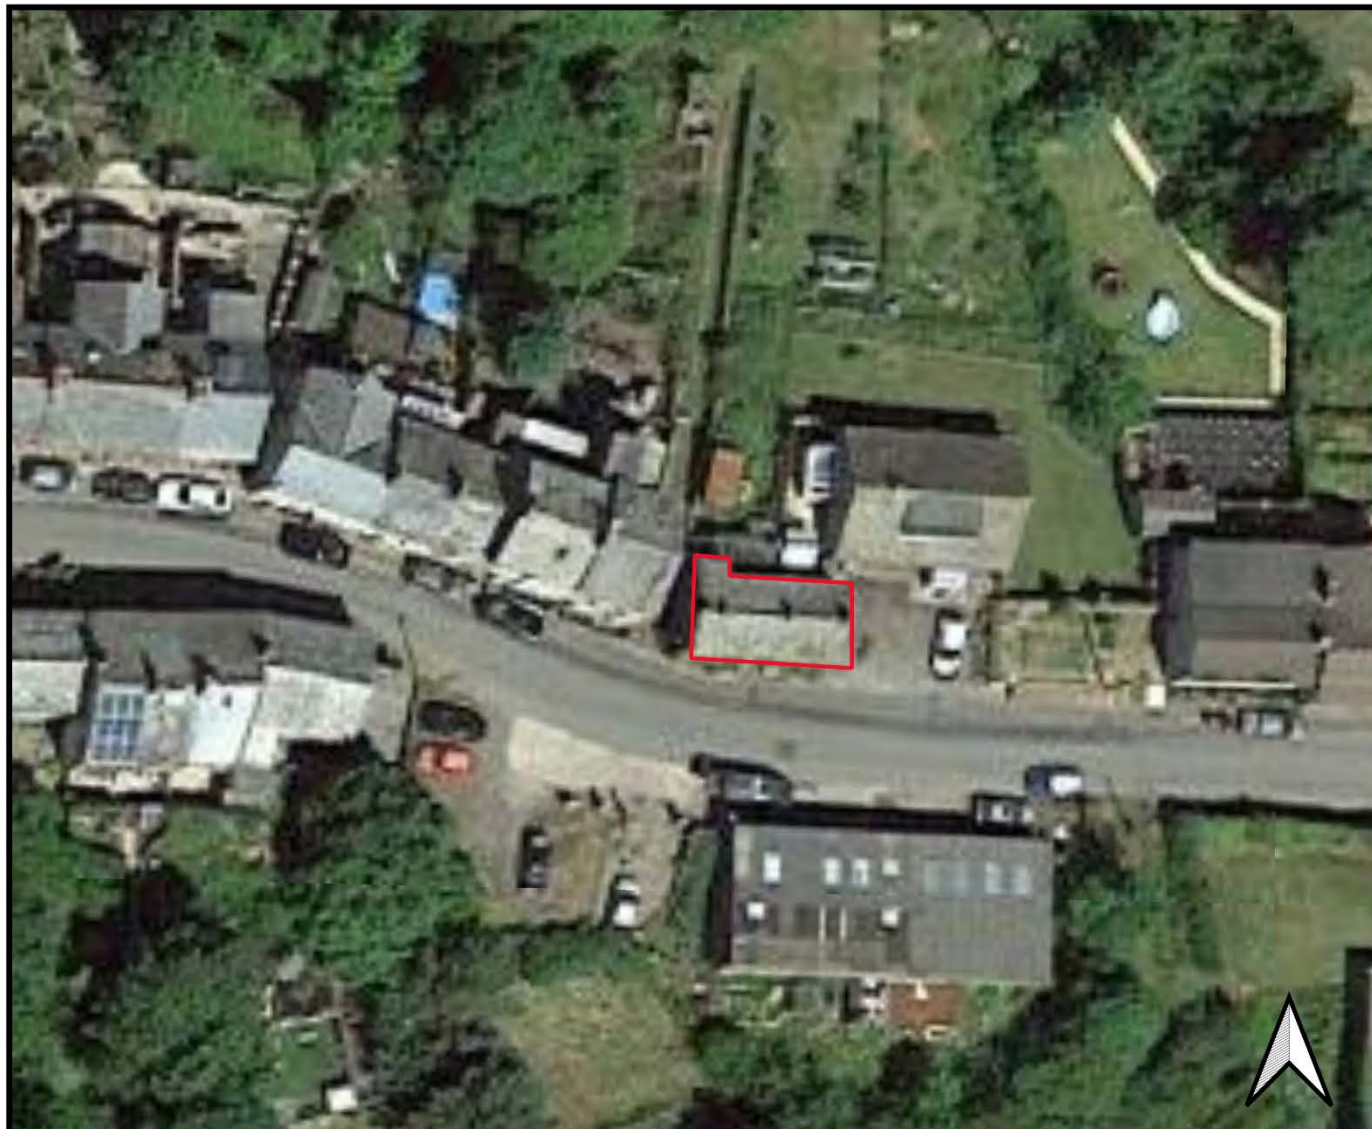
Figure 2  
Site boundary

Whilst there is riparian woodland to the north, the site sits in an exposed position directly along Nursery Road, central grid reference NY 02226 06699 (Figures 1 and 2).

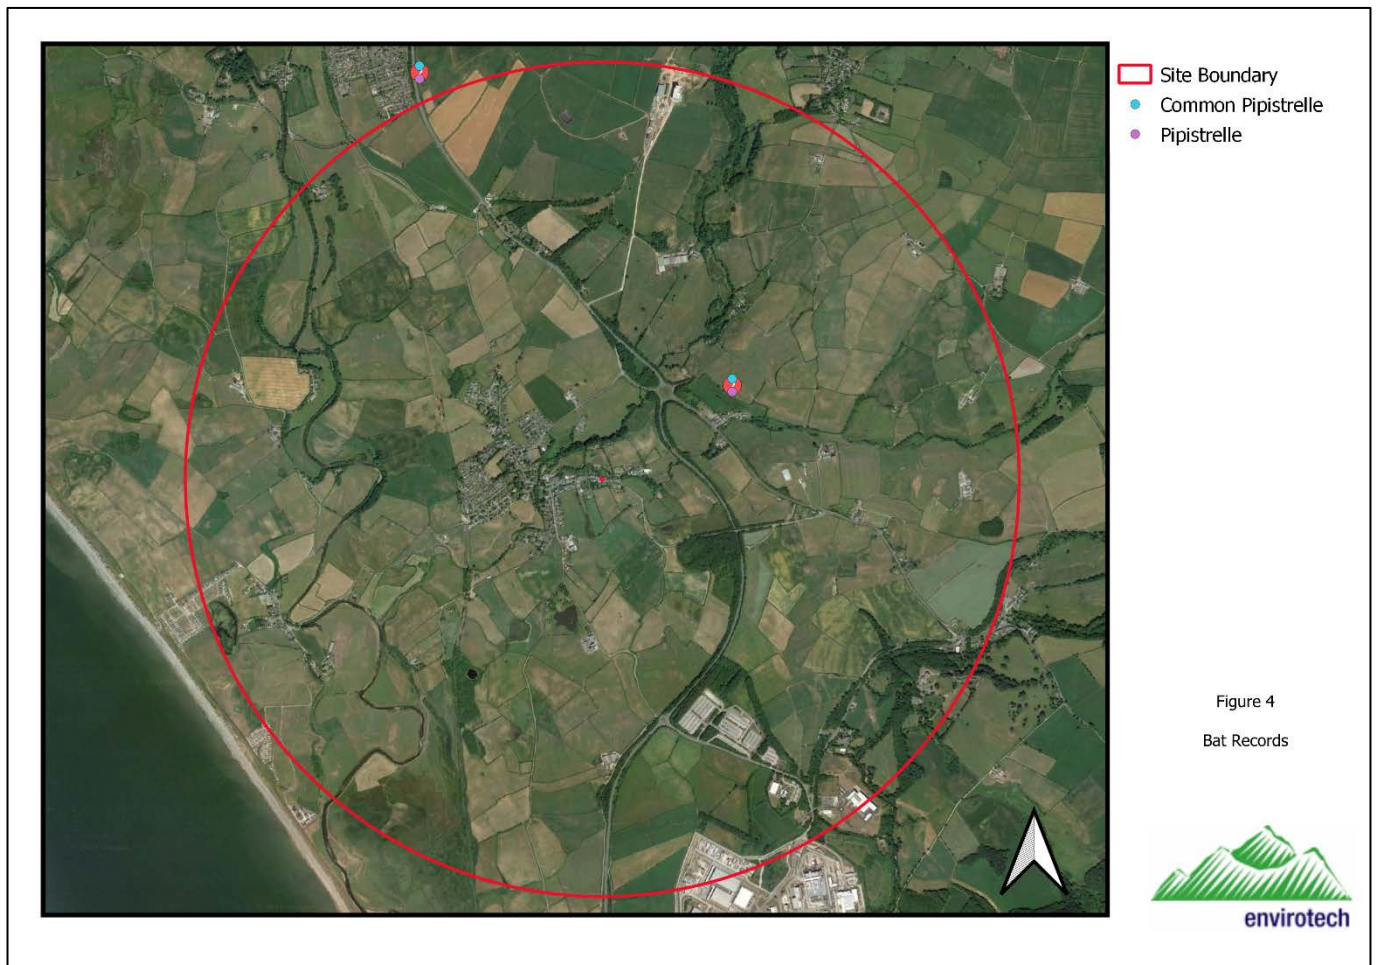
A search of the Envirotech dataset returned two records of two bat species within 2km of the site. These records are located 770m to the north-east, towards the village of Blackbeck. No records are present for the site itself.

Records are shown on Figure 4.

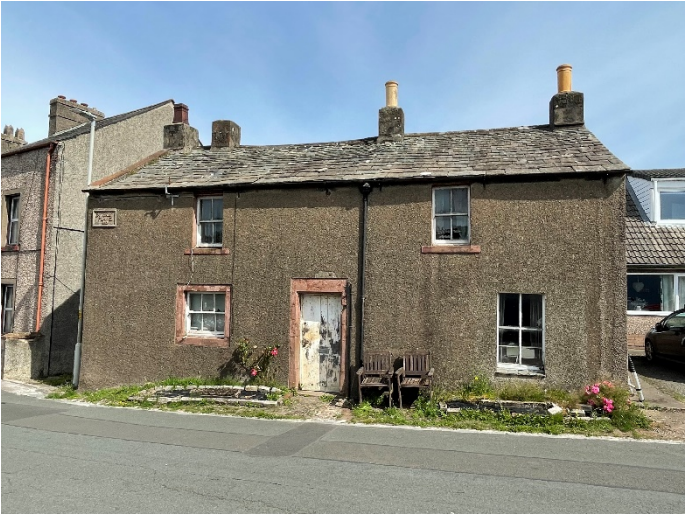
<p>The Cottage as seen from the front road (Nursery Road).</p>

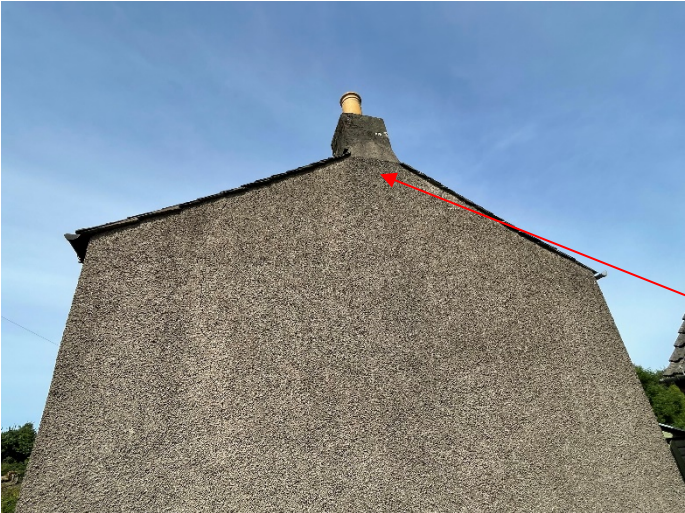
<p>The eastern gable end.</p> <p>The roof verge is well-sealed with mortar.</p> <p>An externally mounted bat box for crevice-dwelling bats could be installed on this wall.</p>

9. Consider the erection of an externally-mounted crevice-dwelling bat box on the eastern gable end of the property (as far away from the road and streetlights as possible). We consider the Kent bat box to be inexpensive, easy to install and maintain over time.

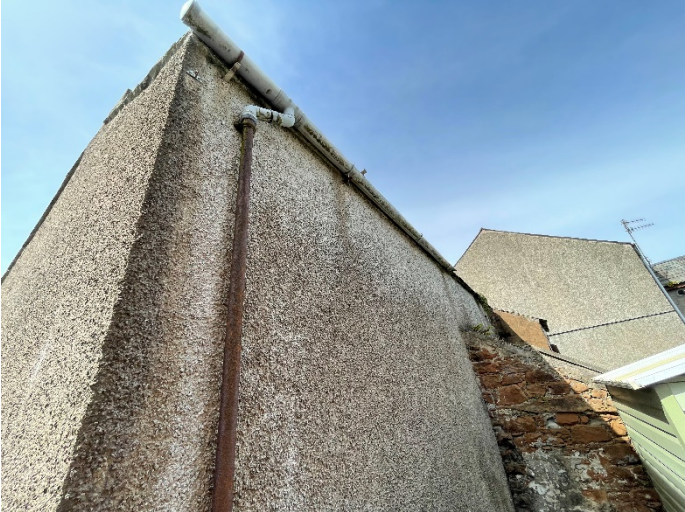
<p>The eaves were shallow and occupied with gutters.</p>

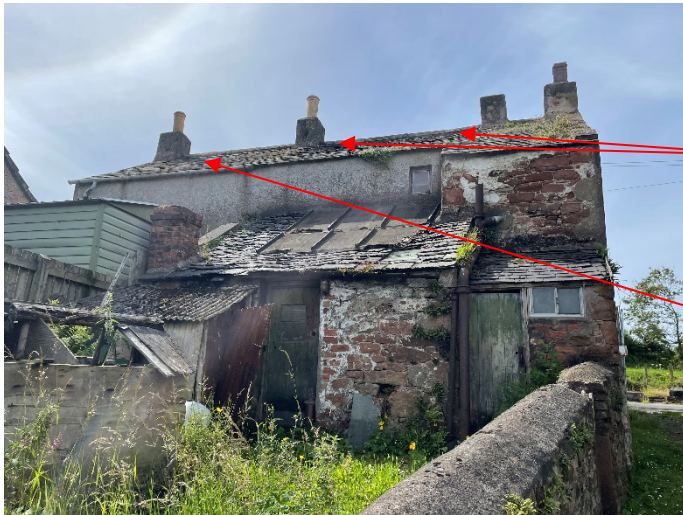
The roof of the cottage is made from slate and is partially lined with a traditional membrane. The eastern half of the cottage's roof, whilst aged, is in good condition, with no broken or raised slates noted. This area of the roof is fully lined on both pitches. The western half of the cottage's roof is in poorer condition- bowing in the centre. The presence of half a dozen metal slate hooks suggests some repair work has been conducted on this section of roof in the past. Owing to the roof bowing in this area of the cottage, gaps are present beneath some of the slate tiles. The full extent of these gaps could be seen from the ground with close focus binoculars and a 1,000,000-candle power torch. No indications of use by bats- such as presently roosting bats, droppings, urine/oil staining, scratch marks or damaged/removed moss could be found around or beneath these slates. Checking

with close focus binoculars and a torch revealed these gaps to be shallow. The rear pitch of the western half of the roof is unlined, meaning any use of this area of roof (where the cottage's bat potential is highest) would result in droppings being deposited internally. No droppings were found internally in the cottage's loft space. The ridgeline of the pitched roof consisted of concrete tiles that are fully overlapping and well-sealed with mortar along their base.

The rear of the property. Small gaps beneath some of the slate tiles are present on the western half of the roof.

The eastern half of the roof is in good condition.

6. Remove all roof coverings by hand only.
7. Create at least 8 gaps along the eave lines of the cottage. This can be done onsite by the builders and costs nothing to implement. This will allow access to the wall tops under the eaves during any re-roofing which is undertaken. A plan for this type of roost is shown on Figure 9. These potential roost sites will be a significant improvement on existing site conditions.

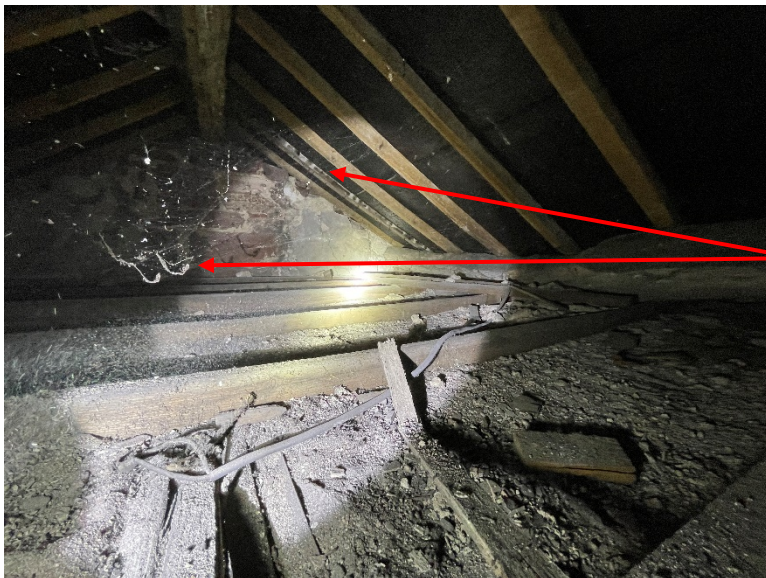
The cottage's roof void is split in two with a textured sandstone wall. The eastern roof void is well-sealed, containing timber beams in good condition with no rot, splits or gaps suitable for roosting or hibernating bats. There was a good covering of cobwebs under the roof and spanning the internal space. The roof membrane is also in good condition.

The eastern roof void is well-sealed. Cobwebs span the entire internal space.

No evidence of bats was present.

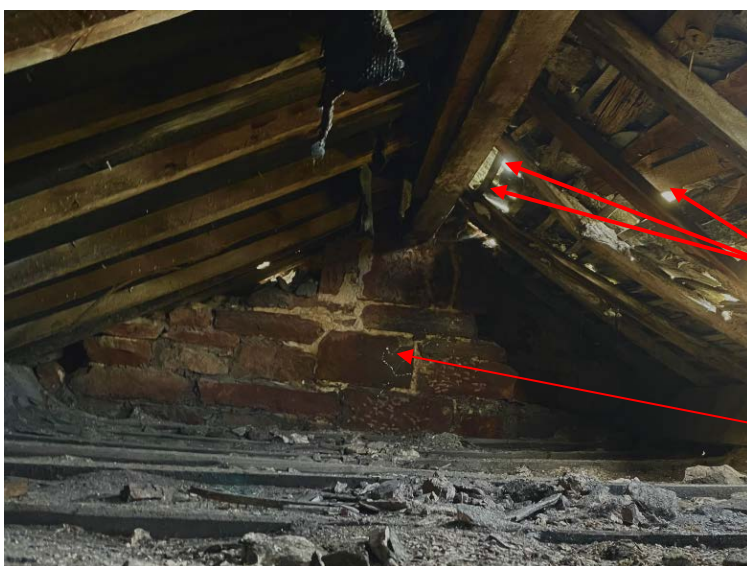
The western roof void is of identical dimensions. Gaps beneath some of the slates were visible from the inside of the roof where the wooden purlins had bent/becomes dislodged. The timber in the rear pitch of the western roof void is therefore in poorer condition than found elsewhere in the cottage- though it was also free of any rot. This roof void was draughty owing to only the front pitch being lined. There was a good covering of cobwebs beneath both sides of the ridge beam, in addition to the internal space and over the surface of the dividing wall.

The western roof void. The rear pitch is unlined.

Some gaps beneath the slates can be seen from the inside of the roof, most likely as a result of the roof bowing and subsequent moving of the wooden purlins.
