## BAT SURVEY AT

Reading Room, Beckermeth, CA21 2XS

Author	Bradley Foster	Date	01/08/2022
Checked by	Andrew Gardner	Date	02/08/2022
Report Version	1		
Field data entered	<input type="checkbox"/>		
Report Reference	8050

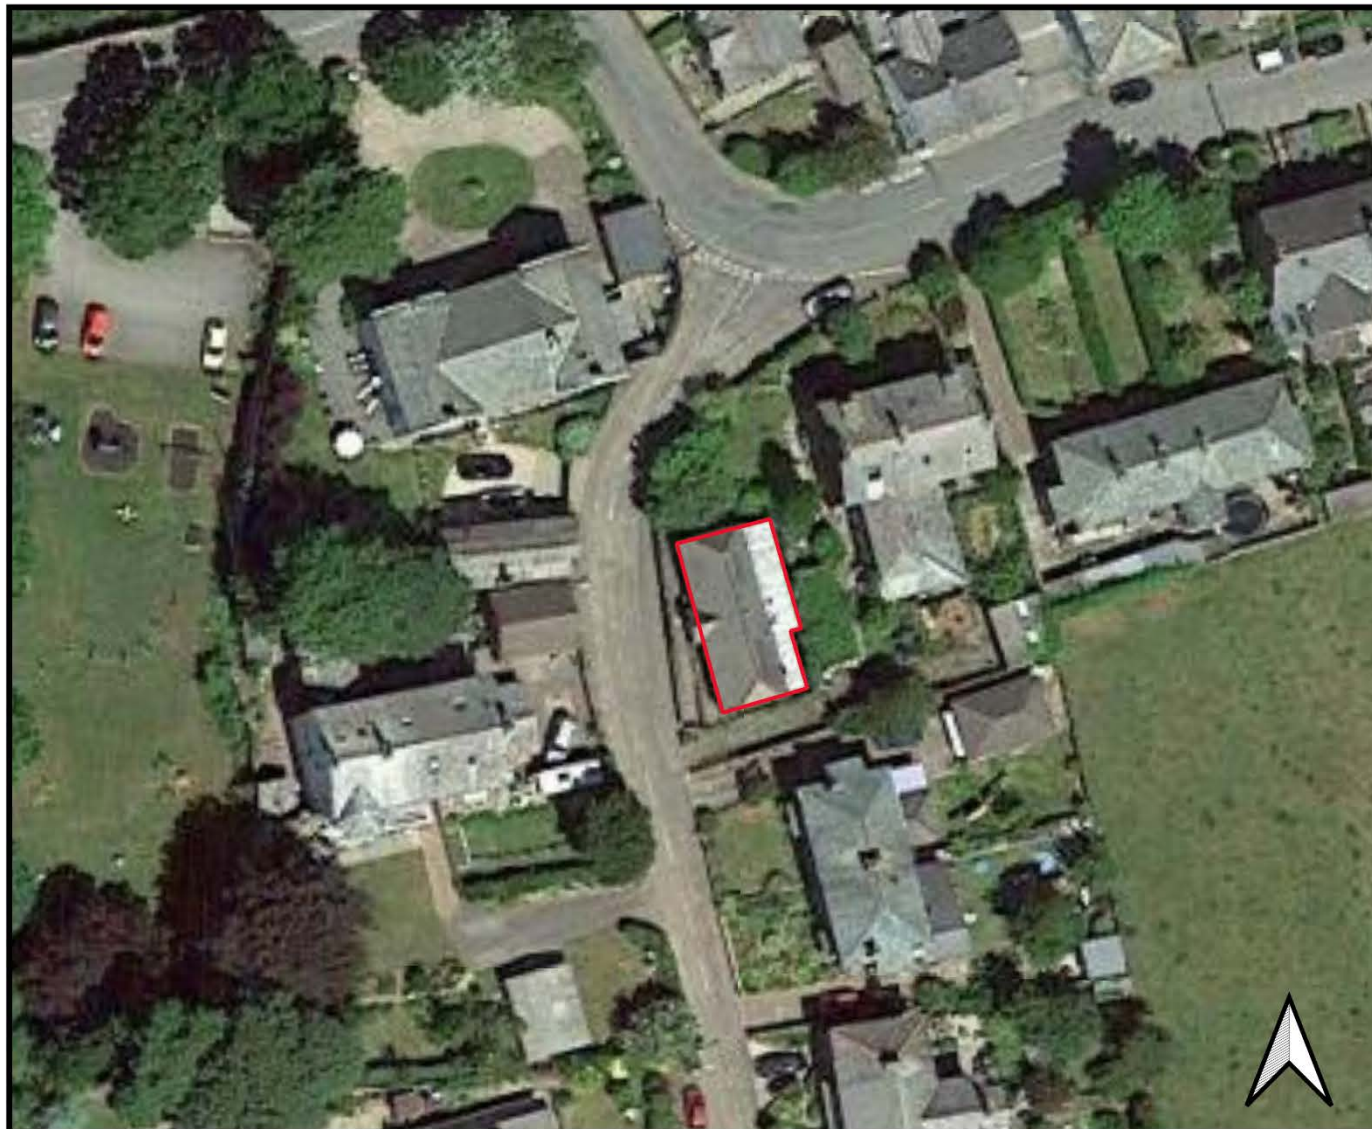
Site Boundary

Whilst there is riparian woodland to the north-east, the site sits in an exposed position near the junction between Nursery Road and Sellafield Road, central grid reference NY 01990 06630 (Figures 1 and 2).

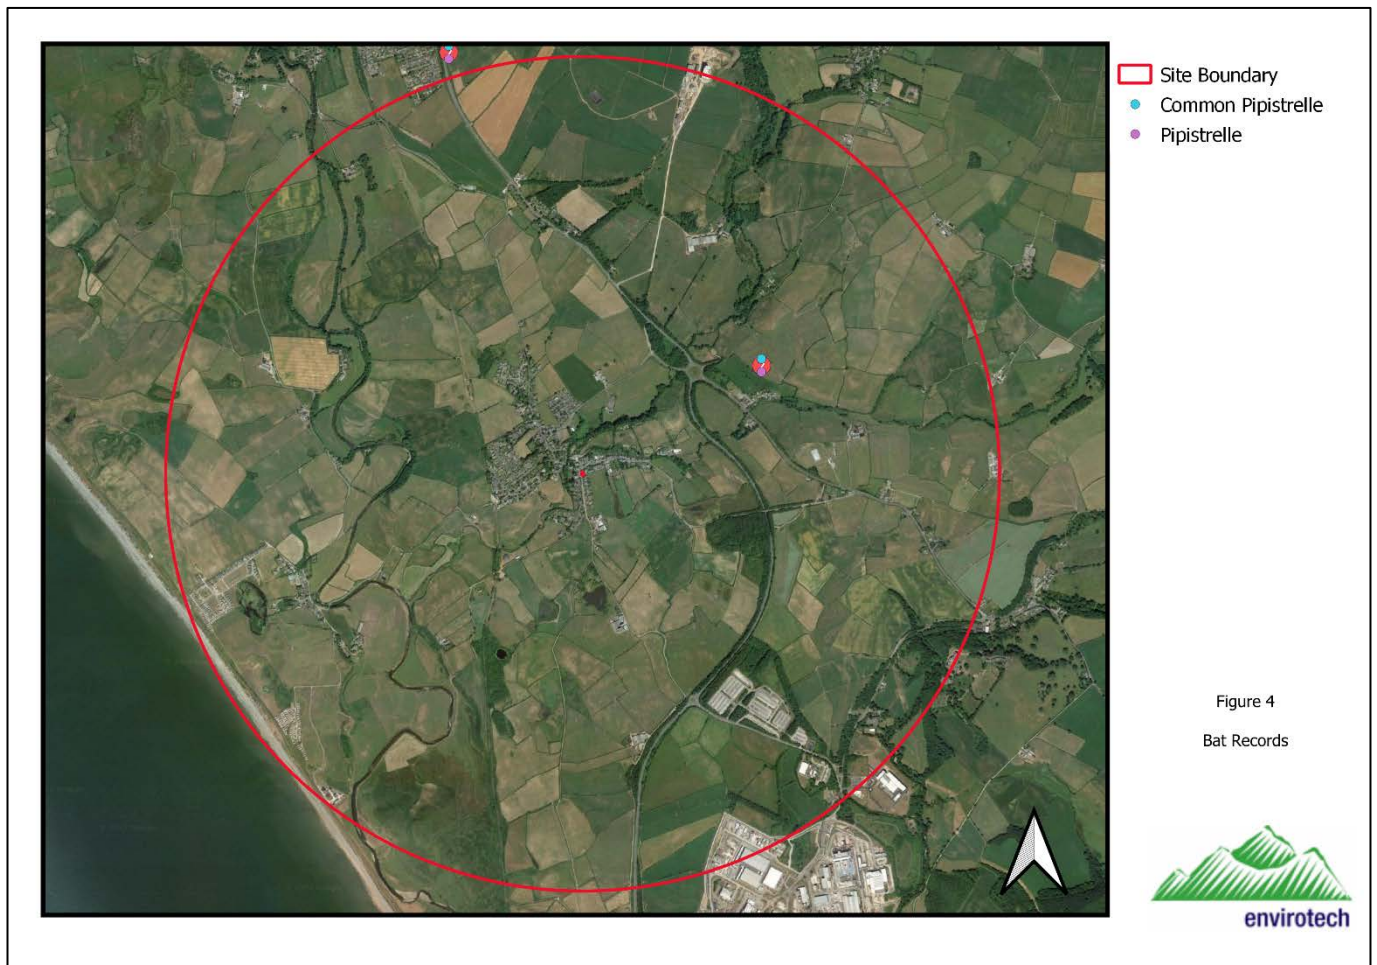
A search of the Envirotech dataset returned two records of two bat species within 2km of the site. These records are located 1km to the north-east, towards the village of Blackbeck. No records are present for the site itself.

Records are shown on Figure 4.

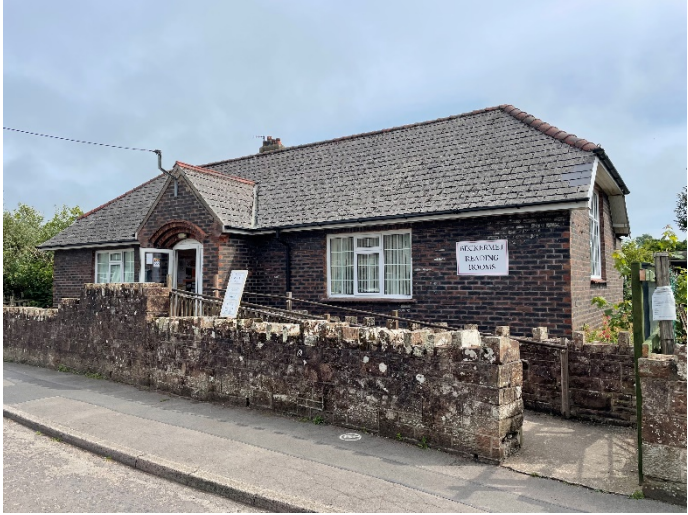
<p>The front of the building (looking north-east from Sellafeld Road).</p>

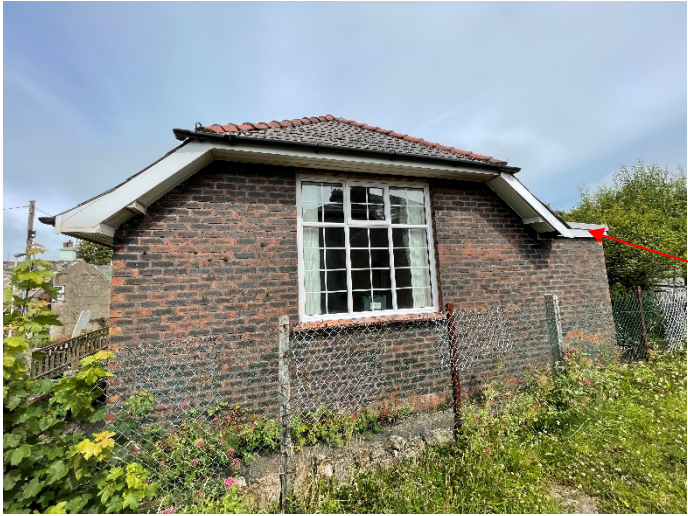
The soffit and fascia boards consist of overhanging uPVC panelling. Whilst the majority of the material is in excellent condition, some of the soffit boards appear loose and/or broken, such as in the south-east corner of the site- which has previously been occupied by nesting birds. This soffit board was inspected with a torchlight and found to be blocked 10 inches in with nesting material. No evidence of use by bats was present.

<p>Beneath the large jerkinhead roof are large, overhanging soffit and fascia boards.</p> <p>The location of the broken soffit board.</p>

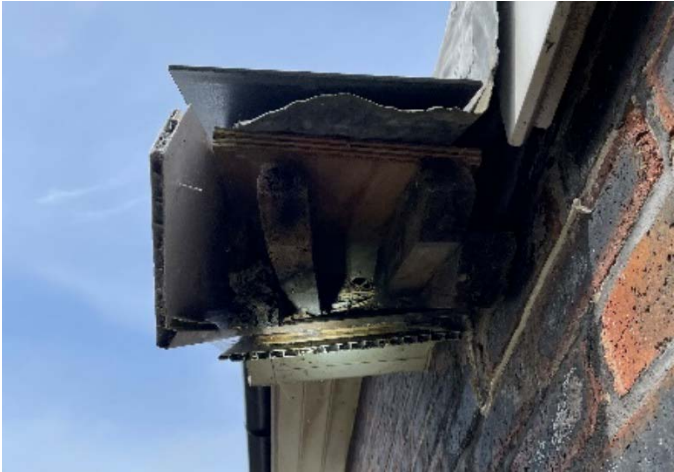
A vacant bird's nest is present behind a broken soffit board in the south-east of the site. The site should be rechecked for nesting birds if work is to commence in the period March-September inclusive.

<p>A vacant bird's nest was found approximately 10 inches into the soffit void.</p> <p>The internal space was blocked entirely with nesting material. No evidence of bats was present.</p>

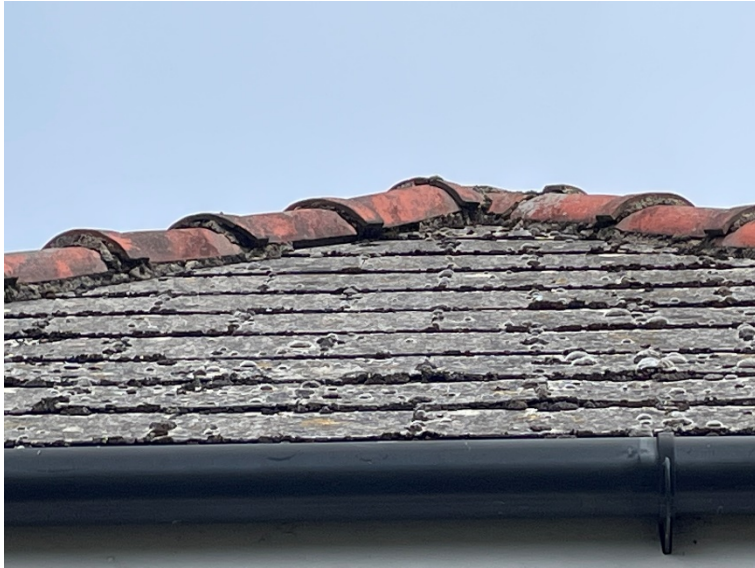
consist of clay tiles which remain fully overlapping and lined with mortar along their base. To the rear of the property is a small flat-roofed extension covered with intact lead flashing. The full extent of both roof types could be seen using close focus binoculars and a 1,000,000-candle power torch. No indications of use by bats could be found in these areas of the building's roof.

The hips of the roof remain overlapping and well-sealed with mortar.

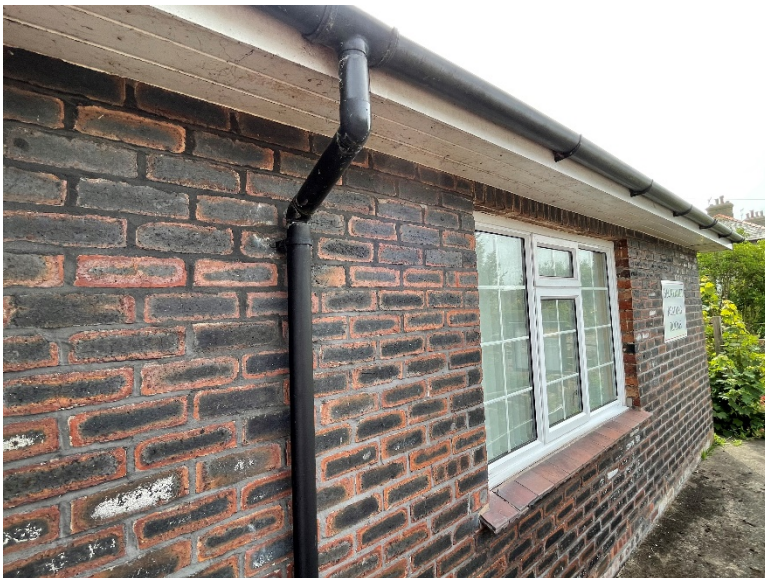
The soffit and fascia boards are mostly well-sealed. There are no gaps along the wall tops.

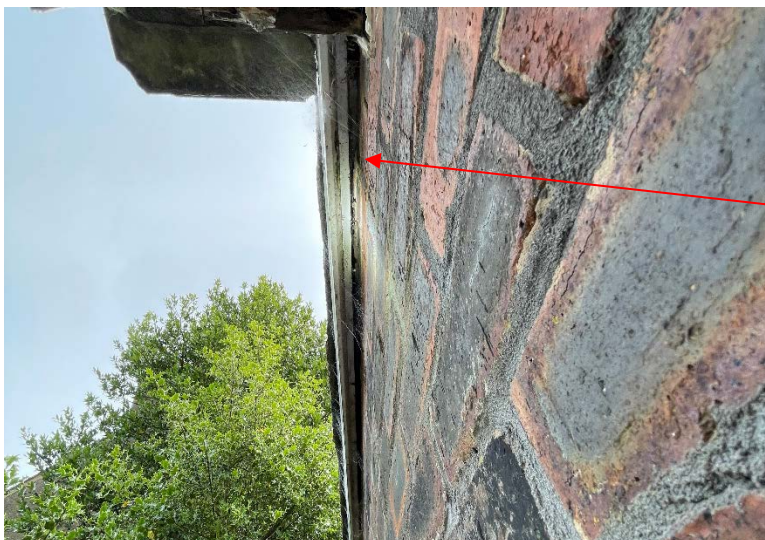
The bargeboards site flush with the clay brick walls and are covered with overlapping cobwebs.

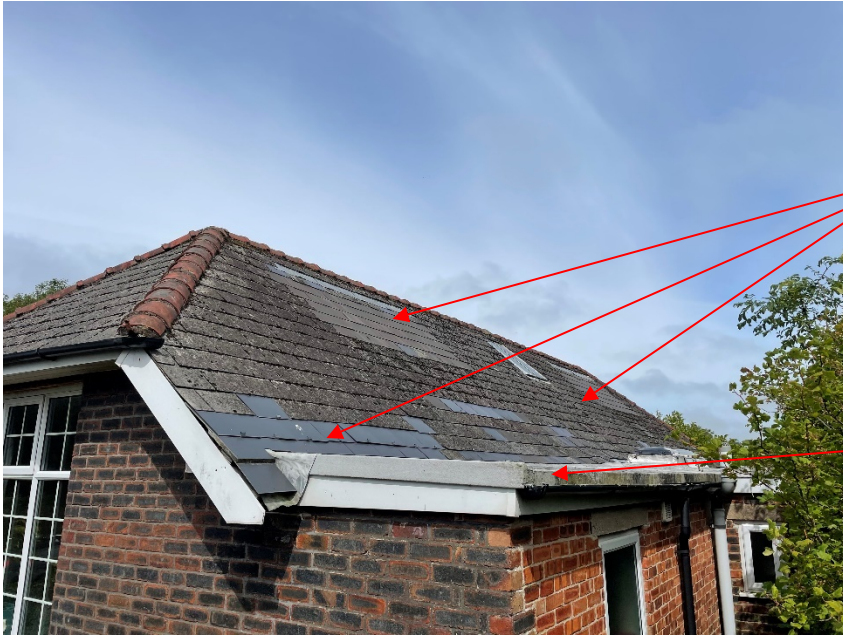
The roof of the building is made from felt shingle and is lined. Both pitches of the property are in good condition, with no raised, slipped or missing felt tiles evident. Moss and other bryophytes have colonised some areas of the western facing pitch, such as along the junction between individual shingle tiles. A large amount of historic repair work has been conducted on the rear pitch, with much of the felt shingle having been replaced with flat sheet metal shingle. The hips of the roof

Multiple sheet metal shingle repairs have been conducted on the rear roof pitch.

The small flat-roofed extension is topped with lead flashing.

6. Remove all roof coverings by hand only.
7. Create at least 8 gaps along the eaves lines of the building which allow access to the wall tops under the eaves during any re-roofing which is undertaken. A plan for this type of roost is shown on Figure 6. These potential roost sites will be a significant improvement on existing site conditions.

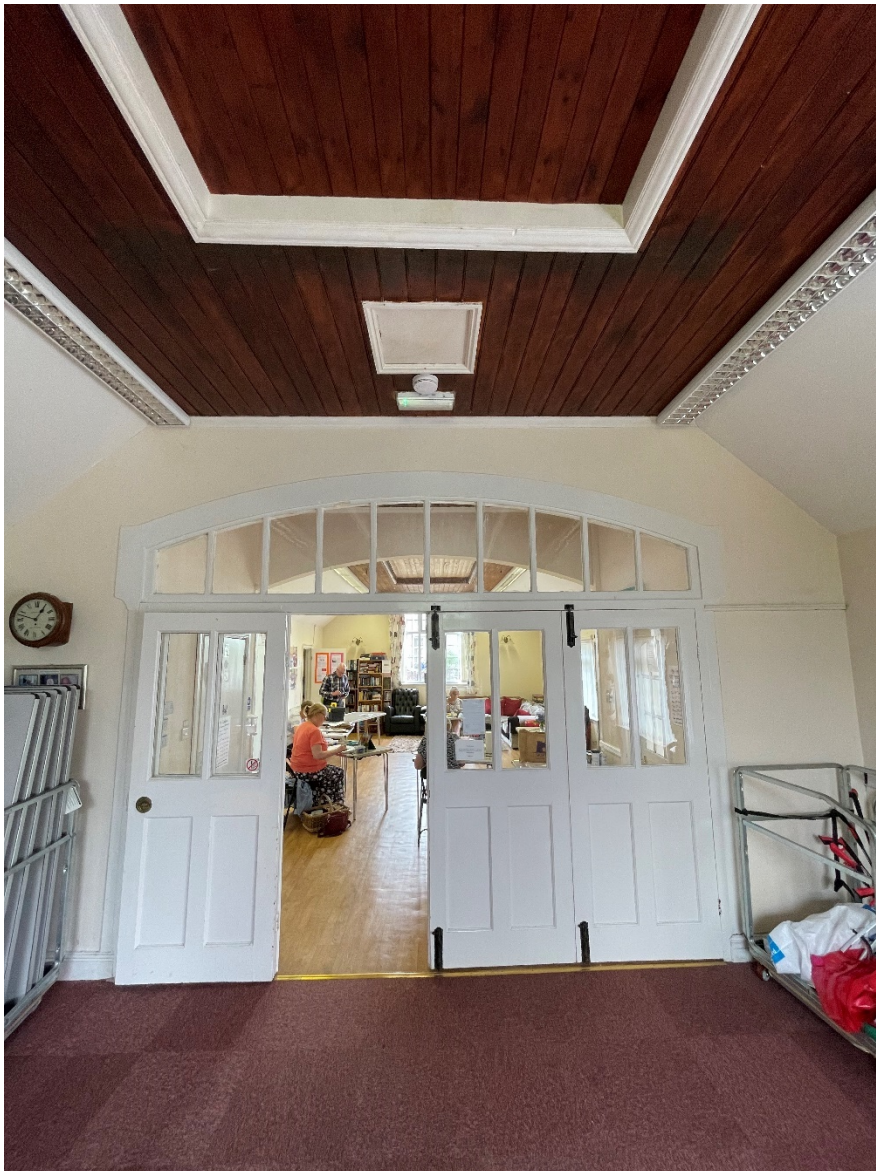
The building has a vaulted ceiling finished with wood panelling. Resultingly, the only void space present is a shallow, triangular-shaped crawl space directly beneath the ridgeline. Owing to the height and hinged design of the loft hatch, only the void space directly above the hatch could be momentarily seen whilst on the ladders. For health and safety purposes the loft could not be fully inspected, nor could it be photographed whilst on the ladder. Owing to the small dimensions of the crawl space and good condition of the roof, we deduce that the roof void space likely possesses a low potential for use by roosting bats.

The ceiling has been vaulted and finished with wood panelling.

The roof void space could not be fully inspected owing to height of the hatch.

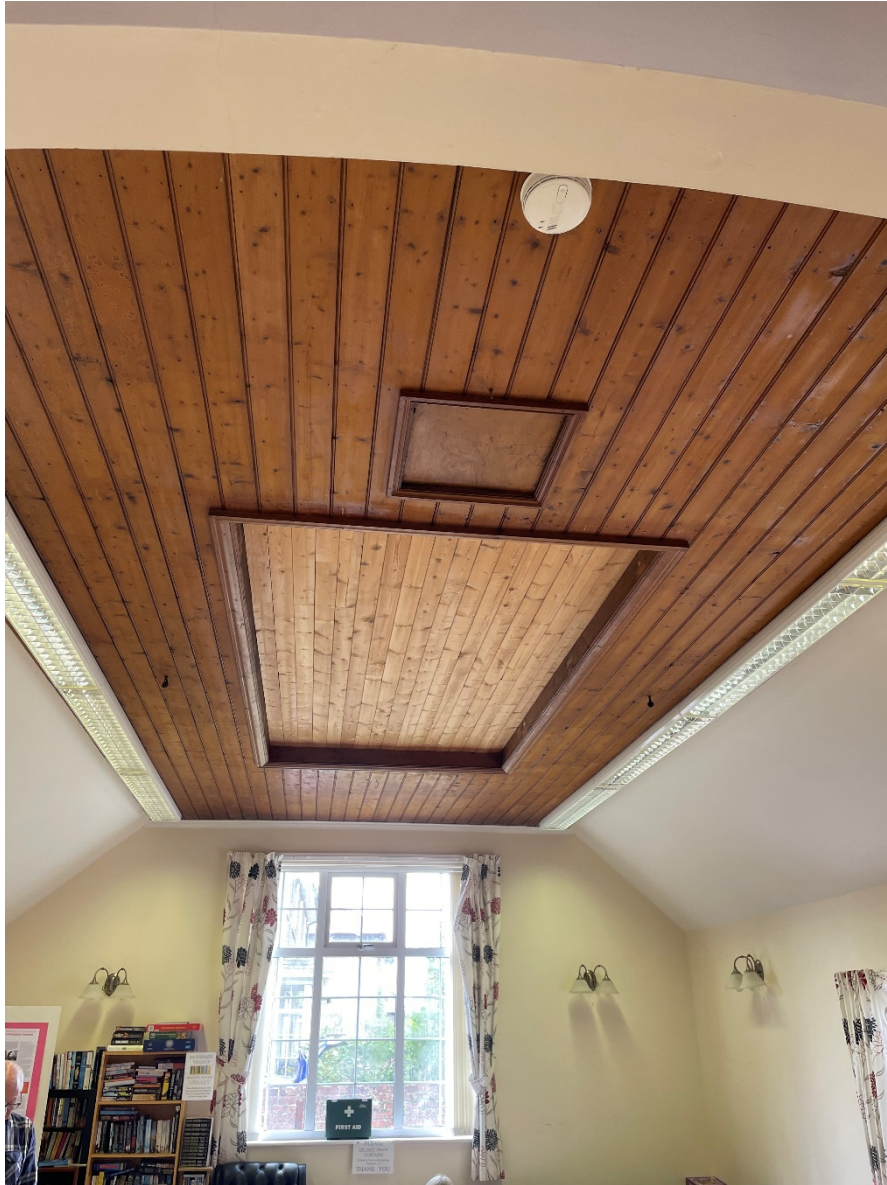
A second loft hatch is present in the hall's main room.

This hatch could not be accessed for the same reasons as above.
