## DESIGN & ACCESS STATEMENT

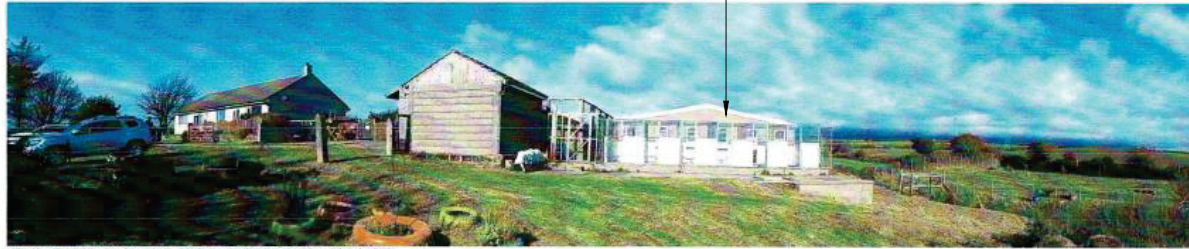
VIEW 07 - VIEW OF BUNGALOW, KENNEL COMPLEX AND SENSORY GARDEN LOOKING NORTH

● EXISTING KENNELS TO BE DEMOLISHED

Since the 'surface' repairs and upgrades have been completed there has been further degradation of the main unit structure and grounds which are now causing serious issues to the building fabric. The surface coatings of the concrete floors are lifting due to the crumbling and splitting of the main concrete base, the walls are also crumbling, and the gaps are attracting vegetation into the dog areas.

The kennel surface deterioration is making cleaning and maintenance impossible. Flaking paint from the concrete floors impacts directly on the welfare and safety of the dogs in situ. Further general work on the kennels is neither practical nor cost effective and a waste of valuable resources. The management team have considered this at length and are of the view that full demolition with rebuild of a modern up to date kennel block is a more pragmatic option.

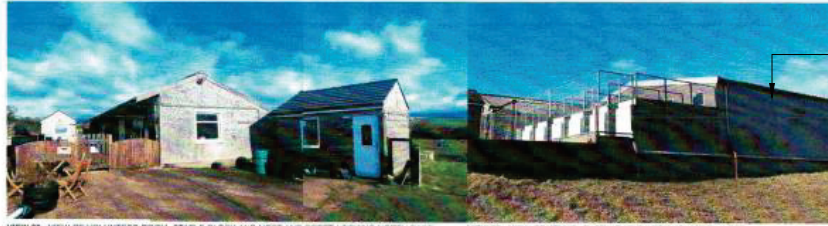
VIEW 08 - VIEW OF VOLUNTEER ROOM, STABLE BLOCK AND MEET AND GREET LOOKING NORTH EAST

● EXISTING KENNELS TO BE DEMOLISHED
